PERMIT INFORMATION

Permit Number: C-1981-018 Mine Name: Deserado Mine Operator: Blue Mountain Energy, Inc. Operator Address: Mr. Kurtis Blunt 3607 County Road 65 Rangely, CO, 81648	County: Moffat, Rio Blanco Operation Type: Underground Permit Status: Active Ownership: Private
	Operator Representative Present: Kurt Blunt
Operator Representative Signature: (Field Issuance Only)

Inspection Start Date: November 28, 2023 Inspection Start Time: 10:20 Inspection End Date: November 28, 2023 Inspection End Time: 15:10		Inspection Type: Coal Complete Inspection Inspection Reason: OSM Oversight Inspection Weather: Cloudy	
Joint Inspection Agency: OSMRE		Joint Inspection Contacts: Thomas Medlin	
Post Inspection Agency: OSMRE		Post Inspection Contacts: Thomas Medlin	
Inspector(s): Clayton Wein Todd Jesse Travis Marshall	Inspector's Signature: <i>Clayton Wein</i>		Signature Date: 12/13/2023

This report documents the Division's observations taken during a complete inspection of the Deserado Mine conducted on November 28, 2023. The inspection was also an Office of Surface Mining Reclamation and Enforcement (OSMRE) Complete Oversight Inspection. This report was written by Clayton Wein of the Div

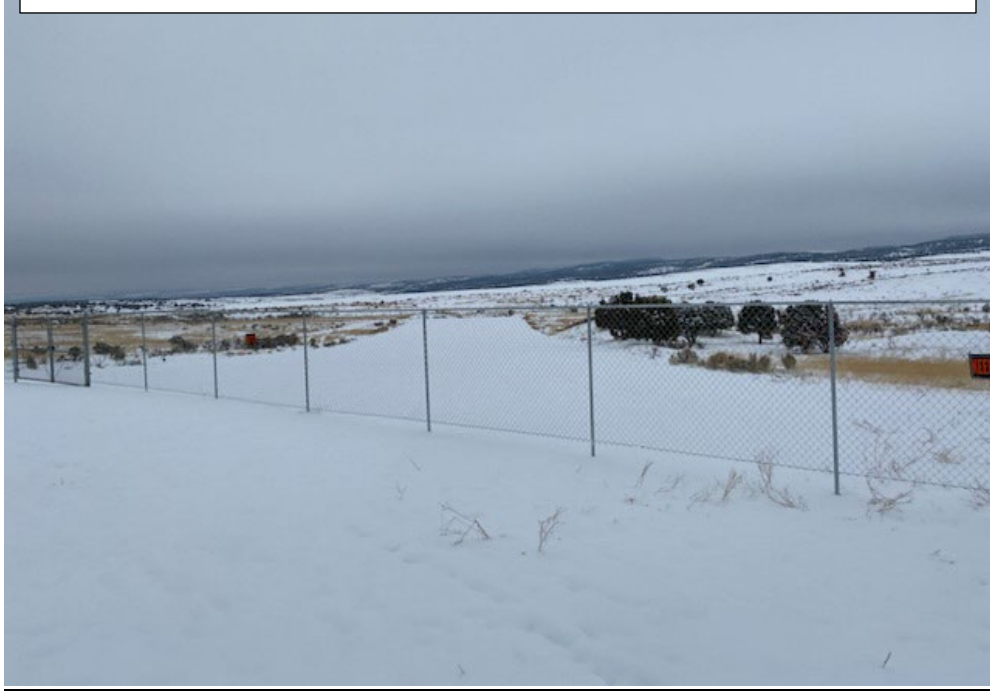
The Halandras Landfill is located north of the main facilities area and just west off of County Road 65 (CR-65). The landfill had been retired BME during the fall of 2023 (Photo 1). The pits have been backfilled and graded to approximate original contour. BME is waiting to replace the topsoil until the spring of 2024 to allow time for any settling of the subsoil to occur. The site was stable with no indications of erosional features. Snow completely covered the landfill during the inspection. The operator's representative stated that the landfill's sump will remain in place until reclamation at the site has been completed. There was a fence installed between the backfilled landfill and the access road to deter people from dumping their trash at the site.

Photo 1: The Partially Reclaimed Halandras Landfill.

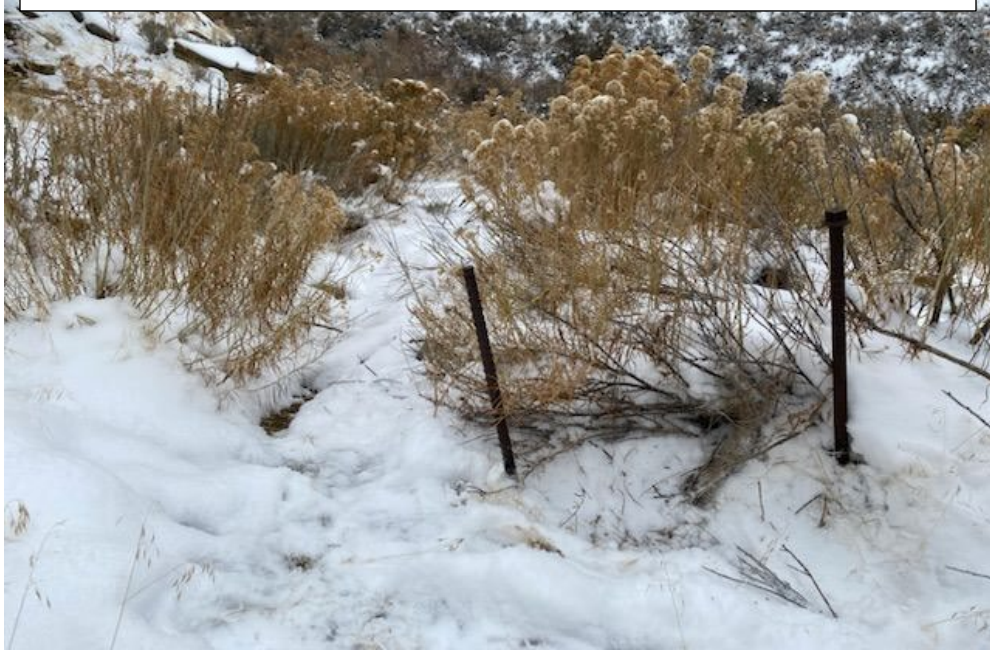
The explosives storage area for the Deserado Mine is located at the southern end of the main facilities area. The storage consists of a pad with a storage bunker for the explosives. The cut and fill slope for the pad were stable with no erosional features. The berm for the pad was stable with vegetative cover. Runoff from the pad is directed to an outlet at the southern end of the pad and passes down a channel through straw bales. **During the inspection, the straw bales were noted to have deteriorated (Photo 2). Please replace the straw bales at the outlet to ensure runoff from the pad continues to be treated before leaving the disturbed area. The Division also identified several large fiberglass pipes laying on the north end of the pad. Please remove these pipes from the pad to an appropriate laydown area or dispose of the pipes if they are no longer usable.**

Photo 2: The Stakes at the Outlet Channel from the Explosives Storage Pad That Need to Have the Straw Bales Replaced.

1. During the inspection of the explosive storage area, the straw bales at the runoff outlet channel were noted to have deteriorated. Please replace the straw bales at the outlet to ensure runoff from the pad continues to be treated before leaving the disturbed area.
2. Several large fiberglass pipes laying on the north end of the explosives storage area pad. Please remove these pipes from the pad to an appropriate laydown area or dispose of the pipes if they are no longer usable.
3. A burrow was located on the southwestern part of the Last Chance Pond's embankment. Please plug the burrow.
4. Burrows were identified on the northwestern portion of the RP-4 pond's embankment. Please plug the burrows.

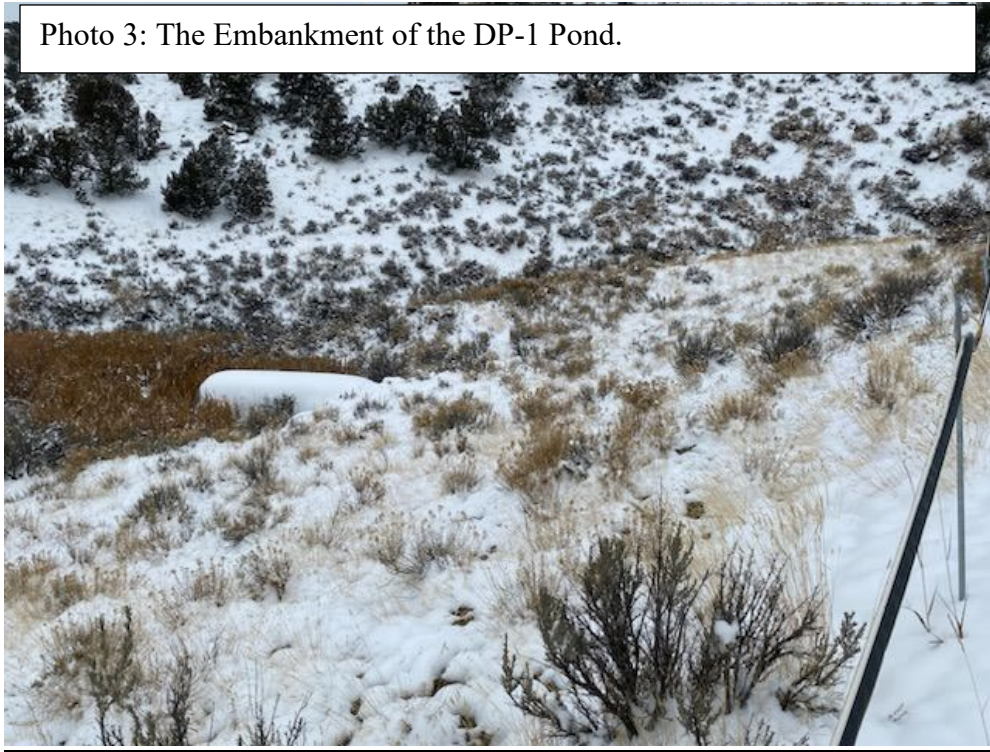
Photo 3: The Embankment of the DP-1 Pond.

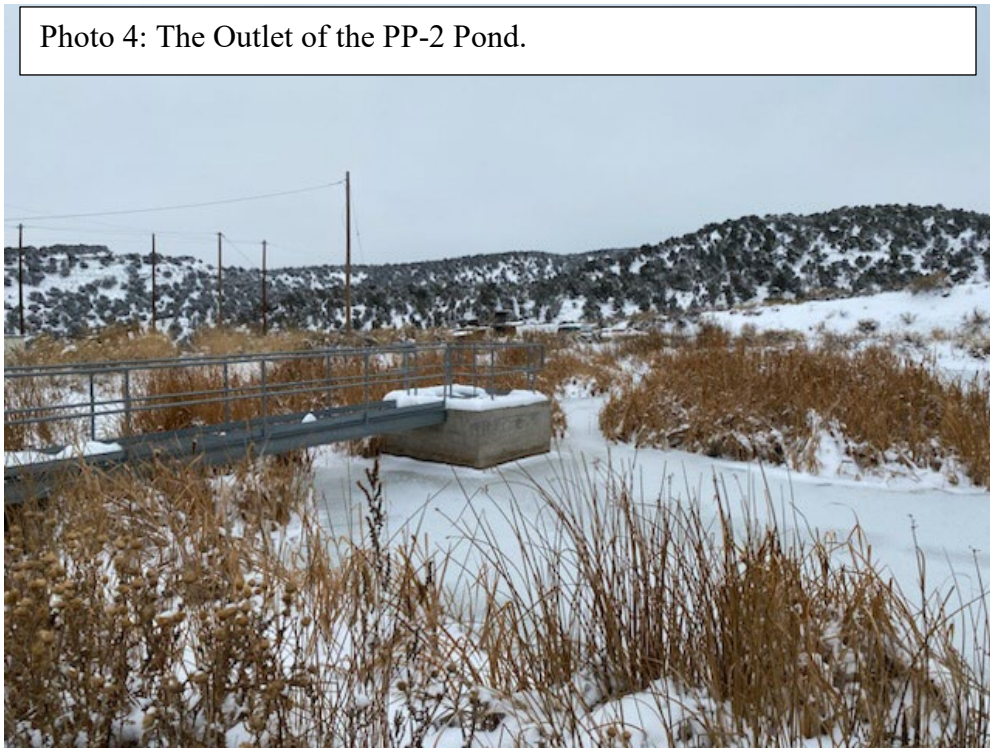
The main facilities area has three ponds located within it. The DP-1 Pond is located on the southern part of the lower facilities bench. DP-1 collects all runoff from the three main facilities benches. The pond was covered with snow and frozen over during the inspection. Discharge through the primary discharge outlet was observed. The trash rack for the outlet was unobstructed. There were no indications of instability or erosion observed on the embankment (Photo 3). The emergency spillway is a riprap lined channel located at the northwest corner of the pond. The channel was covered with snow and appeared to be stable. The PP-1 Pond is located on the middle facilities bench in the middle of the prep plant. The pond was frozen and covered with snow. There were no erosional features or signs of instability seen. No discharge was observed. The primary outlet was unobstructed. The PP-2 pond is located on the upper facilities bench. This pond was also frozen and covered with snow. The outlet for the pond was observed to be unobstructed (Photo 4). There were no indications of instability or erosion on the pond's embankment.

Photo 4: The Outlet of the PP-2 Pond.

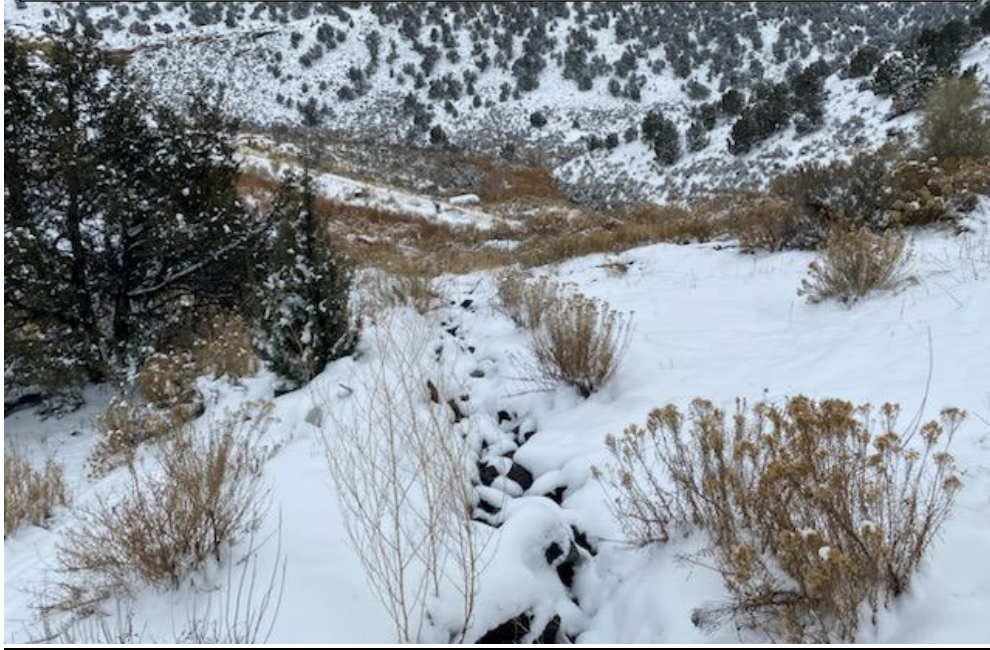
Water diversion ditches throughout the main facilities area were unobstructed and stable. Snowmelt was being properly conveyed to the DP-1 Pond. There were no signs of instability in the channels. Two armored channels convey runoff from the Middle facilities bench to the DP-1 Pond (Photo 5). The channels were covered with snow during the inspection. There were no indications of channel erosion or instability. There are several half culverts that transport runoff from the upper and middle facilities benches to the lower facilities bench. The culverts were unobstructed and stable.

Photo 5: One of the Ditches Leading from the Middle Facilities Bench to the DP-1 Pond.

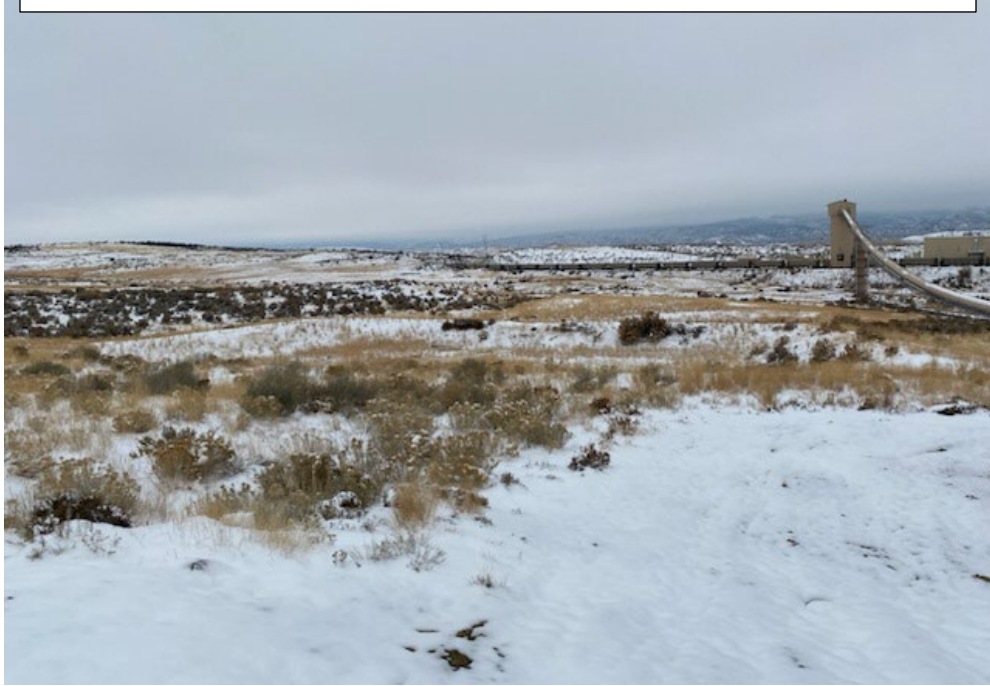
Photo 6: The SS-2 Pond.

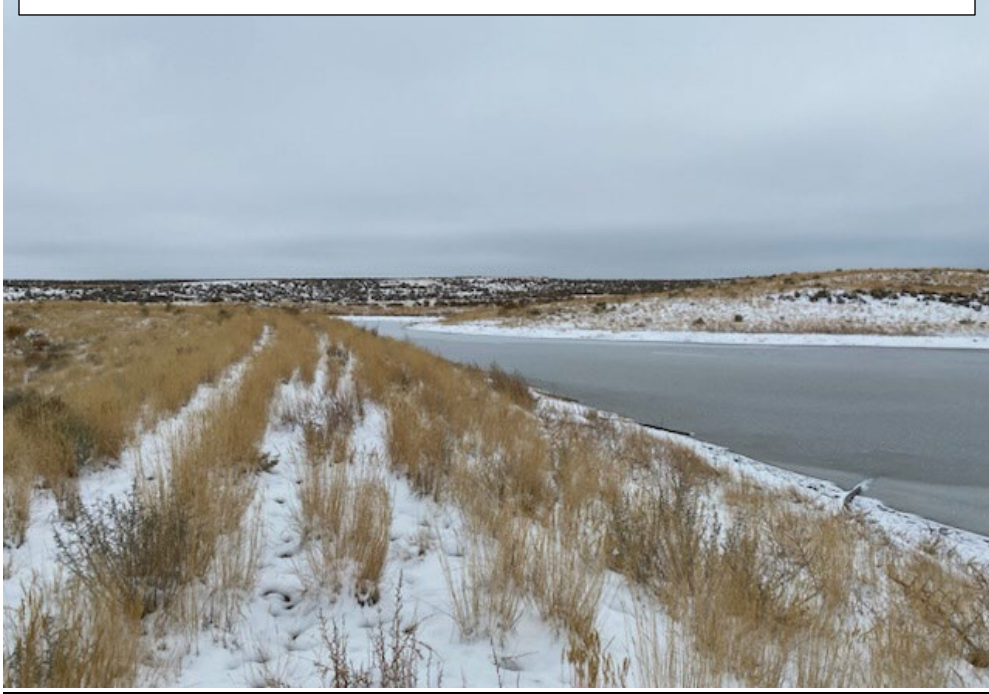
The B Seam Dewatering System #2 was inactive during the inspection. The dewatering system is located to the southeast of the Slot Storage. The upper and lower cells were covered with snow during the inspection. There were no indications of erosion or instability on the embankments. The middle cell was holding some frozen water in it below the level of the discharge outlet (Photo 7). The outlet was clear of debris. The embankment for the middle cell was stable and covered with snow. There were no indications of erosion observed.

Photo 7: The Middle Cell of the B Seam Dewatering System #2.

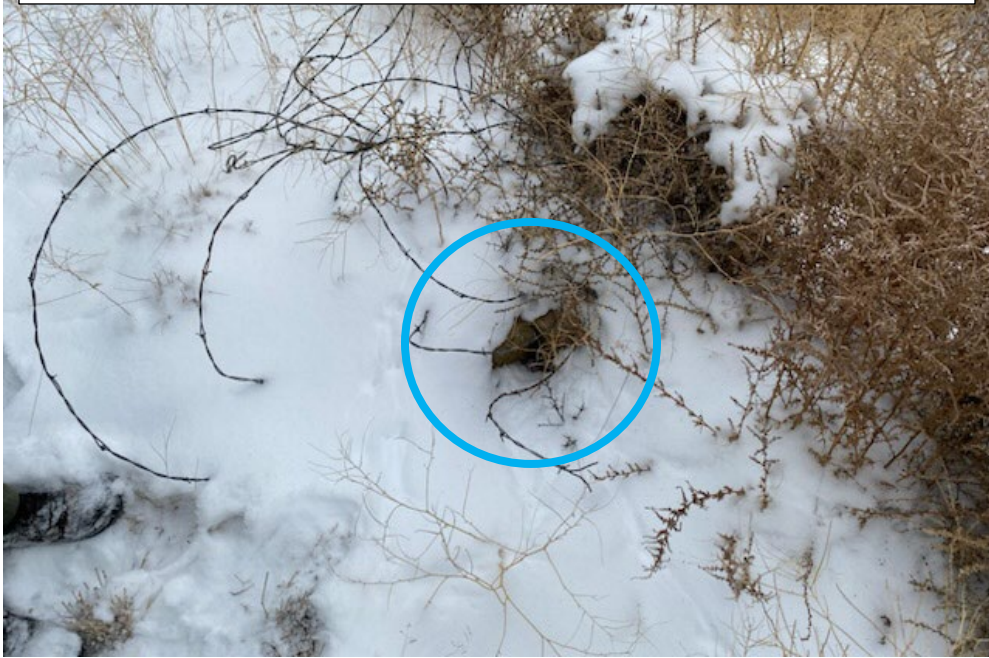
The B Seam Dewatering System #1 was holding water in all cells. Most cells in the system were frozen over with the exception of the first cell and the Last Chance Pond. Discharge through the concrete flume spillway at the Last Chance Pond was observed. The flume spillway was stable and there were no indications of undercutting. The embankments' throughout the dewatering system were covered with snow. There were no indications of erosion or instability. **A burrow was located on the southwestern part of the Last Chance Pond's embankment (Photo 8). Please plug the burrow.**

Photo 8: The Burrow Located on the Last Chance Pond's Embankment.

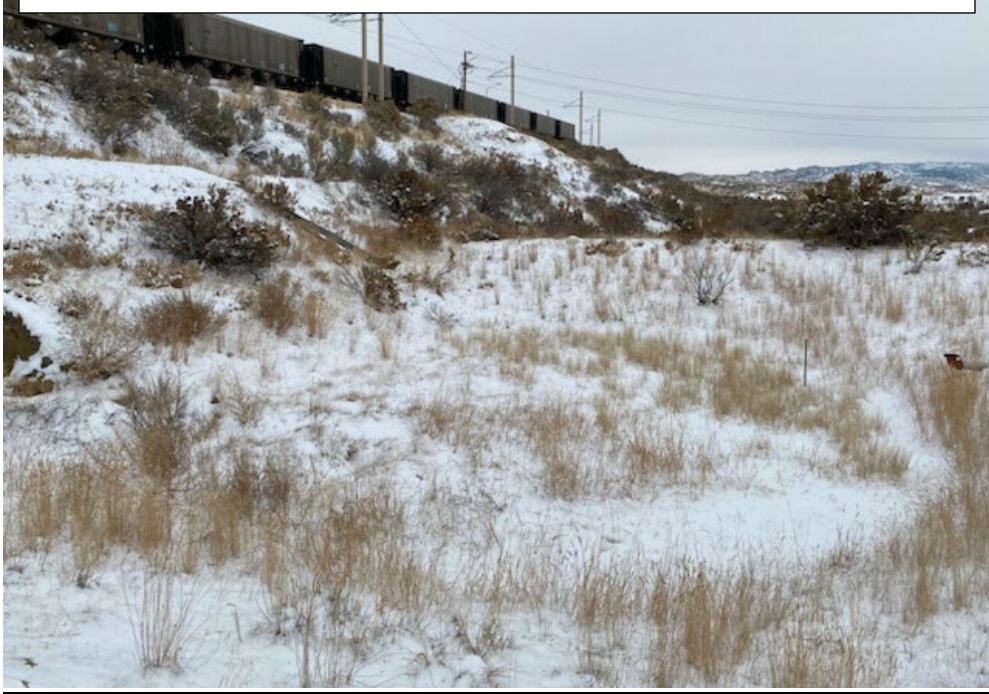
Photo 9: The RR-1 Pond.

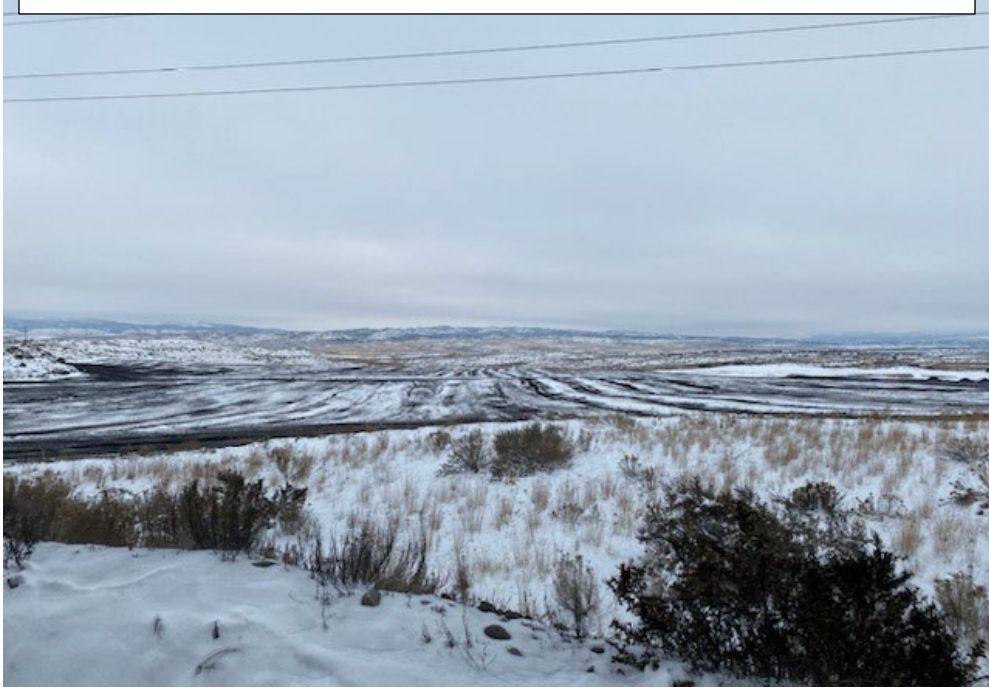
Three refuse piles are active at the Deserado Mine. The RP-2/3/4, RP-5a and RP-A piles. Slopes for the RP-2/3/4 and RP-5a piles were covered with snow. Minor rilling was observed on the slopes of the two piles. The rills have not yet reached the size of gullies and do not appear to affect the stability of the refuse piles. The rills will be graded and patched as a part of the spring maintenance that occurs at the mine. No other erosional features were observed on the RP-2/3/4 and RP-5a piles. No indications of instability were observed. The top of the RP-2/3/4 and RP-5a piles were exposed and appeared to have been graded and compacted. The tops of the piles are ready for the winter stockpiling of refuse material in windrows. The RP-A refuse pile was stable and there were no observed erosional features (Photo 10). Some refuse material had been stockpiled in small windrows.

Photo 10: The RP-A Refuse Pile.

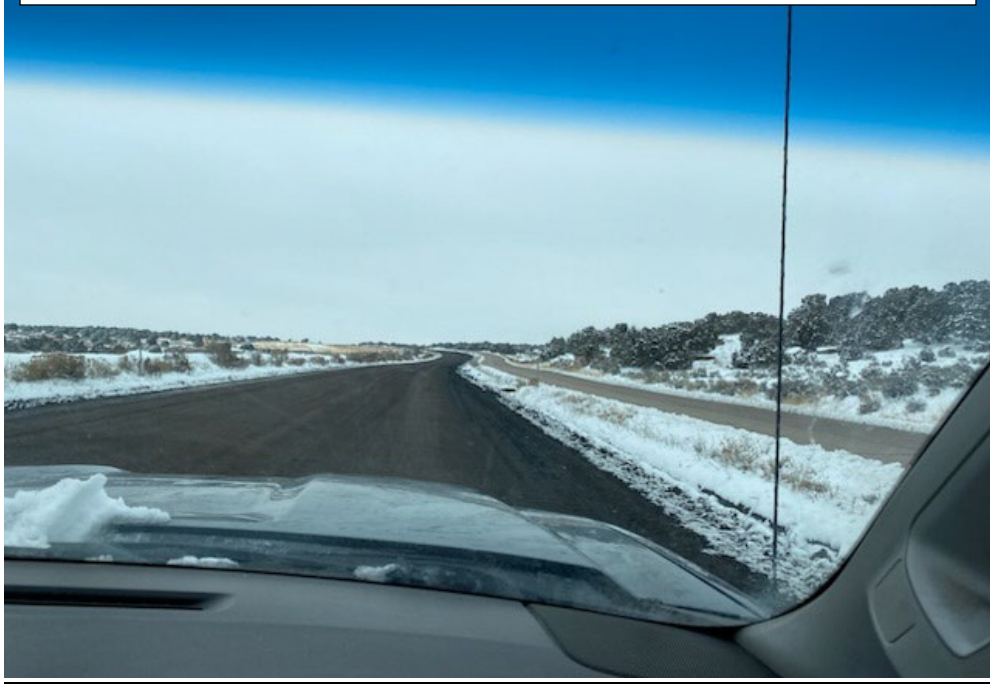
The haul road was cleared of snow and well maintained (Photo 11). There were no sections with ruts or other road damage. The ditches that parallel the road were covered in snow. There were no erosional features observed or indications of instability. The intersection of the haul road and CR-65 was cleared of snow.

Photo 11: The Southern Portion of the Haul Road.

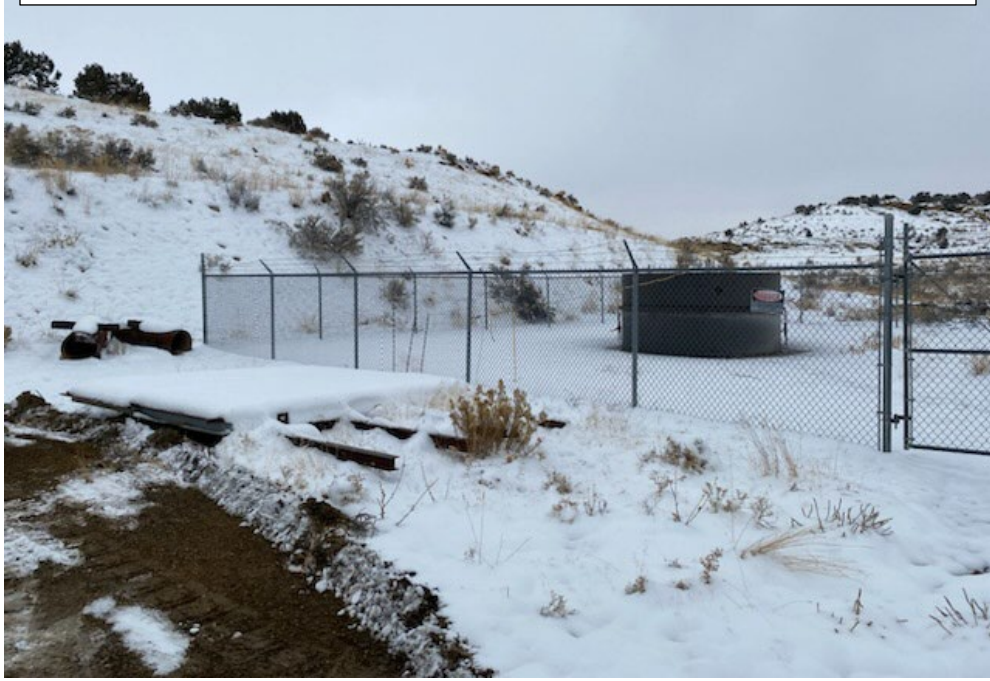
The B Seam Vent Shaft #1 pad is located north of the main facilities off of the haul road. The cut and fill slopes for the pad were stable with no erosional features (Photo 12). The safety fence surrounding the shaft was in good condition.

Photo 12: The B Seam Vent Shaft #1 Pad.

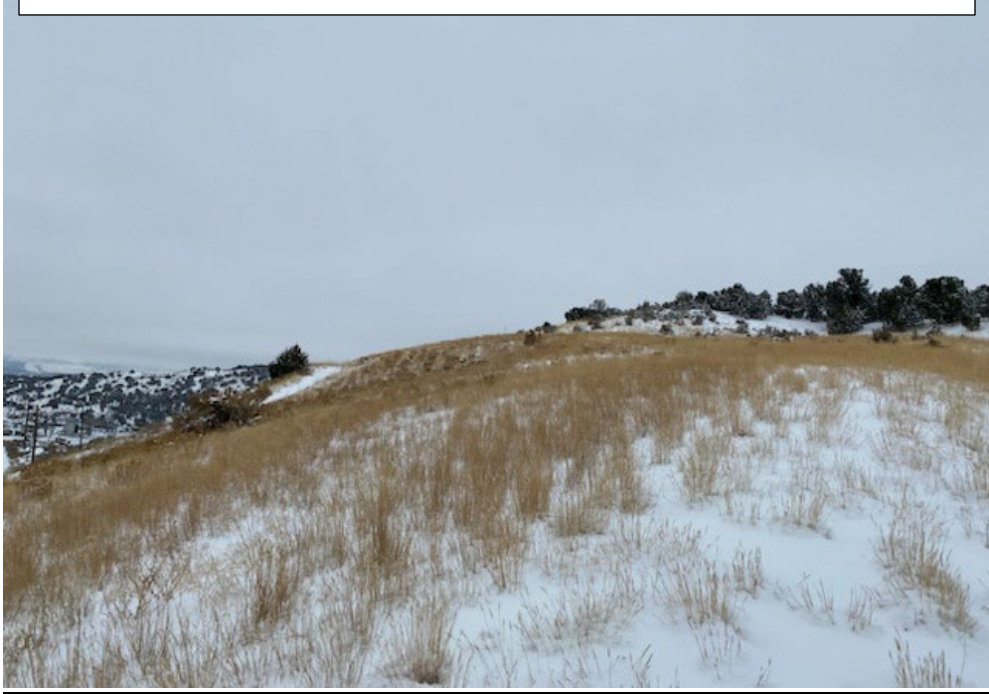
Various topsoil piles were visited during the inspection. The topsoil pile for the main facilities area (Photo 13), B Seam Vent Shaft #1 topsoil Pile, RDH-2 topsoil pile, Halandras Landfill topsoil piles, RR-1 Pond topsoil pile (Photo 14), Slot Storage topsoil pile, RDH-4 topsoil pile, B Seam Dewatering System #1 topsoil pile, RP-2/3/4 topsoil piles, RP-5a topsoil pile, various Access road topsoil piles, and various Haul Road topsoil piles. Topsoil stockpiles visited during the inspection were covered with snow. The piles did not exhibit any erosional features of concerns with stability. Topsoil pile markers placed on the tops of the piles were white PVC markers with topsoil written on them. The markers were placed in visible locations and easy to spot. Perimeter berms for the stock piles were also covered with snow. No indications of erosion were identified.

Photo 13: The Main Facilities Area Topsoil Stockpile.

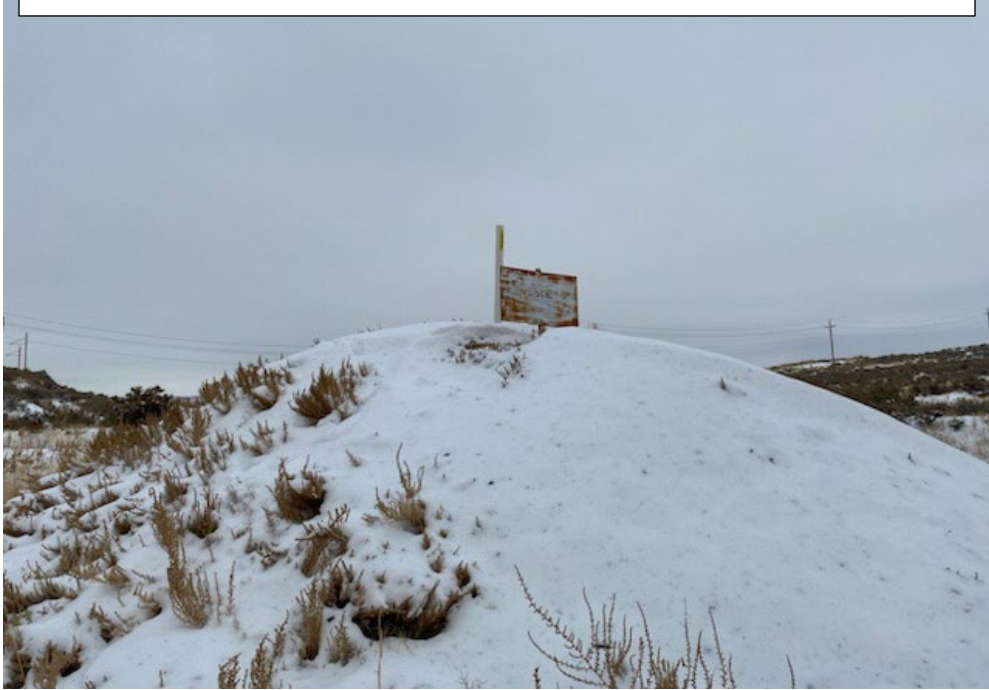
Photo 14: The RR-1 Pond Topsoil Stockpile.
