# Highwall Inspection

Project: 8-Mile Quarry

Subject: Highwall Inspection of 8-Mile Quarry

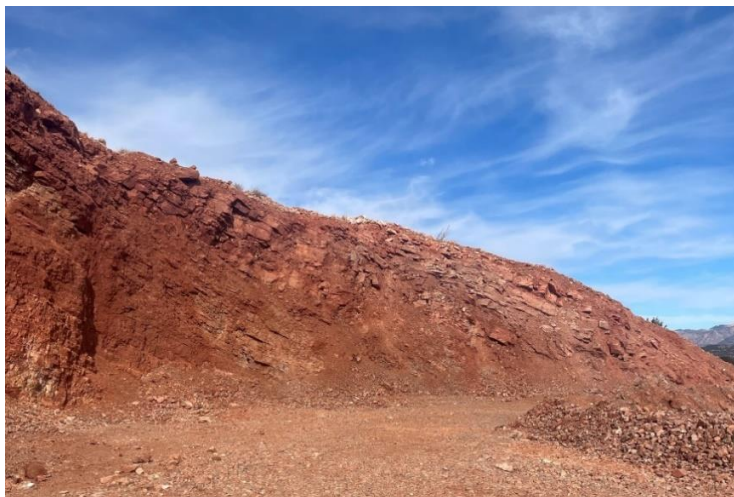
**Figure 2: South-facing exposure of bedrock dip angle.**

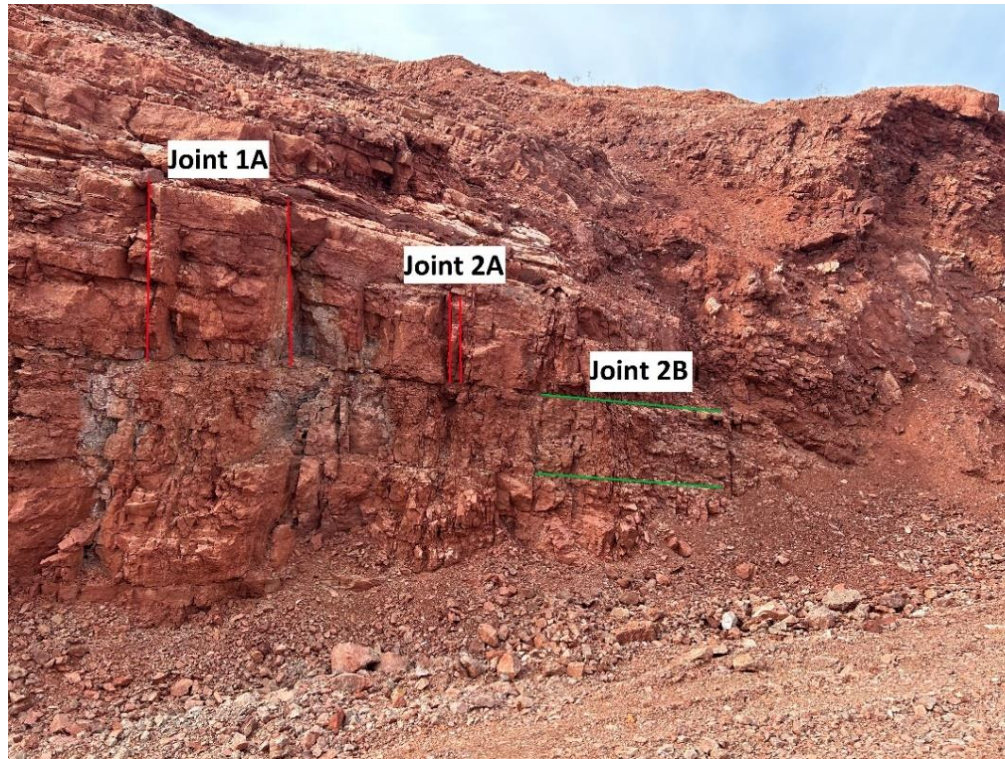
Figure 3: East-facing highwall with marked joint sets.

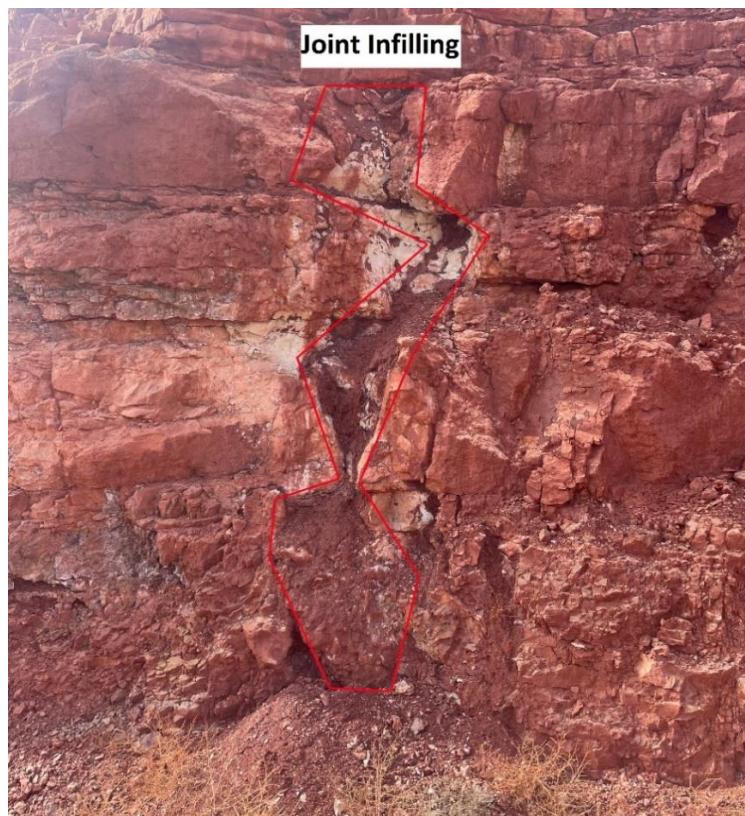
HDR began the site visit by driving to the major focus area along the east-facing highwall. The quarry is very small and contains only three relatively short benches (~20-30 feet tall) along the north-south strike of the bedrock. The encountered material consisted of red carbonaceous sandstone, with a dip direction of approximately 30-67 degrees (NE) and a dip of about 16-32 degrees, as shown in **Figure 2**. The exposed east-facing benches contain various discontinuities, as shown in **Figure 3**, characterized by highly weathered, moderately infilled, well-developed seamy joints with a wide aperture and infrequent recurrence interval, followed by less weathered, more frequent narrow spacing with tighter aperture joints. The first two joint sets are present along the vertical fracture planes of the exposed bedrock (Orientation A). Joint 1A (not shown) is a vertical fracture with a dip angle of approximately 76-86 degrees and dip direction of 272-291 that exhibits a ½-inch to 2-inch aperture, 3-9 feet spacing, greater than 10 feet of persistence, and some silty/clayey infilling. Joint 2A is a vertical fracture that displays a tight aperture, 1-inch to 3-feet spacing, ½-foot to 5-feet persistence, and occasional calcite infilling. The second set of joints is present along the horizontal bedding planes of the exposed bedrock (Orientation B). Joint 1B is a wavy bedding joint with a dip angle of about 70-90 degrees, 6-inch to 1-foot aperture, greater than 30 feet spacing, and 10-20 feet of persistence. Joint 2B is a wavy bedding joint with a tight aperture, 1-inch to 10-foot spacing, and 6 inches to 3 feet of persistence. Based on field observations, the estimated Geological Strength Index (GSI) value of the bedrock is approximately 35-45. A small silty/clayey seam approximately half a foot wide and 3 feet tall was observed near the center of the east-facing highwall, as shown in **Figure 4**.

Figure 4: Silt/clay seam exposure along the east-facing highwall.
