Permit Number: C-1992-081 Mine Name: Hayden Gulch Loadout Operator: Hayden Gulch Terminal, LLC Operator Address: Ms Miranda Kawcak 29515 Routt County Road 27 Oak Creek, CO 80467	County: Routt Operation Type: Loadout Permit Status: Active Ownership: Private
	Operator Representative Present:
Operator Representative Signature: (Field Issuance Only)

Inspection Start Date: December 13, 2023 Inspection Start Time: 09:00 Inspection End Date: December 13, 2023 Inspection End Time: 10:00		Inspection Type: Coal Partial Inspection Inspection Reason: Normal I&E Program Weather: Clear	
Joint Inspection Agency: None		Joint Inspection Contacts:	
Post Inspection Agency: None		Post Inspection Contacts:	
Inspector(s): Hunter Ridley	Inspector's Signature:

This was a partial inspection of the Hayden Gulch Loadout; DRMS Permit No. C-1992-081, operated by Hayden Gulch Terminal, LLC (HGT). This inspection was conducted by Hunter Ridley with the Colorado Division of Reclamation, Mining, and Safety (Division). No mining activity was occurring on site at the time of inspection and no operator representative accompanied the inspection. **Please address the Bold items below.**

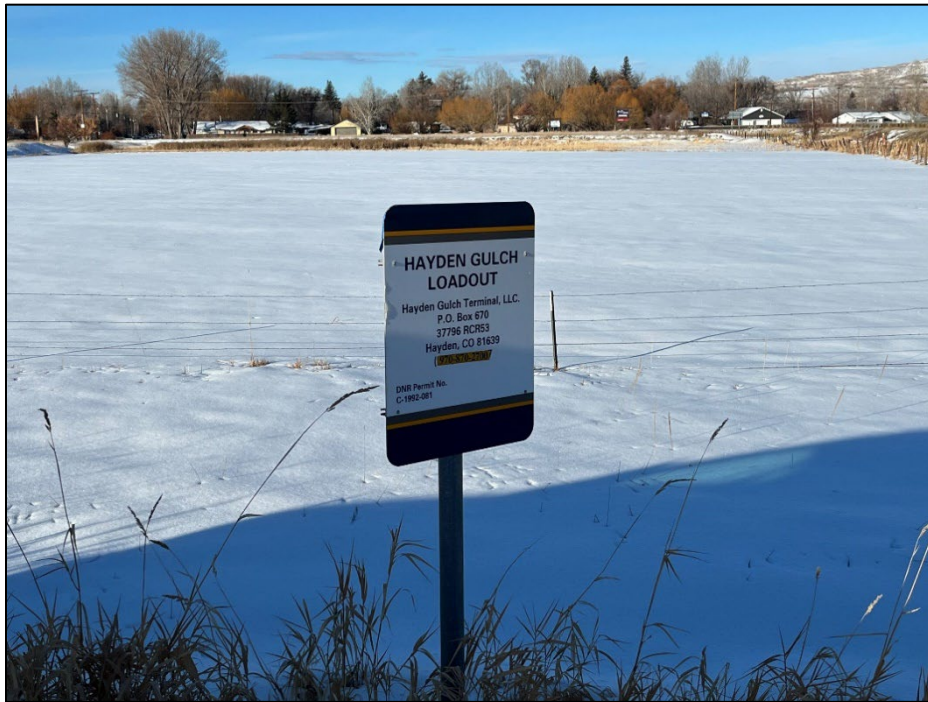
Mine identification signs were observed at the western end of the TAHR (Photo 7) and adjacent to the unreleased agricultural section north and south of Hwy 40 (Photo 1). All required information was present on the signage.

Photo 1: Mine sign located just off Hwy 40.

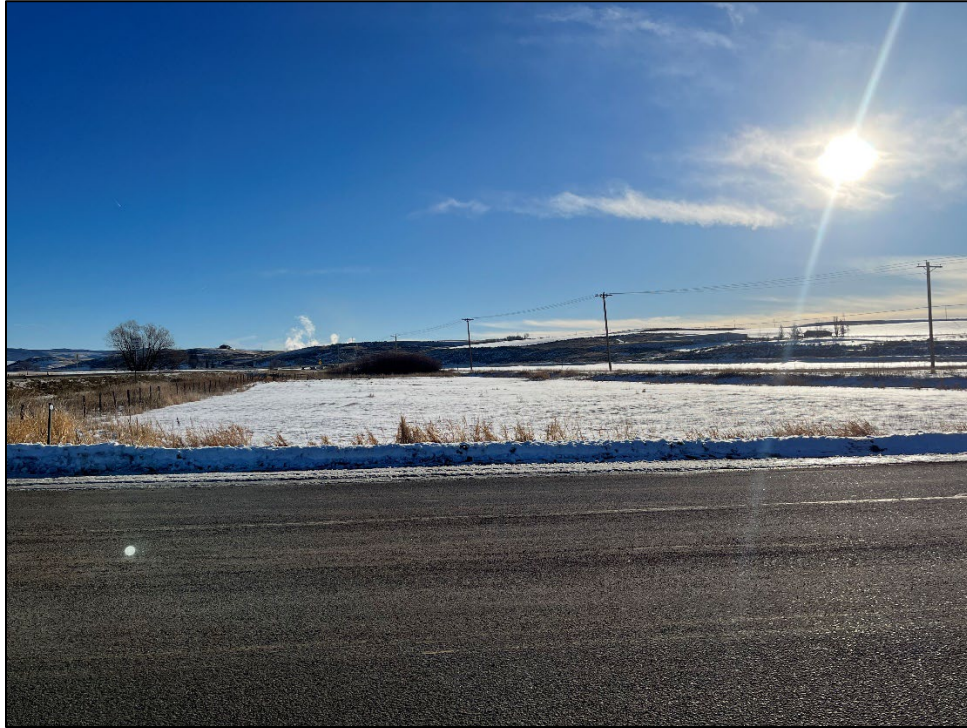
Areas not Phase III bond released and not included in the current SL-3 release area includes the fields directly north and south of Hwy 40, to be reclaimed to agricultural use as hay fields. This area includes 6.8 acres of which 2.3 are disturbed (Photo 2).

Photo 2: View east of the agricultural hay field located adjacent to Hwy 40, not yet released.

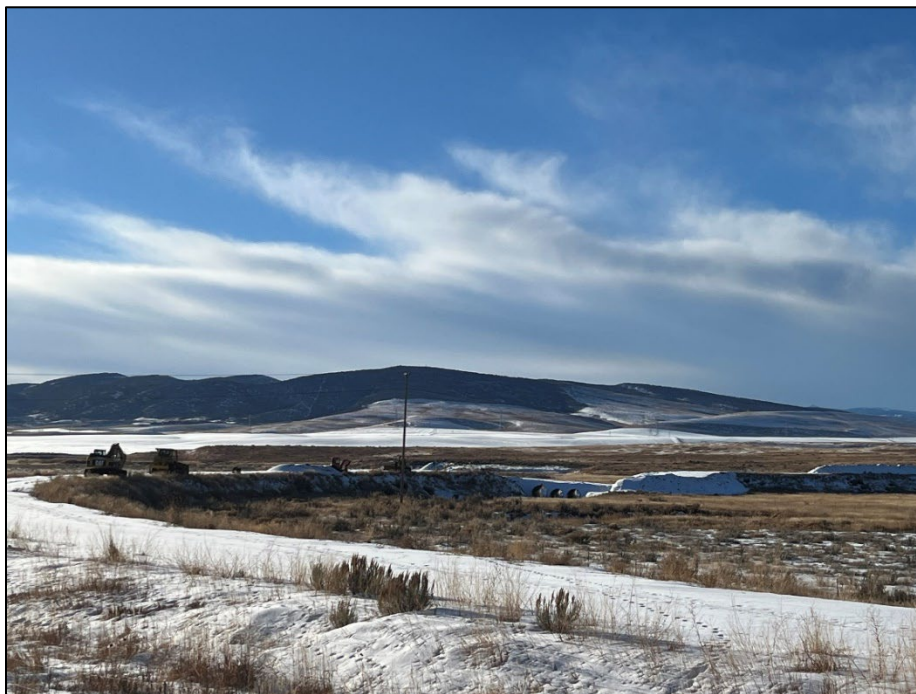
Culverts within the previously released Tracks to Trails area are still under construction by the City of Hayden (Photo 3). This area was turned over to the City of Hayden for recreational use with the approval of SL-2 in 2022. Culverts in this area which were not being replaced were flowing and free of blockages.

Photo 3: View south of Sage Creek Trail recreation loop where work on culvert replacement continues.

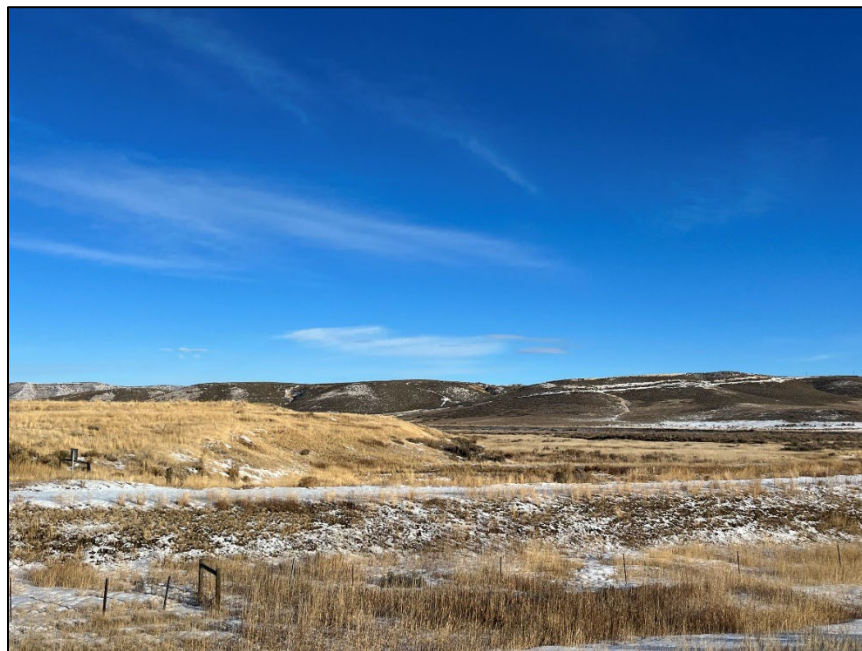
Truck Loop Pond 001 was functioning properly (Photo 6). Rail Loop Pond 002 was inaccessible due to the culvert construction happening along the Sage Creek Trail but looked to be frozen over (Photo 4).

Photo 4: View north of Rail Loop Pond 002 as seen from the TAHR.

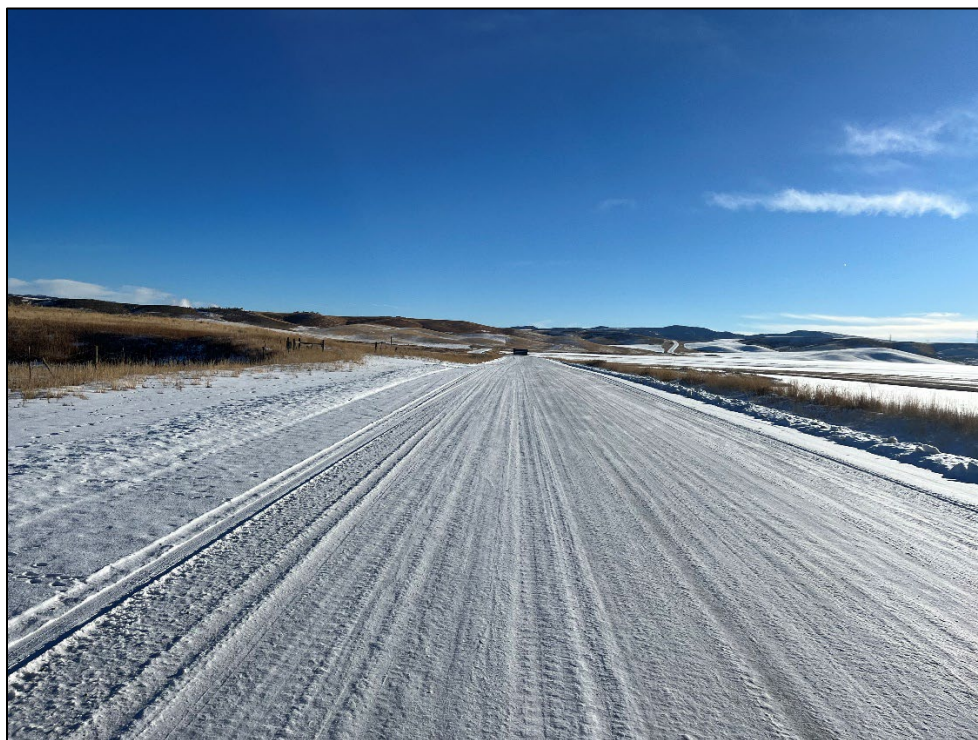
The Tie Across Haul Road (TAHR) was plowed and navigable, but remained snow packed and icy (Photo 5). No erosion features of concern were noted.

Photo 5: Road conditions were plowed but snow packed and icy.

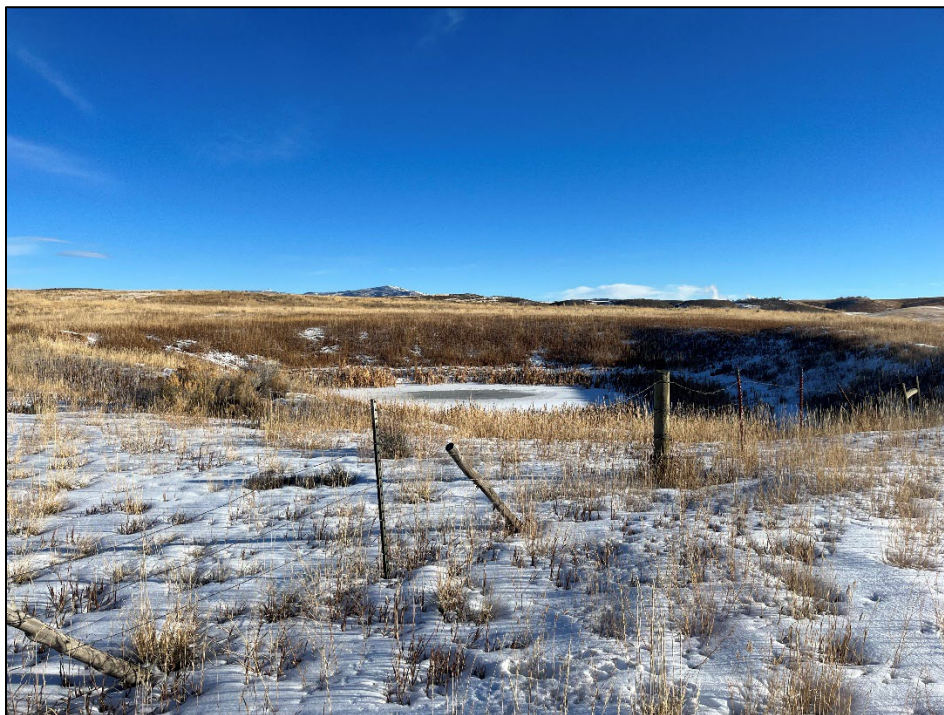
Photo 6: Truck Loop Pond 001 as seen from the TAHR.

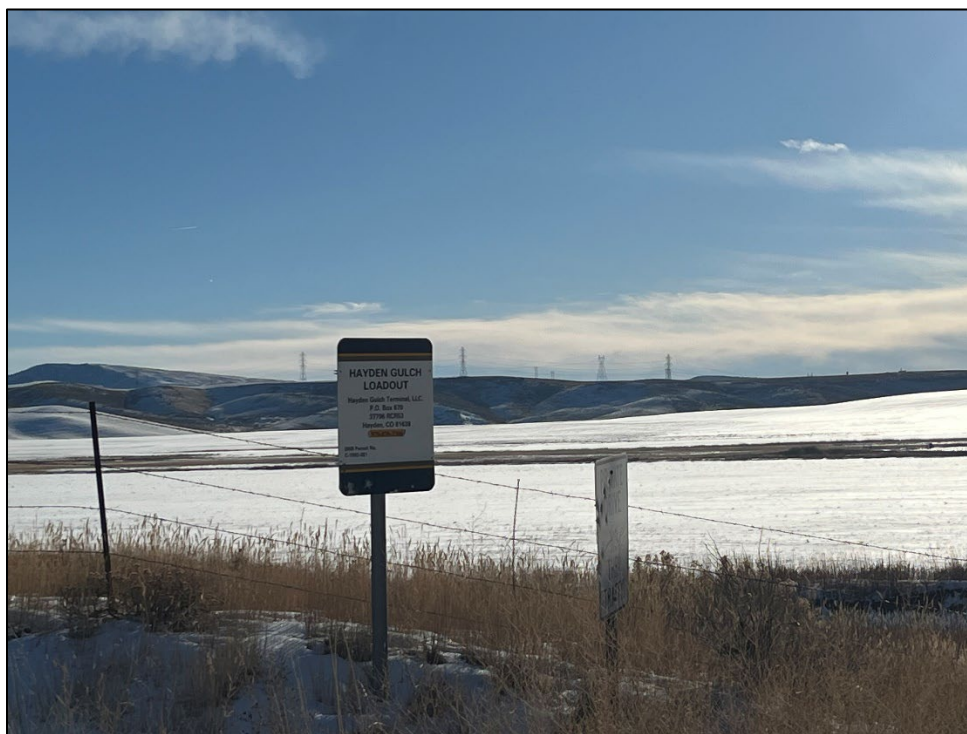
Photo 7: Secondary mine signage located at the western end of the TAHR.
