Permit Number: C-1980-004 Mine Name: McClane Canyon Mine Operator: ARC McClane Canyon, LLC Operator Address: Joe Brinton 652 Peony Dr. Grand Junction, CO 81507	County: Garfield Operation Type: Underground Permit Status: Temporary Cessation Ownership: Private
	Operator Representative Present: Chuck Silengo
Operator Representative Signature: (Field Issuance Only)

Inspection Start Date: November 29, 2023 Inspection Start Time: 08:40 Inspection End Date: November 29, 2023 Inspection End Time: 12:10		Inspection Type: Coal Complete Inspection Inspection Reason: OSM Oversight Inspection Weather: Clear	
Joint Inspection Agency: OSM		Joint Inspection Contacts: Thomas Medlin	
Post Inspection Agency: OSM		Post Inspection Contacts: Thomas Medlin	
Inspector(s): Clayton Wein	Inspector's Signature: <i>Clayton Wein</i>		
		Signature Date: 12/14/2023

This report documents the observations taken by the Division during a complete inspection of the McClane Canyon Mine. This inspection was also an Office of Surface Mining, Reclamation and Enforcement Complete Oversight Inspection. The inspection was conducted on November 29, 2023 by Clayton Wein of the Division. Thomas Medlin represented OSMRE during

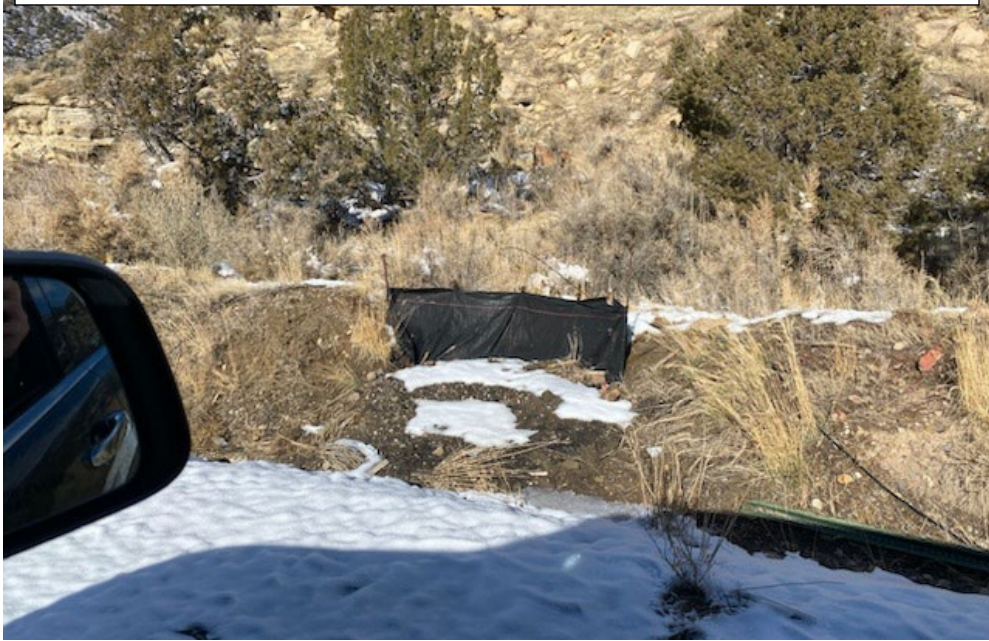
2. Sump P has filled in with sediment and needs to be cleaned (Photo 1). The soil in the sump has frozen and is too hard to clean at this time. **Please clean the sump as soon as ground conditions allow.**

Sump P is located on the north side of the Haul Road in-between the office pad and the sediment pond. During the inspection the sump was dry. The silt fence at the outlet was clear of debris. **The sump has filled in and needs to be cleaned.**

Photo 1: Maintenance Item No. 2, Sump P needs to be cleaned as soon as ground conditions will allow.

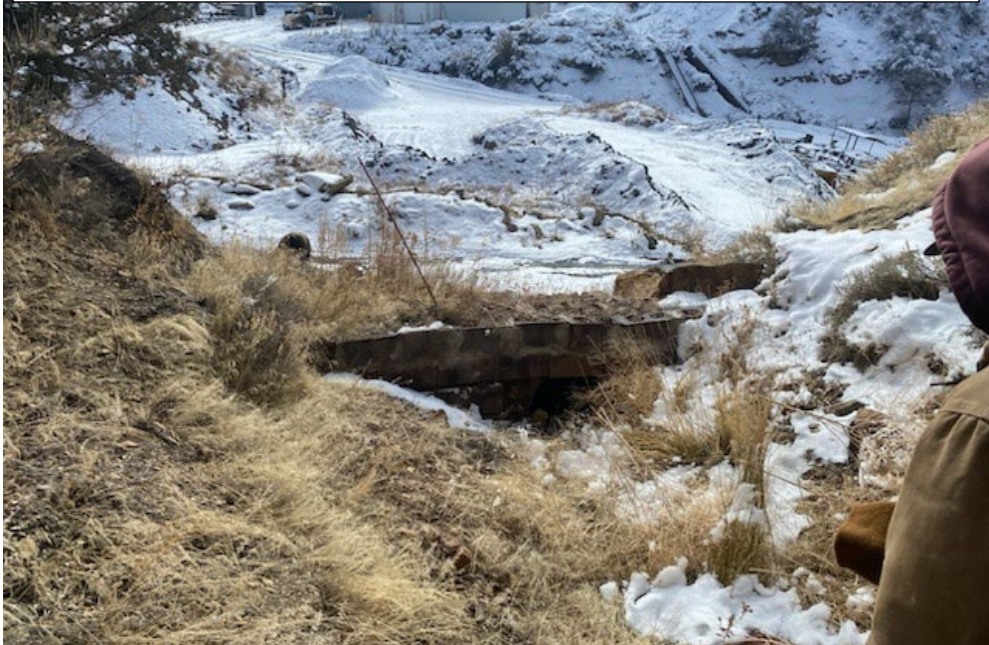
3. Sump B has filled with sediment and requires cleaning (Photo 2). The soil in the sump has frozen and is too hard to clean at this time. **Please clean the sump as soon as ground conditions allow.**

Sump B is a diversion for clear water that transports upstream runoff under the portals bench. The outlet from the sump was free of obstructions. No water was in the sump at the time of the inspection. The sump was stable and there were no erosional concerns identified. **Sump B has filled with sediment and requires cleaning. Please clean out the sump to restore its original capacity.**

Photo 2: Maintenance Item No. 3, Sump B needs to be cleaned as soon as ground conditions will allow.

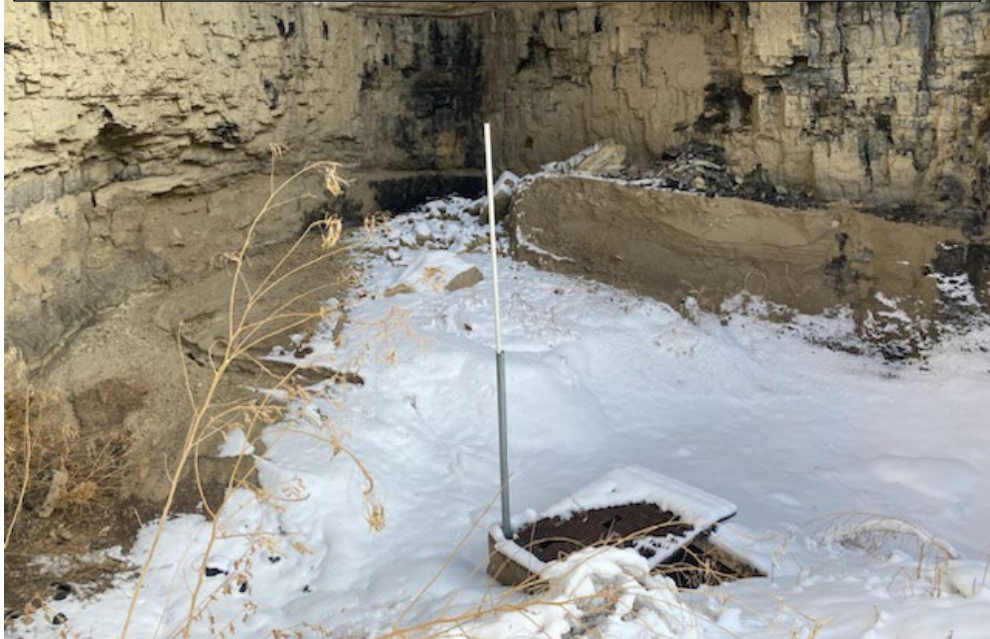
4. The trash rack over the Sump D's outlet was only partly covering the outlet (Photo 3). Please place the trash rack over the outlet to ensure that no large debris enter the outlet. **Please re-position the trash rack no later than December 20, 2023.**

Sump D is located on the eastern end of the portals bench. The sump collects upstream clear water and diverts the water under the portals bench. The sump was dry during the inspection. **The trash rack over the sump's outlet was only partly covering the outlet. Please place the trash rack over the outlet to ensure that no large debris enter the outlet.**

Photo 3: Maintenance Item No. 4, the trash rack on Sump D needs to be pulled all the way over the sumps outlet.

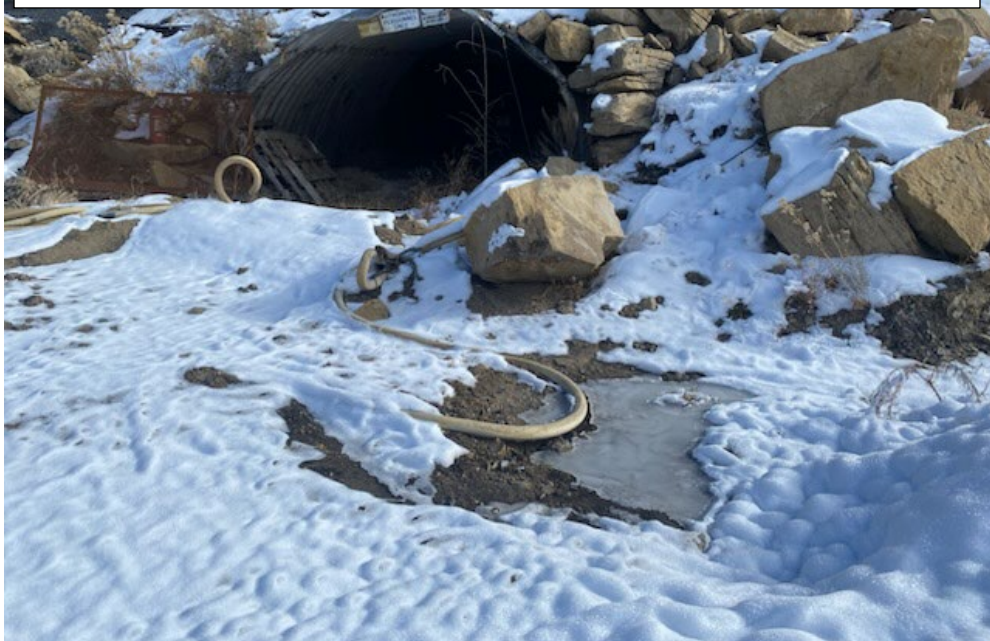
5. A length of flexible cable was observed adjacent to the portals (Photo 4). Please pick up and store this cable in a laydown area or in the shop. **The cable must be placed in an appropriate location no later than December 20, 2023.**

Photo 4: Maintenance Item No. 5, the cable laying on the ground in front of the portals need to be moved to a proper storage area.

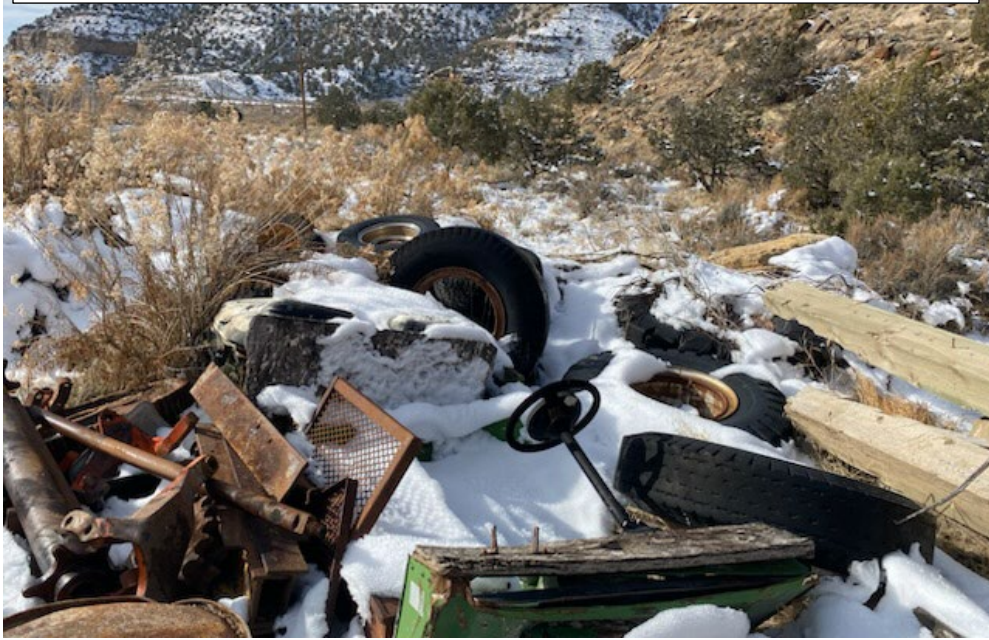
6. A pile of tires was observed in the lower laydown area across the haul road from the sediment pond (Photo 5). Please remove any pneumatic tires from the laydown area as they were observed to be dry rotted. **Non-coal waste**

cannot be stored within the laydown areas. Please remove the dry rotted pneumatic tires no later than December 20, 2023.

Photo 5: Maintenance Item No. 6, any pneumatic tires located in the laydown area that have dry rotted need to be disposed of.

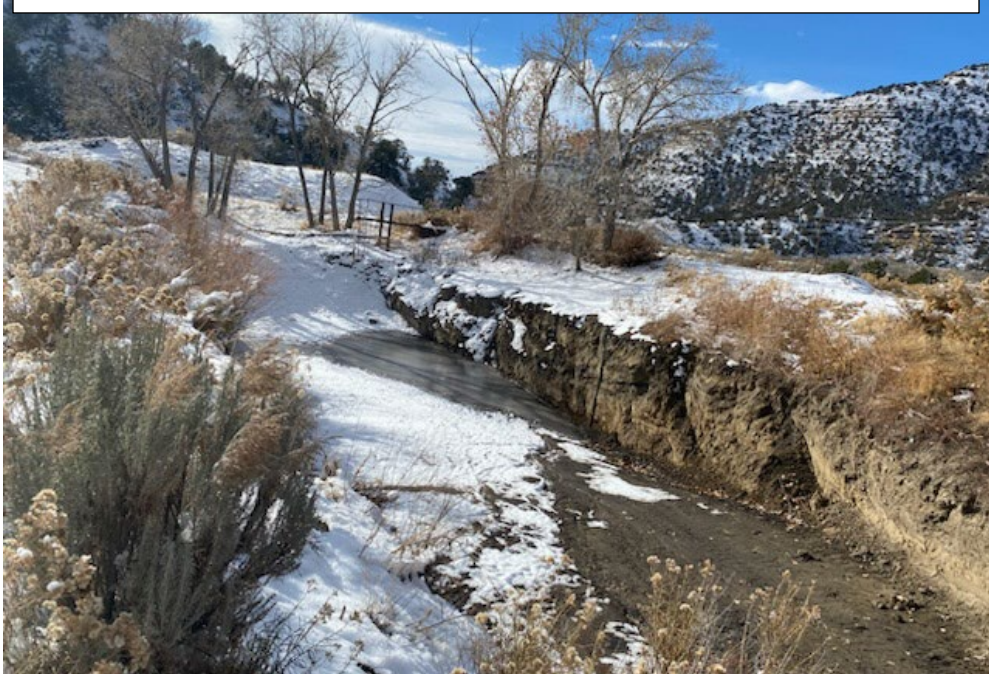
There is on sediment pond located at the McClane Canyon Mine. The pond is east of the Mine Office Pad. The Sediment pond was holding a small amount of frozen water in it during the inspection (Photo 6). The level of water in the pond was below the primary discharge pipe. Most of the sediment pond had been cleaned prior to the inspection. Only a small portion of the western section had not been fully cleaned. The pond had ample capacity remaining. The embankment was covered with snow. There were no indications of erosional

features or instability. The discharge pipe was clear of debris. The sediment marker was posted and marked the elevation in which the pond requires cleaning. Two inlets to the pond are located in the northeastern corner. A culvert inlet from Culvert Q and the inlet from Ditch D-6. Culvert Q's outlet was clear of debris and functional. The D-6 inlet was also unobstructed. No flow was entering the pond from the inlets at the time of the inspection.

Photo 6: The sediment pond.

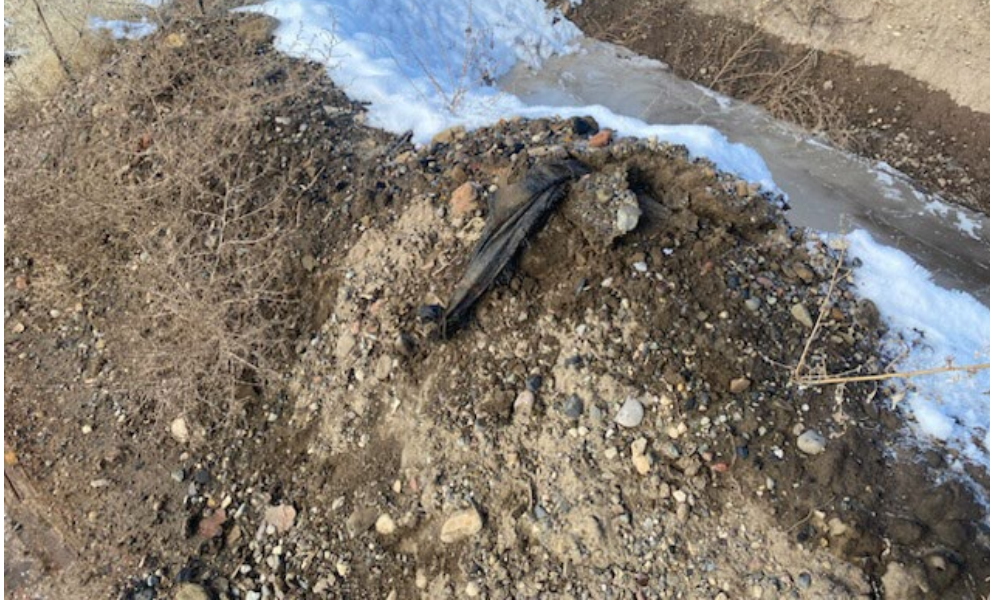
The north and south office pad sumps were holding frozen water in them. The silt fences placed at the sumps' outlets were in good condition. There were no indications of instability or erosion noted. A piece of steel rebar was removed from the embankment of the north office sump during the inspection (Photo 7). The rebar will be stored on the office pad with the other usable materials.

Photo 7: The location where a piece of rebar identified in the embankment of the north office sump. The rebar was removed during the inspection.

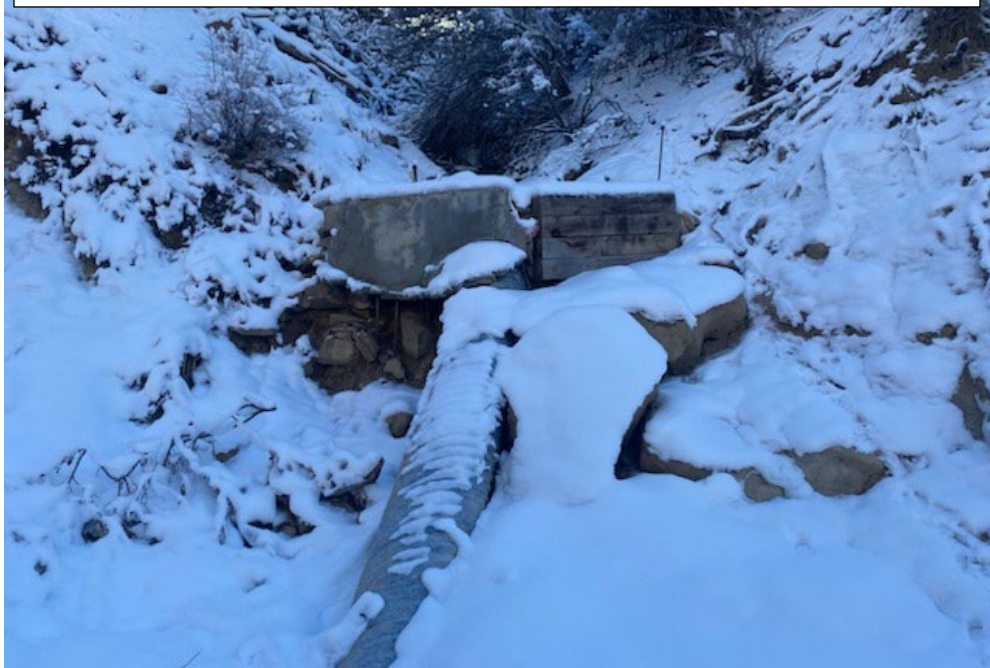
Sump E was repaired in the summer of 2023. The embankment's concrete structure was in good condition. Much of the sump was covered with snow (Photo 8). The pipe connecting the sump to the main diversion under the portals pad was stable with no sections requiring repairs.

Photo 8: The repaired embankment for Sump E.

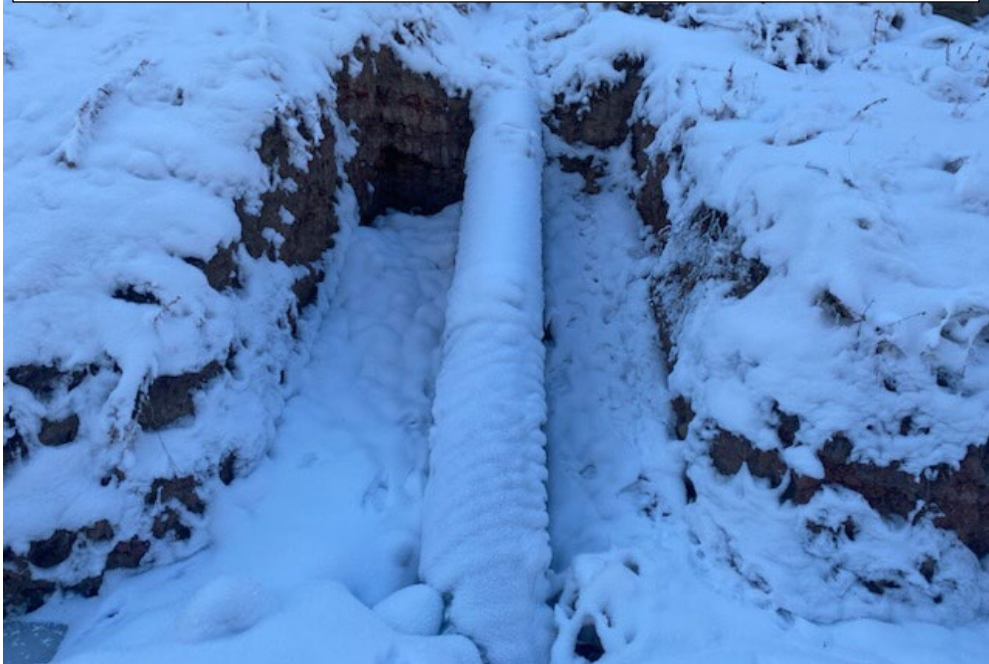
The culvert for the D-5 was also repaired in the summer of 2023. The repaired section of culvert was stable with no indications of breaches (Photo 9).

Photo 9: The repaired segment of culvert for the D-5 Ditch.

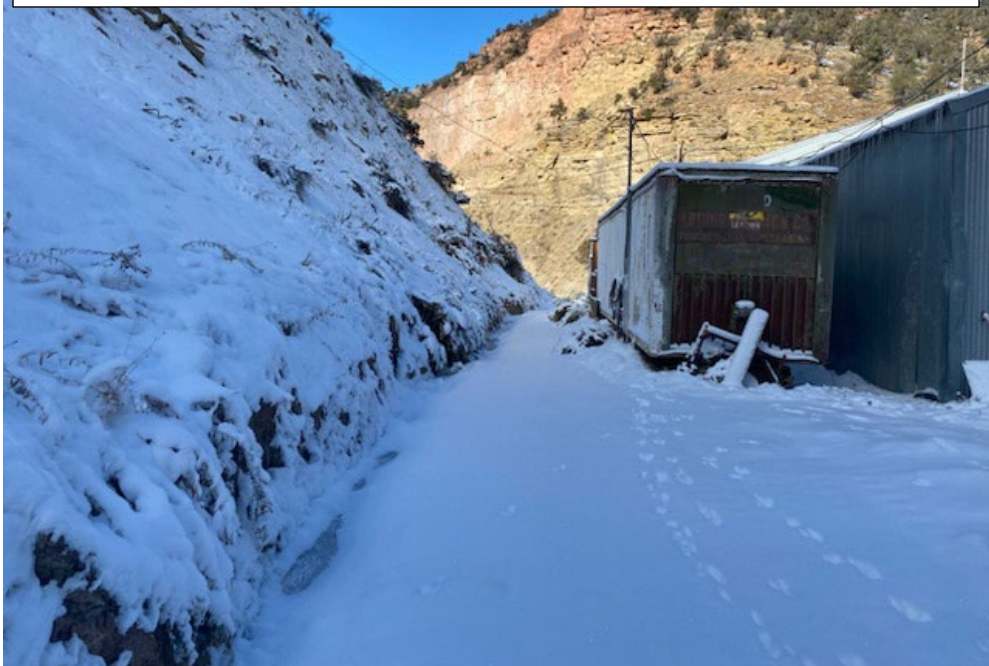
Ditch D-2 is located behind the shop. The ditch was covered with snow (Photo 10). There were no indications of blockages or erosion.

Photo 10: The D-2 Ditch.

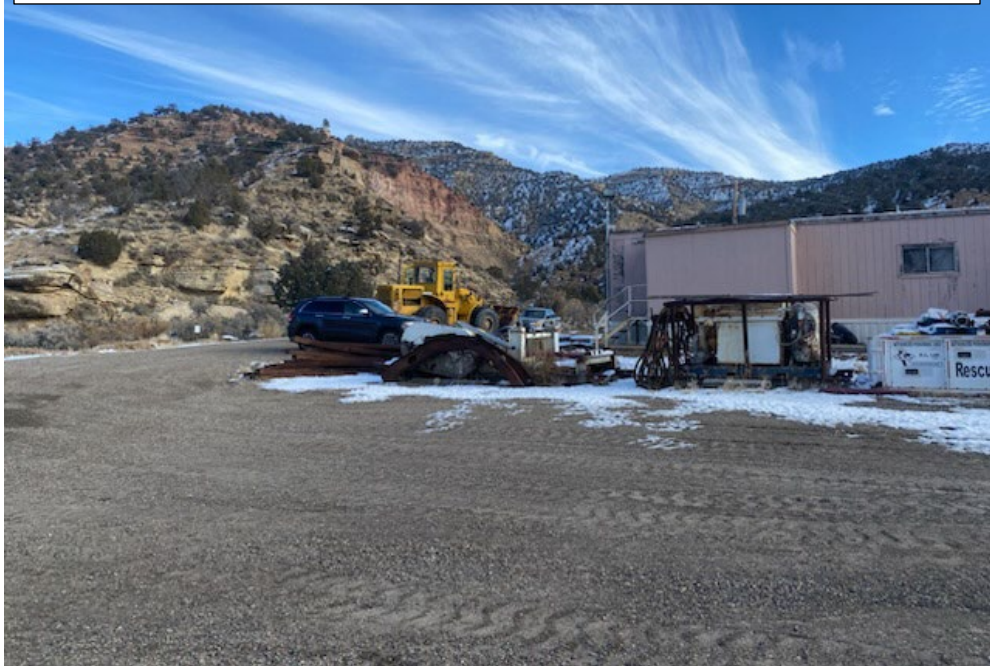
The mine office pad is located at the west end of the permit area, on the south side of the haul road. The pad was well kept and stable (Photo 11). There were no indications of erosion. No fuel spills were observed and no off site impacts were identified. The perimeter berm was stable and covered with snow. All hydrocarbons were observed to be stored in a secondary containment structure (Photo 12).

Photo 11: The northern part of the mine office pad.

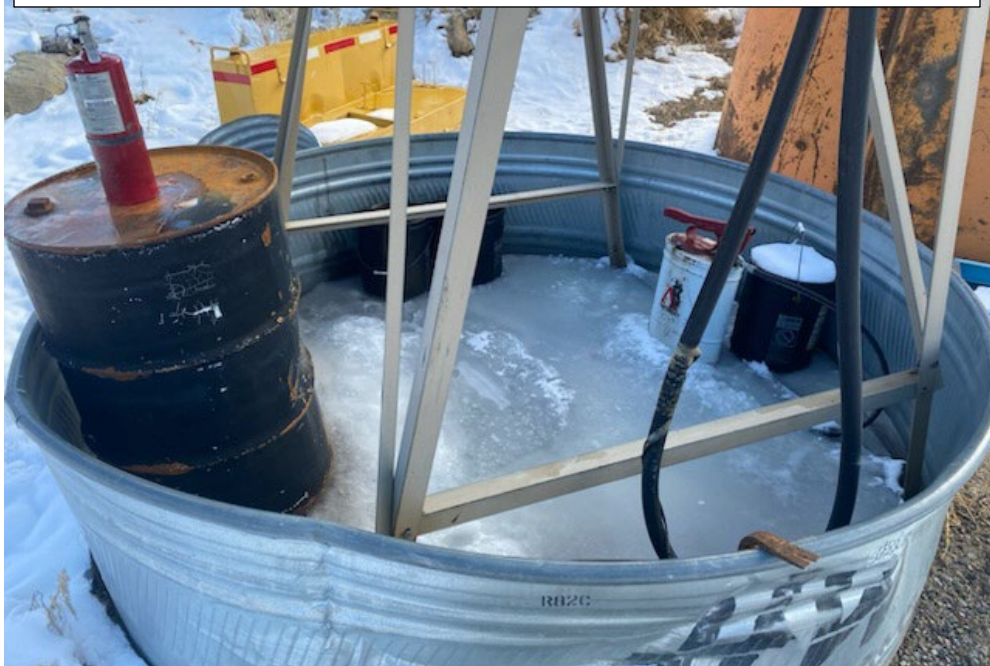
Photo 12: The secondary containment structure at the mine office pad.

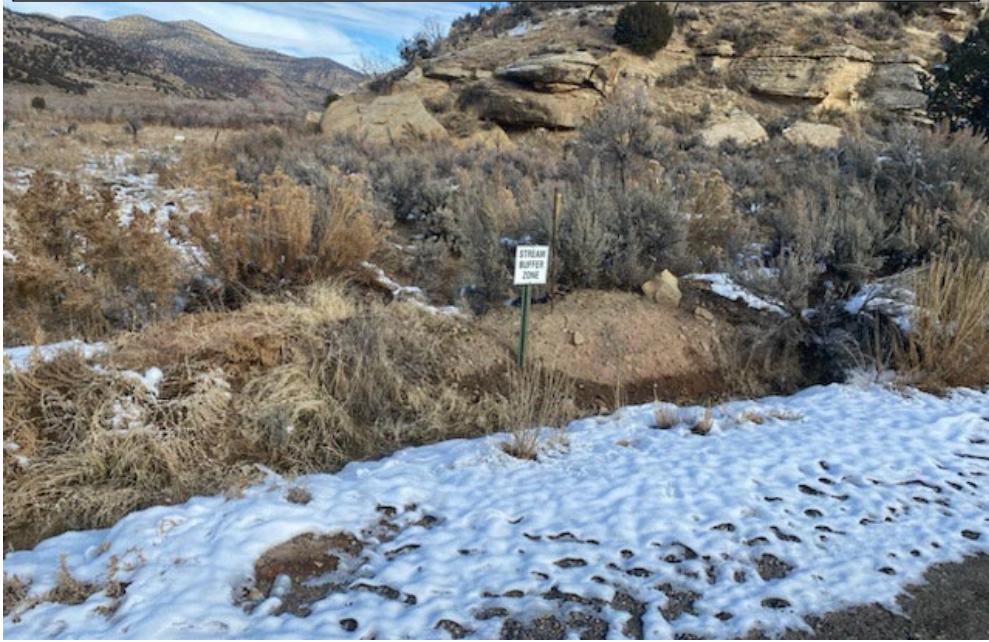
Along the north side of the haul road were several stream buffer zone markers Photo 13). The signs were all placed in easy to locate positions.

Photo 13: The stream buffer zone marker placed near the mine office pad.

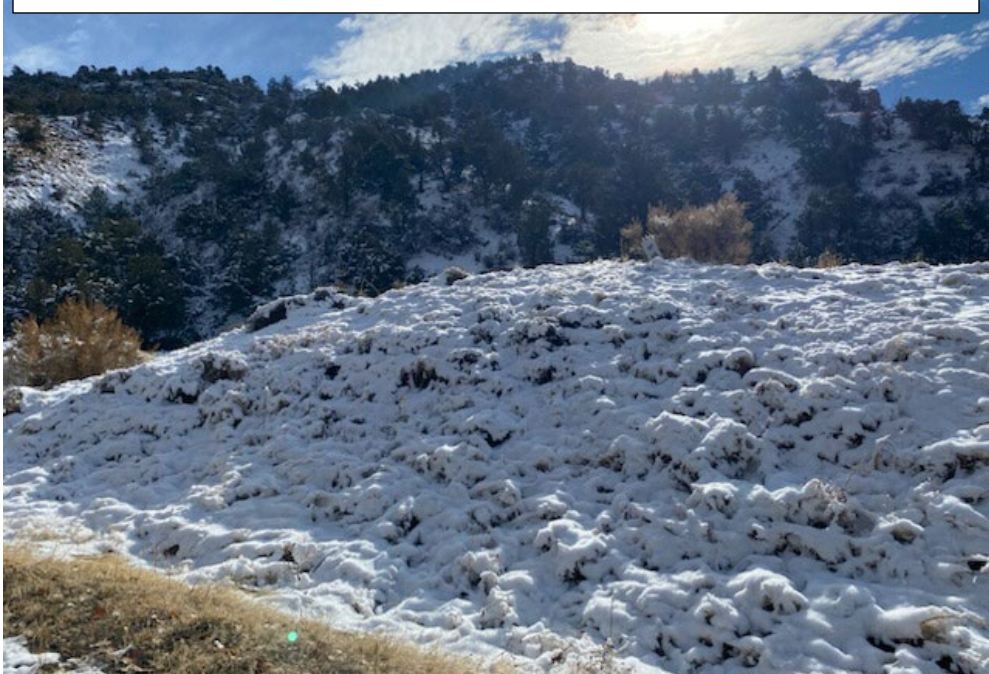
The topsoil stockpile and associated perimeter ditch were covered with snow during the inspection (Photo 14). The pile was stable with no erosional concerns. The perimeter ditch was also stable with no breaches observed. The topsoil pile marker was in place on top of the pile.

Photo 14: The topsoil stockpile.
