MINERALS PROGRAM INSPECTION REPORT
PHONE: (303) 866-3567

MINE NAME: Nahcolite Project	MINE/PROSPECTING ID#: M-1983-194	MINERAL: Carbonates	COUNTY: Rio Blanco
INSPECTION TYPE: Monitoring	WEATHER: Snowing	INSP. DATE: November 30, 2023	INSP. TIME: 12:45
OPERATOR: Natural Soda LLC	OPERATOR REPRESENTATIVE: Jamie Reck	TYPE OF OPERATION: 112d-3 - Designated Mining Operation	
REASON FOR INSPECTION: Normal I&E Program	BOND CALCULATION TYPE: None	BOND AMOUNT: \$4,466,425.00	
DATE OF COMPLAINT: NA	POST INSP. CONTACTS: DRMS	JOINT INSP. AGENCY: U.S.BLM	
INSPECTOR(S): Amy Yeldell	INSPECTOR'S SIGNATURE:

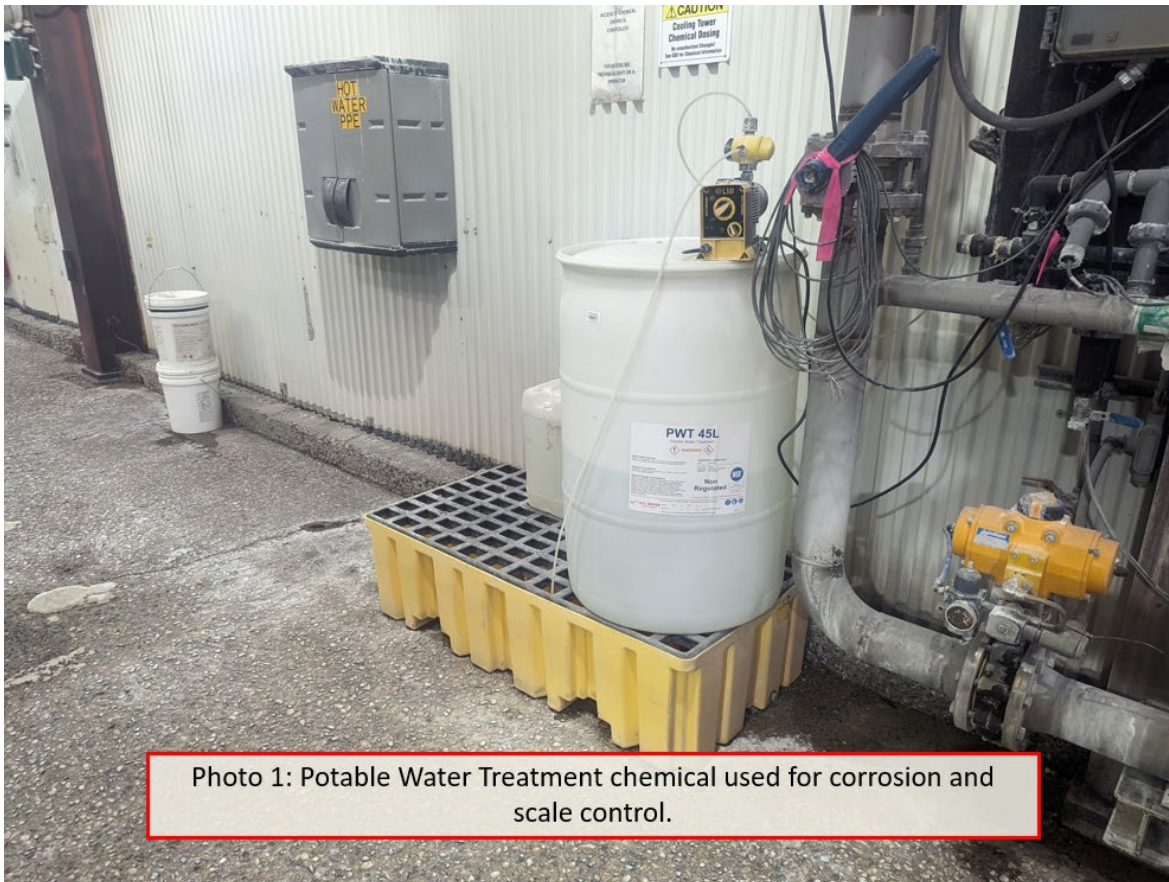
Adjacent to the Train 1 heat exchangers is a Potable Water Treatment chemical (Zinc Polyphosphate [ZN]- PWT 45L) used for corrosion and scale control (Photo One). The chemical is stored in a plastic 55-gallon drum located within a spill pallet. Wetness was observed around the pallet but did not appear to be from leaking chemical rather than just wet from routine floor cleaning.

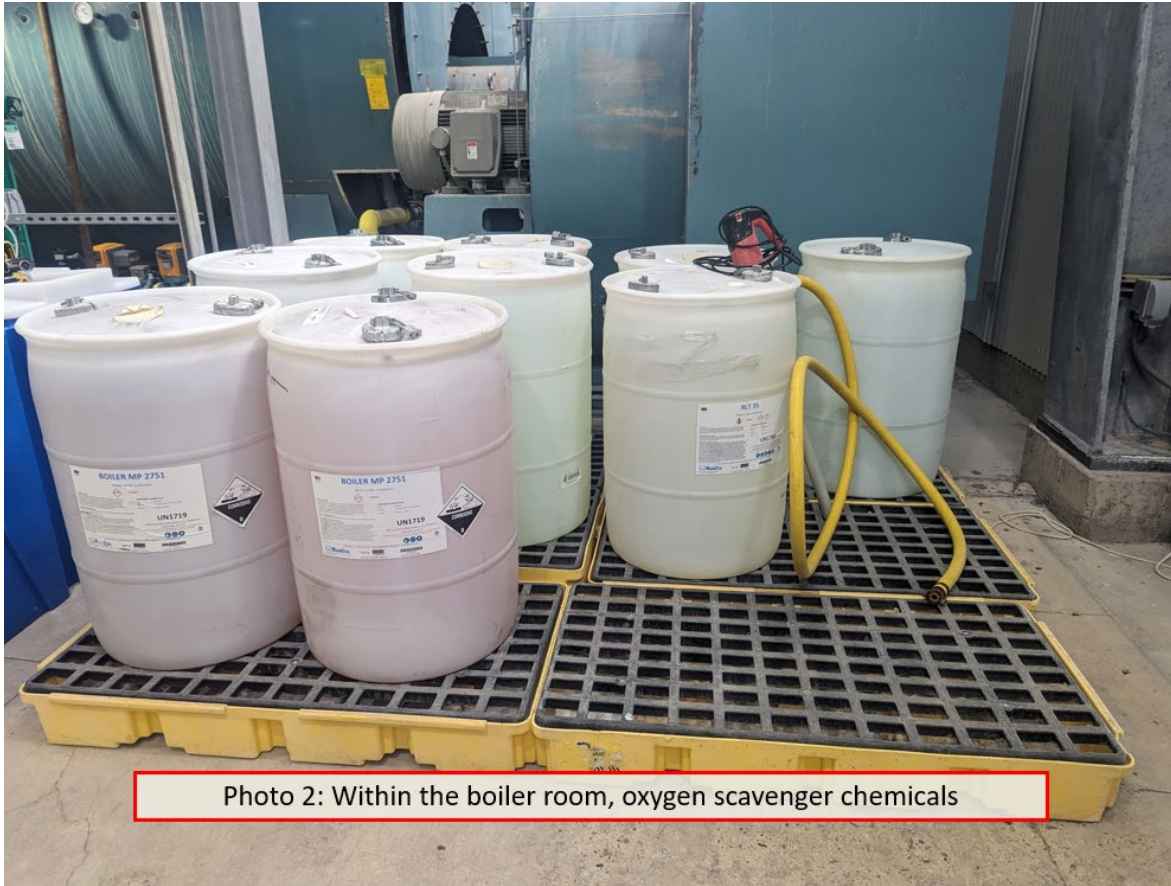
Also stored within the boiler room are the chemicals for the Oxygen Scavenger system. Several plastic 55 gallon drums were located on spill pallets. The two chemicals were Boiler MP 2751 and RTL 35 (Photo Two). All drums were locked as required by CDPHE. Four Oxygen Scavengers were located adjacent to the boilers and chemicals (Photo Three). No leaks or wetness were observed around the chemicals. The in-floor sumps of the boiler room report to process pond #2 and provide additional containment.

Photo 2: Within the boiler room, oxygen scavenger chemicals

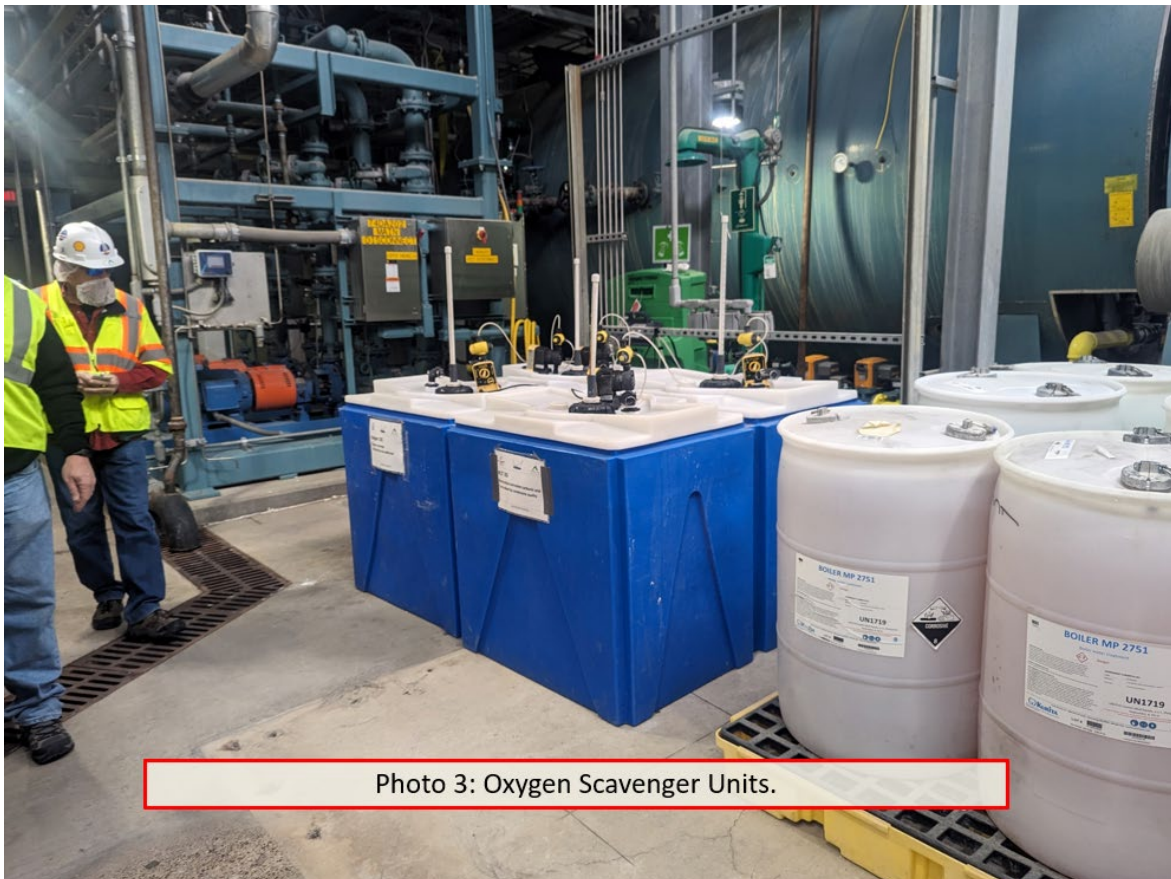
Photo 3: Oxygen Scavenger Units.

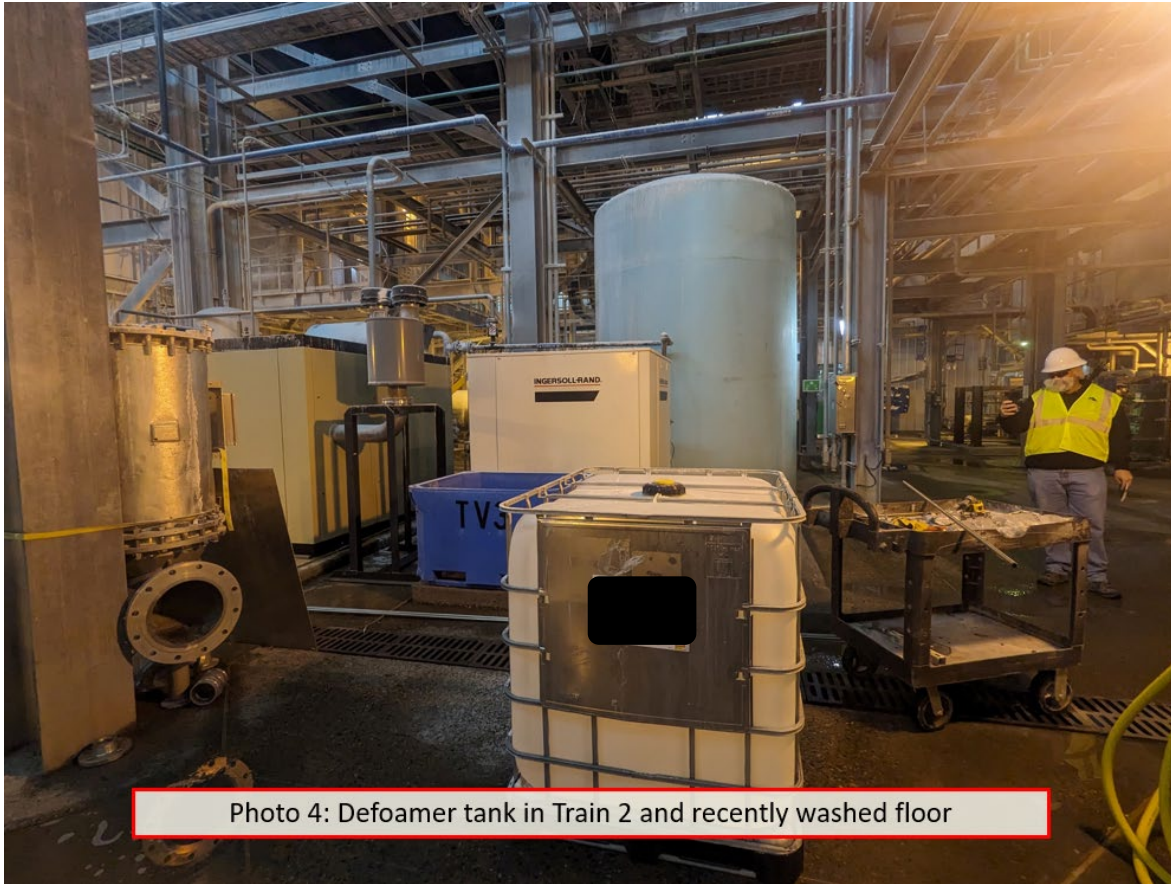
Within the train 2 area is a large tank that contains process defoamer. Adjacent to the tank was a tote of crystal habit modifier. Several totes of process defoamer were in the corner of the building. This area has in-floor sumps that serve as secondary containment. The floor was wet at the time of the inspection (Photo Four). Ms. Reck indicated that they recently rinsed the plant floor as is common practice.

Photo 4: Defoamer tank in Train 2 and recently washed floor

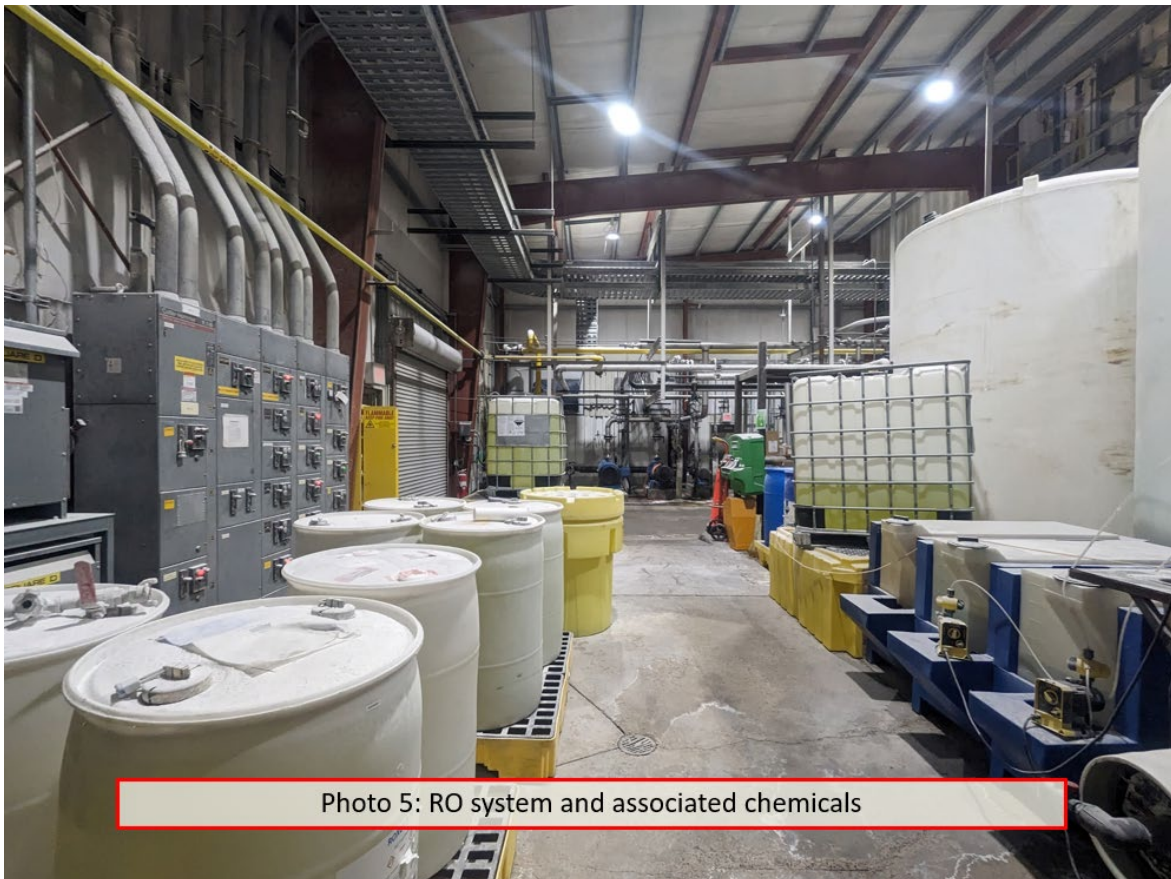
Located within the plant on the southeast side is the RO system. Several plastic 55-gallon drums of RO Treatment chemical (ROXOUT FG) were observed (Photo Five). The drums are located on spill pallets and locked. No leaks or wetness were observed around the chemicals. Concrete was stained indicating that spills in this area do occur.

Photo 5: RO system and associated chemicals

CORRECTIVE ACTIONS: At a minimum please provide the Division with SDS sheets for the chemicals mentioned within the report by the corrective action date. If additional chemicals not identified in the report are used, please also provide those SDS.

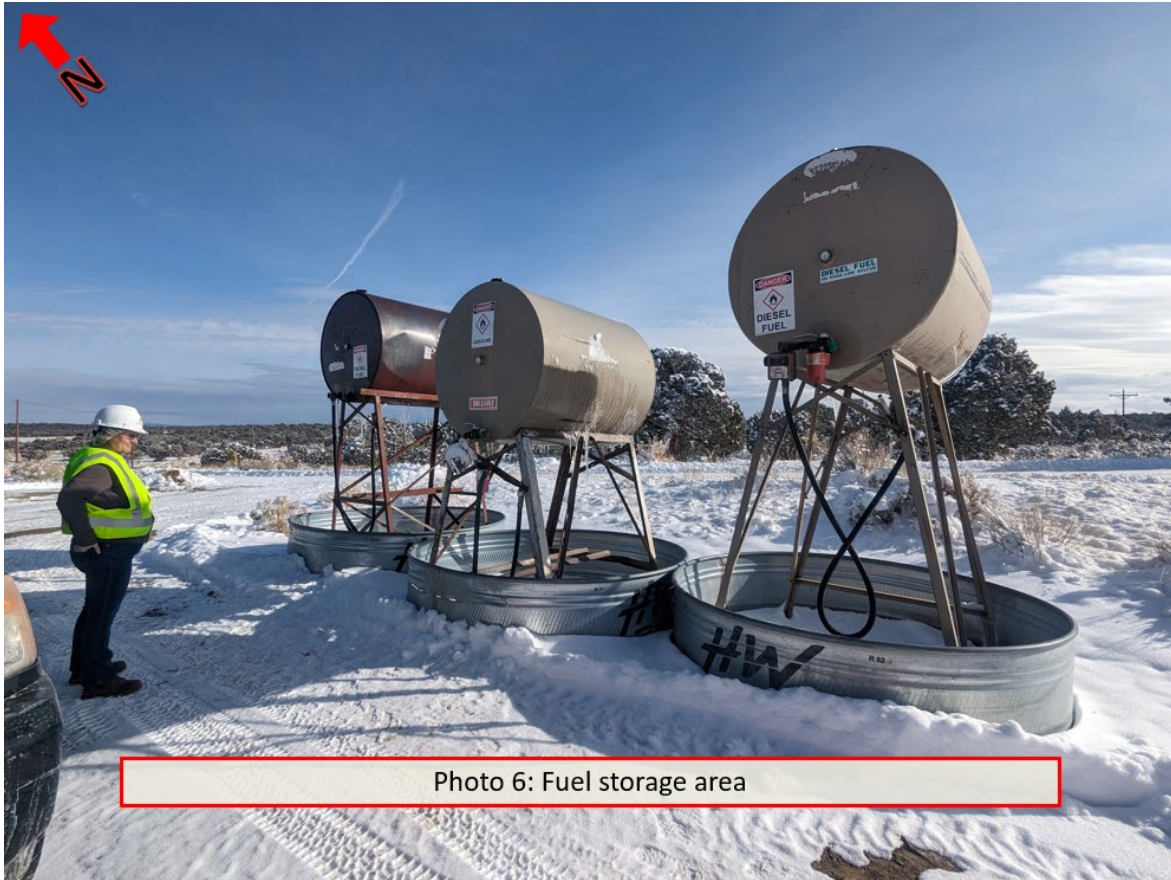
South of the plant is the site's fuel storage area. Three elevated fuel tanks were located within secondary containment (Photo Six). Containment tanks appeared clean and free of excess spills.

Photo 6: Fuel storage area

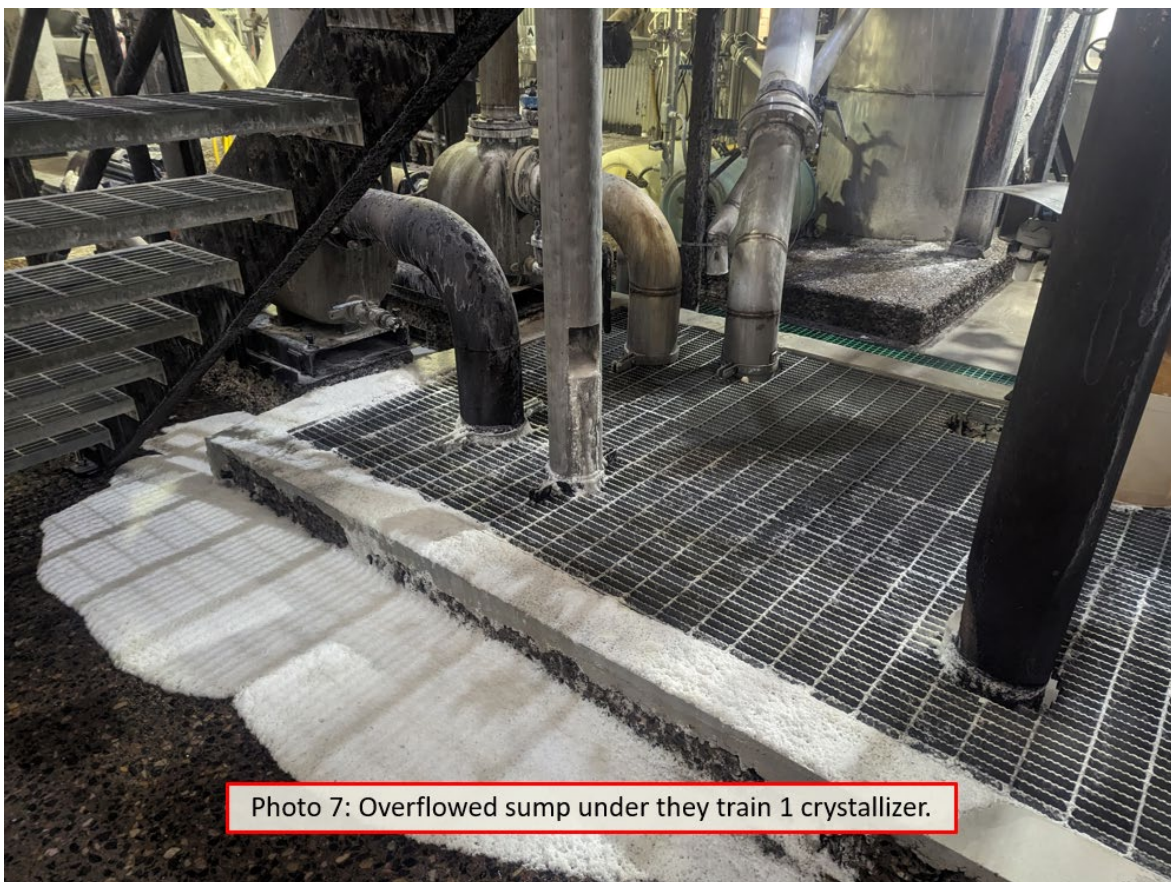
Under each of the crystallizer is a grated sump. Periodically the overflow is designed to be caught in the sumps. During the inspection there was evidence (foam) that the sump under the crystallizers overflowed (Photo Seven). Ms. Reck indicated that this is a common occurrence and that all spilt material is washed off of the plant floor and is contained within the greater mill secondary containment. The Division would recommend that the sump volume be increased by raising the curb level or review pump capacity sizes. A frequent overflow of a sump is an indication of a poor design. This is not cited as an inspection problem since the greater plant is still within secondary containment so there is no potential for loss of containment.

Photo 7: Overflowed sump under they train 1 crystallizer.

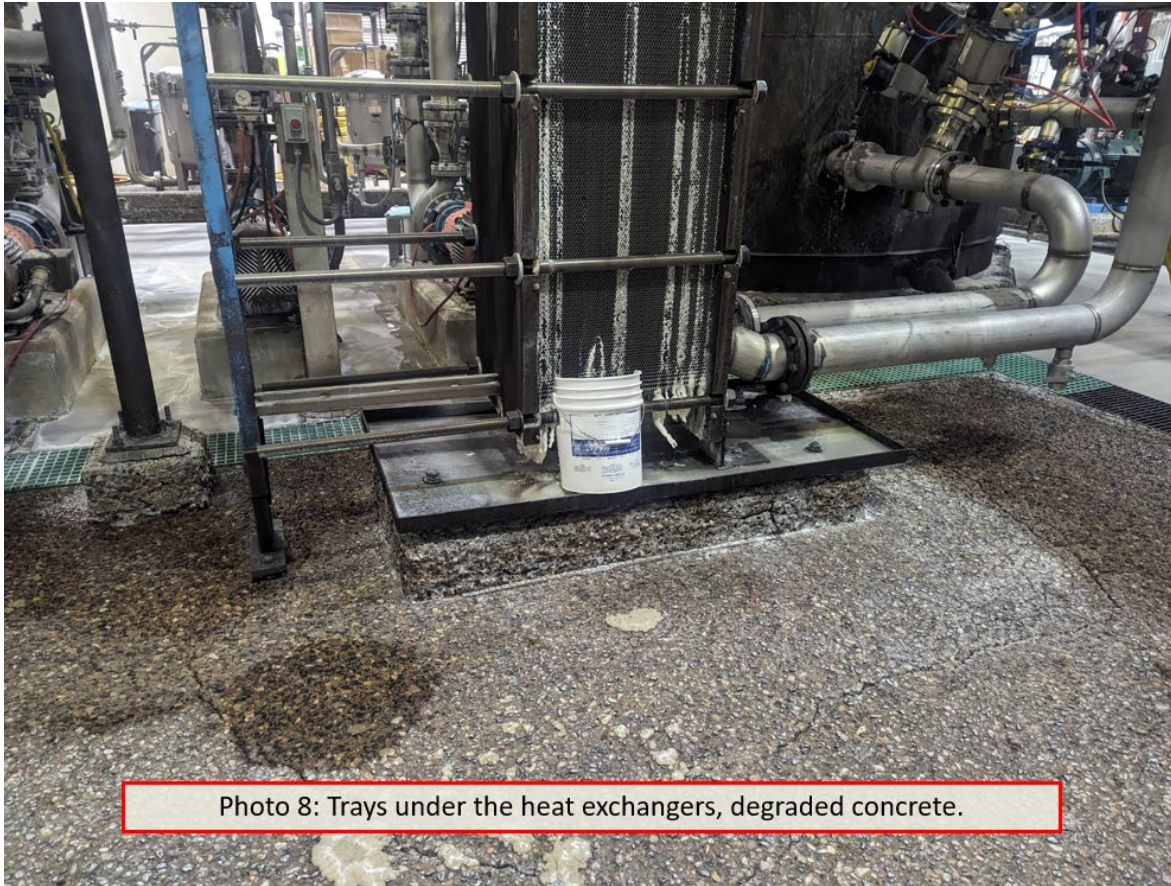
There are trays under the heat exchangers to contain any spills/leaks (Photo Eight). The trays are periodically rinsed out and washed into the in-floor sumps of the plant. The trays are designed to help protect the concrete from degradation. The diluted spilled liquor is far less corrosive than the concentrate.

Photo 8: Trays under the heat exchangers, degraded concrete.

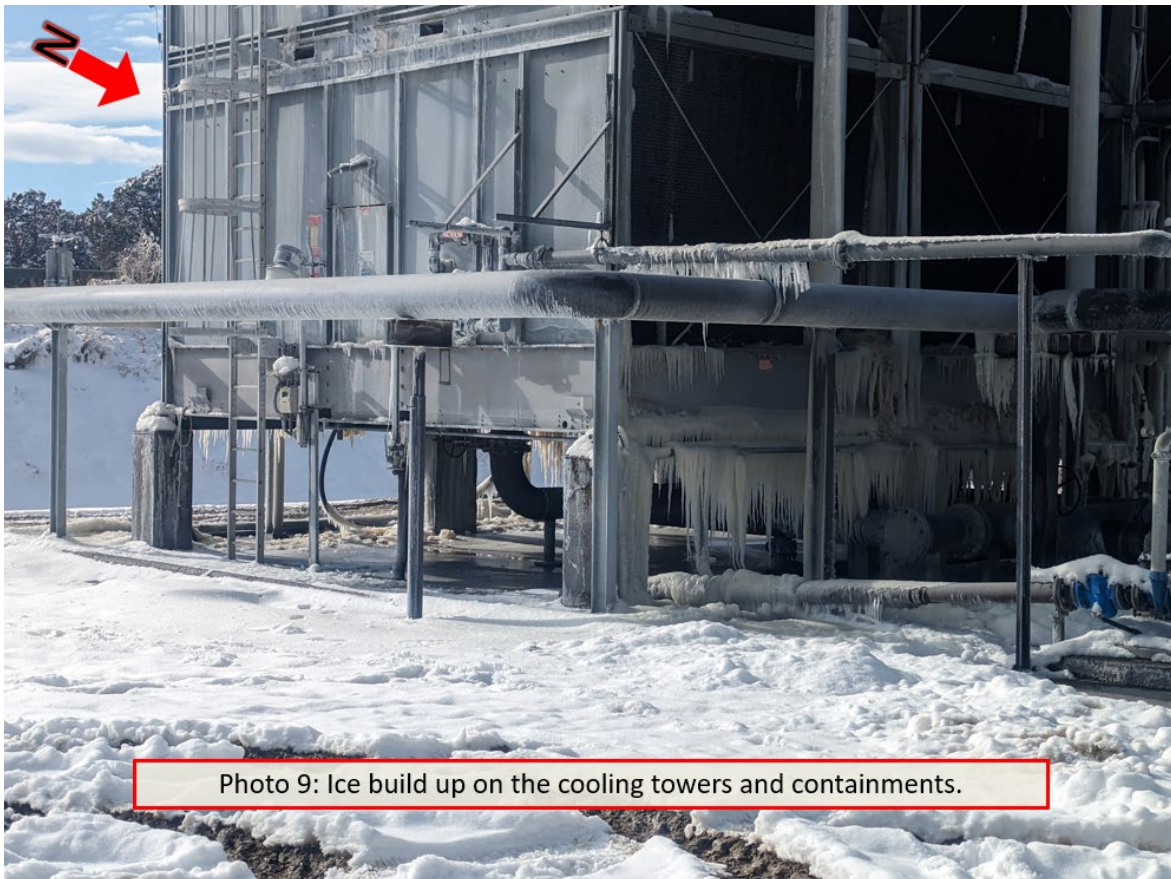
Located outside of the plant to the south are the cooling towers. They are located over a concrete secondary containment structure which is located within the footprint of the grater facility ditches and containment. The towers had lots of ice buildup on them and the containment was also filled with ice (Photo Nine). It was indicated that NSI periodically washes down (rinses) the towers to remove excess frozen liquor.

Photo 9: Ice build up on the cooling towers and containments.

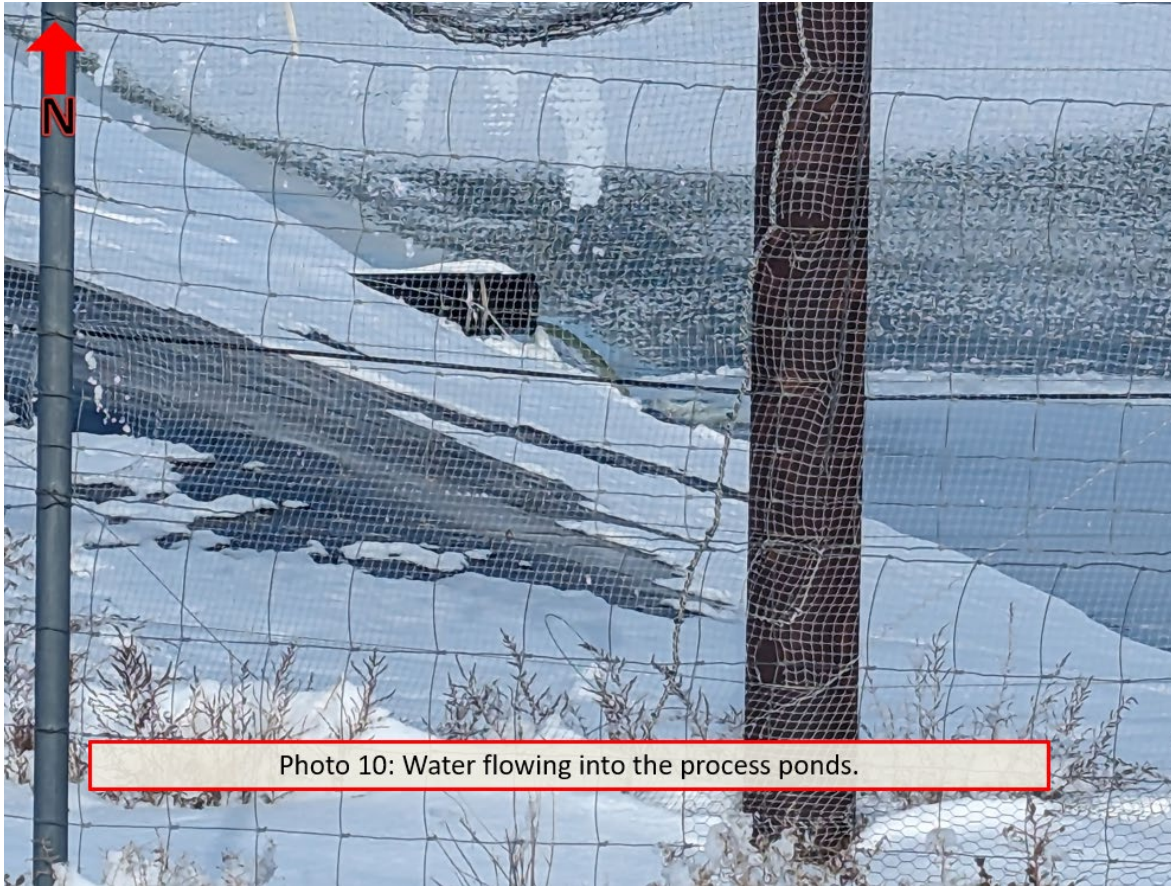
The plant area uses a combination of in-floor sumps and exterior perimeter ditching to ensure containment for the plant. All food grade liquids report back to the barren liquor lines where possible. An overflow for the sumps are directed to the process ponds, which are located to the North of the plant. The pond was inspected, and fluid was observed entering the pond indicating that the sump system remains functional (Photo Ten).
