## MINERALS PROGRAM INSPECTION REPORT

<b>MINE NAME:</b> Mitchell Mine No 1	<b>MINE/PROSPECTING ID#:</b> M-1986-025	<b>MINERAL:</b> Sand and gravel	<b>COUNTY:</b> El Paso
<b>INSPECTION TYPE:</b> Surety Release Inspection	<b>WEATHER:</b> Clear	<b>INSP. DATE:</b> November 29, 2023	<b>INSP. TIME:</b> 10:15
<b>OPERATOR:</b> R E Monks Construction Co.	<b>OPERATOR REPRESENTATIVE:</b> Greigg Newlon	<b>TYPE OF OPERATION:</b> 110c - Construction Limited Impact	
<b>REASON FOR INSPECTION:</b> Surety Release Requested	<b>BOND CALCULATION TYPE:</b> None	<b>BOND AMOUNT:</b> \$11,500.00	
<b>DATE OF COMPLAINT:</b> NA	<b>POST INSP. CONTACTS:</b> None	<b>JOINT INSP. AGENCY:</b> None	
<b>INSPECTOR(S):</b> Timothy Cazier, P.E.	<b>INSPECTOR'S SIGNATURE:</b>

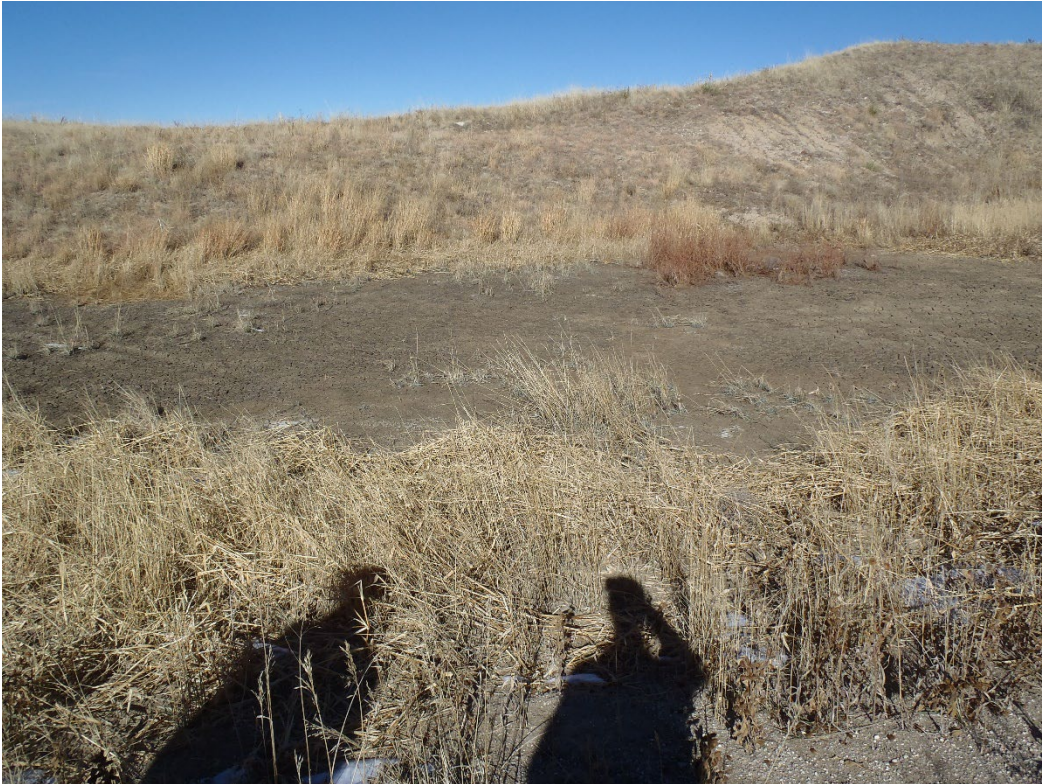
Vegetation (**Photos 1 and 2**) was observed to have become fairly well established despite the poor sandy soil, including some forbs as well as a variety of grasses.

Photo 1. Established vegetation on the pit floor and west highwall (looking NW).

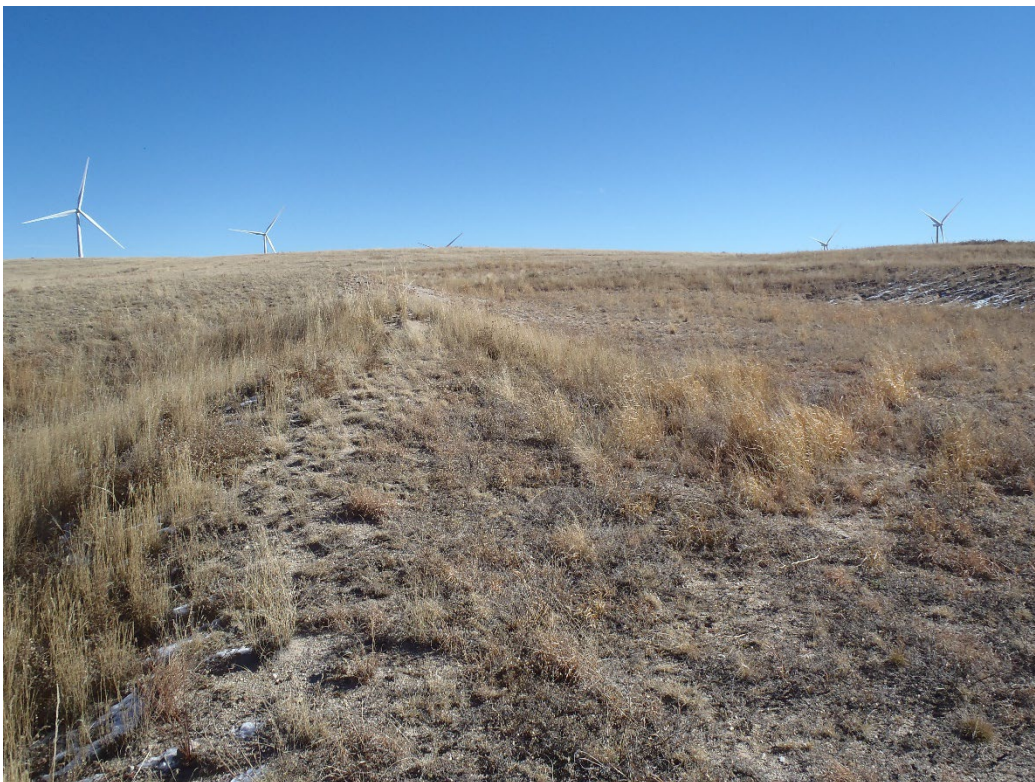
Photo 2. Established vegetation above the crest (looking NE).

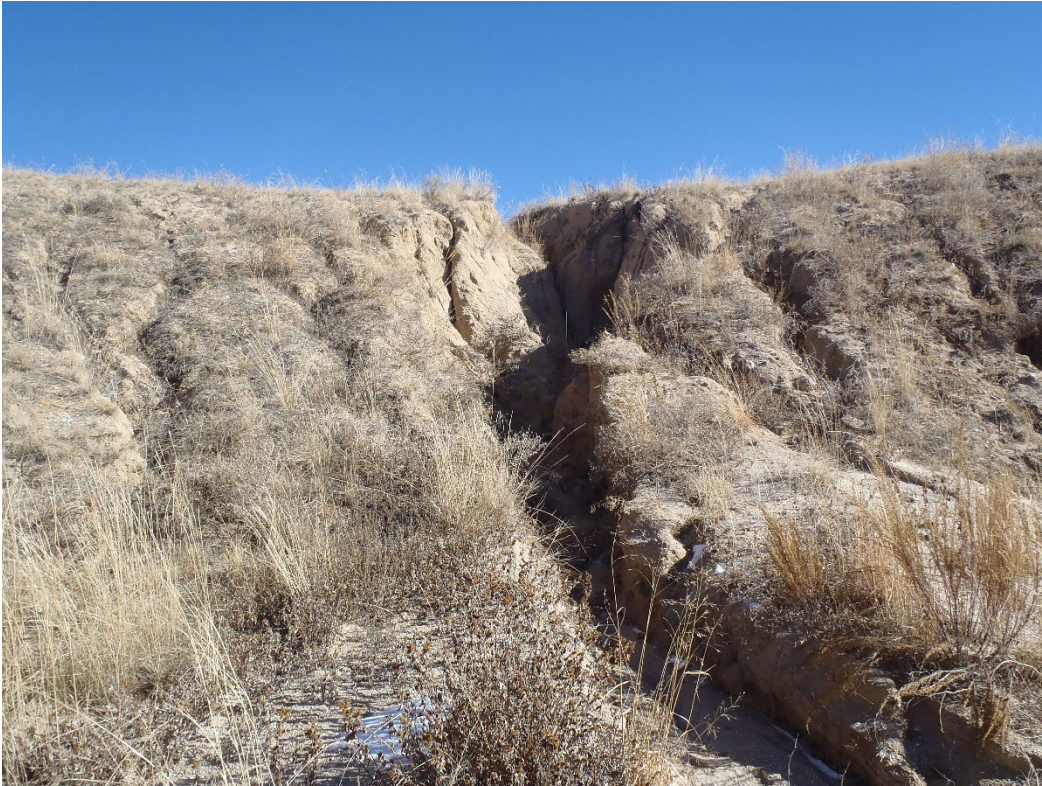
The recent requests for full surety releases have been denied due to a persistent gulley erosion issue. Mr. Newlon explained that despite RE Monks Construction not mining this site since the permit was transferred to them in 1988 (SO-1), they have repaired the gulley four times.

The repaired gulley had eroded (**Photo 3**) since the most recent repair effort, but was less severe, likely due to the established vegetation reducing the amount of runoff. Any further repairs would damage a lot of the established vegetation. In addition, R E Monks evaluated diverting the runoff from above the reclaimed highwall to the west and was concerned the additional runoff might overwhelm the natural drainage there, resulting in sediment deposition on the neighboring property to the west. Mr. Newlon also stated the landowner of the permitted area (Mr. Garrett Balsick) was not concerned about the erosion gulley. It should be noted that in response to the first surety release request (SL-1) the DRMS received a letter from Mr. Balsick in July of 2020, stating the "as-is" condition at the time was acceptable to him.

Photo 3. Persistent gulley at the time of this inspection (looking NE).

The public comment period for this release request closed on November 28<sup>th</sup>, the day prior to this inspection. No comments have been received by the DRMS to date. As the gulley has been repaired multiple times and any further repair would require re-establishing vegetation in a difficult growing environment, the DRMS will recommend approval of the requested surety release.
