MINERALS PROGRAM INSPECTION REPORT
PHONE: (303) 866-3567

MINE NAME: Climax Mine	MINE/PROSPECTING ID#: M-1977-493	MINERAL: Molybdenum	COUNTY: Lake, Summit
INSPECTION TYPE: Monitoring	WEATHER: Clear	INSP. DATE: December 7, 2023	INSP. TIME: 10:00
OPERATOR: Climax Molybdenum Company	OPERATOR REPRESENTATIVE: Alex Ungers	TYPE OF OPERATION: 112d-3 - Designated Mining Operation	
REASON FOR INSPECTION: Normal I&E Program	BOND CALCULATION TYPE: None	BOND AMOUNT: \$91,011,850.00	
DATE OF COMPLAINT: NA	POST INSP. CONTACTS: DRMS	JOINT INSP. AGENCY: None	
INSPECTOR(S): Amy Yeldell Todd Jesse	INSPECTOR'S SIGNATURE:

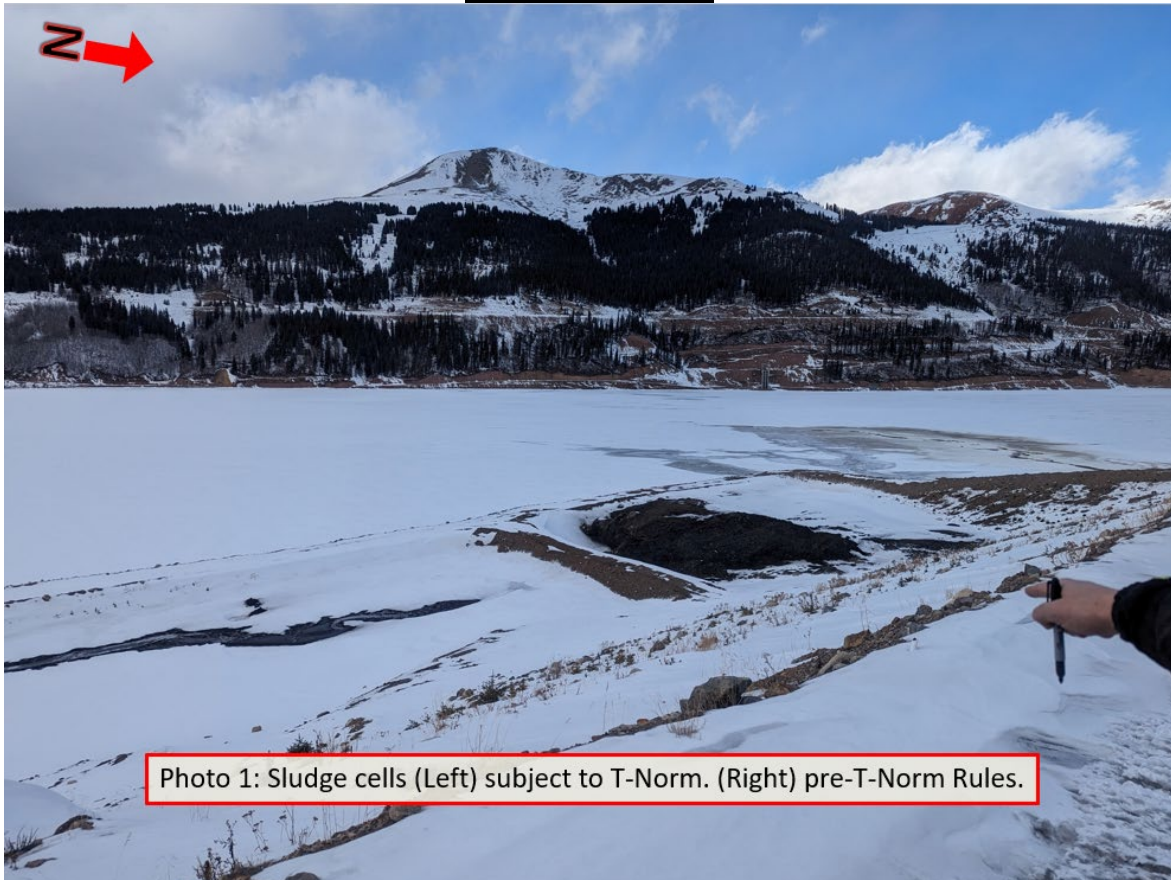
Located on the east side of the Mayflower TSF are the sludge cells (Photo One). These contain the dewatered solids from the PDWTP Thickeners. Recently CDPHE has changed the T-Norm rule making these sludges no longer eligible for on-site disposal. Climax has created two cells within the greater sludge cell. The northern cell contains waste from 2012-22 pre-T-Norm. This material is grandfathered in from registration. Mr. Ungers is working with CDPHE to determine if this material is also eligible for on-site disposal or if it will require removal. The southern cell is 2022 on and falls under the T-Norm Rules. Climax will periodically empty this cell by removing the solids from the site. Climax intends to use the same disposal processes as Henderson but they system has not yet been formally set up. The Division clarified that for bonding purposes we will need to know if the pre-T-Norm sludge can remain. For post-T-Norm, what is the maximum amount of sludge to be on site that could need to be removed.

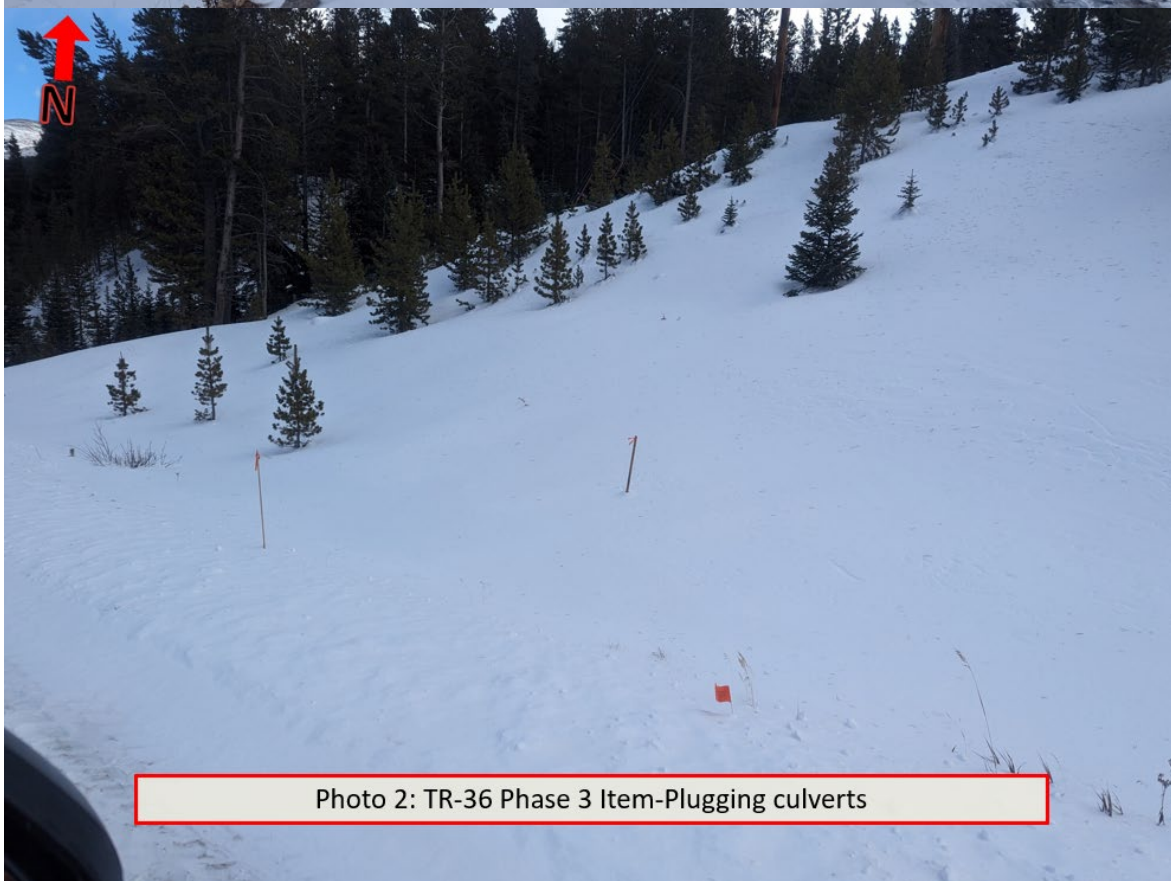
The Division observed the area where three culverts have been plugged. This is associated with the Phase 3 inspection punch list of TR-36. Mr. Ungers explained that crews dug out around the culverts, capped them with cement then re-backfilled and contoured the drainage. Due to snow cover only the survey stakes were visible (Photo Two). Contouring verification should occur when the features are free of snow.

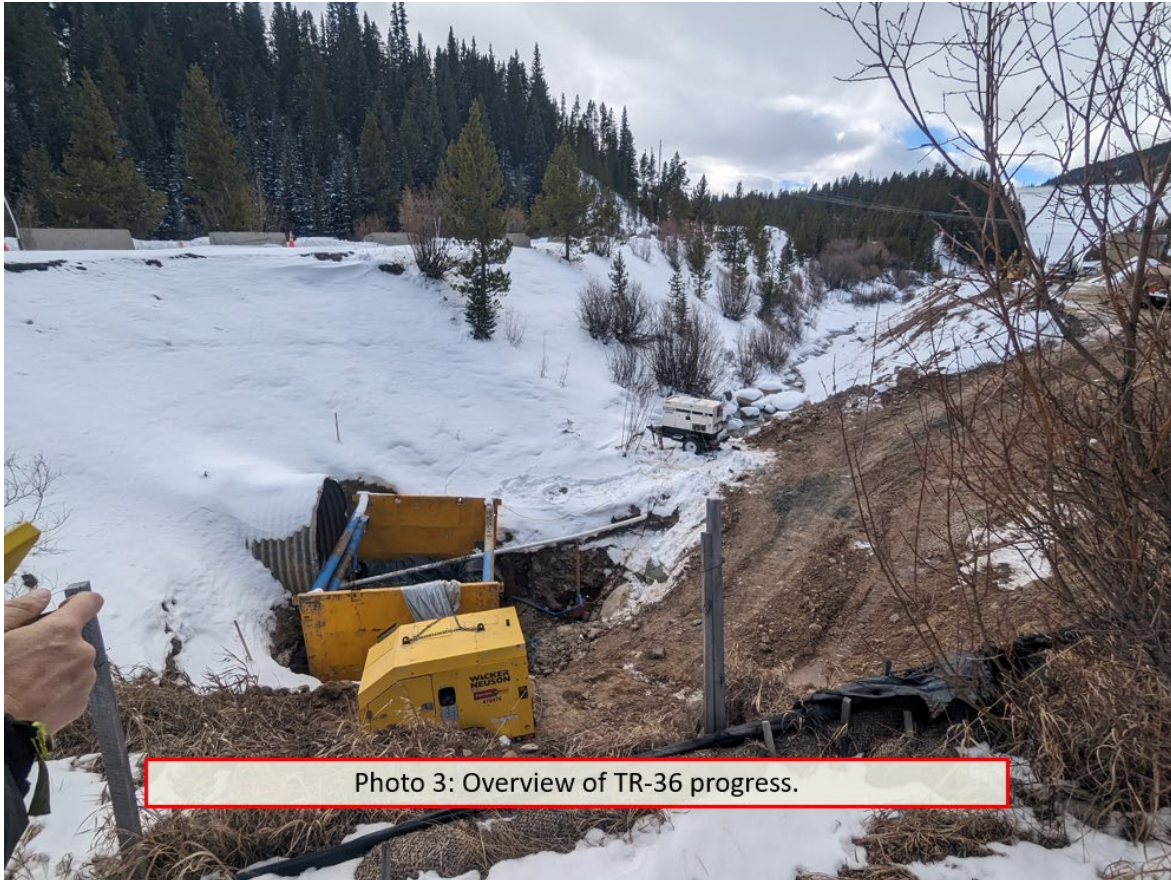
The Division observed the cofferdam in the drainage which holds water back to keep a dry working area. Any drainage is then piped through the culvert. The old cut-off wall is completely demoed and additional excavations have been made in preparation for its replacement. The new bottom portion of the wall has been poured. Staff could see forms and blanketed concrete that's being heated to aid in curing. See Photos Three to Six

Photo 3: Overview of TR-36 progress.

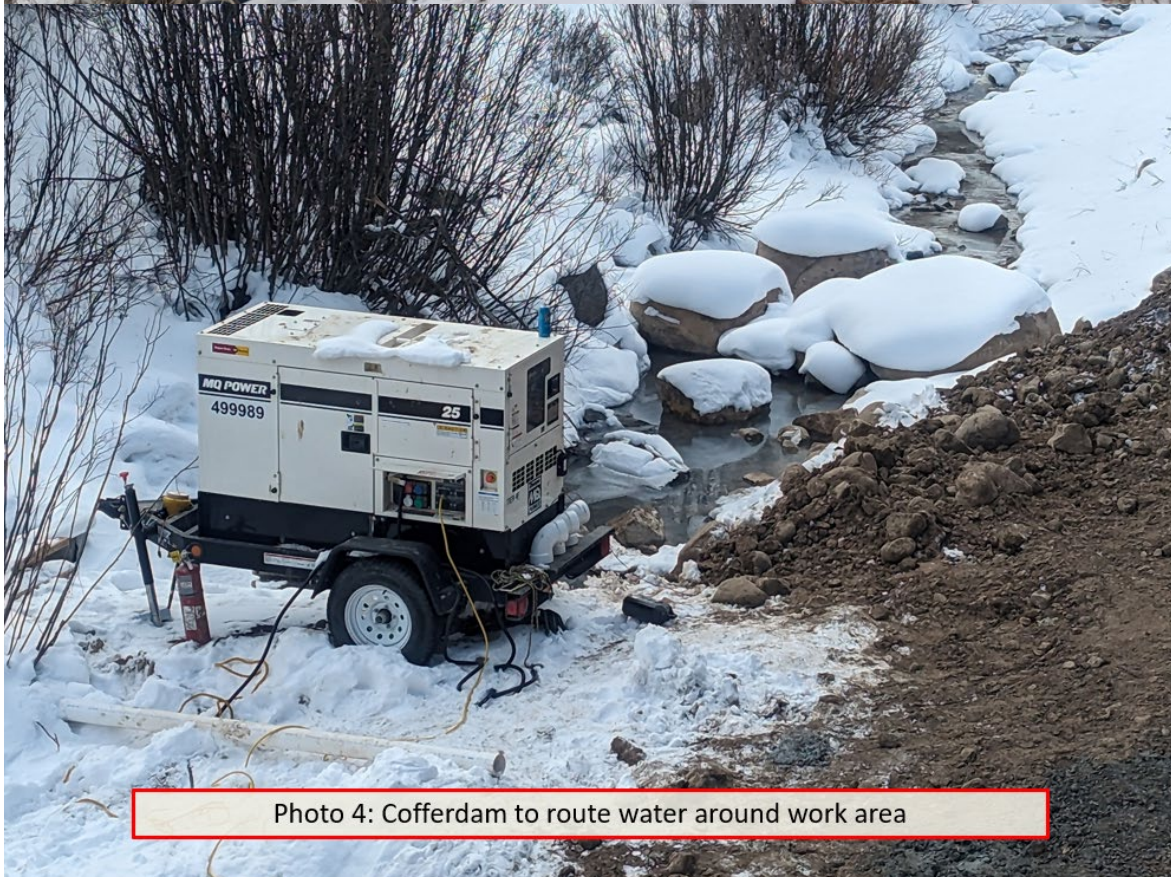
Photo 4: Cofferdam to route water around work area

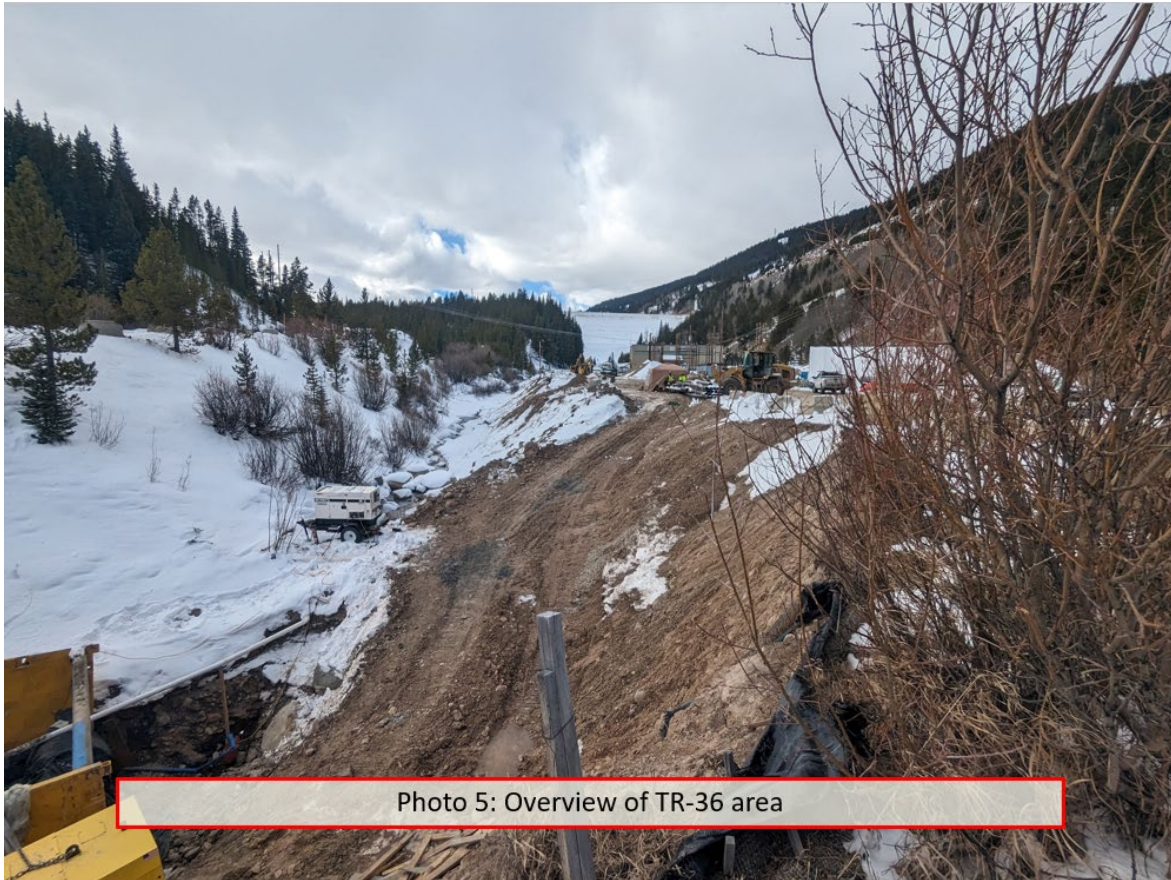
Photo 5: Overview of TR-36 area

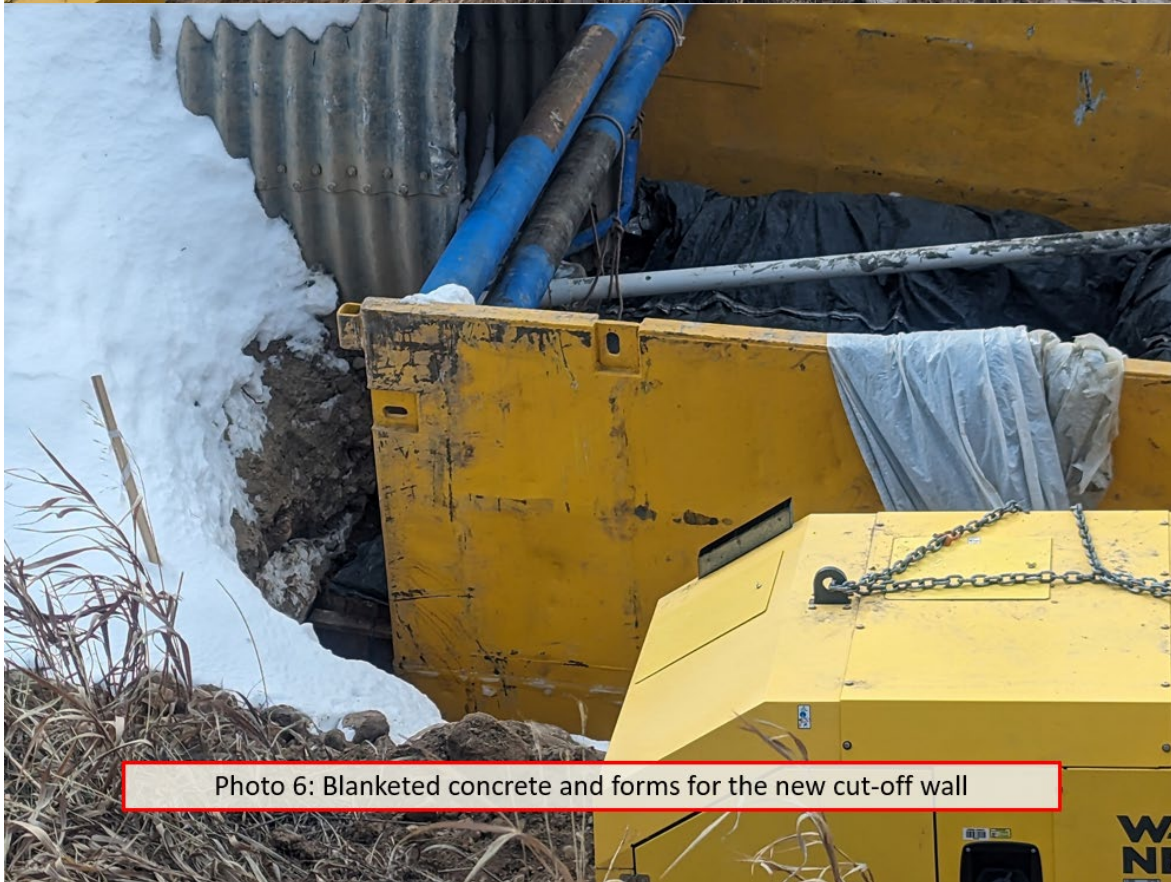
Photo 6: Blanketed concrete and forms for the new cut-off wall

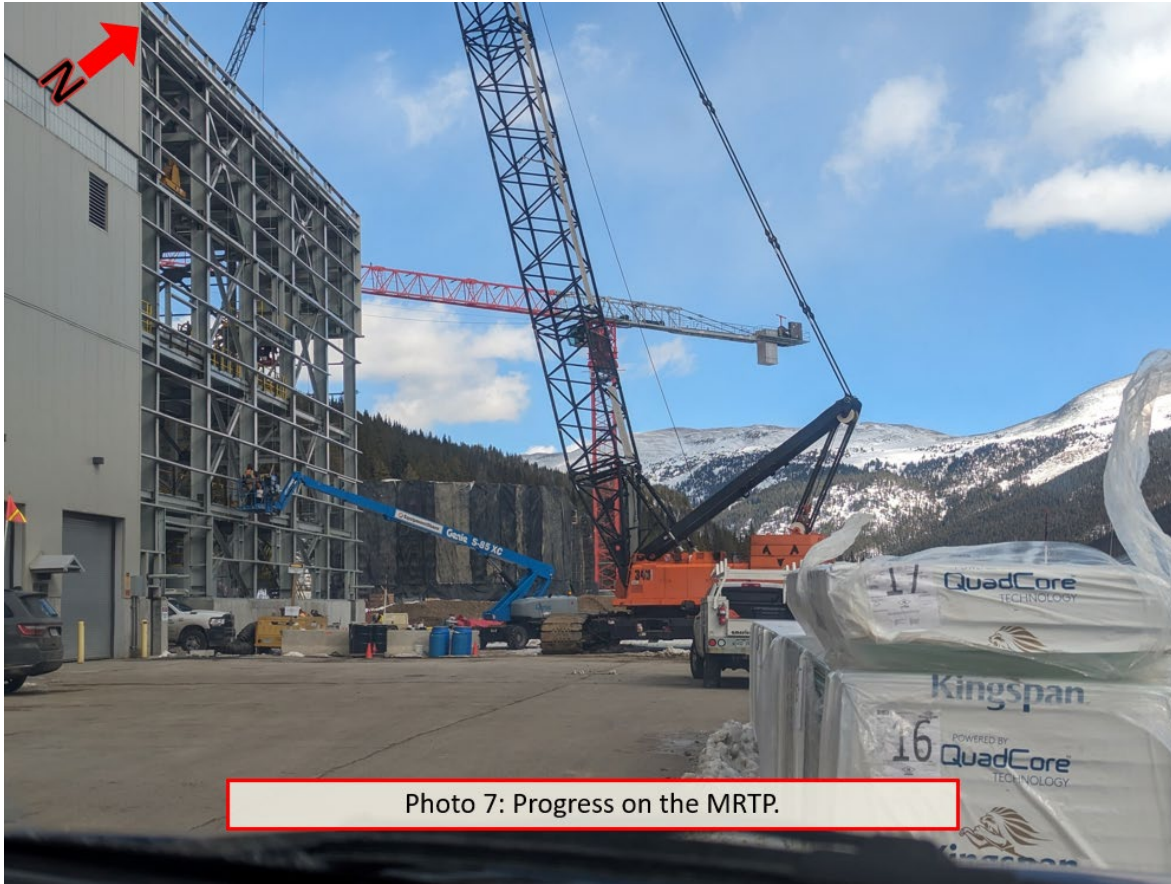
A crane and several crews were on site actively working on this new EPF. The steel frame is nearly complete and the metal siding is being applied. The foundation for the thickener tanks is currently being poured (Photo Seven). The building is slated to be online in the first quarter of 2025.

Photo 7: Progress on the MRTTP.
