Inspection Report, Foidel Creek Mine, C-1982-056

PERMIT INFORMATION

Permit Number: C-1982-056 Mine Name: Foidel Creek Mine Operator: Twentymile Coal, LLC Operator Address: Ms Miranda Kawcak 29515 Routt County Road No. 27 Oak Creek, CO 80467	County: Routt Operation Type: Underground Permit Status: Active Ownership: Private
	Operator Representative Present: Miranda Kawcak
Operator Representative Signature: (Field Issuance Only)

Inspection Start Date: December 12, 2023 Inspection Start Time: 11:00 Inspection End Date: December 12, 2023 Inspection End Time: 13:15		Inspection Type: Coal Complete Inspection Inspection Reason: Normal I&E Program Weather: Clear	
Joint Inspection Agency: None		Joint Inspection Contacts: 	
Post Inspection Agency: None		Post Inspection Contacts: 	
Inspector(s): Hunter Ridley	Inspector's Signature: <i>Hunter Ridley</i>		Signature Date: December 18, 2023

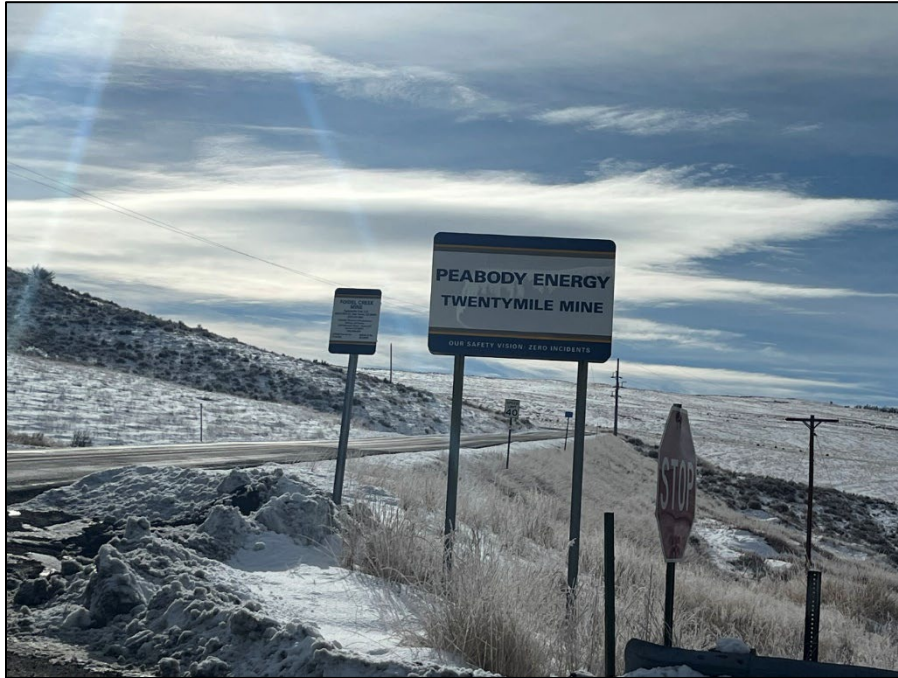
Mine identification markers were observed throughout the site (Photo 1). All information for compliance was present across all signs.

Photo 1: Mine signage located at the site entrance.

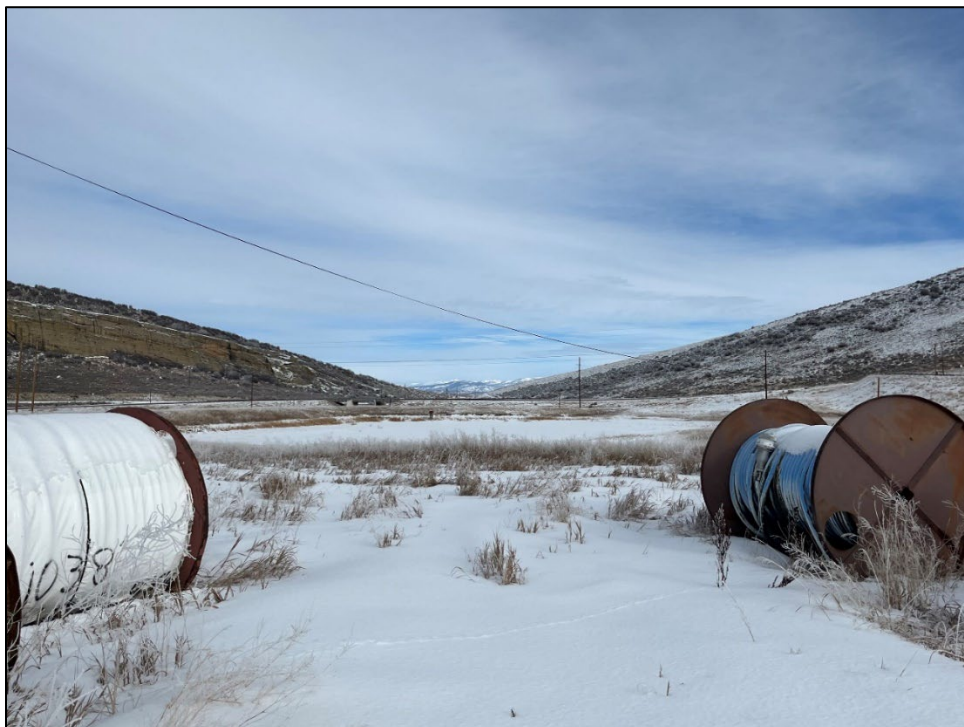
Ponds were checked for discharge and culverts were inspected for function. TC should continue to clean out culverts when vegetation and sediment hinders function. A sample of ponds and discharge points are represented in Photos 2, 4, 5, 7, 9, and 12.

Photo 2: View northeast of Pond G, not discharging.

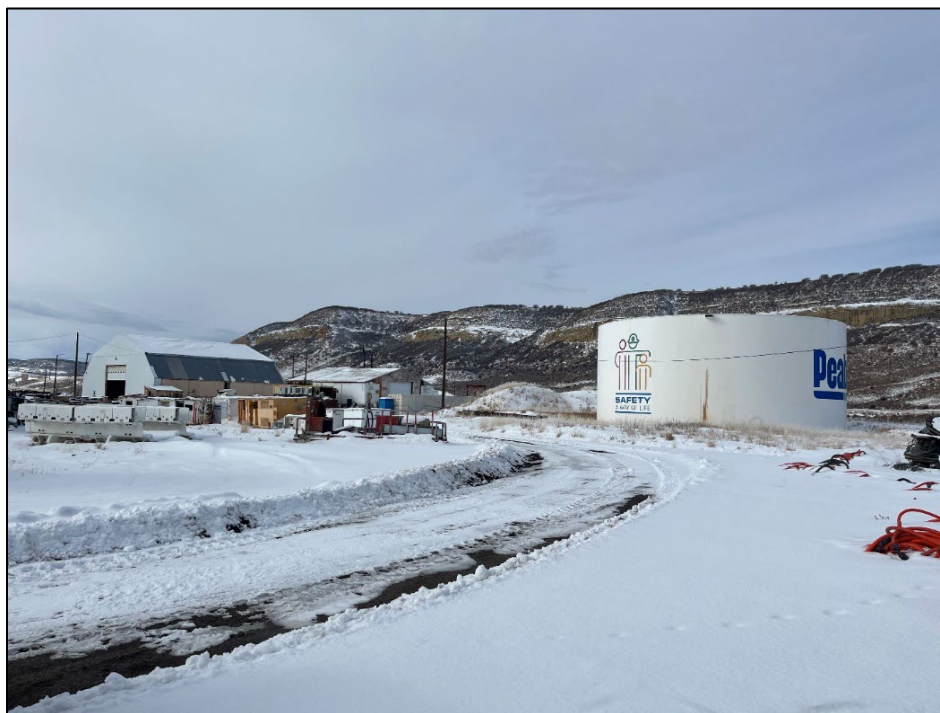
Storage areas were being organized and excess equipment was being stored away for the winter season (Photo 3). The Stoker Coal Loadout building which was sealed in late 2023 to correct a water leakage issue is still sealed well and functioning properly. BMPs installed as part of this corrective action are still in place, though in need of repair (Photo 6). Please ensure these BMPs remain functional throughout the winter season. This has been added as a maintenance item. No coal spills were observed in front of the loadout building.

Photo 3: View west of an equipment storage area and the million-gallon tank.

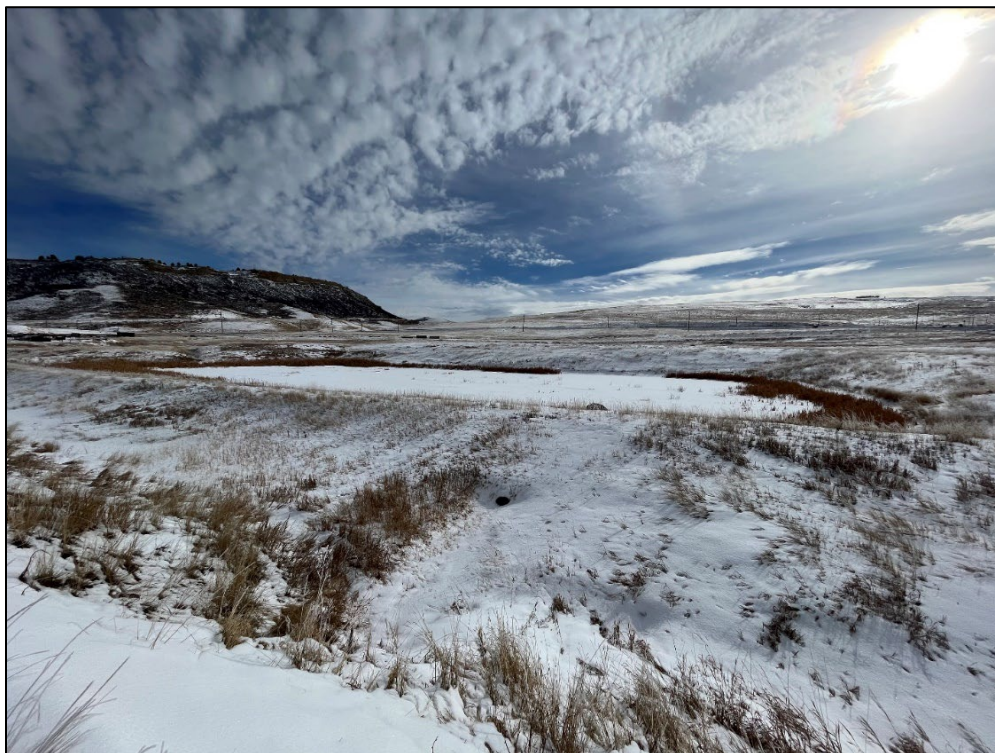
Photo 4: View east of Pond F, not discharging.

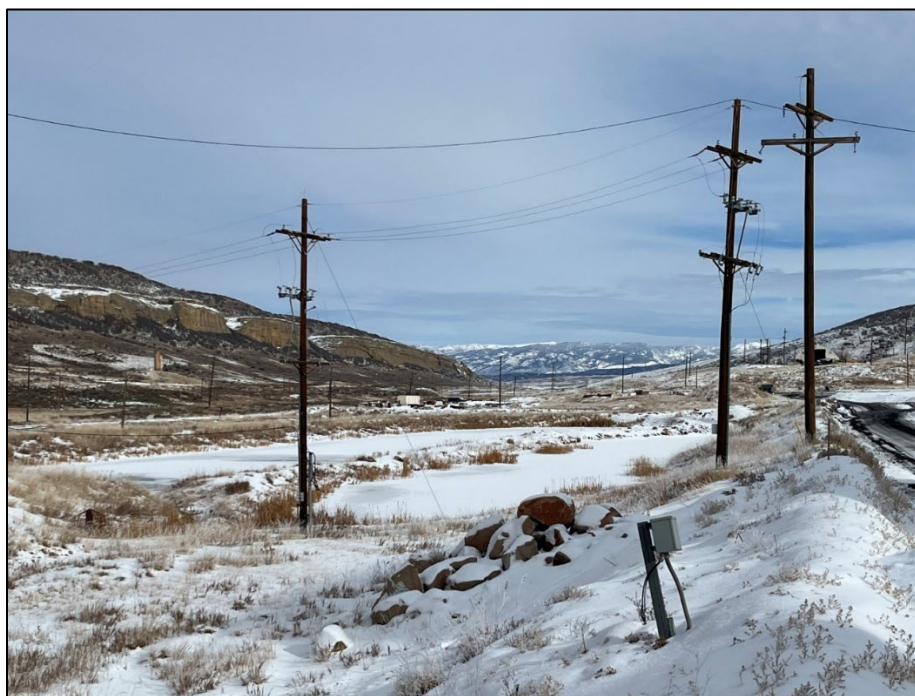
Photo 5: View north of Pond E, discharging.

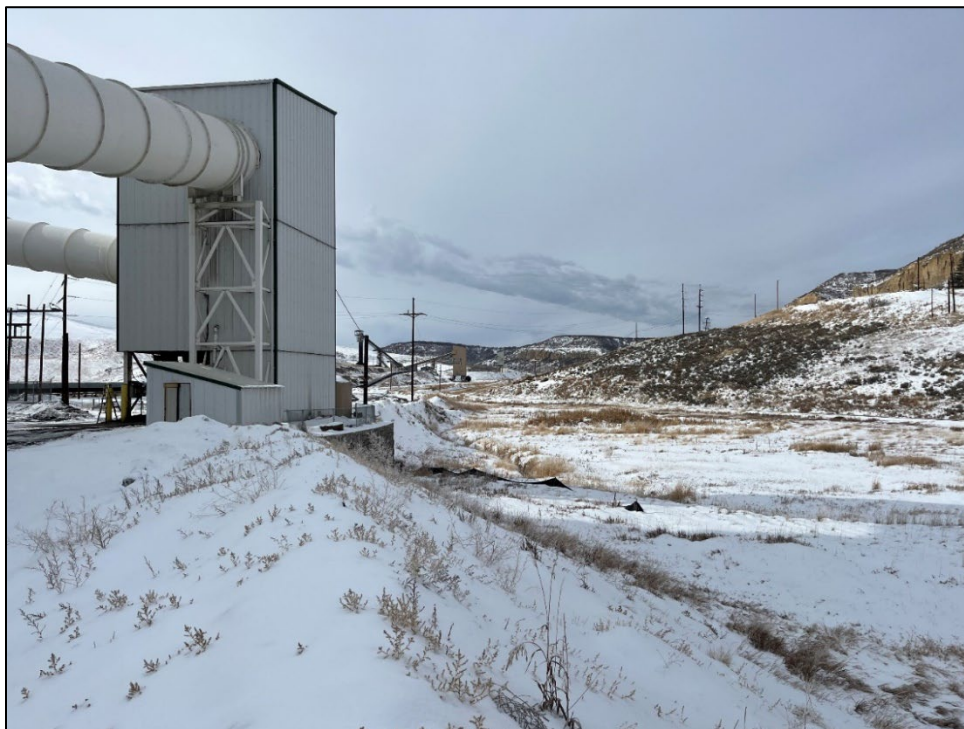
Photo 6: View south of the Stoker Loadout Building and Foidel Creek Buffer Zone.

- Protect topsoil piles throughout the site during maintenance and snow plowing activities in the winter months
- Ensure BMPs near the Stoker Coal Loadout area are maintained and replaced as needed throughout the winter season.

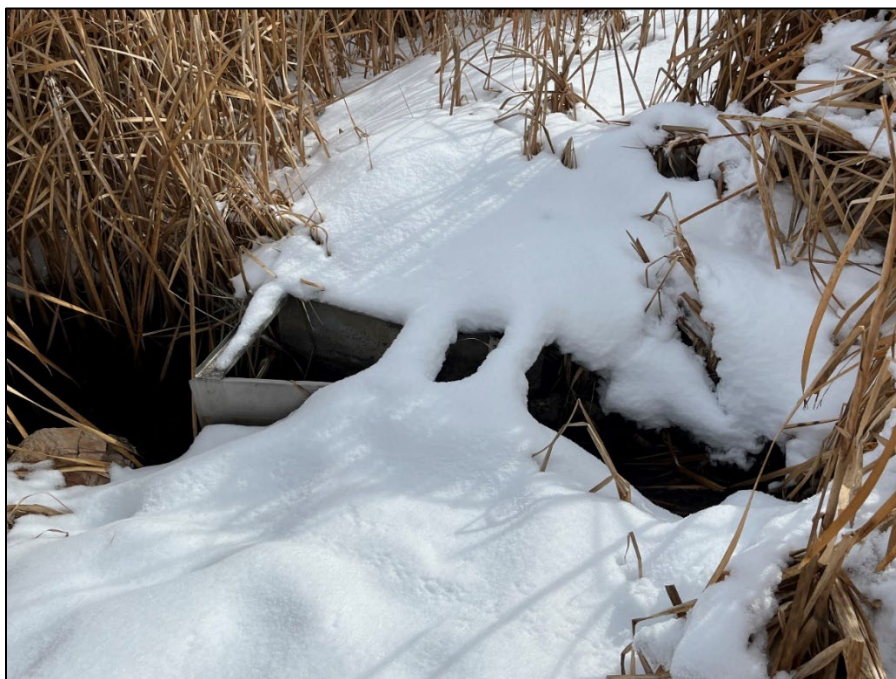
Photo 7: Water sample collection point for Pond D.

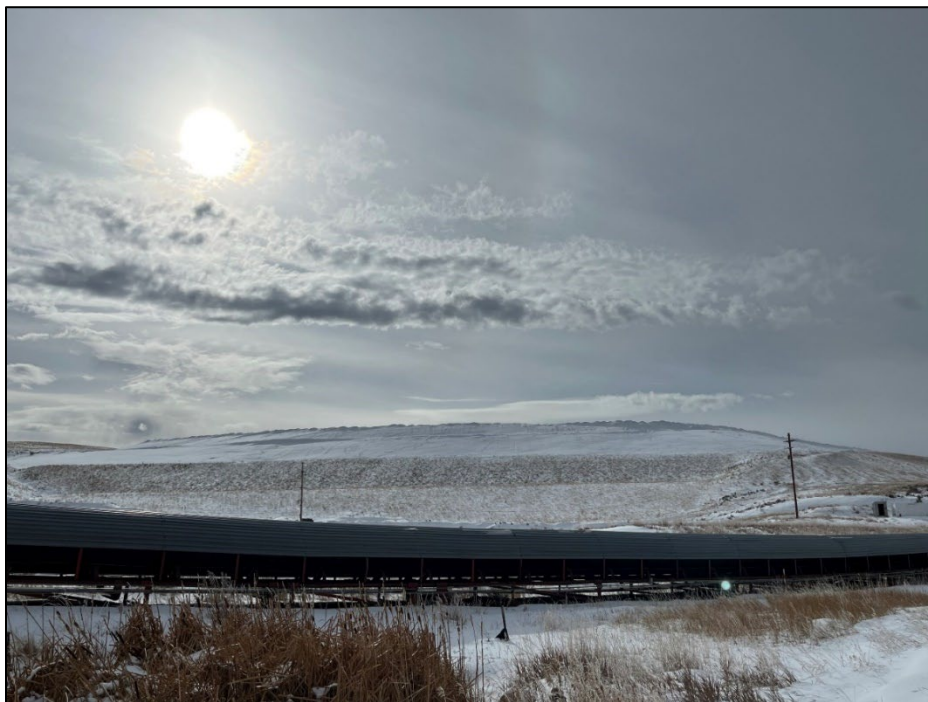
Compaction of refuse material continues (Photos 8, 10 and 11). Lifts three and four are under construction. Lifts are built facing downslope to encourage proper drainage into Pond D. Clay overburden material is then taken from the southern portion of the refuse area to cover the pile before adding topsoil from the nearby stockpile to the northeast.

Photo 8: View south of the refuse pile as viewed from below in the Main Facilities area.

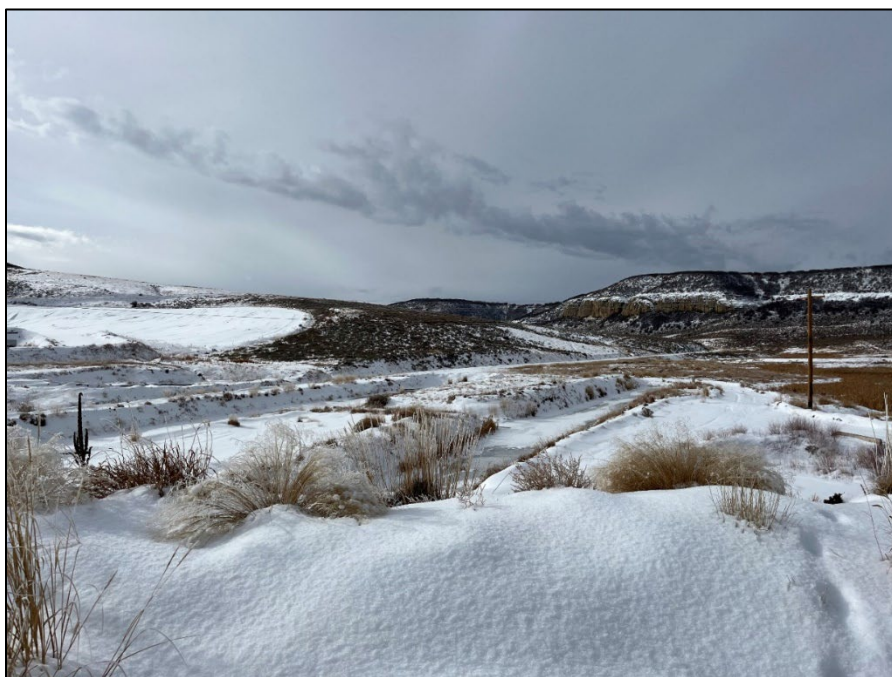
Photo 9: View south of Ponds B, discharging.

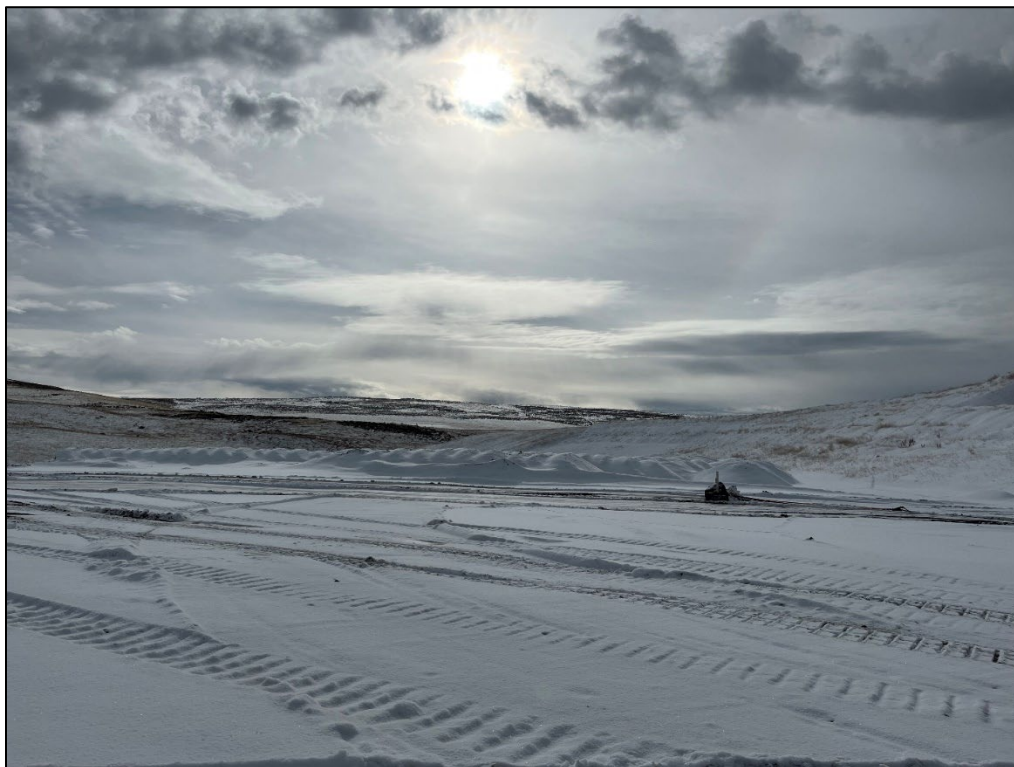
Photo 10: View east atop the refuse pile.

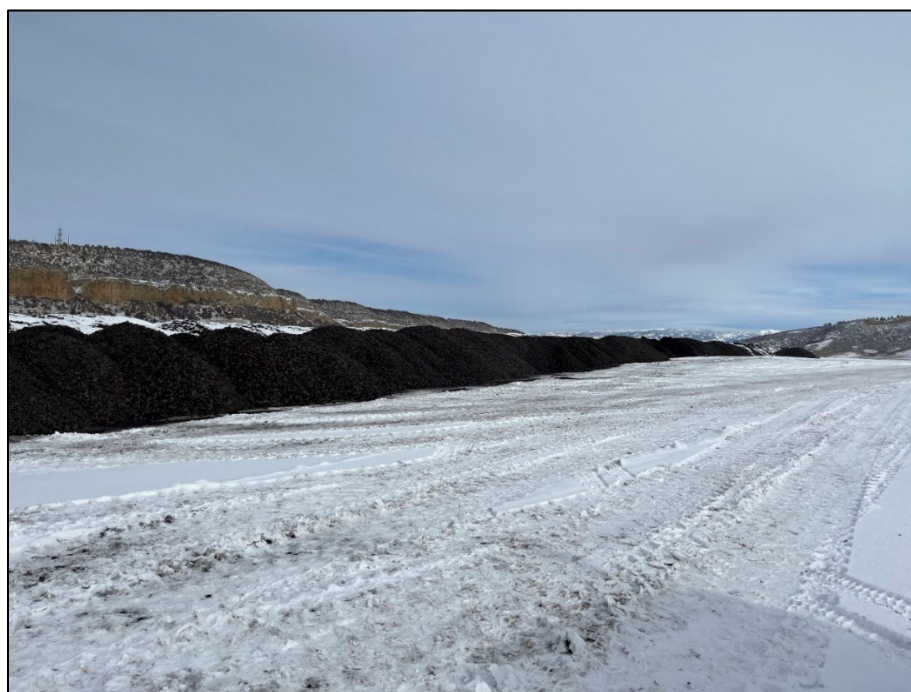
Photo 11: View northwest atop the refuse pile, refuse material continues to be piled in the winter months.

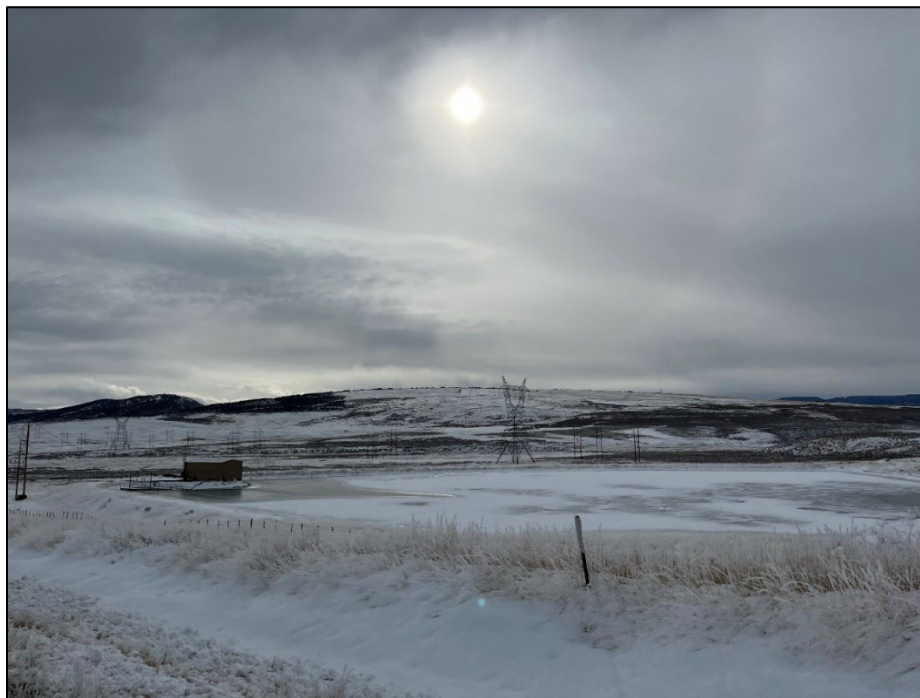
The Passive Water Treatment Plant has been turned off for the winter months. The small weather station and experimental device which were set up in and on the 6 MN Reservoir have been removed (Photo 12). These were being utilized by a university to collect climactic and water level data. The blower fans in this area which bring heat down to the mine workings have been turned on for the winter season.

Photo 12: View east of the 6 MN Reservoir.

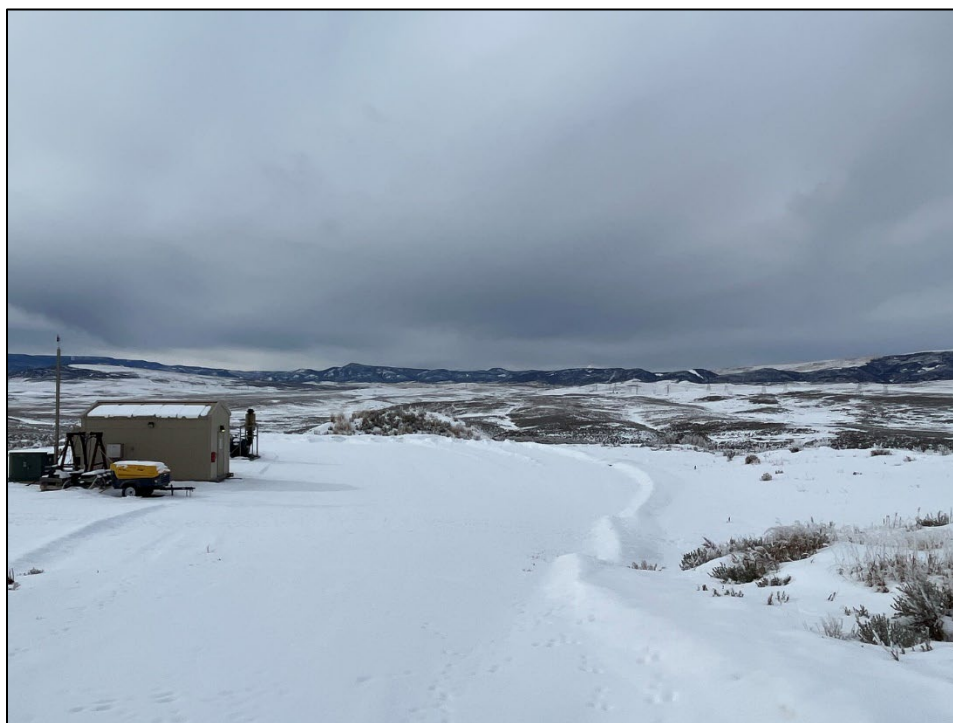
The Tipple Area and Fish Creek borehole is generally unused. The 9 East Exhaust Blower Pad and reclaimed 18 Right borehole were inspected in this area and found to be free of any issues. (Photo 13). The Fish Creek ponds are functioning properly (Photo 14).

Photo 13: View east of the 9 East Exhaust Blower Pad.

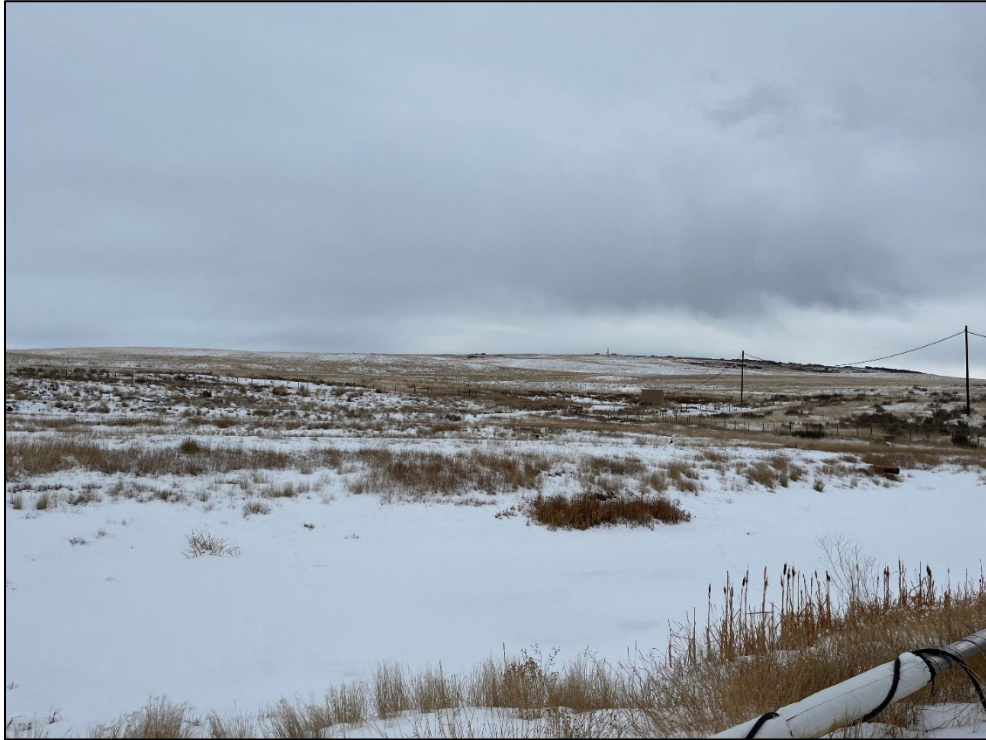
Photo 14: View east of the Fish Creek Borehole ponds.
