**MINERALS PROGRAM INSPECTION REPORT**  
**PHONE: (303) 866-3567**

<b>MINE NAME:</b> Worthing Pit	<b>MINE/PROSPECTING ID#:</b> M-1977-526	<b>MINERAL:</b> Sand and gravel	<b>COUNTY:</b> Adams
<b>INSPECTION TYPE:</b> Surety Release Inspection SR2	<b>WEATHER:</b> Clear	<b>INSP. DATE:</b> December 11, 2023	<b>INSP. TIME:</b> 11:00
<b>OPERATOR:</b> Albert Frei & Sons Inc.	<b>OPERATOR REPRESENTATIVE:</b> Joel Bolduc and Ben Frei	<b>TYPE OF OPERATION:</b> 112c - Construction Regular Operation	
<b>REASON FOR INSPECTION:</b> Surety Related	<b>BOND CALCULATION TYPE:</b> Complete Bond	<b>BOND AMOUNT:</b> \$230,800.00	
<b>DATE OF COMPLAINT:</b> NA	<b>POST INSP. CONTACTS:</b> None	<b>JOINT INSP. AGENCY:</b> None	
<b>INSPECTOR(S):</b> Nikie Gagnon	<b>INSPECTOR'S SIGNATURE:</b>

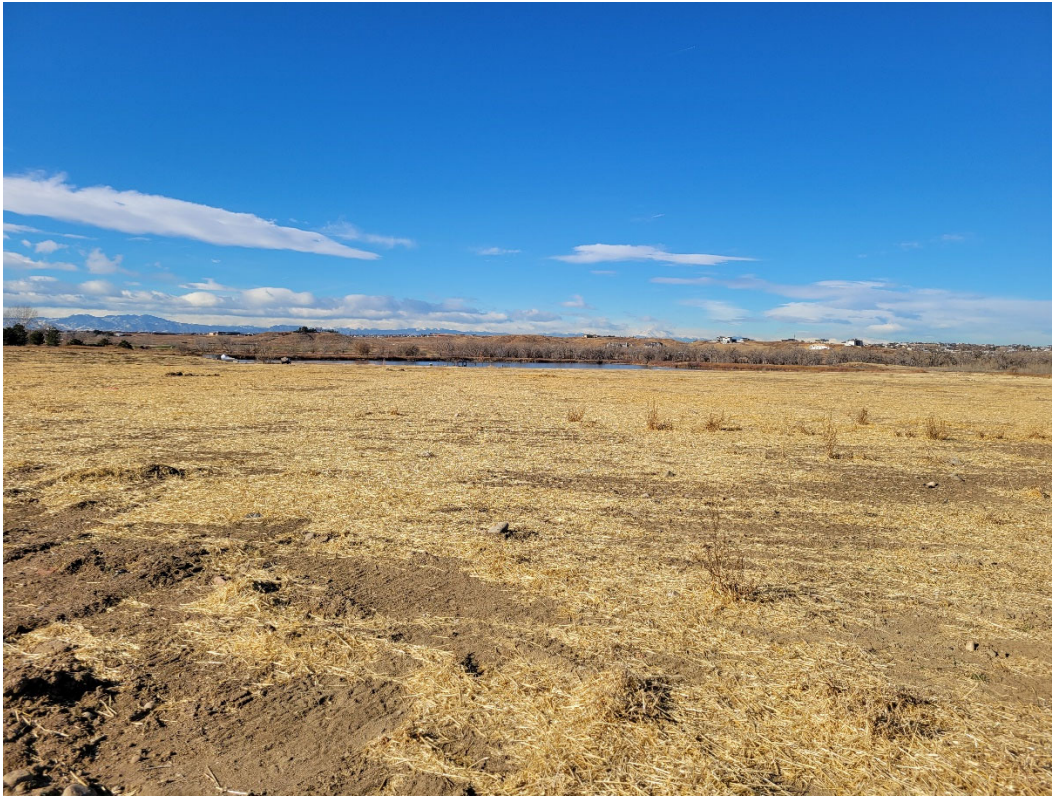
Photo 1: View looking west across the south side of the permit area.

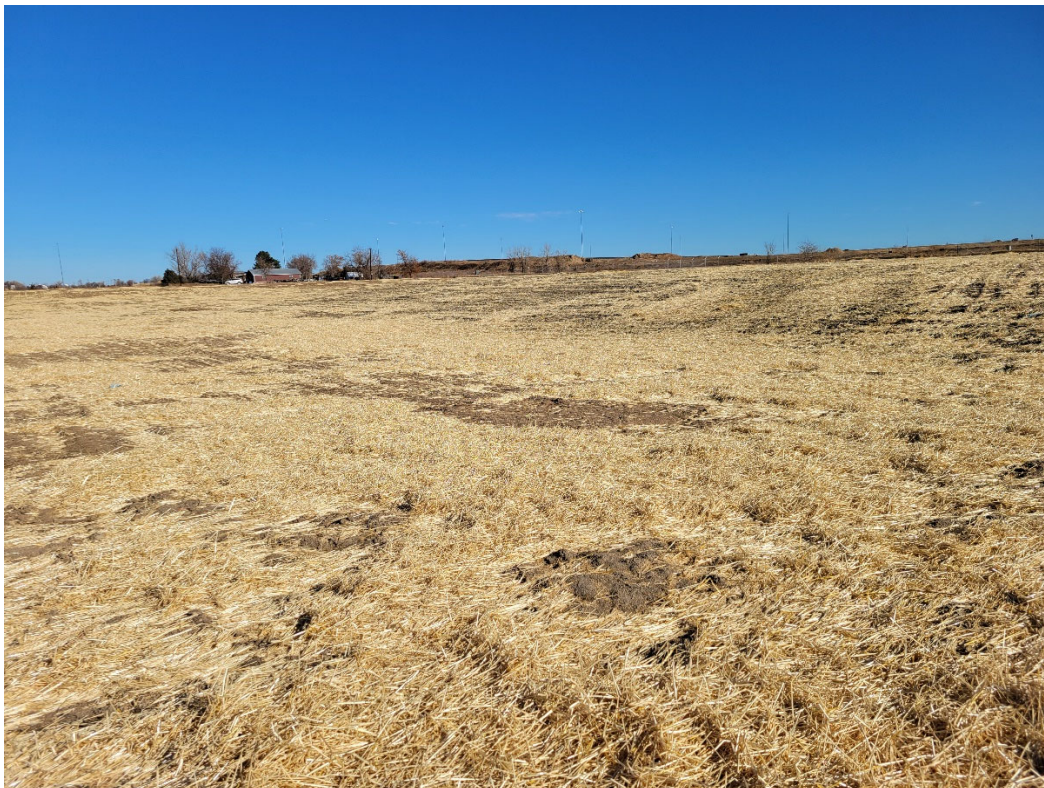
The Division observed evidence of recent grading across the remaining permit area. The south side of the permit area is graded flat to the elevation of the surrounding area, with shallow (3H:1V or less) contours sloping to the west, consistent with the approved reclamation plan. Approximately 30 acres in the north end of the permit area has been backfilled with inert fill. According to the Operator, inert fill activities were completed in 2022. The Division observed the inert fill area and noted it has been graded level to the elevation of Brighton Road and slopes gently to the west, towards the South Platte River.

Photo 2: View looking north across the south end of the permit area. Shallow contours in this area slope to the west.

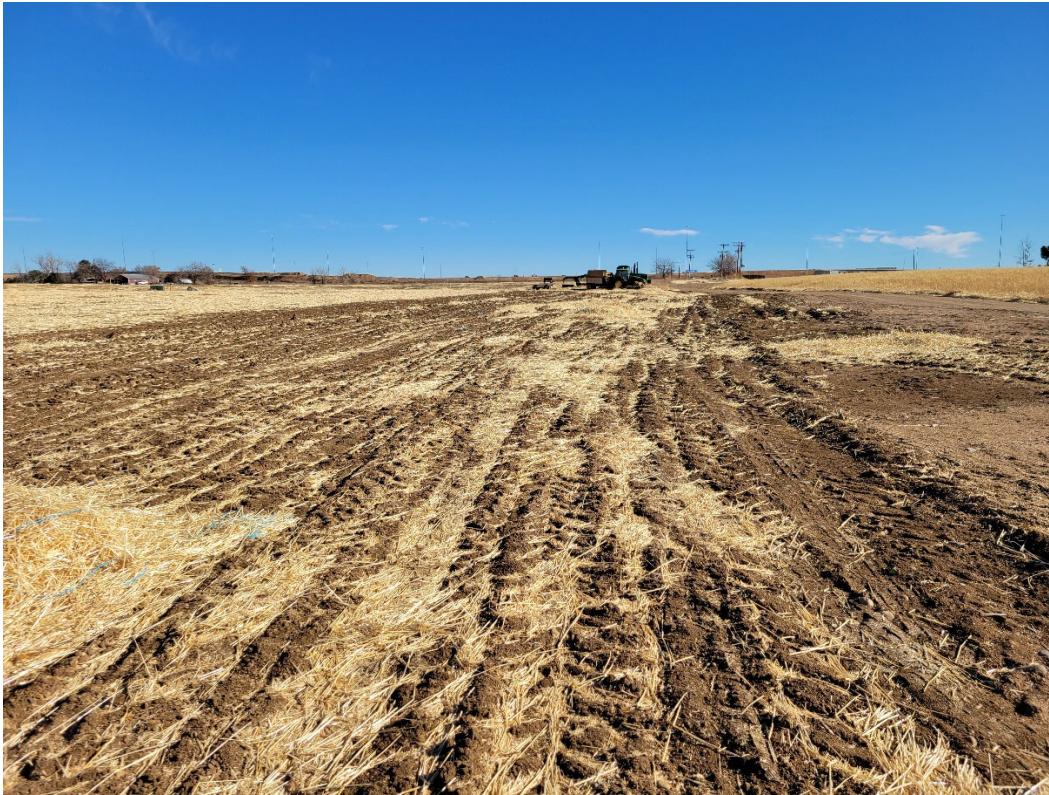
Photo 3: View looking east across the south side of the permit area. Evidence of topsoiling and drill seeding noted here.

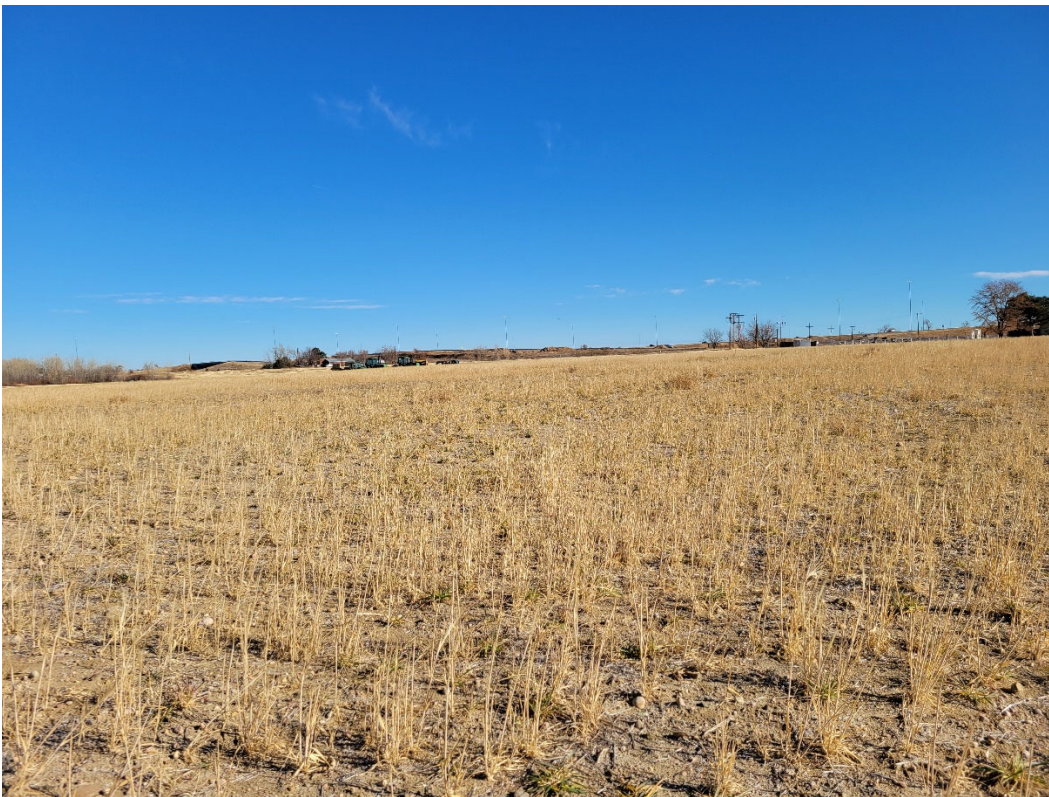
Just south of the entrance, a 3.5-acre area was seeded last fall and wheatgrass was observed growing here during this inspection. Erosion gullies were noted on the western slope of this area. The Operator should keep an eye on this and repair the slope as necessary.

Photo 4: View looking north across area reseeded in the fall on the south end of the permit area.

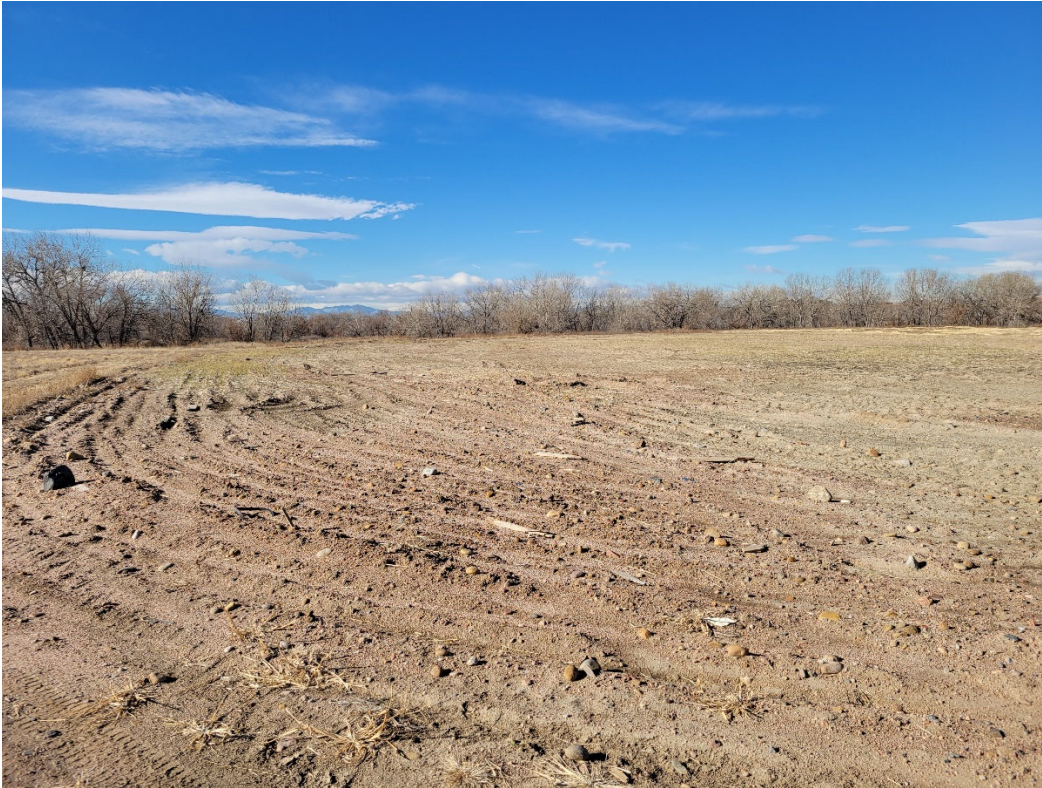
During the inspection, the Operator confirmed that six inches of topsoil was replaced across the remaining acres. The Division observed evidence of recent drill seeding. Straw mulch was observed across most of the reclaimed areas. One area in the southwest section of the permit area had little or no straw mulch. The Division pointed this out to the Operator to correct.

Photo 5: View looking west across recently graded area in the southwest section of the permit area. Straw mulch is thin or missing here.

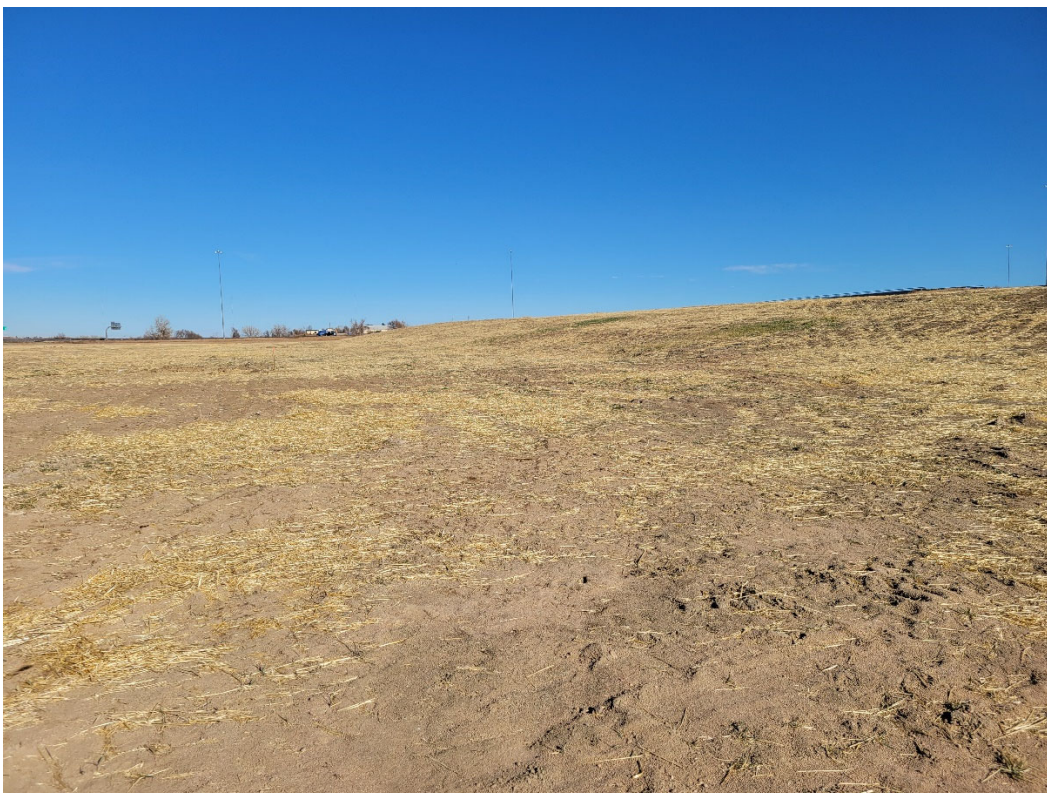
Photo 6: View looking north from the southeast end of the permit area. Shallow contours slope to the west.

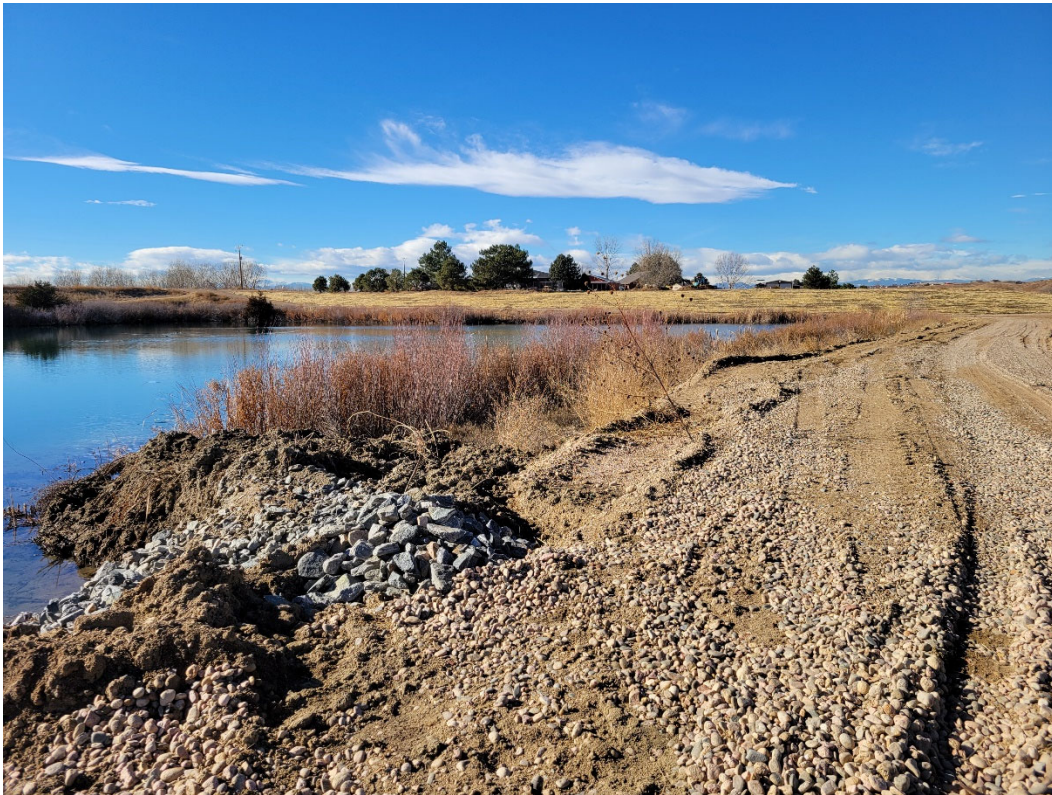
Photo 7: View of access road adjacent to pond on the north end of the permit area.

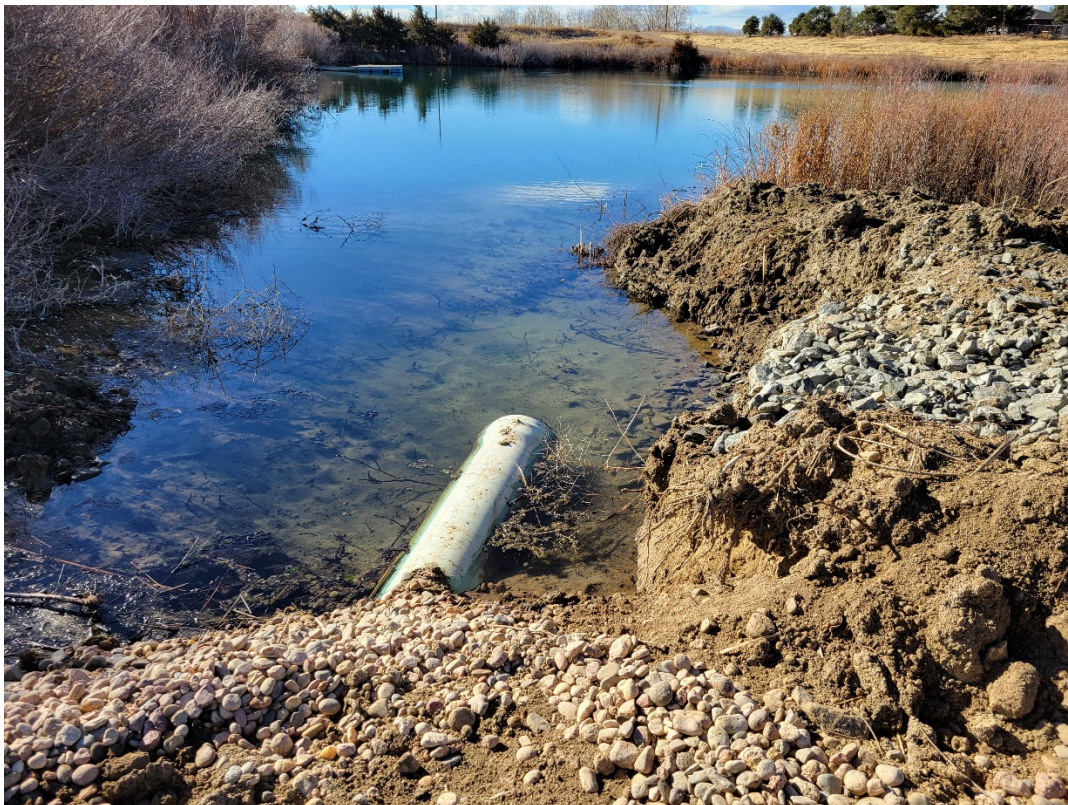
A French drain is installed on the eastern boundary of the clay lined inert fill area. The Division observed manhole covers along the eastern perimeter of this area. A small amount of water was observed discharging into an adjacent pond, between the north and south areas.

Photo 8: Discharge point for the French drain on the north end of the permit area.

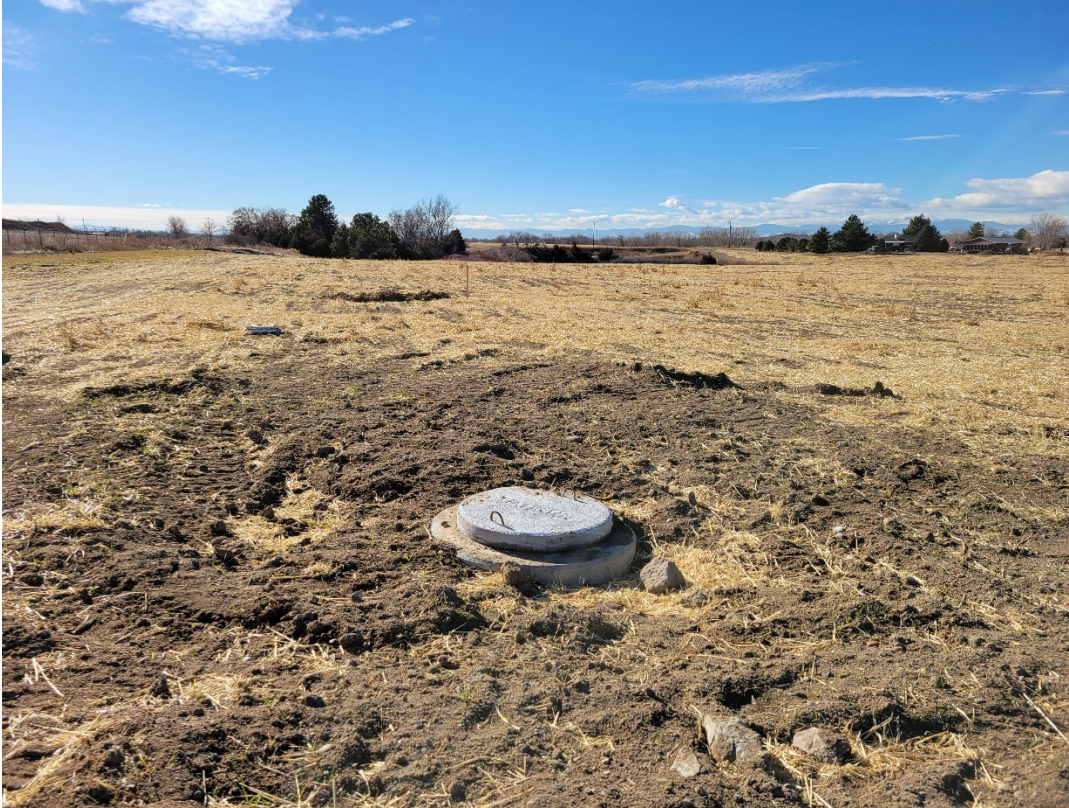
Photo 9: Manhole cover for the French drain along the eastern side of the clay lined inert fill area.

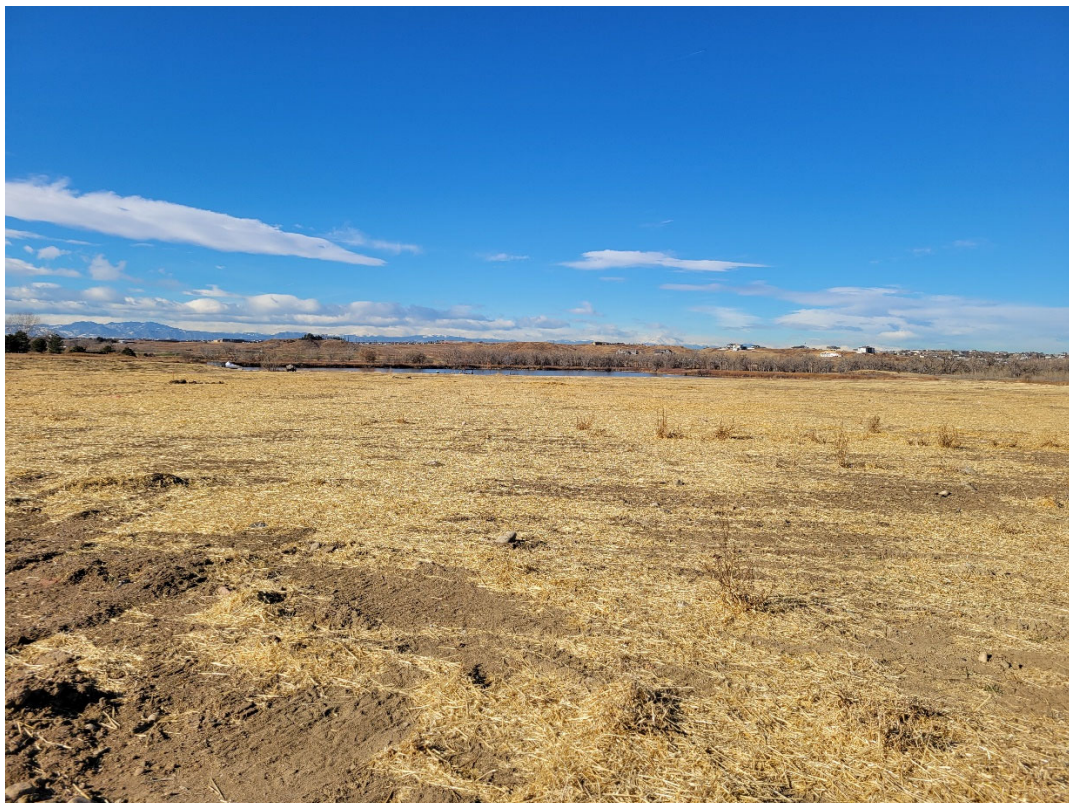
Photo 10: View looking northwest across the graded inert fill area on the north end of the permit area.

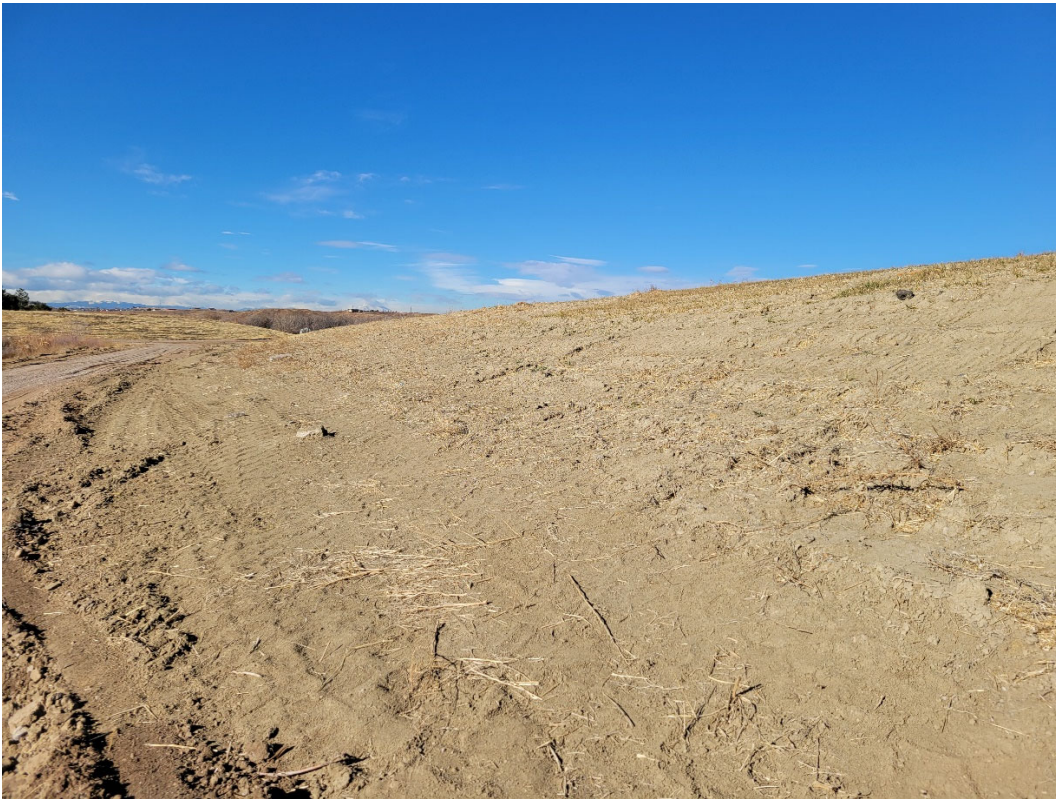
The Division observed the side slopes along the access road on the north end, across from the pond. Reclamation of the slope is incomplete. The Operator indicated this area will be seeded and mulched.

Photo 11: Side slope along the access road on the north end of the permit area. This area has not been seeded or mulched.

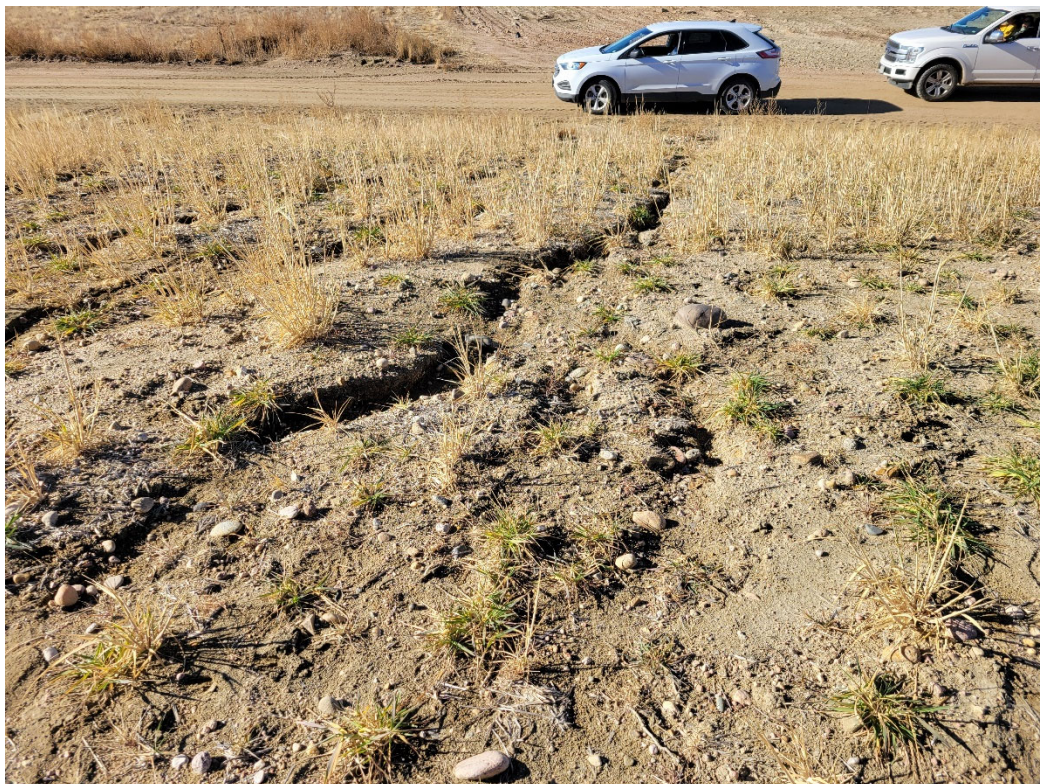
Photo 12: Erosion gullies observed on the western slope of the reseeded area near the entrance, on the south end.
