MINERALS PROGRAM INSPECTION REPORT
PHONE: (303) 866-3567

MINE NAME: Dellacroce Pit	MINE/PROSPECTING ID#: M-1993-050	MINERAL: Gravel	COUNTY: El Paso
INSPECTION TYPE: Surety-Related Inspections	WEATHER: Cloudy (both visits)	INSP. DATES: January 24, 2023 November 29, 2023	INSP. TIMES: 13:20 12:25
OPERATOR: Raymond F. & Robert W. Dellacroce	OPERATOR REPRESENTATIVE: Angela Bellantoni	TYPE OF OPERATION: 112c - Construction Regular Operation	
REASON FOR INSPECTION: Surety Related	BOND CALCULATION TYPE: Partial Bond	BOND AMOUNT: \$74,200.00	
DATE OF COMPLAINT: NA	POST INSP. CONTACTS: None	JOINT INSP. AGENCY: None	
INSPECTOR(S): Timothy Cazier, P.E.	INSPECTOR'S SIGNATURE:

SIGNATURE DATE: December 18, 2023

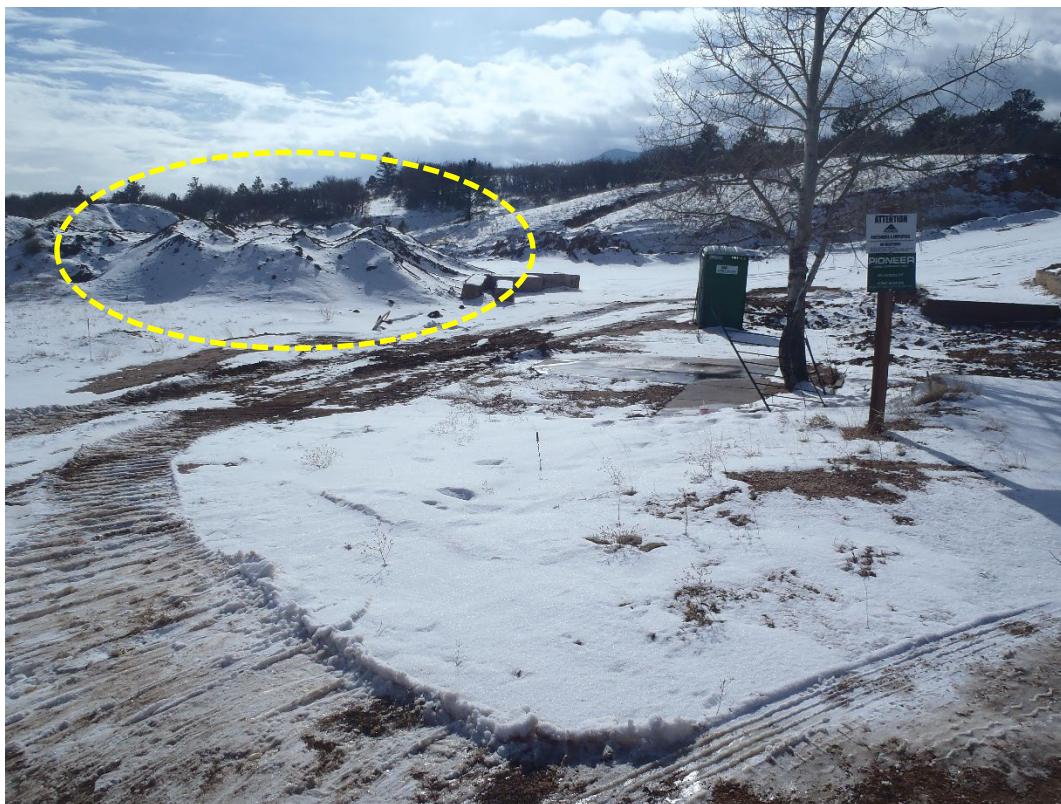
January - Material stockpiles were observed near the sediment pond (see **Photo 1**). Subsequent to this inspection, Dr. Bellantoni stated the landowner wished to keep this material for use on their property. The DRMS will need a signed written request from the landowner stating the material will only be used on their property, in order to keep the material stockpiles after final reclamation.

Photo 1. Material stockpiles near east sediment pond (January, looking SW).

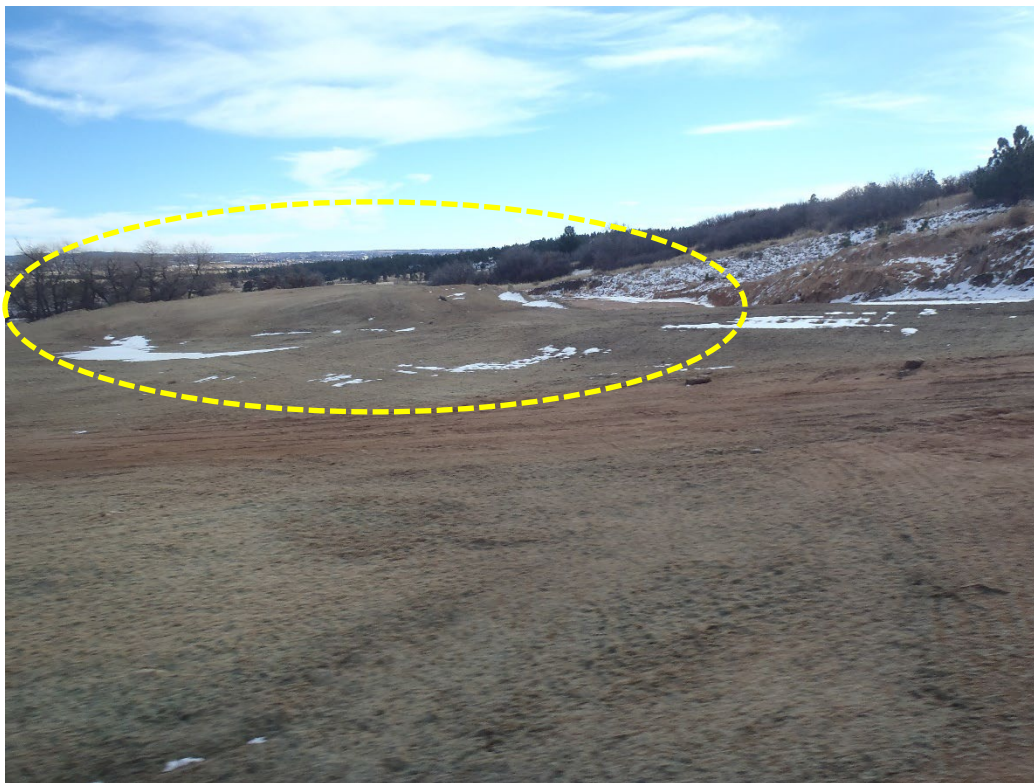
November – All backfilling and grading appeared to conform to the approved reclamation plan. No stockpiles were present near the sediment pond (see **Photo 2**).

Photo 2. Removed material stockpiles, regraded area near east sediment pond (November, looking SW).

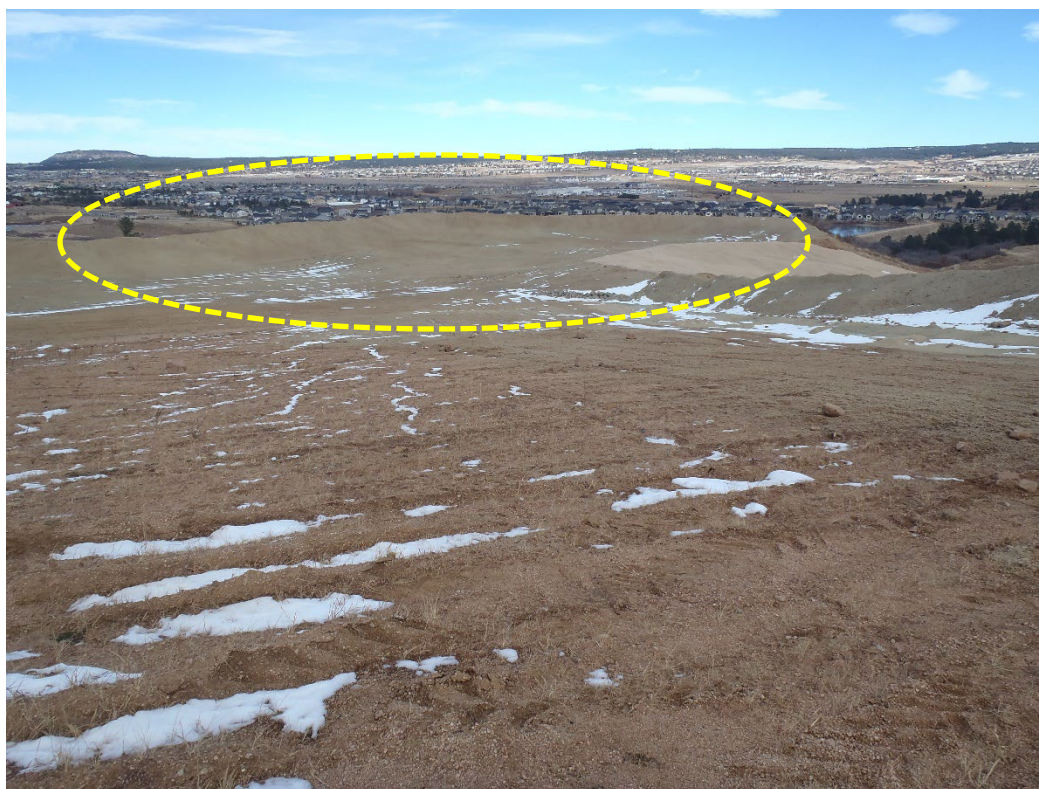
November – No standing water was observed in the pit and no exposed groundwater was observed. A new sediment pond had been constructed (see **Figure 1** and **Photo 3**). A sediment pond was approved in Amendment 1 (AM-1) for the upper portion of the permit, but the approved location was on the north side of west end (upper mine). As this was not a practical location due to site grading, the newly

constructed sediment pond is on the north side of the east end of the upper mine. Dr. Bellantoni explained that it was constructed in this location to help prevent erosion of the regraded area between the upper mine area and the lower/east mine area (see **Photo 4**). Although no water was observed in the pond, the [Permittee should be aware stormwater cannot be retained for more than 72 hours in accordance with Colorado Division of Water Resources \(DWR\) regulations](#).

Photo 3. Newly constructed sediment pond (November, looking NE).

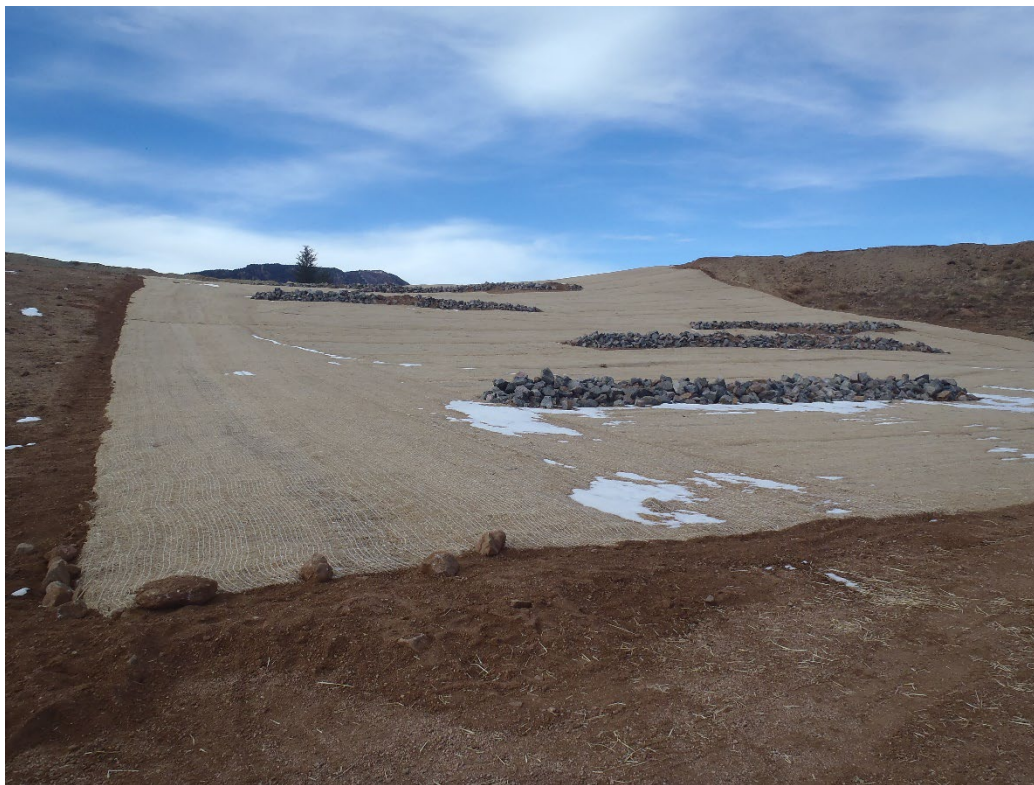
Sediment Control: Some minor erosion problems were observed during the November site visit, but no BMPs were needed at the time of the inspection. Dr. Bellantoni stated the erosion gully between the upper and lower mine areas had been repaired twice. The second time, rock check dams (see **Photo 4**) were added to help prevent a recurrence.

Photo 4. Erosion blanket covered slope between upper and lower mine areas (November, looking west).

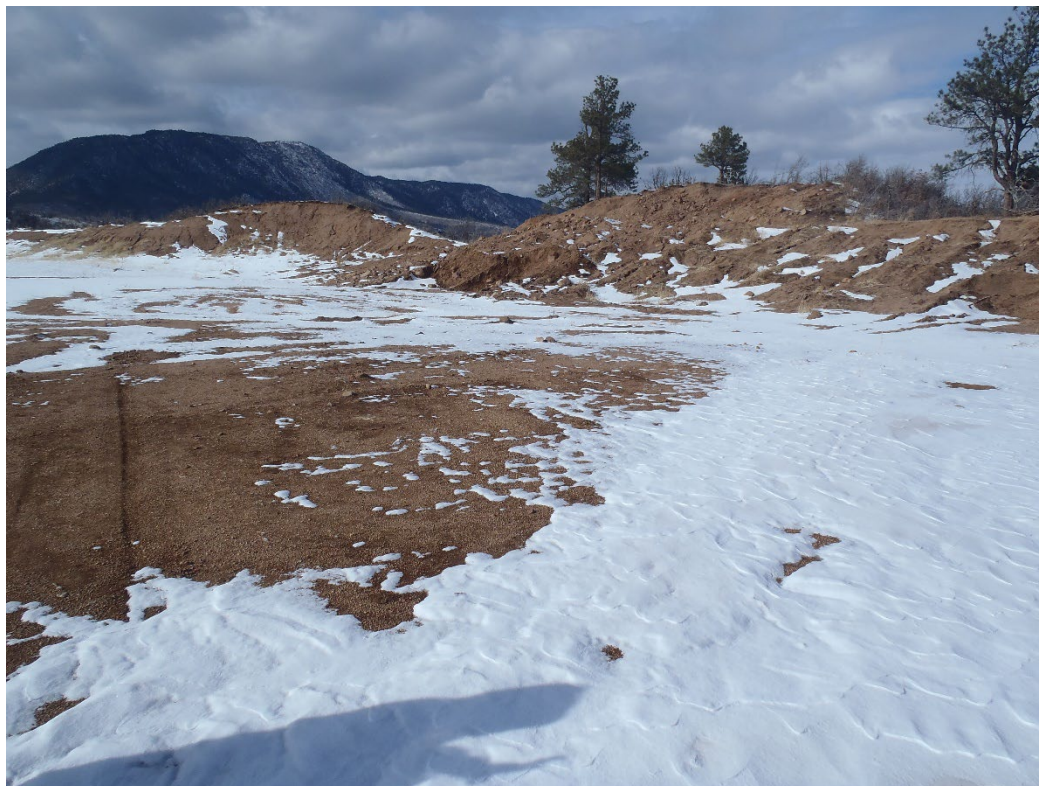
January – Highwalls along the north side of the upper mine area (see **Photo 5**) had not been sloped to 3H:1V or flatter. This is the reason the SR-1 request was withdrawn as mentioned in the introduction to this report. Dr. Bellantoni indicated topsoil had been placed in all reclaimed areas except where the north side highwalls had not been reduced. She also stated seeding had not yet occurred.

Photo 5. Unflattened highwalls (January, upper north side, looking NW).

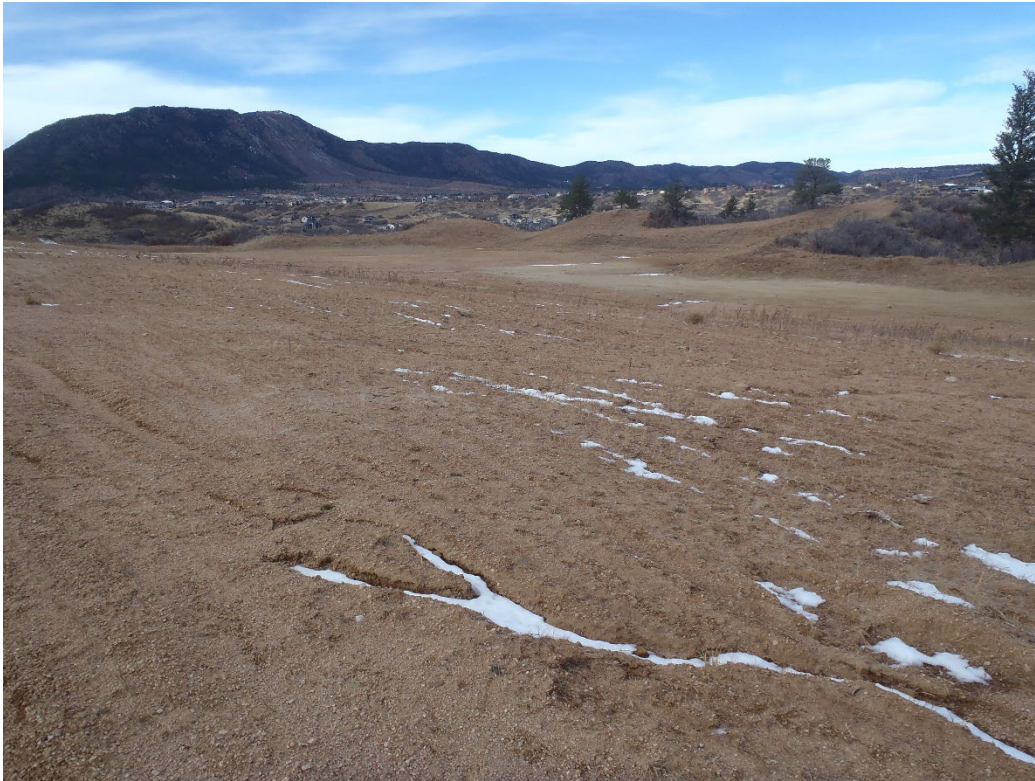
November – The ungraded highwalls observed in January had been properly sloped (see **Photo 6**). Dr. Bellantoni indicated all areas, except for the recently hydromulched (slope between the upper and lower mine areas) and erosion control blanketed areas (near the east sediment pond), see **Figure 1** had been seeded earlier this year. The recently hydromulched and erosion control blanketed areas had been completed just prior to submitting the SR-2 request.

Photo 6. Regraded highwalls (November, upper north side, looking NW).

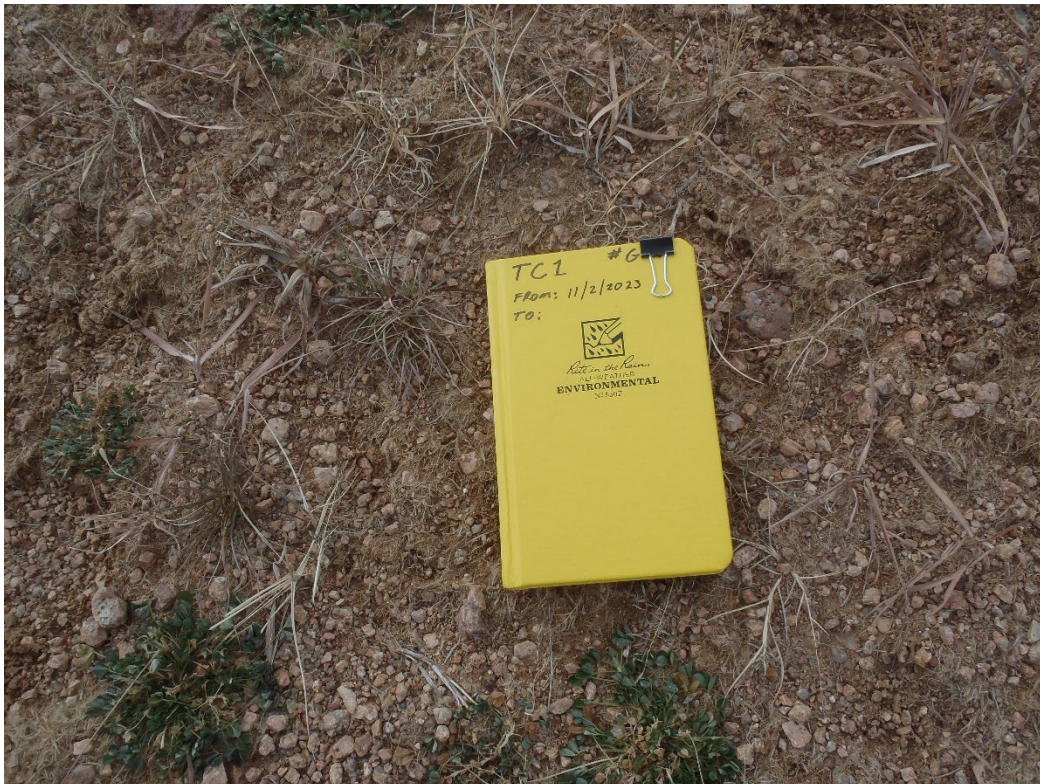
November – Areas seeded earlier in 2023 showed preliminary growth of grasses (**Photo 7**). A few specimens of knapweed were observed, but not sufficient to cite a problem. A noxious weed control plan was submitted with AM-2 and approved. The [Permittee should implement the noxious weed control plan to prevent the knapweed from becoming a problem](#).

Photo 7. Emerging grasses (November, slope immediately south of erosion control blanket).

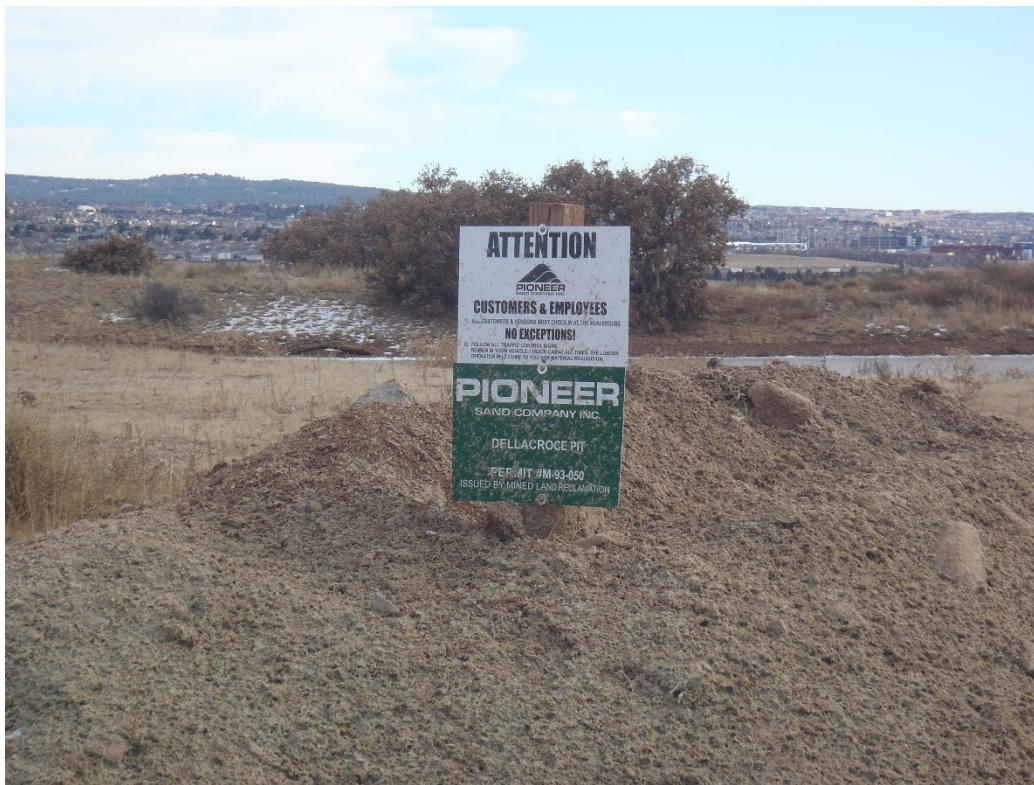
Signs and Markers: The permit sign remains properly posted (**Photo 8**). The affected area boundary had been marked using the perimeter visual berms, which have been regraded. No appurtenant markers (e.g., t-posts) require removal for final reclamation.

Photo 8. Posted permit sign (November, near east sediment pond area).

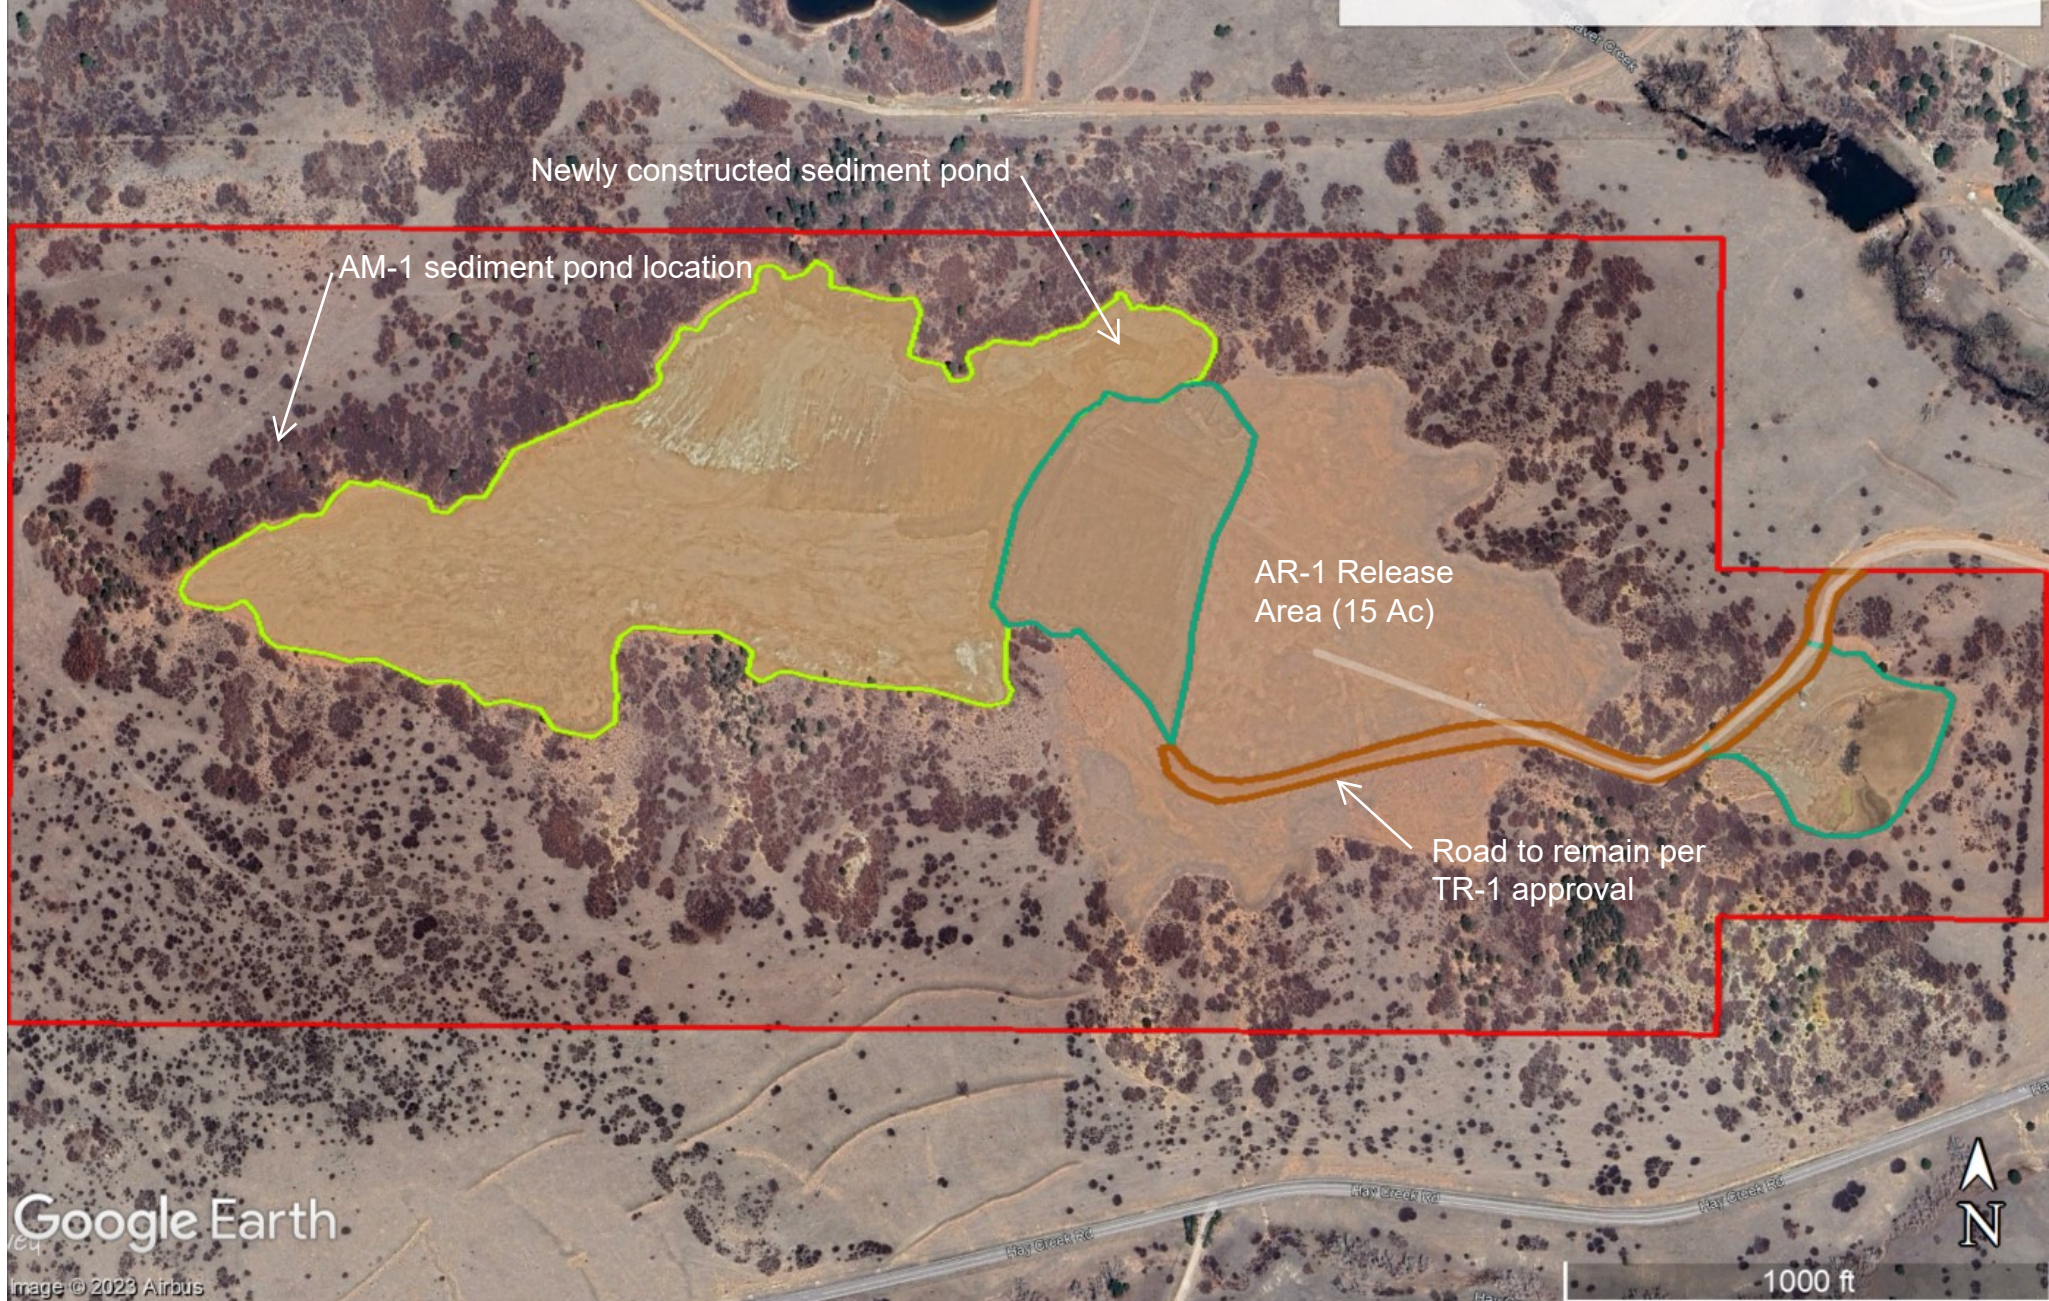
Figure 1. Dellacroce Pit Post SR2 Inspection (11/29/2023)

Financial Warranty: The DRMS currently holds a \$74,200 bond. Based on observations made during the November inspection and a review of Google Earth satellite imagery dated 4/23/2023 (see **Figure 1**), the DRMS has revised the required bond to \$37,112 (see **Attachment A**). [If this amount is acceptable to the Permittee, the DRMS will recommend approval of the SR-2 request.](#)
