MINERALS PROGRAM INSPECTION REPORT

MINE NAME: Pikeview Quarry	MINE/PROSPECTING ID#: M-1977-211	MINERAL: Limestone (general), granite gneiss and do	COUNTY: El Paso
INSPECTION TYPE: Monitoring	WEATHER: Clear	INSP. DATE: November 16, 2023	INSP. TIME: 09:30
OPERATOR: Riverbend Industries Inc.	OPERATOR REPRESENTATIVE: Jerry Schnabel	TYPE OF OPERATION: 112c - Construction Regular Operation	
REASON FOR INSPECTION: Normal I&E Program	BOND CALCULATION TYPE: None	BOND AMOUNT: \$13,389,784.00	
DATE OF COMPLAINT: NA	POST INSP. CONTACTS: None	JOINT INSP. AGENCY: None	
INSPECTOR(S): Timothy Cazier, P.E. Jocelyn Carter	INSPECTOR'S SIGNATURE:

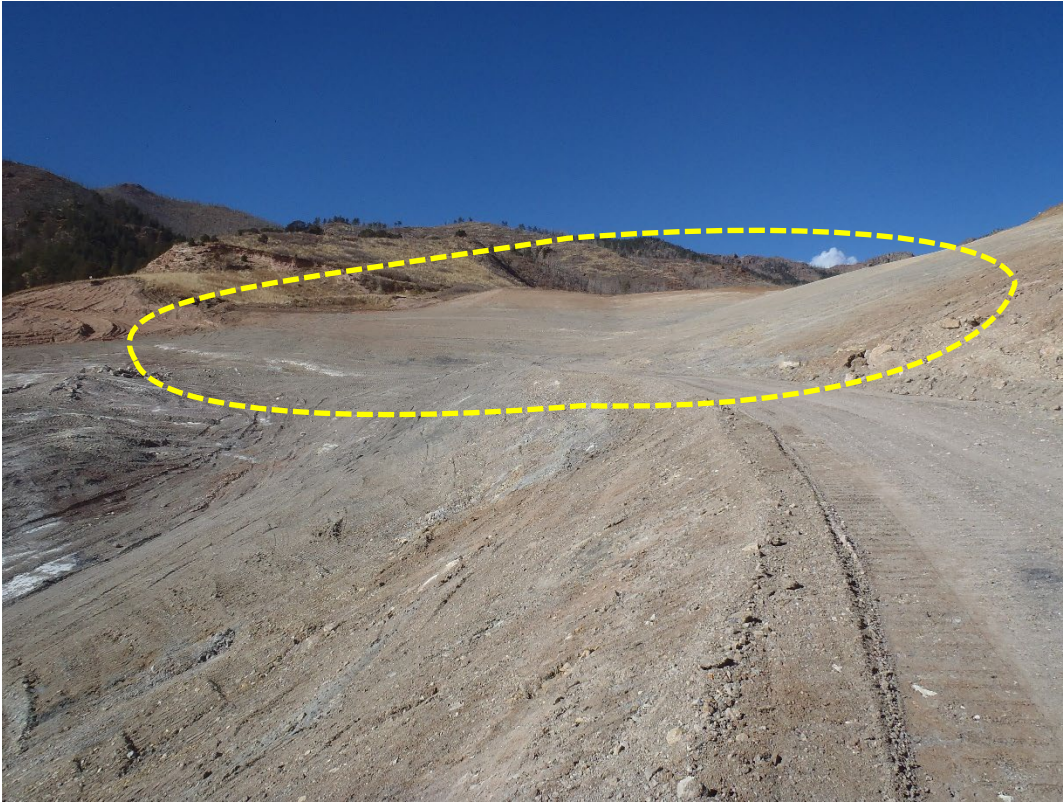
Backfilling and Grading: Material removal and final subgrade contouring was nearly complete in the north borrow area (**Photo 1**). Dozers (**Photo 2**) and scrapers (**Photo 3**) were observed pushing material down from above the slide area. Site representatives stated the 7400 (level 4) area was being worked/checked to ensure it was sufficiently compacted and/or native material prior to placing backfill.

Photo 1. North borrow area (looking west).

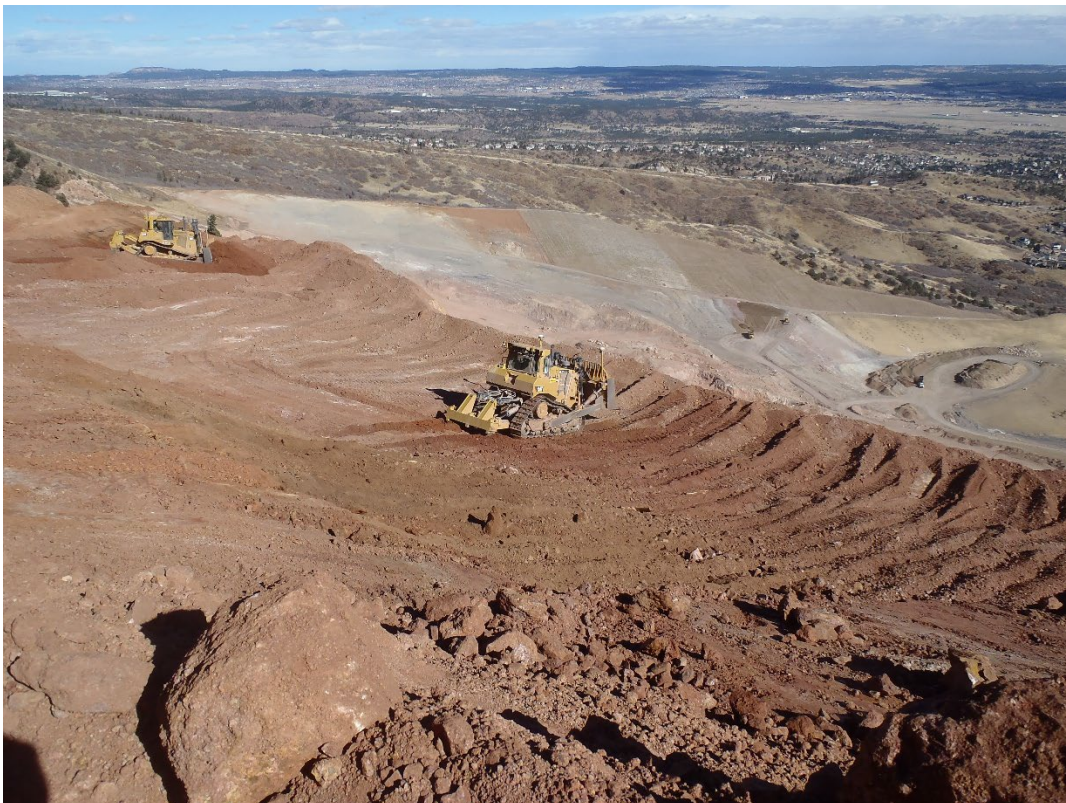
Photo 2. Dozers pushing down material from above the slide area (looking NE).

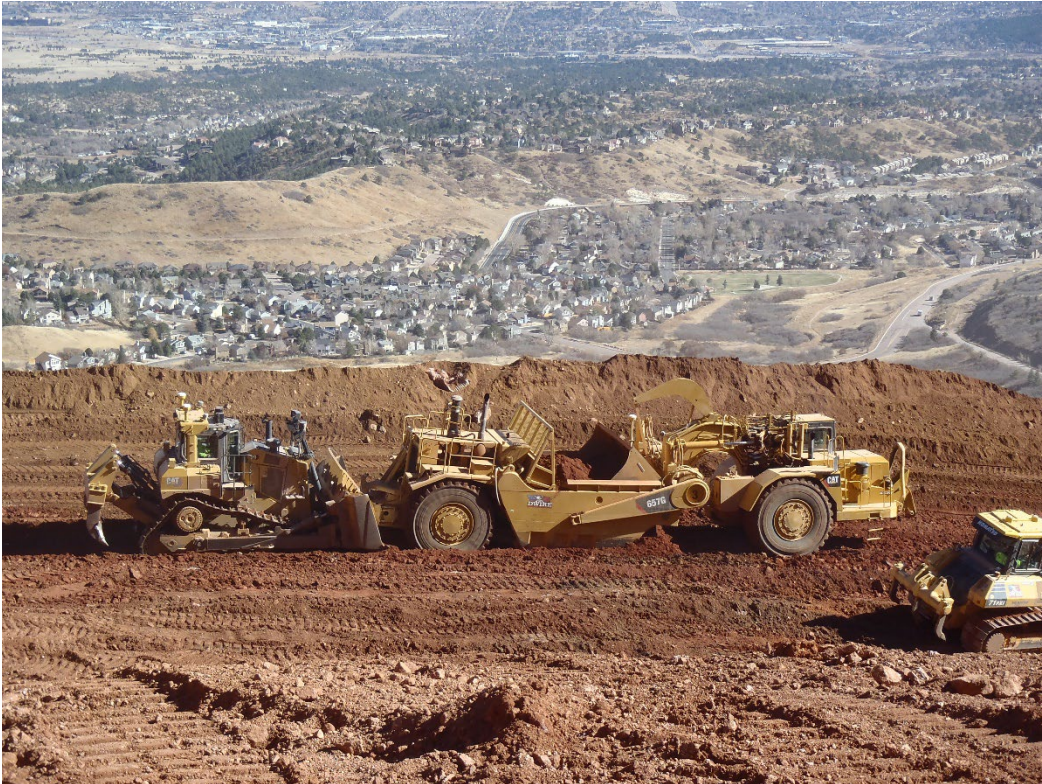
Photo 3. Scraper (dozer assisted) moving material down from above the slide area (looking east)

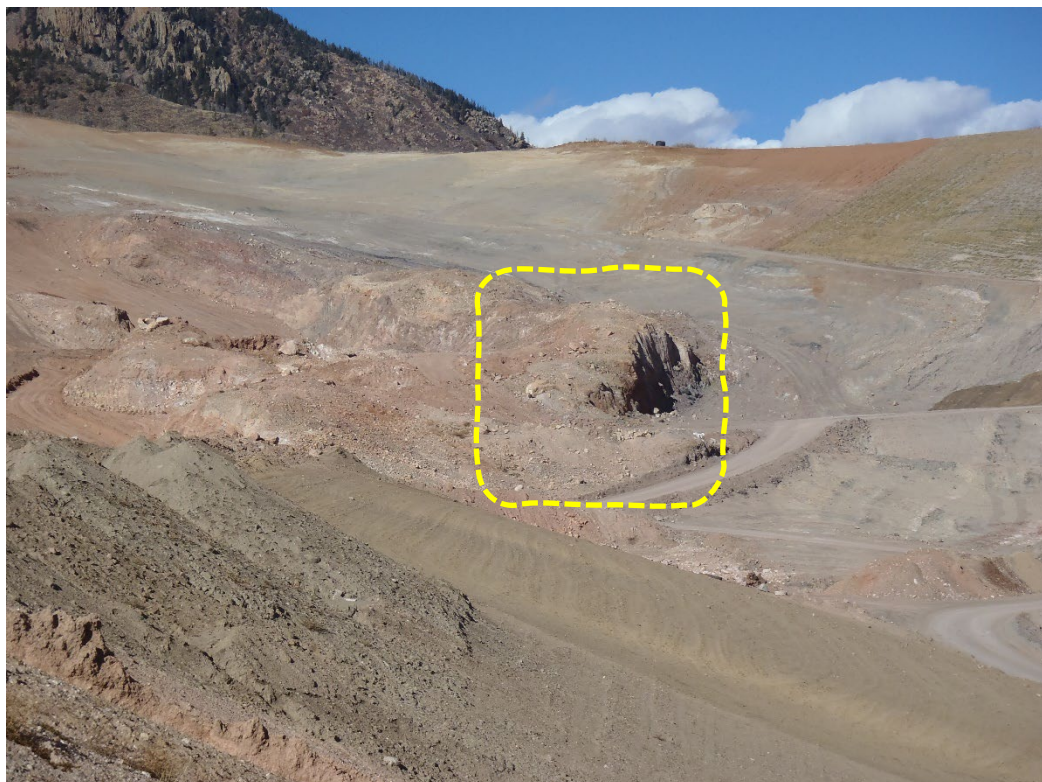
Explosives: Site representatives indicated the ridge of non-rippable quartzite material, referred to as the "dragon back" (**Photo 4**) on the north end of the backfill area would likely need to be blasted to achieve the approved grading plan. They stated proposals for the blasting effort were due to Riverbend by November 17th. The DRMS received a technical revision (TR-23) request on December 12th to update the blasting plan for this activity. The DRMS is currently reviewing TR-23.

Photo 4. Non-rippable “dragon back” (south end, looking north).
