MINERALS PROGRAM INSPECTION REPORT
PHONE: (303) 866-3567

MINE NAME: Sierra Grande Site	MINE/PROSPECTING ID#: M-1994-103	MINERAL: Sand and gravel	COUNTY: Costilla
INSPECTION TYPE: Monitoring	WEATHER: Clear	INSP. DATE: November 28, 2023	INSP. TIME: 13:00
OPERATOR: Costilla County	OPERATOR REPRESENTATIVE: Leroy Medina, Davis Perales	TYPE OF OPERATION: 110c - Construction Limited Impact	
REASON FOR INSPECTION: Normal I&E Program	BOND CALCULATION TYPE:	BOND AMOUNT: \$0.00	
DATE OF COMPLAINT: NA	POST INSP. CONTACTS: None	JOINT INSP. AGENCY: None	
INSPECTOR(S): Lucas West	INSPECTOR'S SIGNATURE:

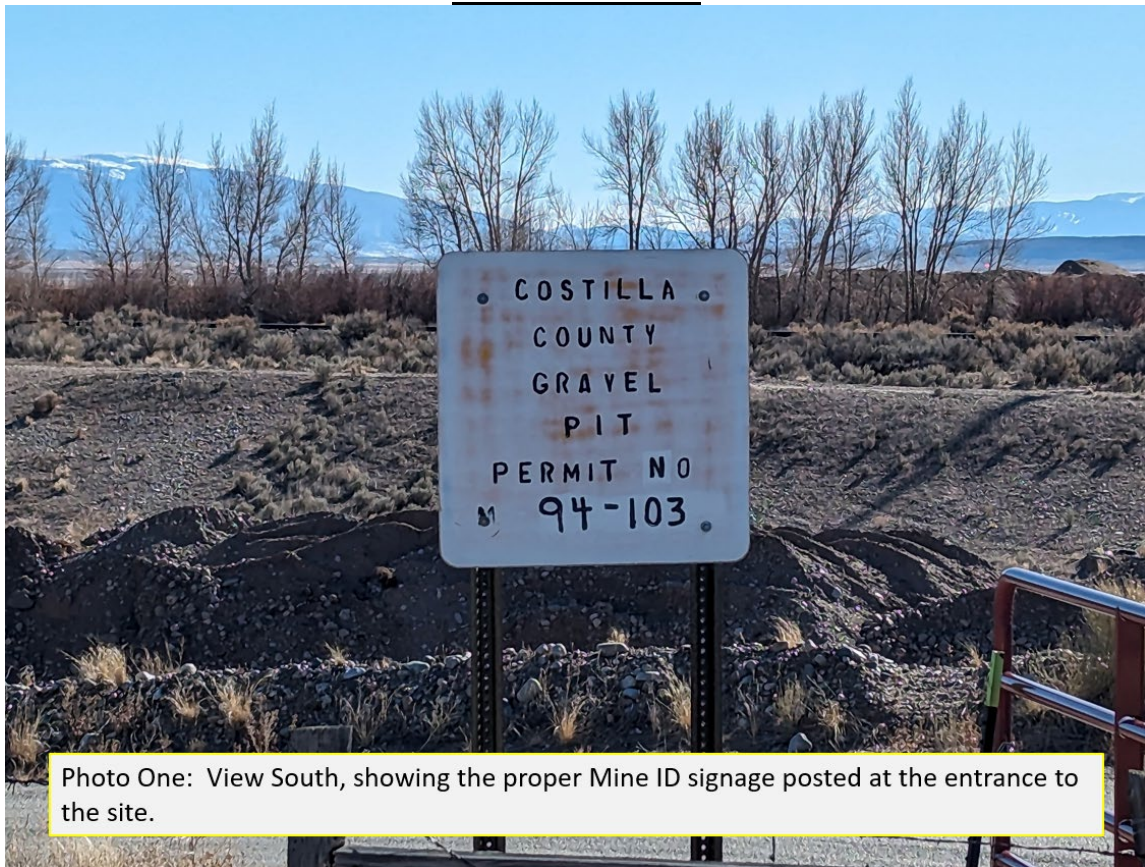
Proper mine identification signage and permit boundary markers were observed on site. The sign was posted at the entrance and can be seen in Photo One. The site was not active during the day of the inspection, and no equipment was on site. The site has not been active in some time, however the operator indicated that the pit floor is often used for temporary storage. When active, the slopes are mined to a stable configuration at approximately 3H: 1V. The side slopes can be seen in Photos Two and Three, appear to be stable and in good condition. Most of the slopes have begun to revegetate themselves with volunteer species such as range grasses as well as Sage and Rabbit brush.

Photo One: View South, showing the proper Mine ID signage posted at the entrance to the site.

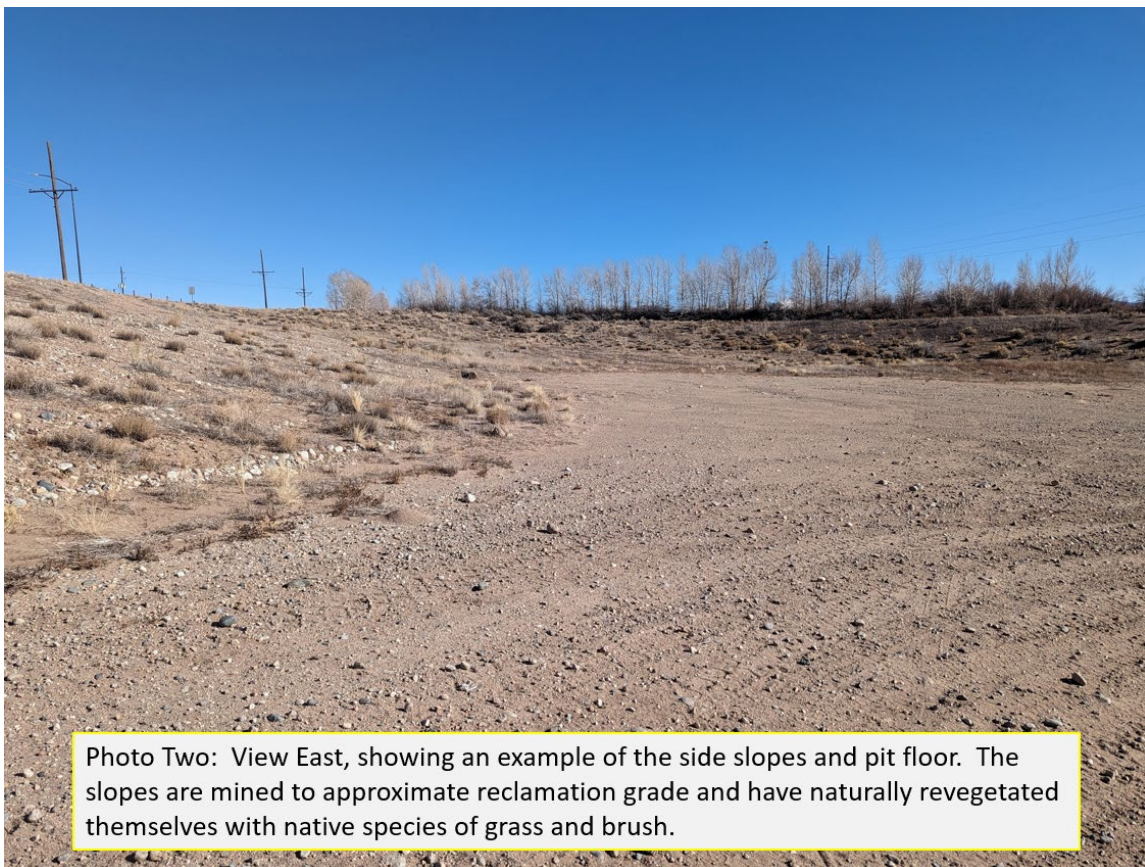
Photo Two: View East, showing an example of the side slopes and pit floor. The slopes are mined to approximate reclamation grade and have naturally revegetated themselves with native species of grass and brush.

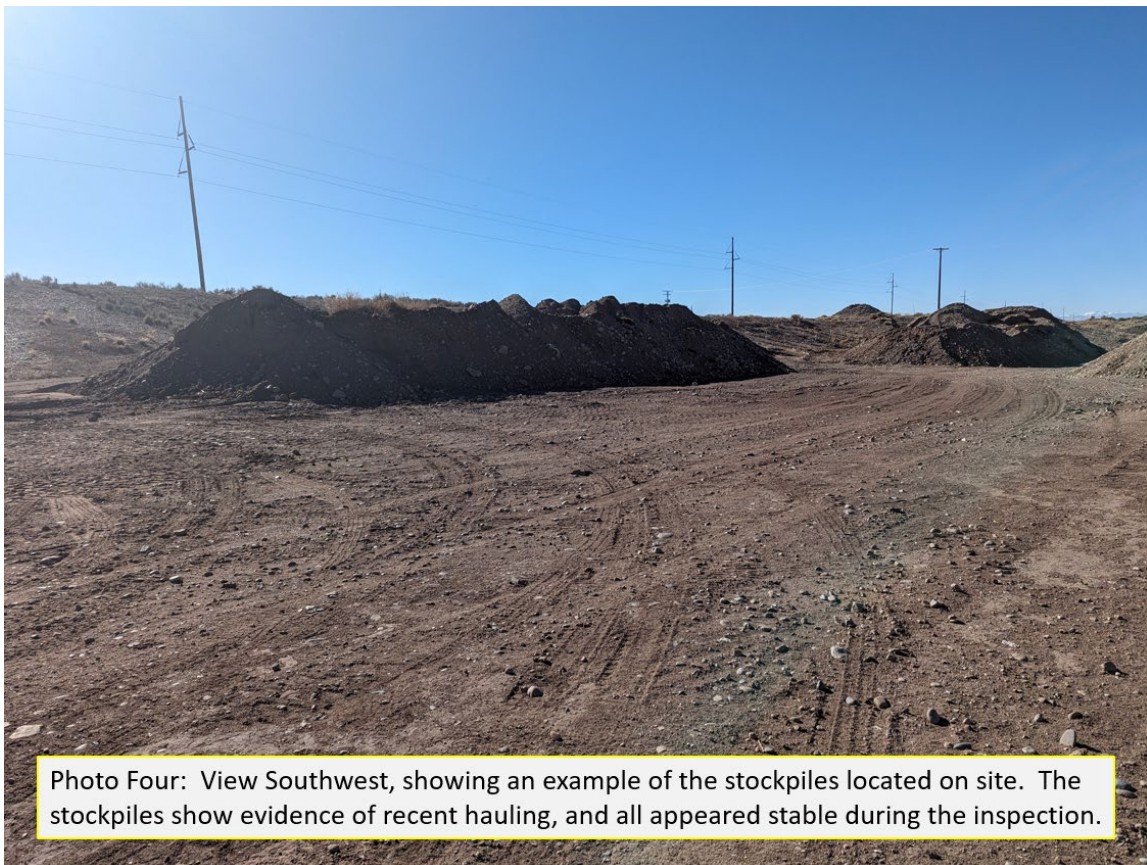
Several stockpiles were noted on site, including several on the pit floor. All stockpiles were in good condition and appeared to be stable. Examples of the stockpiles can be seen in Photo Four. The pit floor itself exhibits positive drainage and impounded storm water was observed on site. Evidence of chemical weed treatment was observed and discussions with the operator indicate that weed management is continuous at all pits operated by the County. Also, on the pit floor various items such as PVC pipe and removed culverts are stored. The items are confined to a designated area, and stored in a neat and orderly fashion, they are not considered a problem.
