MINERALS PROGRAM INSPECTION REPORT PHONE: (303) 866-3567

MINE NAME:		MINE/PROSPECTING ID#:	MINERAL:	COUNTY:
Costilla Cnty Pit 1		M-1977-044	Sand and gravel	Costilla
INSPECTION TYPE:		WEATHER: Clear	INSP. DATE:	INSP. TIME:
Monitoring			November 28, 2023	13:30
OPERATOR:		OPERATOR REPRESENTATIVE:	TYPE OF OPERATION:	
Costilla County		Leroy Medina, David Perales	110c - Construction Limited Impact	
REASON FOR INSPECTION:		BOND CALCULATION TYPE:	BOND AMOUNT:	
Normal I&E Program			\$0.00	
DATE OF COMPLAINT:		POST INSP. CONTACTS:	JOINT INSP. AGENCY:	
NA		None	None	
INSPECTOR(S):	INSPECTOR'S SIGNATURE:		SIGNATURE DATE:	
Lucas West			December 19, 2023	
	A	Alt		
	1	a fin		
	V

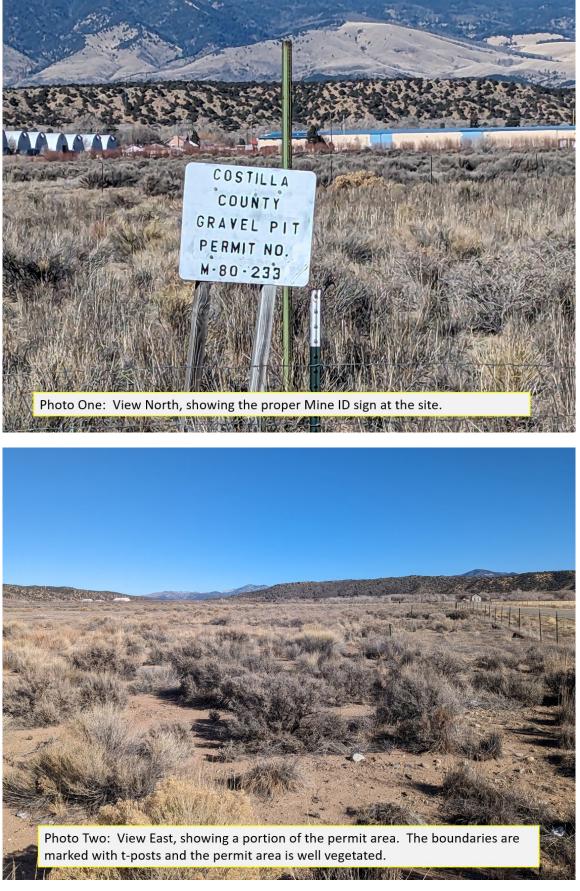
Proper mind identification signage was posted on site, shown in Photo One. Permit boundary markers were also observed on site. The site was not active nor was any equipment present on site. All backfilling and grading of the site has been completed, no evidence of settling, slumping or subsidence was observed. The site has been backfilled a near flat configuration shown in Photo Two. The area appears to be stable and in good condition, no signs of erosion were noted. The site is to be reclaimed to support an industrial / commercial post mining land use.

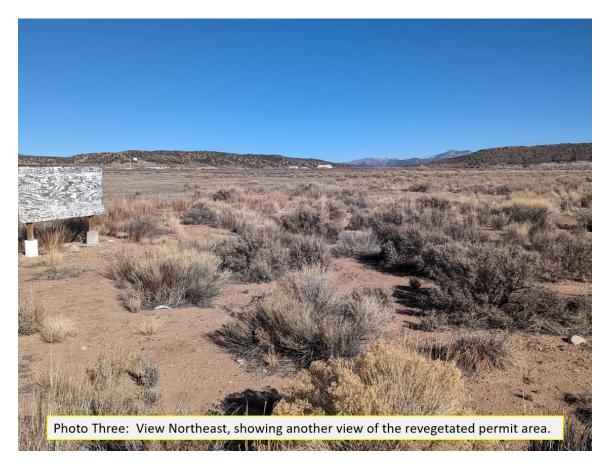
Reclamation of the site has been completed. The site is currently vegetated with range and bunch grasses, sage and rabbit brushes as well as a large population of sunflowers. The vegetation, shown in Photo Three, is diverse, and capable of self-regeneration. Discussions with the operator indicate that weed management is continuous and on-going at the site. The grading and earthwork, as well as the vegetation on site appear to be stable, and adequate when compared to adjacent undisturbed lands.
