**Inspection Report, New Elk Min, C1981012, Partial, December 13, 2023**

**PERMIT INFORMATION**

<b>Permit Number:</b> C-1981-012 <b>Mine Name:</b> New Elk Mine <b>Operator:</b> New Elk Coal Company, LLC <b>Operator Address:</b> Mr. Nick Mason 12250 Highway 12 Weston, CO 81091	<b>County:</b> Las Animas <b>Operation Type:</b> Underground <b>Permit Status:</b> Active <b>Ownership:</b> Private
	<b>Operator Representative Present:</b>  Nick Mason
<b>Operator Representative Signature: (Field Issuance Only)</b>

<b>Inspection Start Date:</b> December 13, 2023 <b>Inspection Start Time:</b> 09:10 <b>Inspection End Date:</b> <b>Inspection End Time:</b>	<b>Inspection Type:</b> Coal Partial Inspection <b>Inspection Reason:</b> Normal I&E Program <b>Weather:</b> Snowing
<b>Joint Inspection Agency:</b>  None	<b>Joint Inspection Contacts:</b>  
<b>Post Inspection Agency:</b>  None	<b>Post Inspection Contacts:</b>  
<b>Inspector(s):</b>  Amber Gibson	<b>Inspector's Signature:</b>

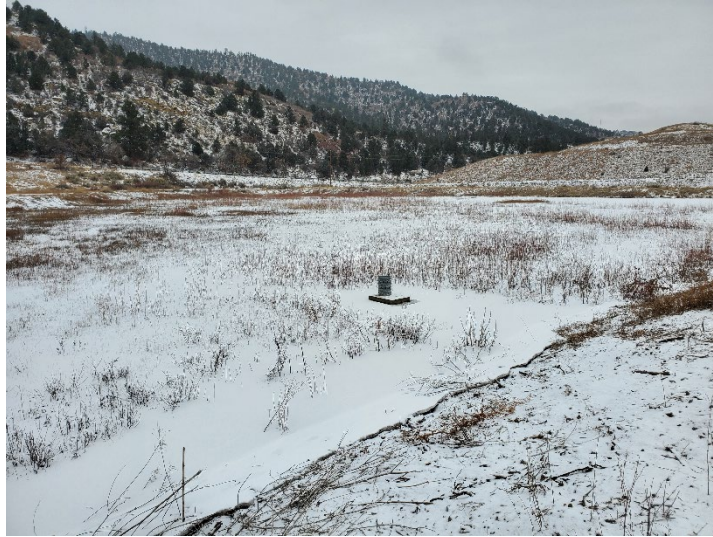
- Pond 004A contains a small amount of water. The water in the pond is frozen (Photo 5). Pond 004A is not discharging. The embankment appears stable. The emergency and primary spillways were clear of obstructions.

**Photo 5:** Pond 004A.

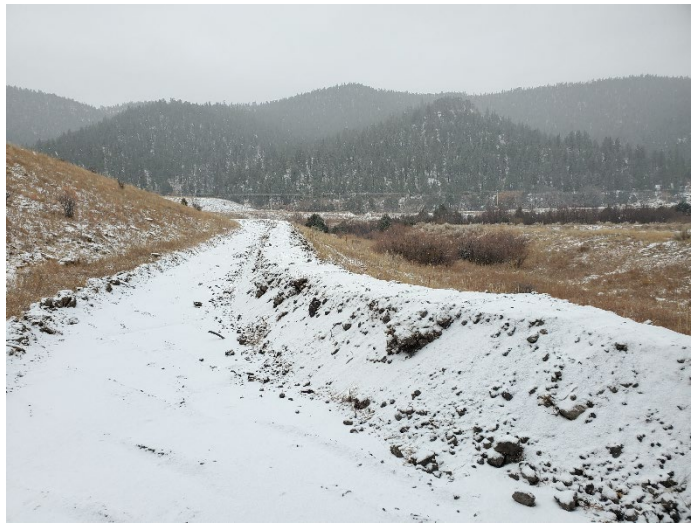
- The Division walked along ditch D3 on the west side of DWDA #1. D3 appeared to be stable and clear. The berm around the drying area on the west side of DWDA #1 has been repaired since the maintenance requirement was cited in the Division's previous November 2023 inspection Report. The berm has been reconstructed and is functioning as desired (Photo 6). The rest of the berm along ditch D15 is stable and clear.

**Photo 6:** Looking south along the repaired berm along west side of DWDA #1.
