## Inspection Report, New Elk Min, C1981012, Partial, December 13, 2023

### PERMIT INFORMATION

<b>Permit Number:</b> C-1981-012 <b>Mine Name:</b> New Elk Mine <b>Operator:</b> New Elk Coal Company, LLC <b>Operator Address:</b> Mr. Nick Mason 12250 Highway 12 Weston, CO 81091	<b>County:</b> Las Animas <b>Operation Type:</b> Underground <b>Permit Status:</b> Active <b>Ownership:</b> Private
	<b>Operator Representative Present:</b>  Nick Mason
<b>Operator Representative Signature: (Field Issuance Only)</b>

<b>Inspection Start Date:</b> December 13, 2023 <b>Inspection Start Time:</b> 09:10 <b>Inspection End Date:</b> December 13, 2023 <b>Inspection End Time:</b> 10:15		<b>Inspection Type:</b> Coal Partial Inspection <b>Inspection Reason:</b> Normal I&E Program <b>Weather:</b> Snowing	
<b>Joint Inspection Agency:</b>  None		<b>Joint Inspection Contacts:</b>	
<b>Post Inspection Agency:</b>  None		<b>Post Inspection Contacts:</b>	
<b>Inspector(s):</b>  Amber Gibson	<b>Inspector's Signature:</b>

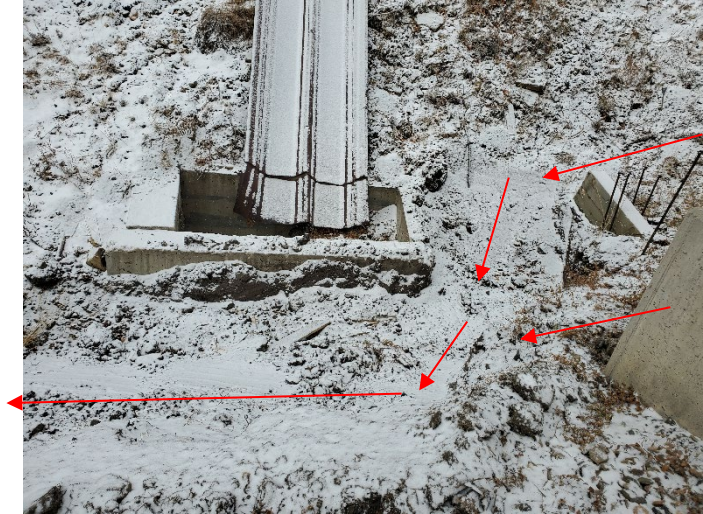
- Pond 007A contained a very small amount of frozen water but was not discharging. The emergency spillway was free of obstructions and the embankment appeared to be stable.
- During the last inspection it was noted that water from the processing areas, that flow south under the fan near the East Portal, were not separated from where water enters into the base of the clean water flume and into culvert C48. The Operator has since used an excavator to lower the profile of the slope over which the processed water flows, below the structure around the C48. This has effectively created a diversion to separate processed water from entering C48 (Photo 1).

**Photo 1:** Arrows indicate how processed water can now flow below and around the structure at the base of the clean water flume, to avoid cross-contamination of the clean water.

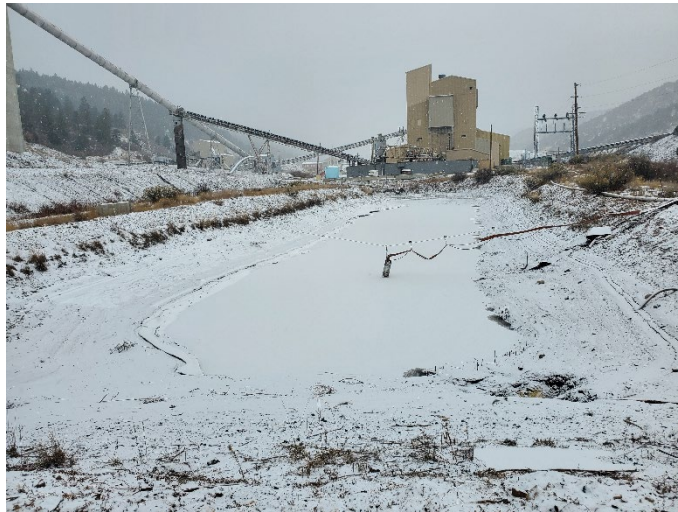
- Pond 006A contained a very small amount of frozen water (Photo 2). The water had been pumped from Pond 08. Pond 006A had plenty of remaining capacity. The Operator stated that Pond 006A had been pumped out the week prior, and that pumping from ponds is likely ceased for the remainder of winter to avoid the need to unfreeze the lines. The emergency and primary spillways were clear of obstructions.

**Photo 2:** Frozen Pond 006A.

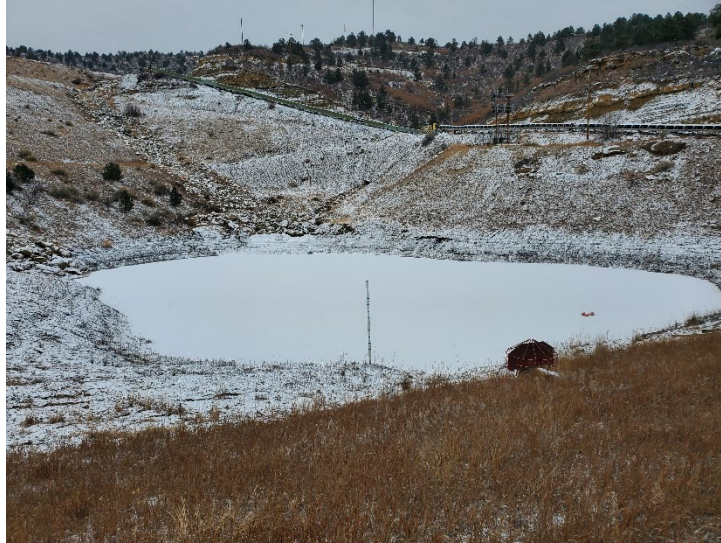
- Pond 08 contained some frozen water but was not discharging (Photo 3). The emergency and primary spillways were clear of obstructions.

**Photo 3:** Pond 08 has frozen over.

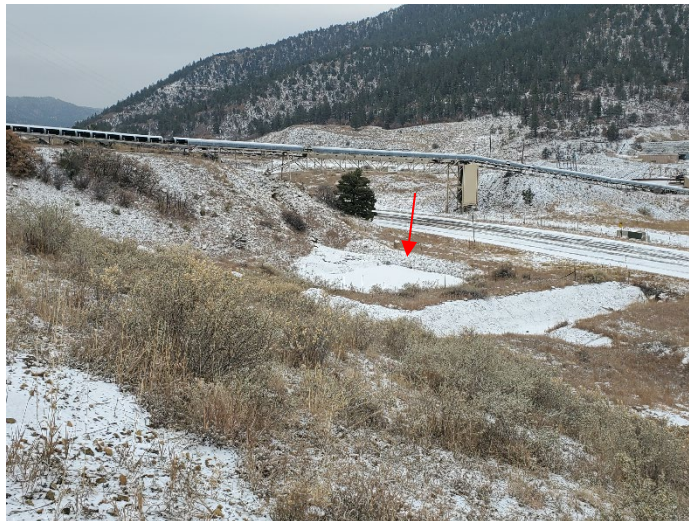
- Containment Area 5 at the base of the RDA contains frozen water (Photo 4). A gas pump is available at all times to pump water from Pond 08 and Containment Area 5, to Pond 006A if needed. Containment Area 5 was not discharging. The Operator stated that they will monitor it, but believes that the water level is not likely to rise enough to require it to be pumped out until spring.

**Photo 4:** Arrow points to Containment Area 5.

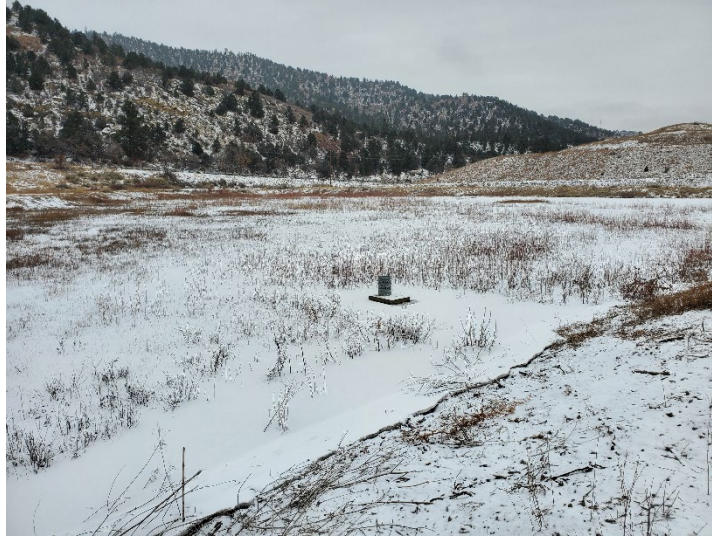
- Pond 004A contains a small amount of water. The water in the pond is frozen (Photo 5). Pond 004A is not discharging. The embankment appears stable. The emergency and primary spillways were clear of obstructions.

**Photo 5:** Pond 004A.

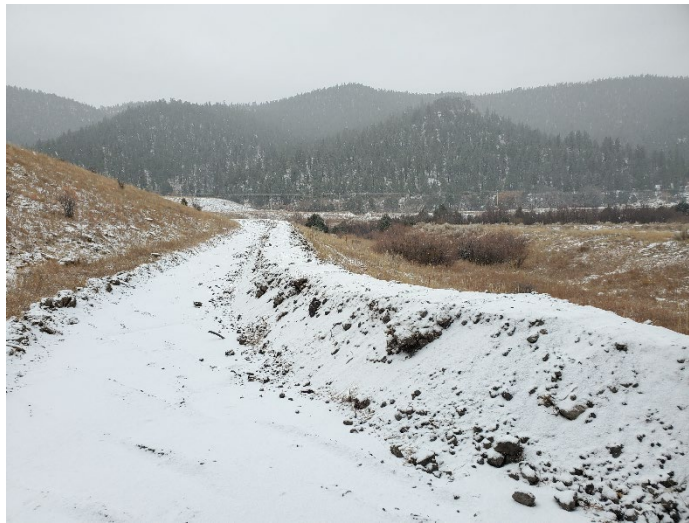
- The Division walked along ditch D3 on the west side of DWDA #1. D3 appeared to be stable and clear. The berm around the drying area on the west side of DWDA #1 has been repaired since the maintenance requirement was cited in the Division's previous November 2023 inspection Report. The berm has been reconstructed and is functioning as desired (Photo 6). The rest of the berm along ditch D15 is stable and clear.

**Photo 6:** Looking south along the repaired berm along west side of DWDA #1.

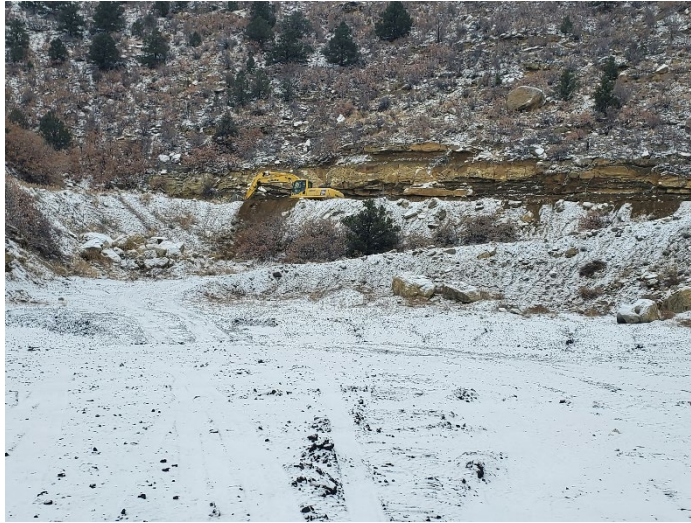
- The Division observed the ditch D55 actively being cleared of sediment and debris with the use of an excavator (Photo 7). The Operator stated that they are working west to east, and that they are also repairing rills and slumps above the ditch.

**Photo 7:** Excavator working in within D55.

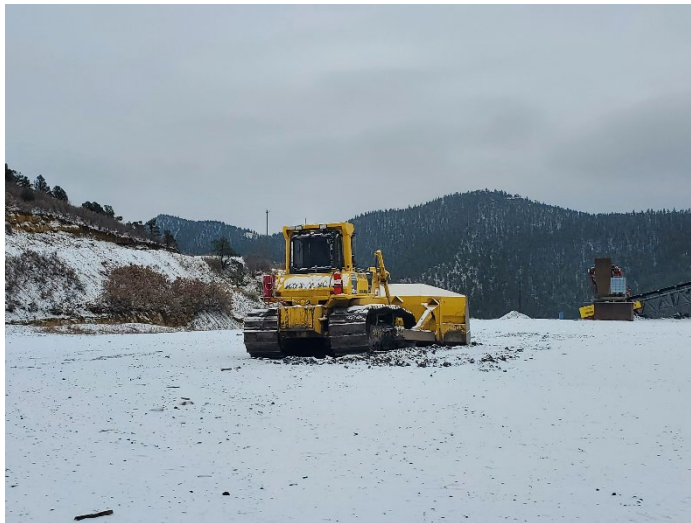
- Boulders cleared from ditch D55 are being salvaged to aid in repairing the slide forming at the western extent of D55 (noted in the previous inspection report). A dozer has been brought up to the RDA for use in stabilizing and repairing the slide (Photo 8).

**Photo 8:** Dozer stationed on the RDA.

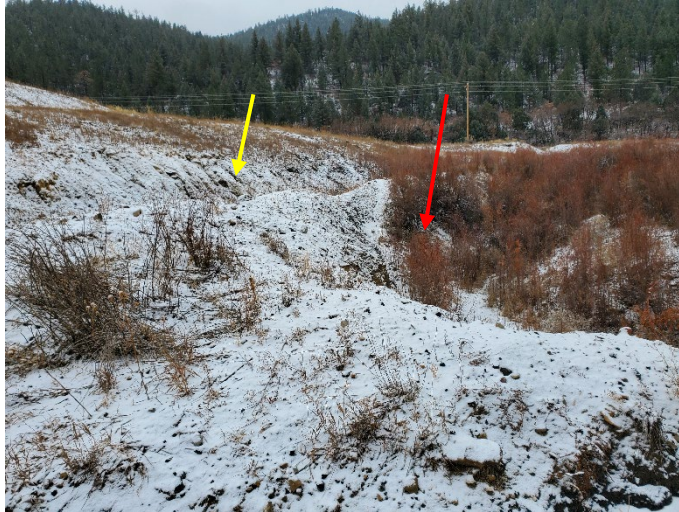
- During the September 2023 inspection, it was noted that the embankment slope on the northwest side of the Soil Storage Area was eroding and sluffing into the ditch that discharges to ditch D6. NECC was instructed to repair and stabilize the area. The ditch embankment separating the affected land drainage from the adjacent clear water ditch (D7) is very thin in areas. Failure of this embankment may overwhelm

the ditch and cause sediment to discharge into the clean water ditch D7 that discharges to the river. During the October 2023 inspection, the Operator stated that they had hydro-mulched the northwest side of the Soil Storage Area in an attempt to stabilize the slope. They also stated that they are unable to safely get equipment in the area to mechanically stabilize the slope and berm separating the treated water run-off from the clean water ditch. NECC has been monitoring this area. The slope appears to be stable at this time (Photo 9).

**Photo 9:** Yellow arrow – side of berm/slope where processed water flows into D6. Red arrow – side of berm/slope where clean water flows through D7.
