Lorencito Canyon Mine C1996084, Inspection Report, December 13, 2023

**COLORADO****Division of Reclamation,
Mining and Safety**

PERMIT INFORMATION

INSPECTION INFORMATION

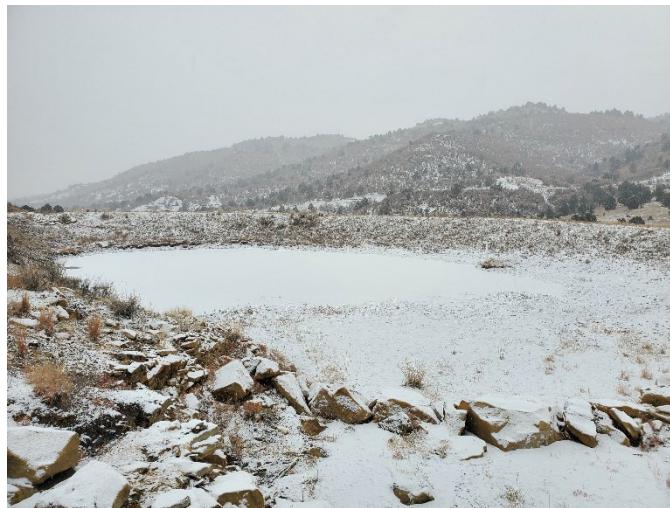
- Pond 006a was holding some frozen water and was not discharging (Photo 1). The pond embankment was stable and vegetated, and the primary and emergency spillways appeared clear and functional.

**Photo 1: Pond 006a**Number of Partial Inspection this Fiscal Year: 4Number of Complete Inspections this Fiscal Year: 2

- The reclaimed land above Pond 006a, reported to have been seeded in 2007, is still eroded (see Photo 1). Upon approval of RN5, NECC will be required to submit a revision that provides a plan to stabilize this area. DRMS is waiting for NECC's response to RN5 adequacy concerns at this time.
- The Division and the Operator(s) walked the contours of Fill 008 (Photos 5-8). The fill appears to exhibit positive drainage to the side armored channels. The ditches and channels are free of obstructions. Some slight rilling was observed along the top contour, to which the Operator stated that they had tried to address in the past by applying sand, without success. However, ample vegetation is growing on the slope through the rills, and it appears to be stable at this time. No other signs of erosion were observed.

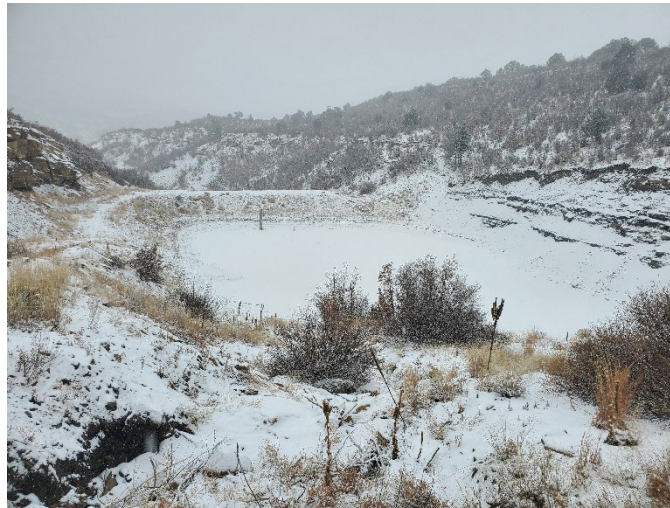
- Pond 008 was holding some frozen water and was not discharging (Photo 2). The pond embankment was stable and vegetated, and the primary and emergency spillways appeared clear and functional.

Photo 2: Pond 008.

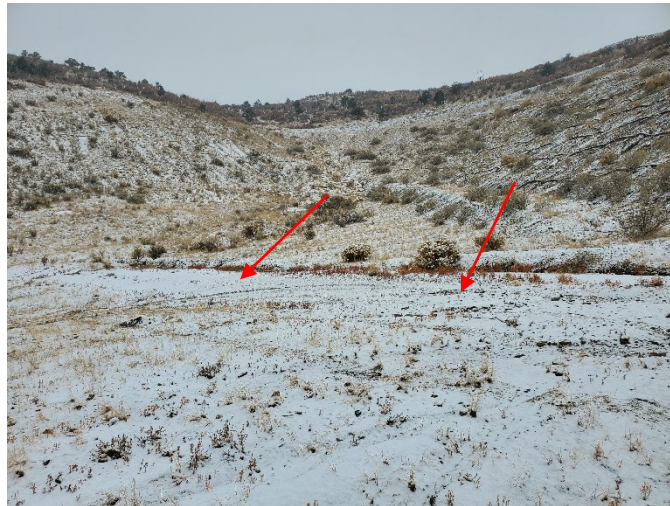
- Because both Operator representatives were present, we observed the reclaimed area above Pond 006a and the many gullies which have undercut the wattles, mentioned in the last report. We also observed the ditch along the road leading to Pond 006a that is eroding, nearly full of sediment, and needs to be cleaned out and repaired. There currently are hunting restrictions on the property that end at the beginning of 2024. The Operator stated that at that time, they plan to mobilize a crew to address some of the erosion problems onsite.

Photo 3: Erosion going southeast across the access road towards Pond 006a. Slope on the right side of the photo is the area known as the reclaimed area above Pond 006a.

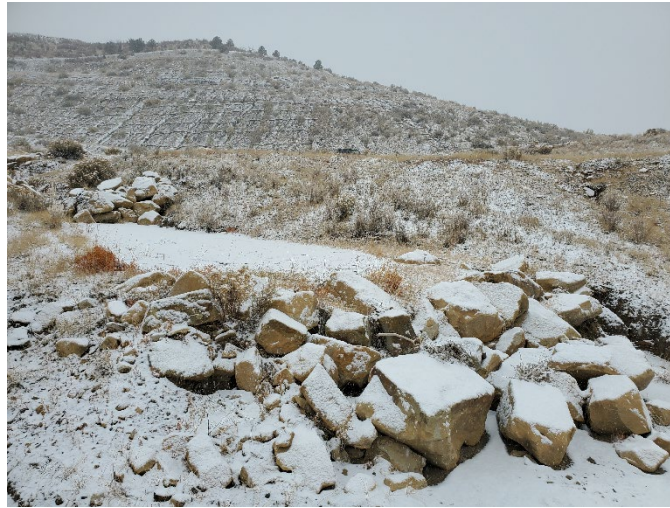
- The first check dam, located east of this access road and north-west above Pond 006a, is nearly full of sediment and at risk of being over-run (pictured in previous report). A few check dams down from the

Photo 4: Check dam nearly full of sediment.

road are nearly filled with sediment as well (Photo 4). **Due to this, the area above the check dams leading from the road, eastward, towards Pond 006a needs to be cleaned out to prevent damage to the dam, and to prevent excess sediment from entering Pond 006.**

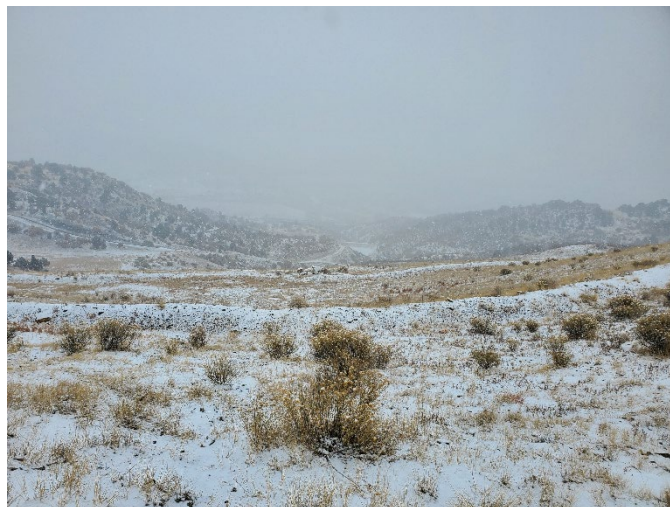
Photo 5: Looking downslope from the top of Fill 008.

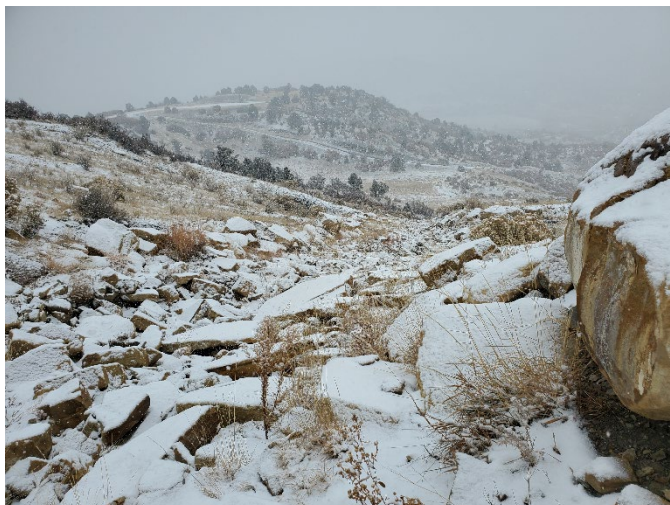
Photo 6: Looking downslope of the western armored channel along Fill 008.

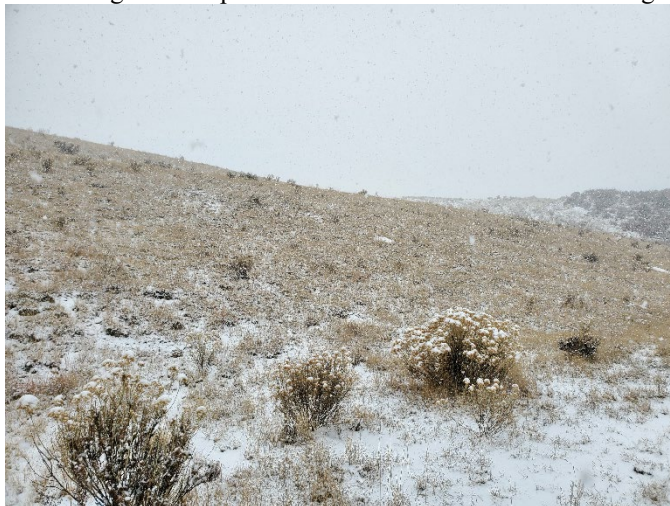
Photo 7: Looking upslope along one of the contours of Fill 008.

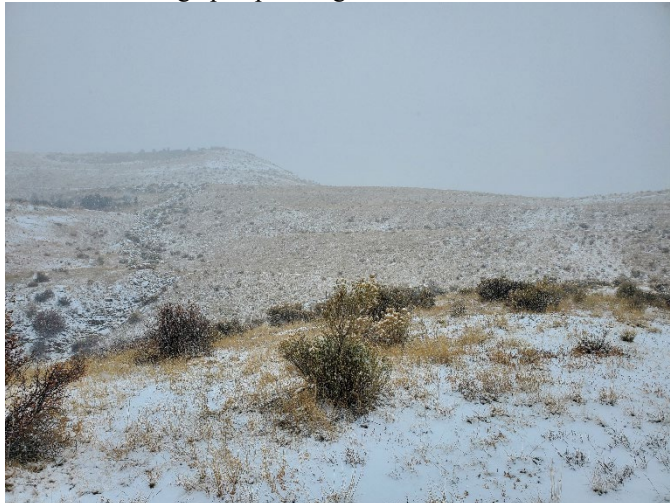
Photo 8: Looking upslope from the bottom of Fill 008.

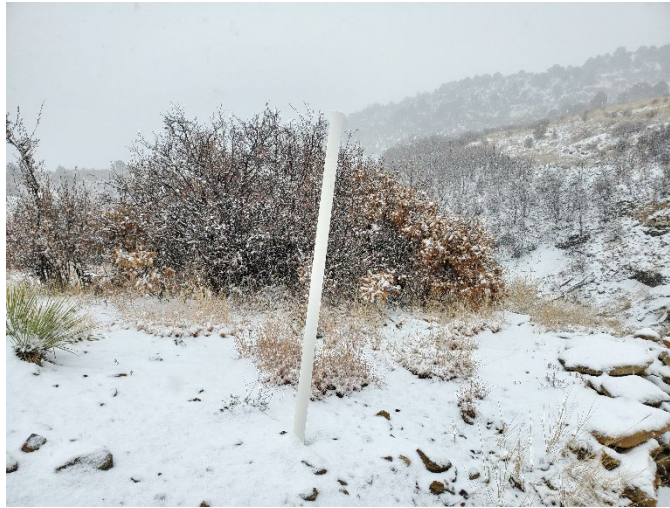
- Mine signs were posted at road entrances and at the entrance to permit boundary in compliance with Rule 4.02.
- A white monument marker was observed near the north-west side of the downslope portion of Fill 008, to the east of the nearby access road. The Operator stated that these white markers mark the disturbance boundary.

Photo 9: Disturbance boundary marker observed near the north-west side, downslope, of Fill 008.
