## **Deserado Mine, C-1981-018 December Partial Inspection Report**

**PERMIT INFORMATION**

**INSPECTION INFORMATION**

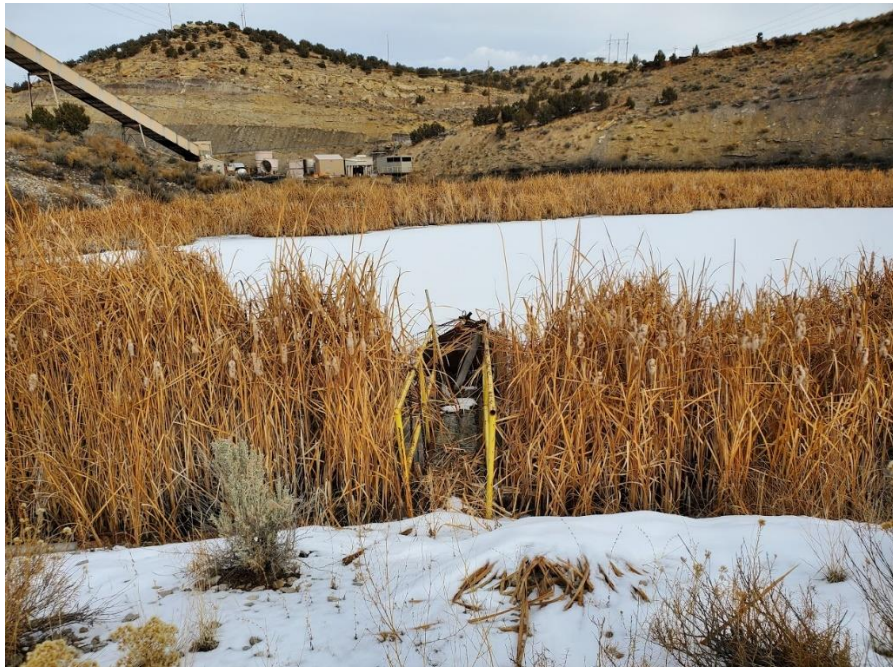
Three ponds are located within the facilities are of the mine site; the DP-1 pond, the PP-1 pond and the PP-2 pond. All three facility ponds were accessible at the time of the inspection. DP-1 collects all runoff from the three main facilities benches. DP-1 was frozen and covered with snow at the time of the inspection. The pond was discharging through the primary outlet at the time of the inspection. The discharge was free of obstructions (Photo 1). There were no indications of instability or erosion observed. The PP-1 pond is located on the middle facilities bench by the prep plant. The pond was frozen at the time of the inspection. No signs of instability or erosion were noted (Photo 2). Pond PP-1 was not observed to be discharging. The PP-2 pond is located on the upper facilities bench. This pond was also frozen and snow covered. There were no indications of instability or erosion on the pond's embankment.

Photo 1 – Outlet to pond DP-1. Pond was discharging at time of inspection.

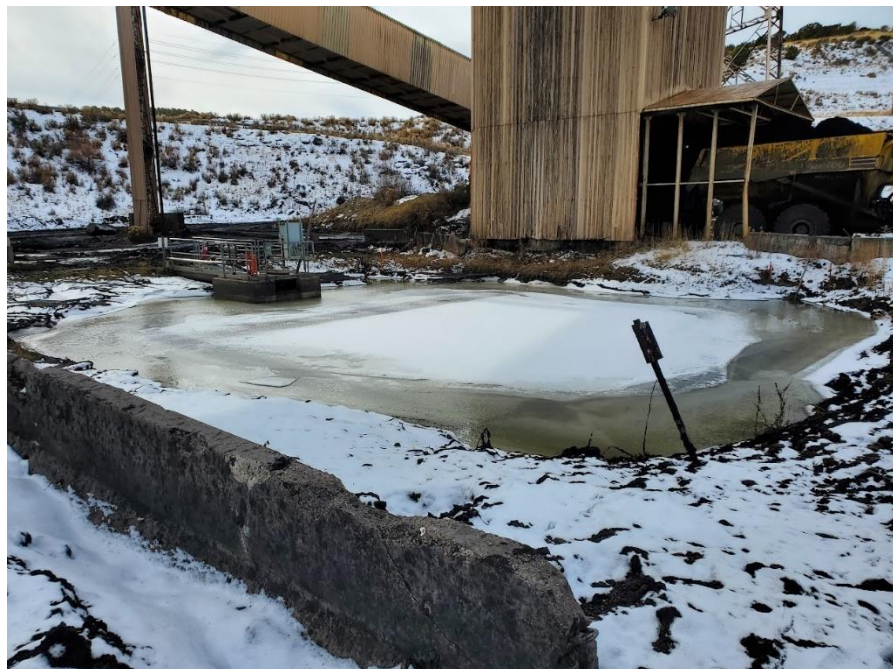
Photo 2 – Pond PP-1 near the prep plant. No signs of erosion or instability.

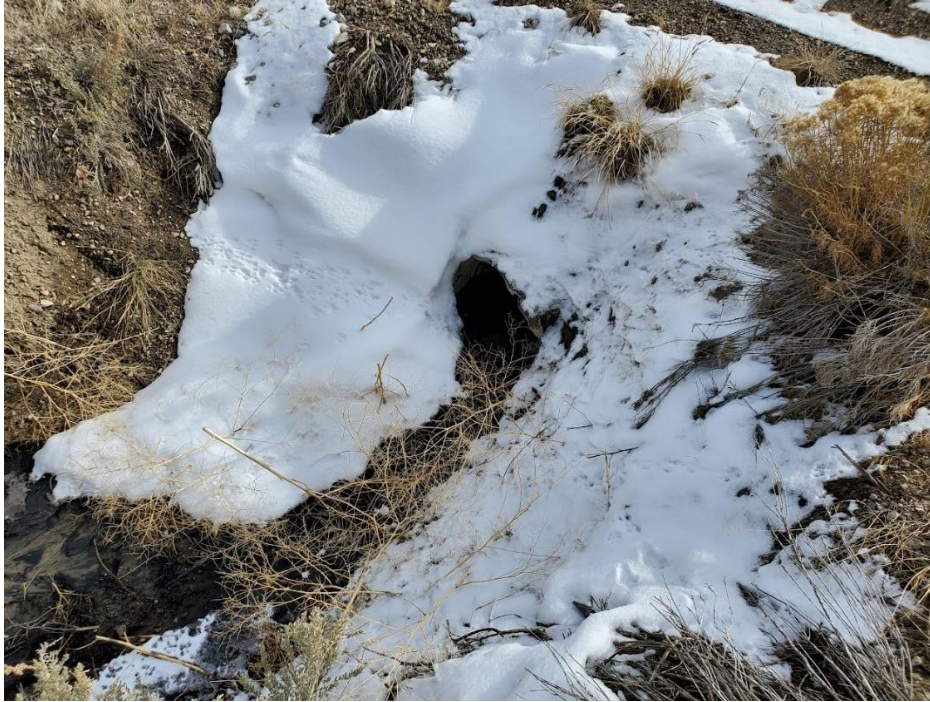
stable with no indications of erosion. The culvert leading into the pond was clear (Photo 3). The SS-2 Pond was not holding water at the time of the inspection. The embankment of the pond was stable with no signs of erosion.

Photo 3 – Culvert above pond SS-1. Culvert is clear and functions as normal.

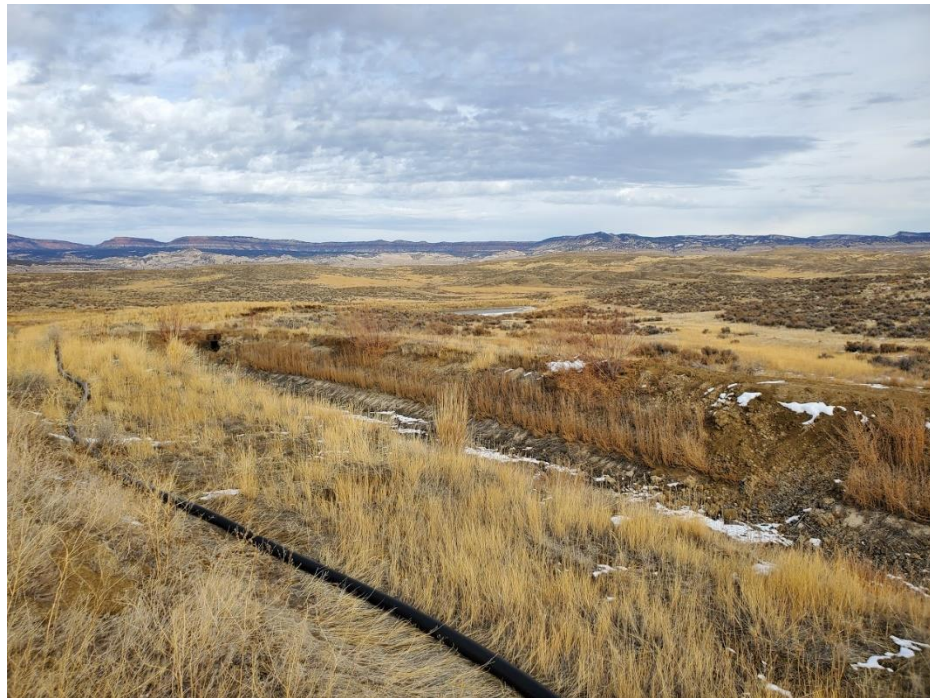
The B Seam Dewatering System #2 is located to the south of the Slot Storage. The B Seam Dewatering System #2 was inactive during the inspection. The upper and lower cells of the system were dry. The embankment of the upper cells are intact with minor erosion where repair work was completed (Photo 4). Some water was being held in the middle cell of the system below the level of the discharge outlet.

Photo 4 – Upper pond of B Seam Dewatering System #2. Minor erosion can be seen on the repaired area in the foreground.

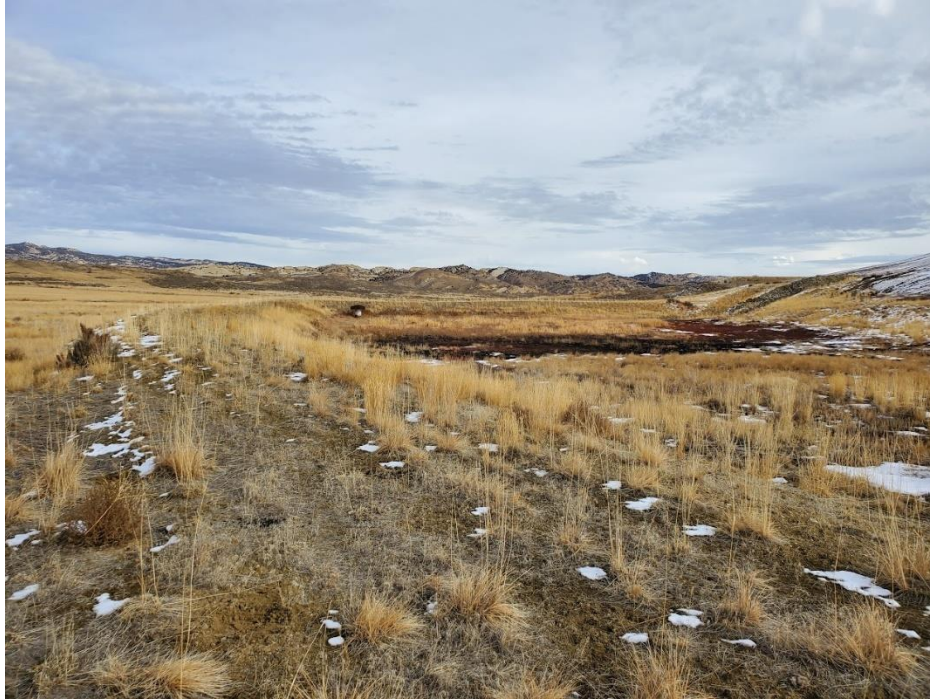
Pond RP-4 is located at the northwestern base of the RP-2/3/4 Refuse Pile. The embankment of the pond was stable with no erosional issues identified (Photo 5) No burrows were seen in the embankment. The outlet was clear of blockages.

Photo 5 – Pond RP-4. Embankments are stable.

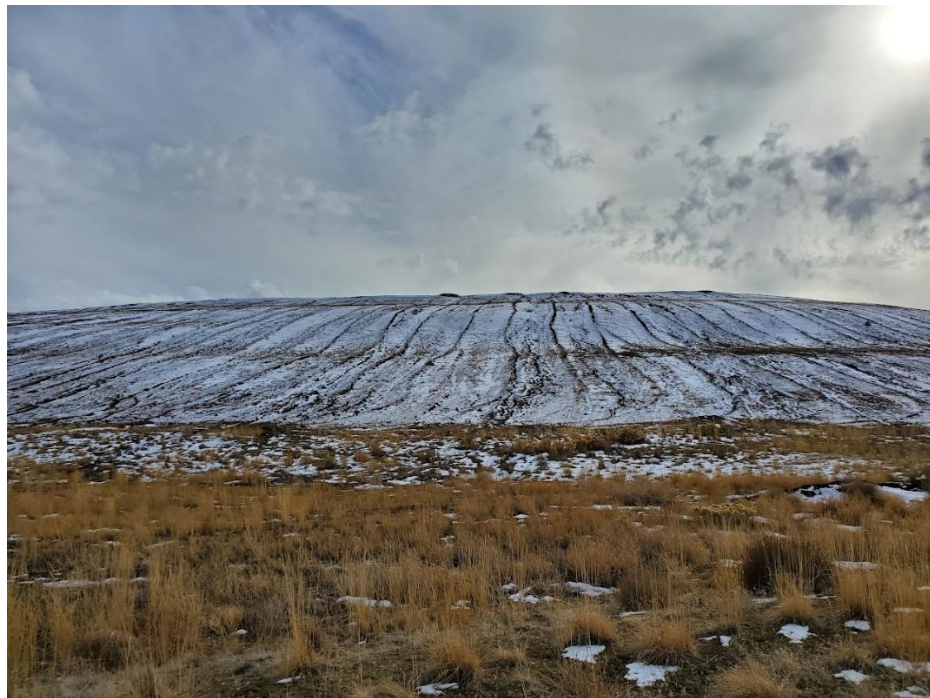
Three refuse piles are active at the Deserado Mine. The RP-2/3/4, RD-5a and RP-A piles. Minor rills were observed on the slopes of RP-2/3/4 and RP-5a. The rills have not yet reached the size of gullies and do not appear to affect the stability of the refuse piles (Photo 6). The rills are typically graded and patched as part of the spring maintenance that occurs at the mine. No other erosional features or displacement were observed on RP-2/3/4 or RP-5a. No indication of displacement, slumping, or other instability was observed in the waste piles. The RP-A refuse pile has waste material stockpiled in windrows (Photo 7). The pile appears stable with no observed erosional features.

Photo 56– Waste Pile RP-2/3/4 with minor rills on the slope face.

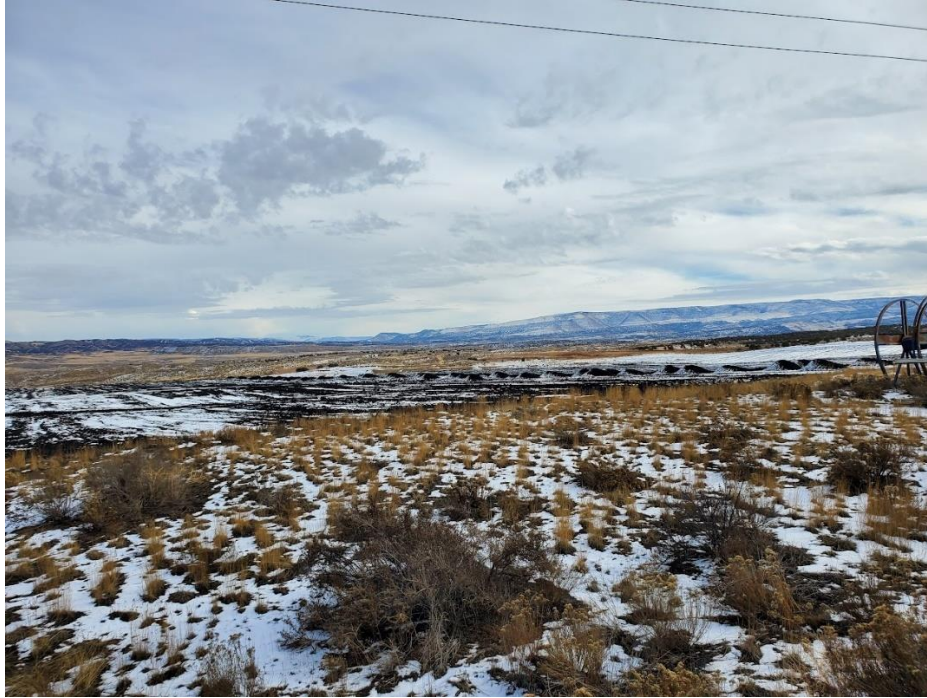
Photo 7 – Waste Pile RP-A with waste being stockpiled in windrows.

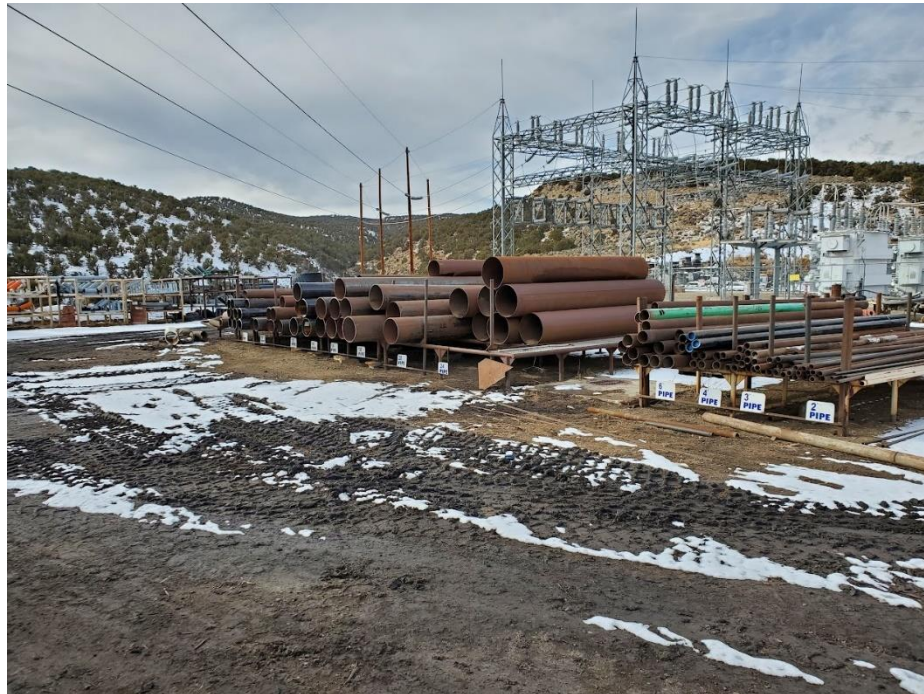
plant and the upper bench contains a materials laydown yard and electric substation. The drainage structures in the main facilities area were functioning correctly. There were no indications of erosional features on the three benches and berms were in good condition. The material laydown yard is well kept and organized (Photo 8). The safety fence surrounding the electric substation was in good condition.

Photo 8 – Laydown yard in on the top facilities bench. Yard is clean and organized.

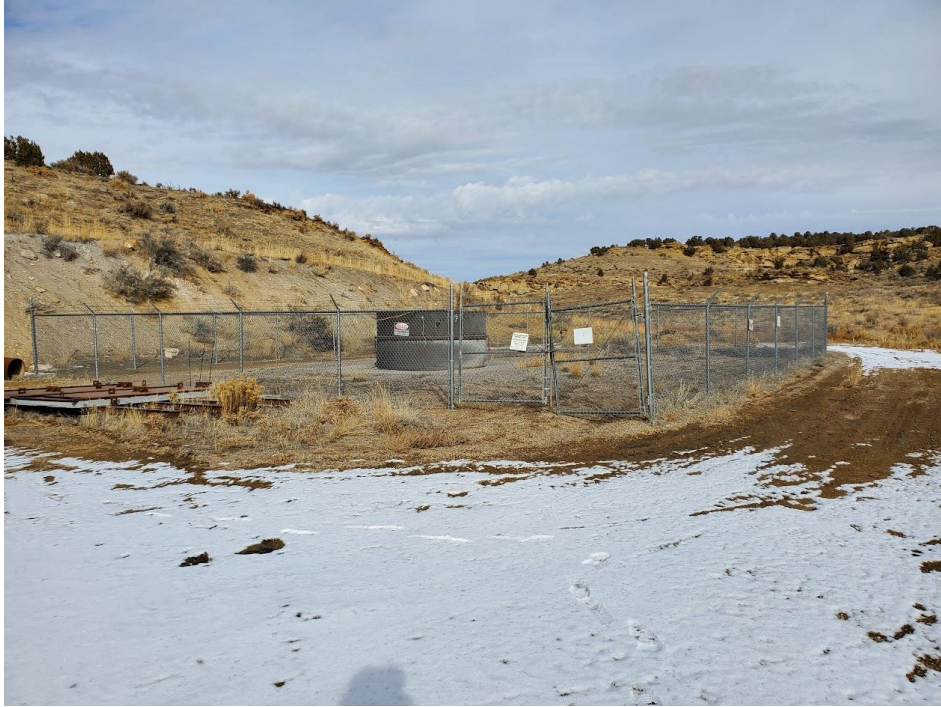
The B Seam Vent Shaft #1 is located north of the main facilities off of the haul road. The pad was stable with no erosional features. The fencing around the shaft to prevent unauthorized entry was in good condition (Photo 9).

Photo 9 – B Seam Vent #1. Fence prohibits unauthorized entry and pad shows no signs of instability

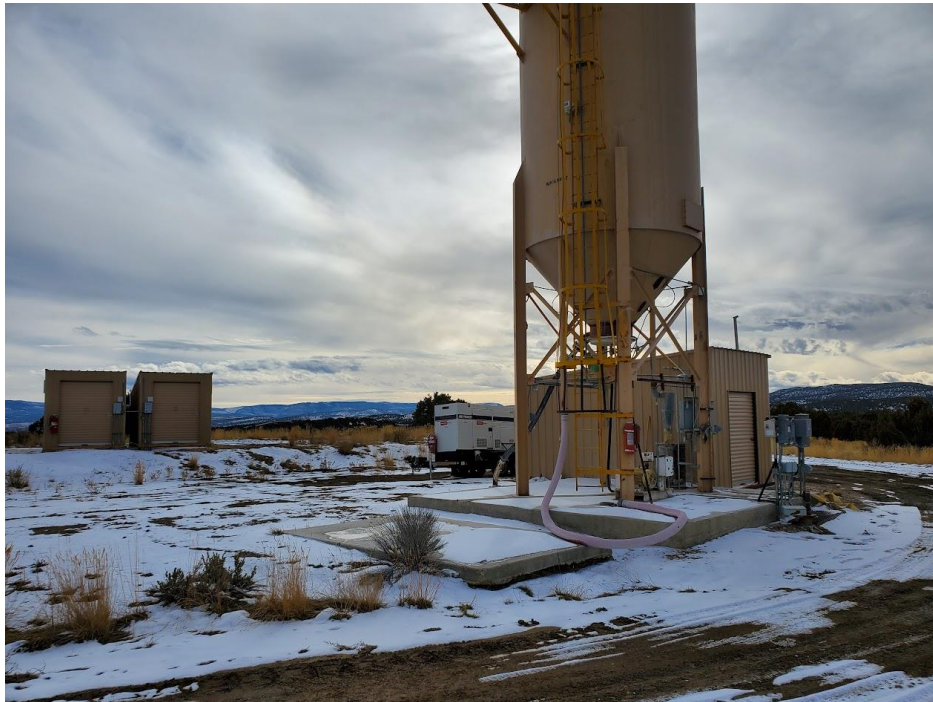
The pad for RDH-2 rock dust tank is located to the east of the B Seam Vent Shaft #1. The pad is stable with no erosional features (Photo 10).

Photo 10 – RDH-2 pad and rock dust tank. Pad shows no signs of instability.

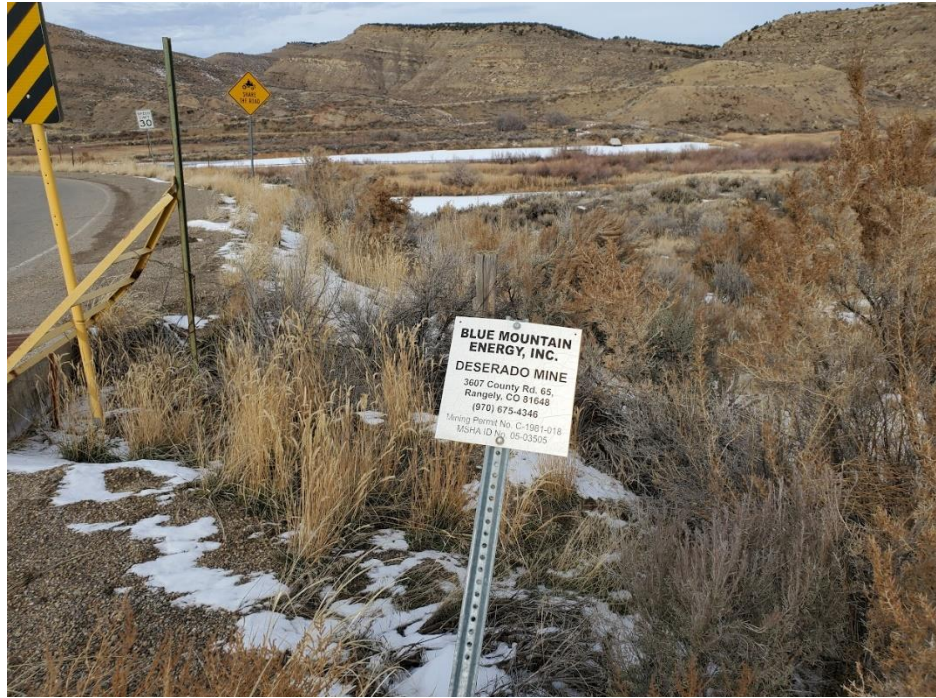
The mine identification signs are posted on the entrance to the permit boundary on CR-65. The signs displayed the current contact information for the permittee. The signs also include the assigned DRMS permit number. The ID signs were placed in unobstructed location and the text was clearly legible (Photo 11).

Photo 11 – Mine Identification Sign placed at the permit boundary along CR-65.

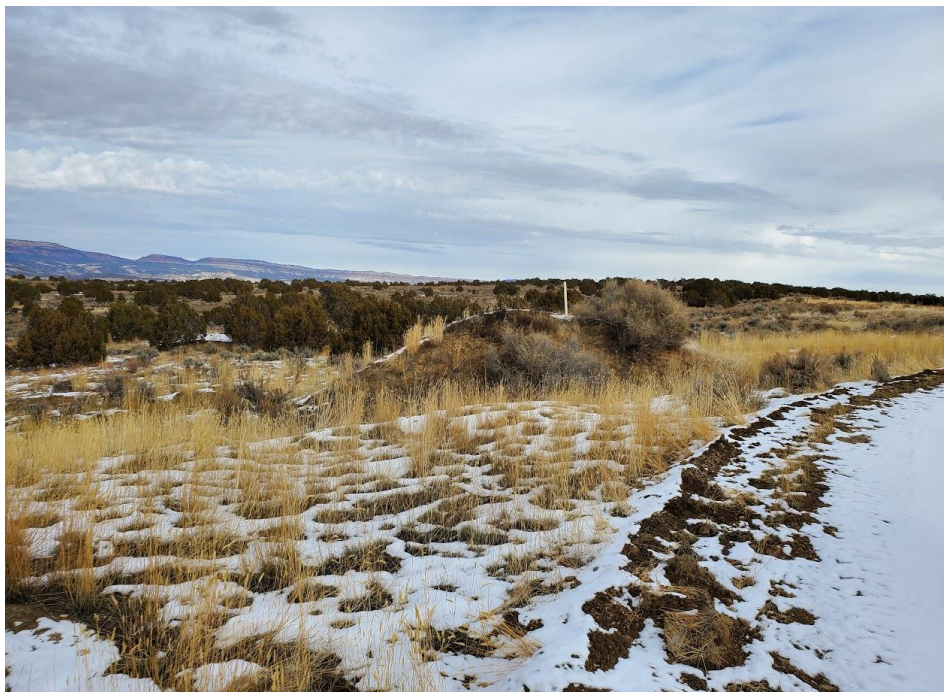
Topsoil stockpiles are located throughout the mine site. Topsoil stockpiles observed during this inspection include the B-Vent Raise, rail loop, and RDH-2 (Photo 12) stockpiles. The stockpiles were protected by vegetation and showed no indications of erosion or instability. Each topsoil pile that was observed had topsoil markers at the top of the pile. The markers are T-posts covered with pieces of white PVC. The markers were placed in visible locations and easy to spot.

Photo 12 – Topsoil stockpile at RDH-2. Topsoil is protected by vegetation and is marked with PVC marker.
