MINERALS PROGRAM INSPECTION REPORT

MINE NAME: Richardson Pit	MINE/PROSPECTING ID#: M-2021-014	MINERAL: Borrow material for construction	COUNTY: Cheyenne
INSPECTION TYPE: Monitoring	WEATHER: Clear	INSP. DATE: December 5, 2023	INSP. TIME: 09:00
OPERATOR: Castle Rock Construction Company of Colorado	OPERATOR REPRESENTATIVE: Travis Bell	TYPE OF OPERATION: 111 - Construction by Government Agency	
REASON FOR INSPECTION: Normal I&E Program	BOND CALCULATION TYPE: Complete Bond	BOND AMOUNT: \$12,500.00	
DATE OF COMPLAINT: NA	POST INSP. CONTACTS: None	JOINT INSP. AGENCY: None	
INSPECTOR(S): Nikie Gagnon	INSPECTOR'S SIGNATURE:

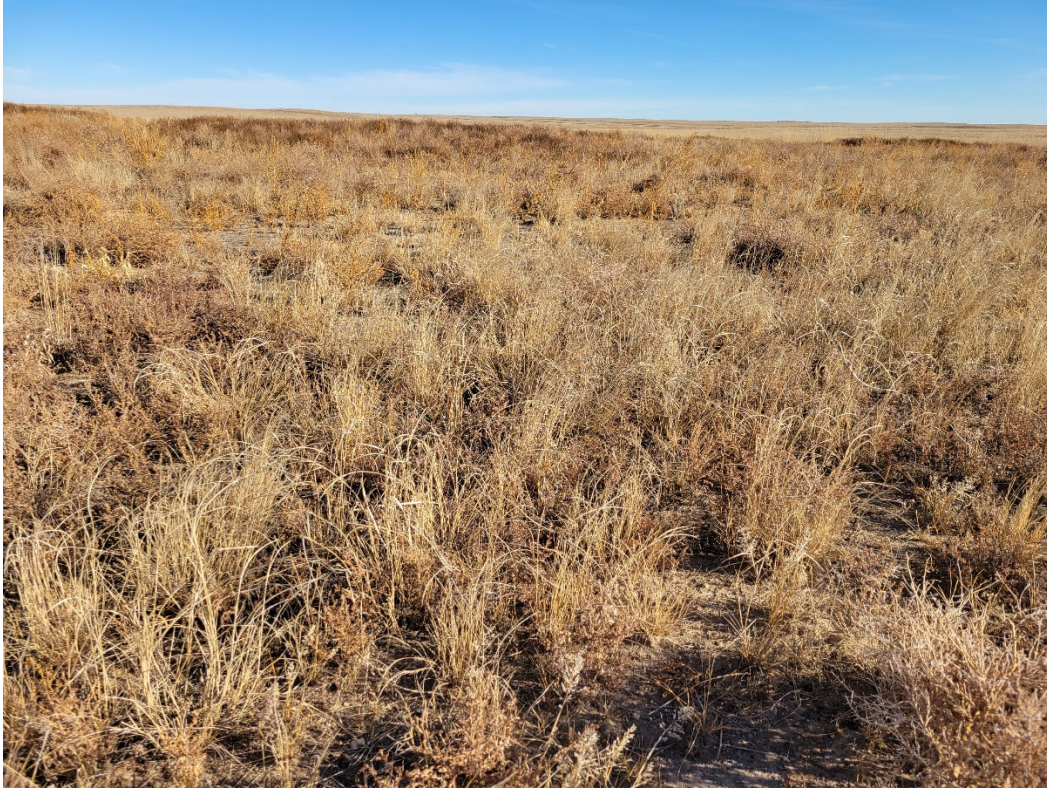
Photo 1: View looking east from the entrance to the site. Patches of grasses observed interspersed with annual weeds.

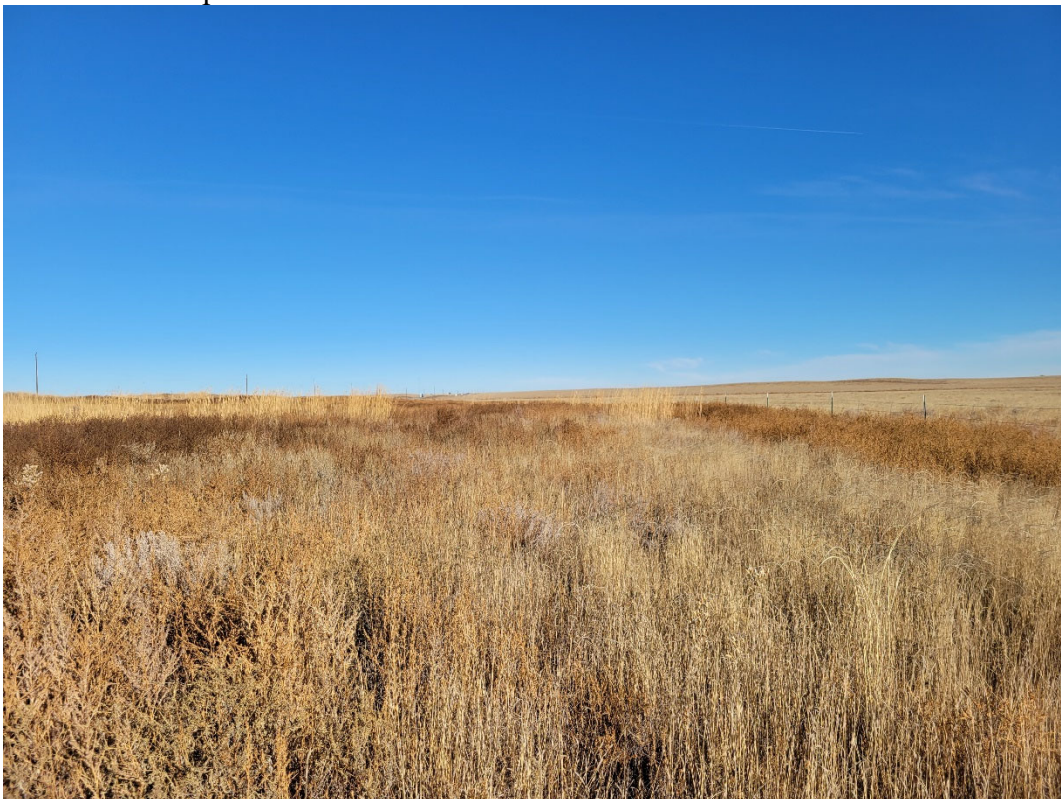
Photo 2: View looking north along the eastern boundary. Swath of dense grass observed growing along the eastern side of the permit area.

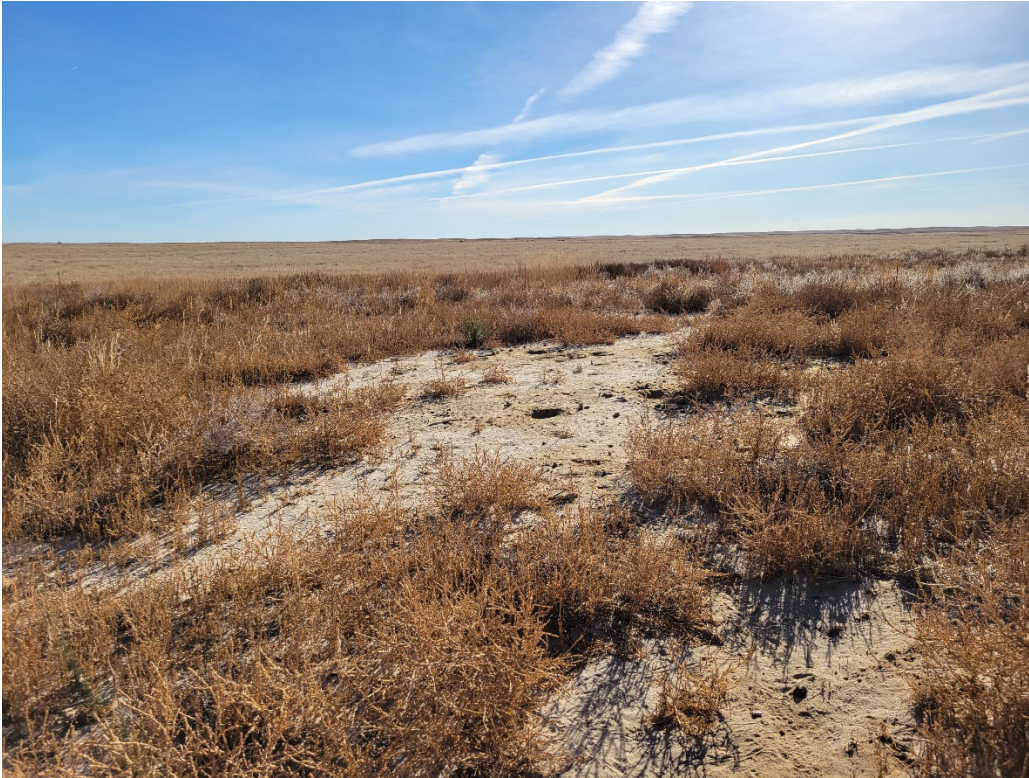
According to the Operator, the site was graded, seeded and mulched in the fall of 2021. During this inspection, desirable grass species were observed in clumps throughout the site (e.g., buffalo grass, blue grama, western wheatgrass), interspersed with patches of annual weeds, primarily Russian thistle. A few bare spots were observed near the entrance and around the site likely due to snow and storm runoff inhibiting vegetation growth. The Division recommends monitoring vegetation recovery and reseeding the bare areas as necessary.

Photo 3: Bare ground and Russian thistle observed in a few spots.

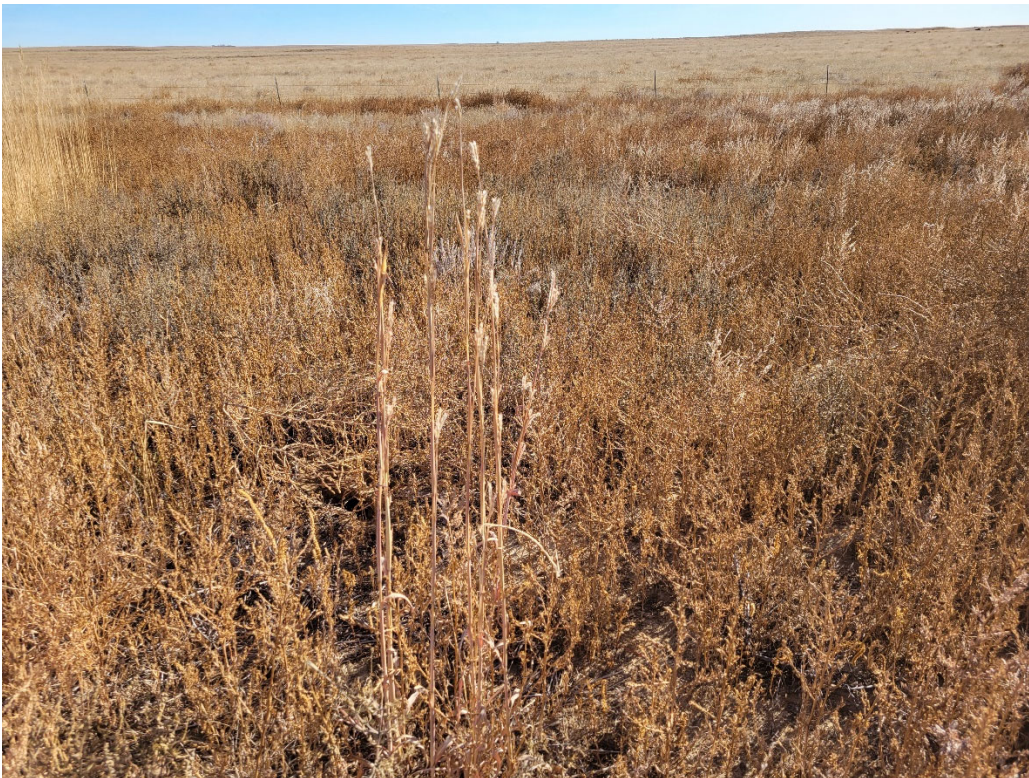
Photo 4: Desirable species noted across the site, including Little bluestem, buffalograss, and western wheatgrass

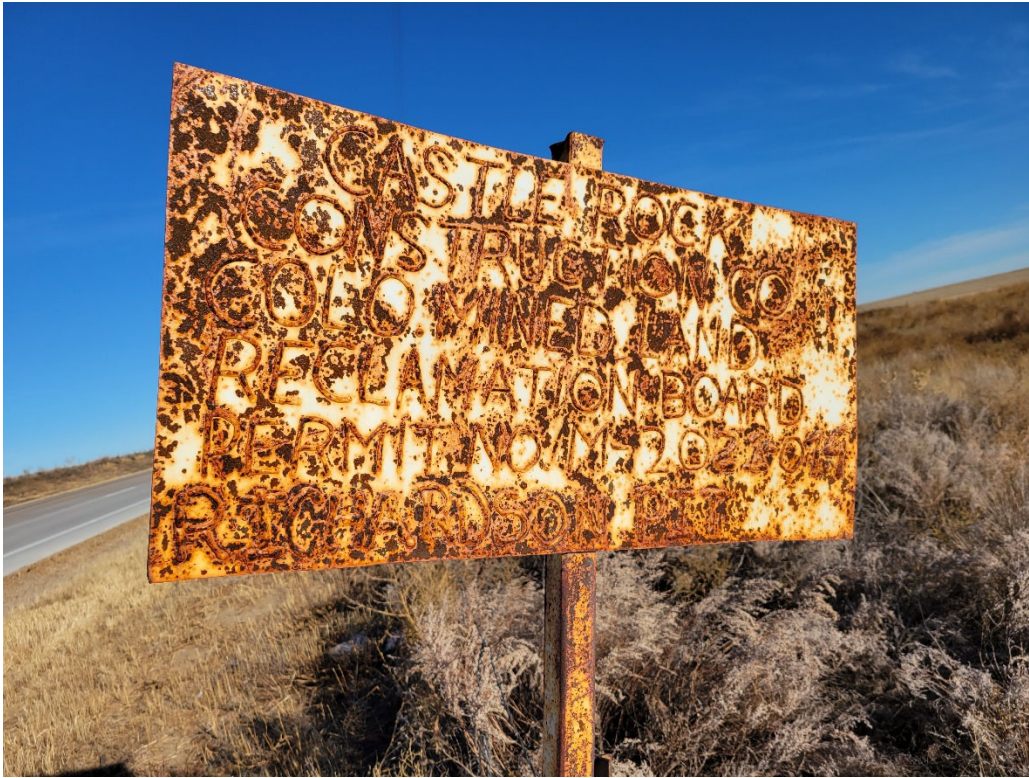
A barbed wire fence and gate secures the site. Pursuant to Rule 3.1.12(1) a mine sign was in place at the entrance to the pit facing US 287; however, the sign is rusty and is difficult to read. The Division discussed this with the Operator over the phone after the inspection. The Operator stated they will sandblast and repaint the sign. The Division requests that the Operator submit a photo of the sign as proof that this has been corrected.

Photo 5: Sign posted at the entrance is difficult to read.
