Keenesburg inspection report

PERMIT INFORMATION

Permit Number: C-1981-028 Mine Name: Keenesburg Strip Mine Operator: Coors Energy Company Operator Address: Mr Ben Moline P.O. Box 4030 Golden, CO 80402	County: Weld Operation Type: Surface Permit Status: Permanent Cessation Ownership: Private
	Operator Representative Present: None
Operator Representative Signature: (Field Issuance Only)

INSPECTION INFORMATION

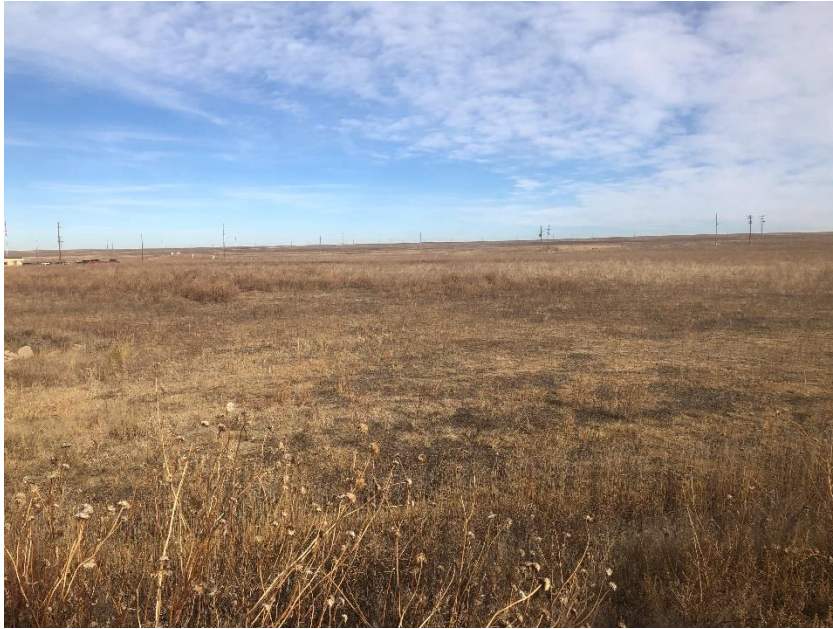
Area 38 – reclaimed topsand pile, looking northeast

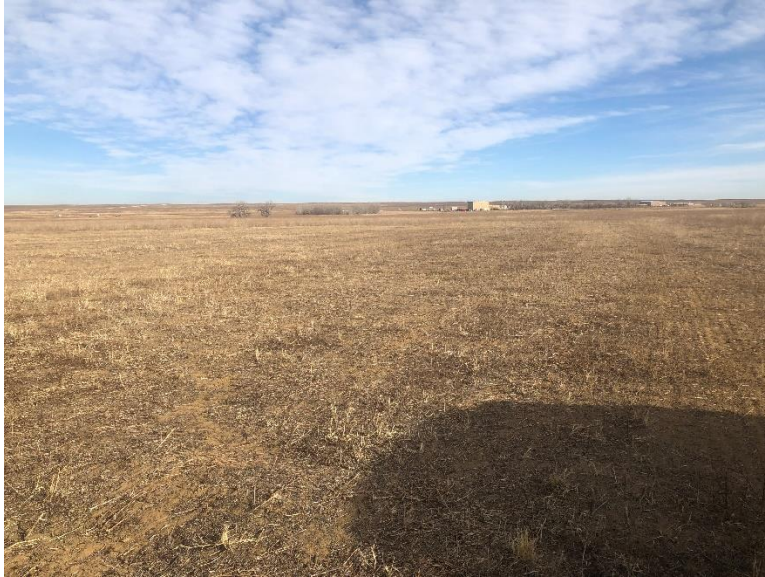
West side of Area 36 – recently harrowed and seeded

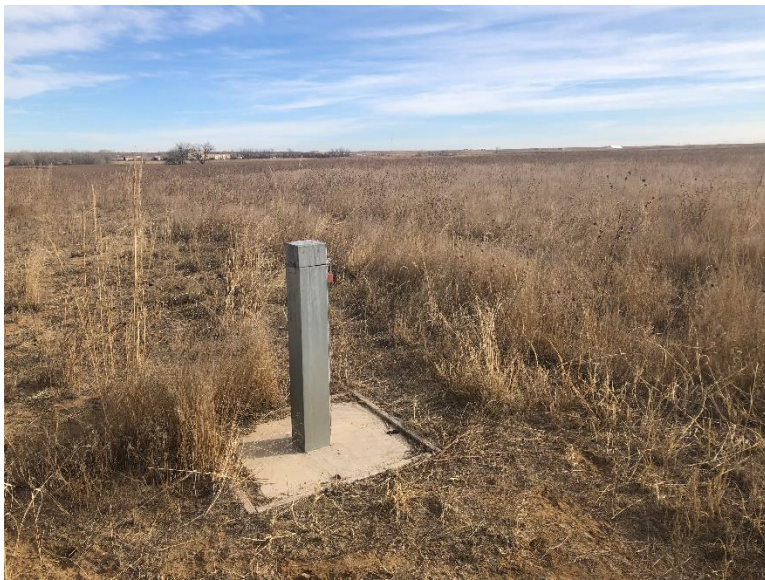
Sunflowers were found to be the dominant species in many areas, including Area 42. Large amounts of cheatgrass were seen in Area 43. Other areas that were inspected contained good stands of grasses, including the west side of Area 37.

West side of Area 37, with monitoring well

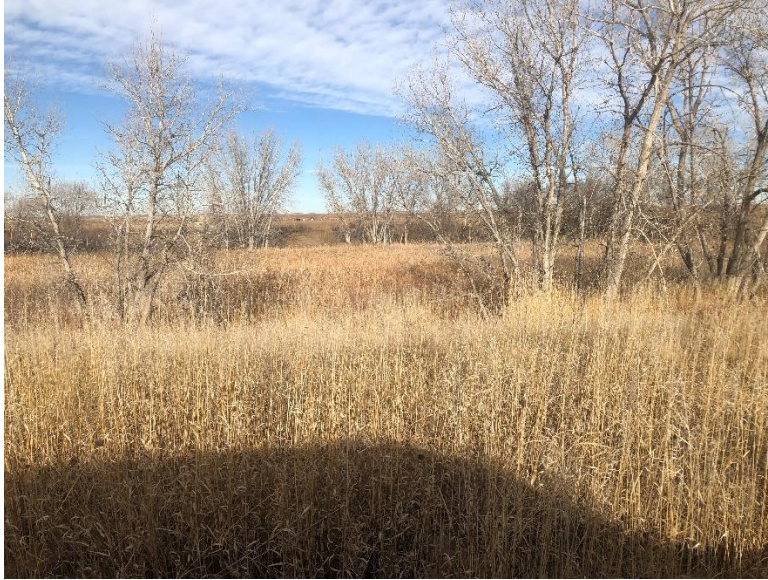
Sediment Pond 2 and the Dugout Pond were inspected, and each contained little to no water (thick vegetation obscures the bottoms of both ponds). They were not discharging during the inspection. There were no signs that either pond had discharged recently. No problems were observed.

Sediment Pond 2, looking across pond at spillway

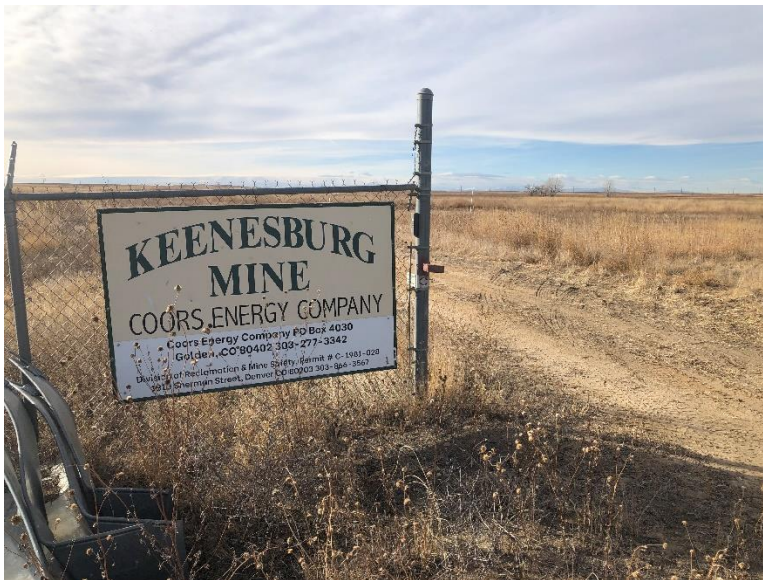
The entrance sign was seen at the gate on the west side of the facility area, which was released with SL-08. The sign contained all necessary information. Boundary markers were observed on all sides of the site except the west side, which was not inspected.

Entrance sign at gate
