PERMIT INFORMATION

Permit Number: C-1981-041 Mine Name: Roadside Portals Operator: Snowcap Coal Company, Inc. Operator Address: Ms Tonya Hammond 743 Horizon Court, Suite 334 Grand Junction, CO 81506	County: Mesa Operation Type: Underground Permit Status: Active Ownership: Private
	Operator Representative Present: Tonya Hammond
Operator Representative Signature: (Field Issuance Only)

Inspection Start Date: December 6, 2023 Inspection Start Time: 11:10 Inspection End Date: December 6, 2023 Inspection End Time: 12:25		Inspection Type: Coal Complete Inspection Inspection Reason: Normal I&E Program Weather: Clear	
Joint Inspection Agency: None		Joint Inspection Contacts: None	
Post Inspection Agency: None		Post Inspection Contacts: None	
Inspector(s): Clayton Wein	Inspector's Signature: <i>Clayton Wein</i> Signature Date: 12/20/2023

This document records the Division's observations taken during a complete inspection of the Roadside Mine on December 6, 2023. The inspection was conducted by Clayton Win of the Division. Snowcap Coal Company was represented by Tonya Hammond during the inspection. The weather was clear with a temperature of 47° F. The ground conditions were dry.

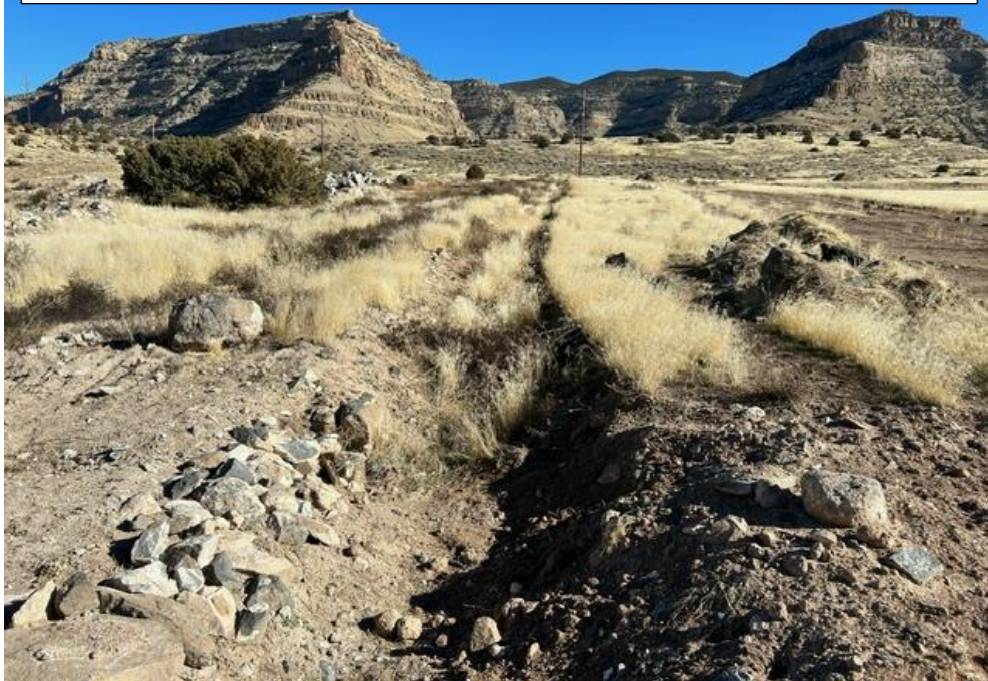
The Carey Pit is located in the southwestern portion of Tract 71. The pit is not associated with the mining permit. The pit was observed to be dry at the time of the inspection. There was no evidence of recent water being applied into the pit. Mr. Fontanari's trenches on the north (Photo 1) and eastern portions of Tract 71 were also observed to be dry. There was no evidence of recent water in the trenches.

Photo 1: Mr. Fontanari's northern trench at Tract 71.

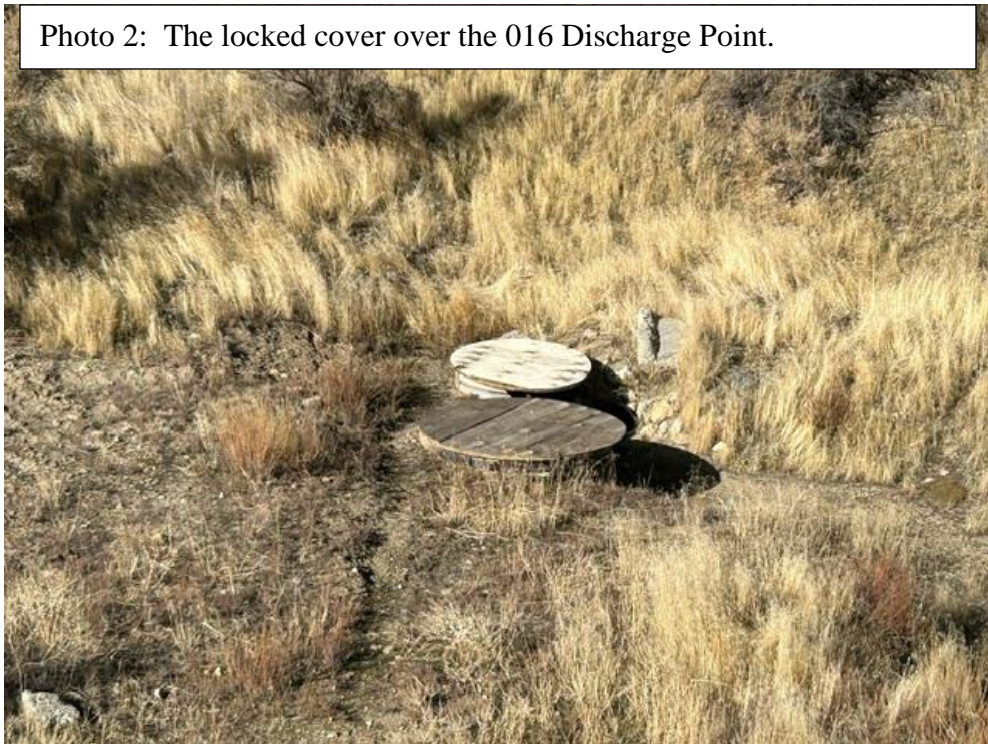
The Mine's discharge point, 016, is located in the northeastern section of the permit area. The discharge point is a pipe that drains water from the mine workings. The pipe was in good condition with a locked cap over it (Photo 2). At the time of the inspection, the discharge meter was averaging 114.4 gpm. There were no blockages within the pipe.

Photo 2: The locked cover over the 016 Discharge Point.

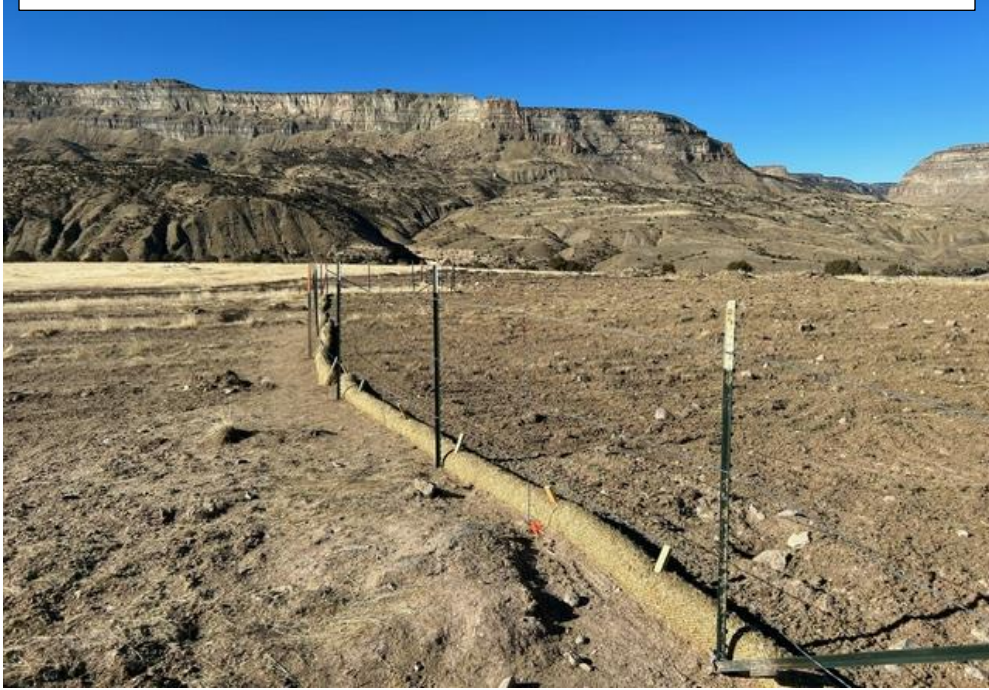
The remaining permitted disturbance at the Roadside Mine is referred to the TR-69 Repair Area. The TR-69 Repair Area is located in the northern portion of Tract 71. The area is approximately 0.4 acres in size. The Division documented in the October 2023 Inspection Report that Mr. Fontanari had bladed through Snowcap's reclamation at the TR-69 Repair Area. Since this activity had occurred, Snowcap had redistributed the soil and topsoil at the TR-69 Repair Area. The site was then re-staked with disturbed boundary markers and a wire fence. The straw waddles were replaced as well. A mine identification was also placed on the fence to further mark the reclamation area. The site was also reseeded in November 2023. During the inspection the TR-69 Repair Area was observed to be stable with no indications of erosional features (Photo 3, 4 and 5). The straw waddles located on the south and west sections of the disturbed area were in good condition and in the correct locations. The disturbed boundary was clearly marked and the mine identification sign was posted in a highly visible location (Photo 6). No off-site impacts from the TR-69 Repair Area were observed.

Photo 3: The southern portion of the TR-69 Repair Area.

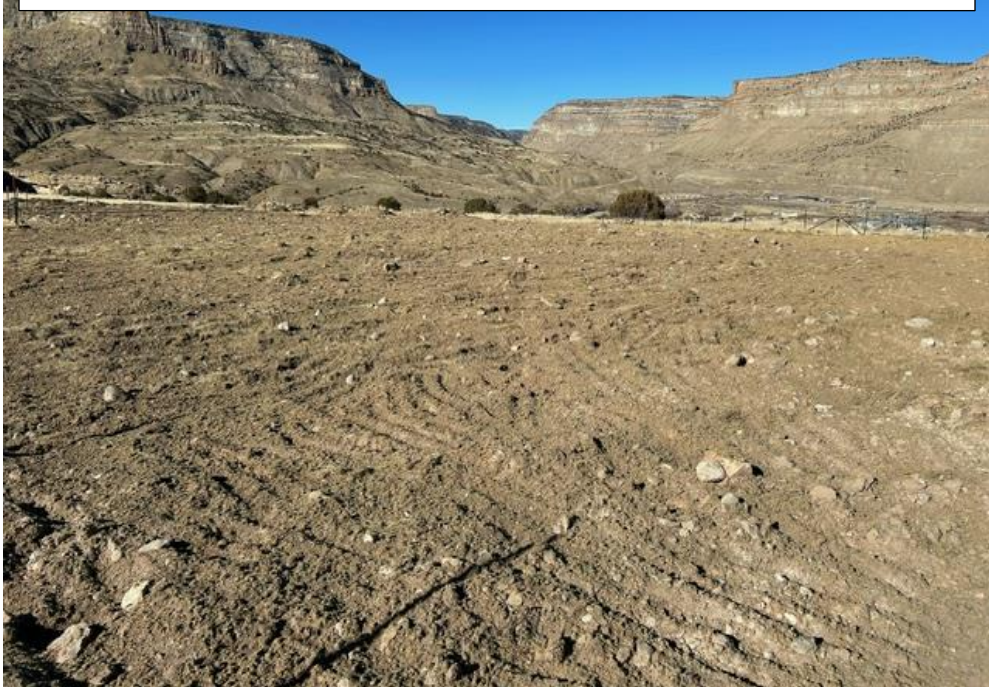
Photo 4: The central portion of the TR-69 Repair Area.

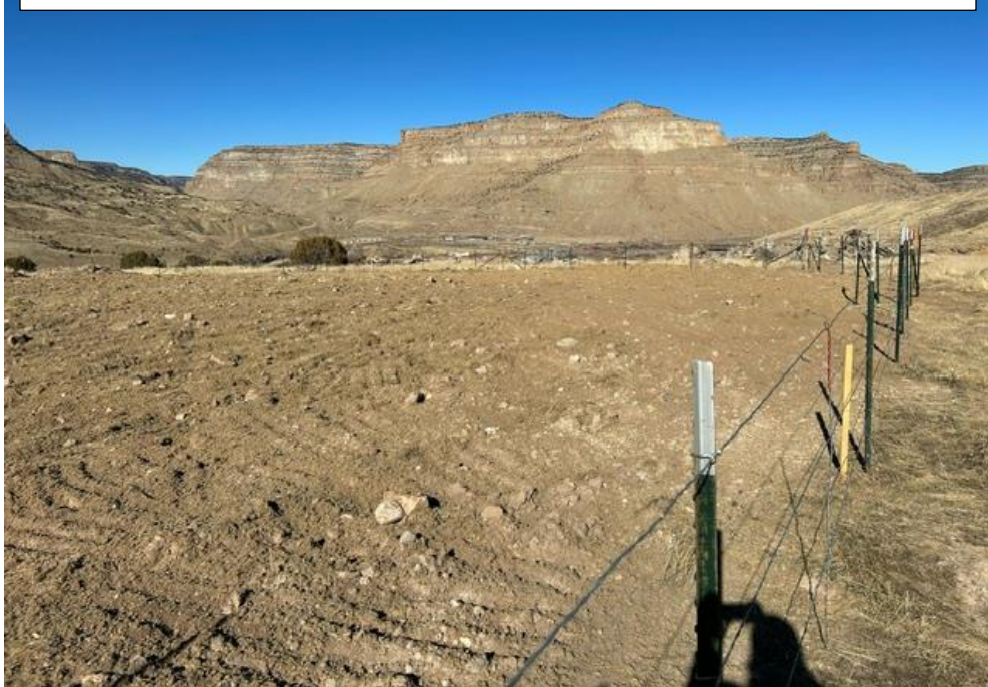
Photo 5: The northern and eastern portion of the TR-69 Repair Area.

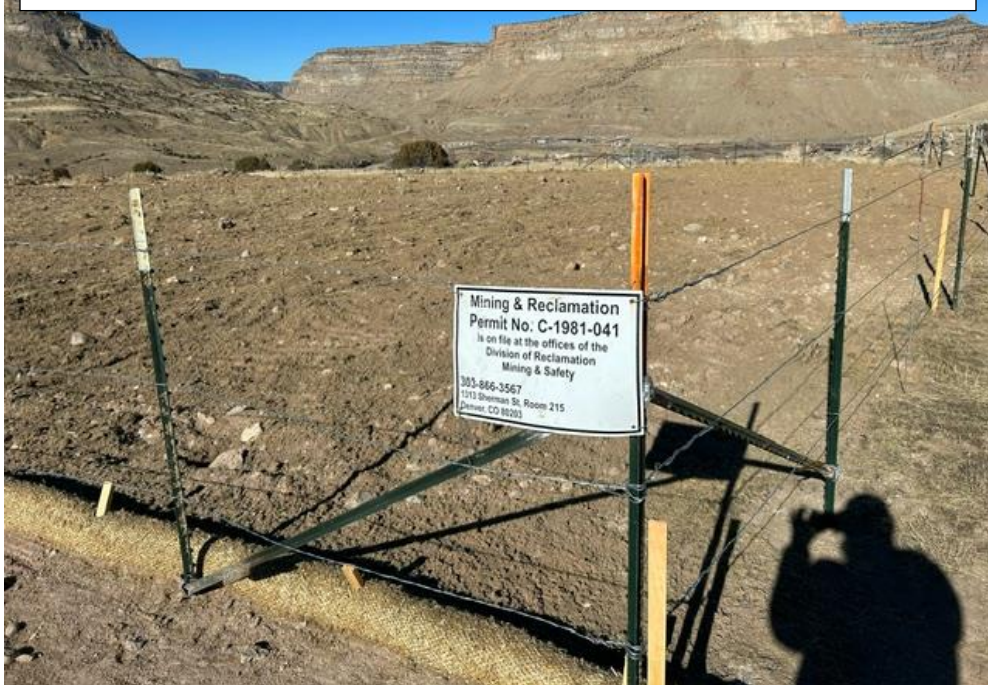
Photo 6: The additional Mine ID sign at the TR-69 Repair Area.
