PERMIT INFORMATION

Permit Number: C-1981-015 Mine Name: Fruita No 1 & 2 Operator: Dorchester Coal Company Operator Address: Greg Lewicki 9054 South Forrest Drive Highlands Ranch, CO 80126	County: Mesa Operation Type: Underground Permit Status: Revoked Ownership: Private
	Operator Representative Present: NA
Operator Representative Signature: (Field Issuance Only)

INSPECTION INFORMATION

Inspection Start Date: December 6, 2023 Inspection Start Time: 13:40 Inspection End Date: December 6, 2023 Inspection End Time: 14:25		Inspection Type: Coal Complete Inspection Inspection Reason: Normal I&E Program Weather: Clear	
Joint Inspection Agency: None		Joint Inspection Contacts: None	
Post Inspection Agency: None		Post Inspection Contacts: None	
Inspector(s): Clayton Wein	Inspector's Signature: <i>Clayton Wein</i>		
			Signature Date: 12/20/2023

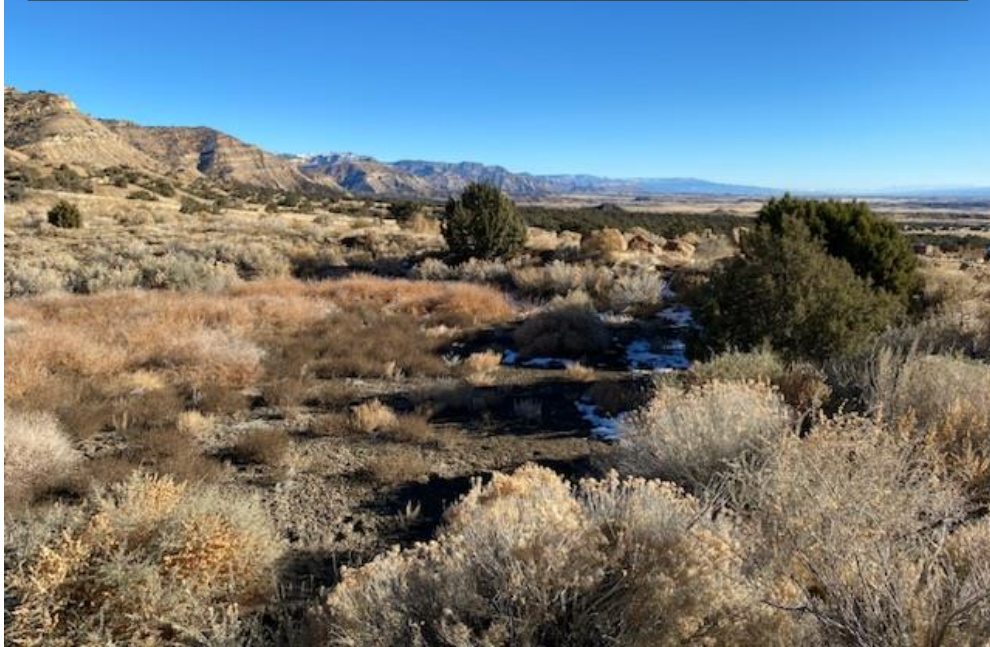
The sediment pond for the mine site is located in the southern portion of the permit boundary. The pond was mostly dry with small amounts of snow on the north facing portion of the embankment (Photo 1). The embankment was stable with vegetative cover. There were no indications of erosional features or burrows. The discharge outlet for the pond is lined with large rip rap. The channel was clear of debris and stable. There were no erosional concerns identified.

Photo 1: The sediment pond. The photo was taken looking to the southeast.

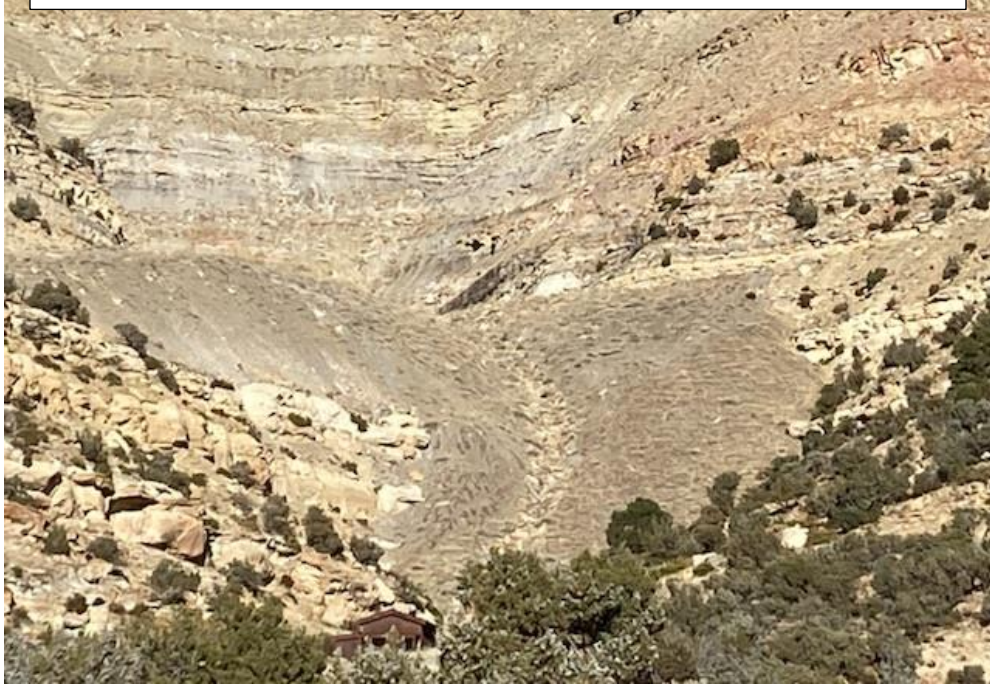
The armored channel leading from the portals bench to the drainage above the sediment pond was dry during the inspection. The channel was observed to be stable with no erosional features (Photo 2). The rip rap armor was in good condition.

Photo 2: The armored channel on the slope of the portals bench.

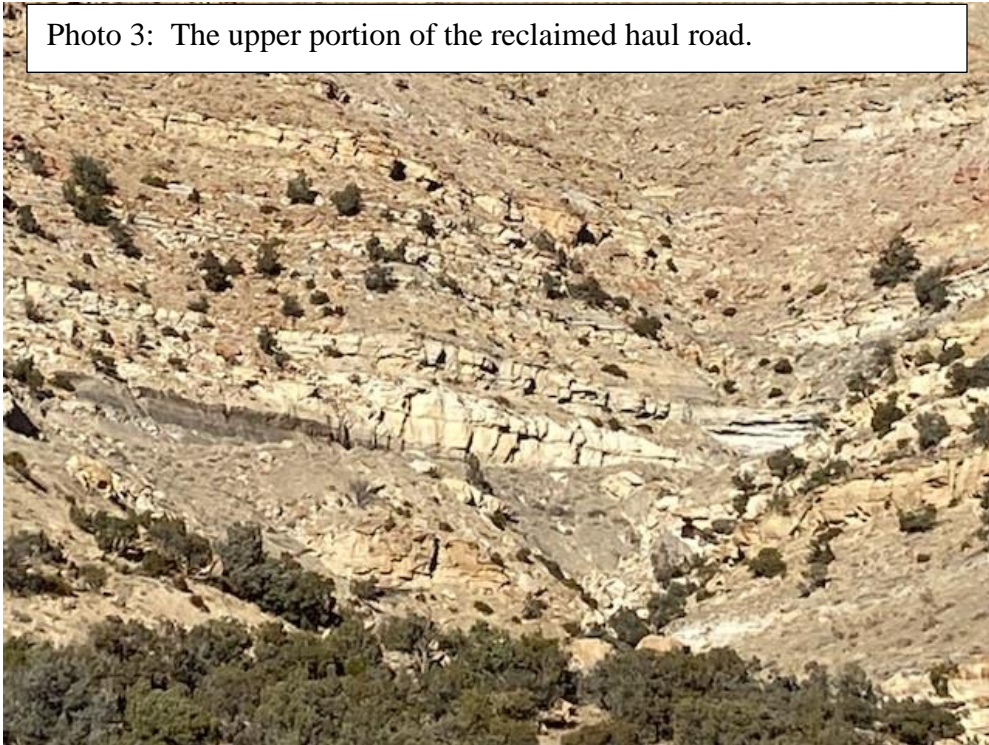
Reclaimed portions of the mine include; the portals bench with backfilled portals, the upper reclaimed haul road (Photo 3) and the lower reclaimed haul road (Photo 4). The portals bench was stable with vegetative cover. The bench had no new indications of erosional features. The large rill documented in previous inspection reports has self-stabilized and did not appear to have enlarged. The large rill has been transporting runoff to the armored channel draining of the bench. The backfilled portals were stable with no indication of erosion. The

The upper reclaimed haul road was covered with vegetation and stable. There were no erosional features observed. The cut and fill slopes of the reclaimed haul road were also noted to be stable with no erosional concerns. The lower haul road was also stable with vegetative cover. The cut and fill slopes of the lower haul road had no indication of erosion. The large rill noted near the middle of the reclaimed haul road was stable. There did not appear to have been any changes in the rill's size since the previous inspection. The rill appears to have stabilized and transports runoff to the drainage leading into the sediment pond.

Photo 3: The upper portion of the reclaimed haul road.

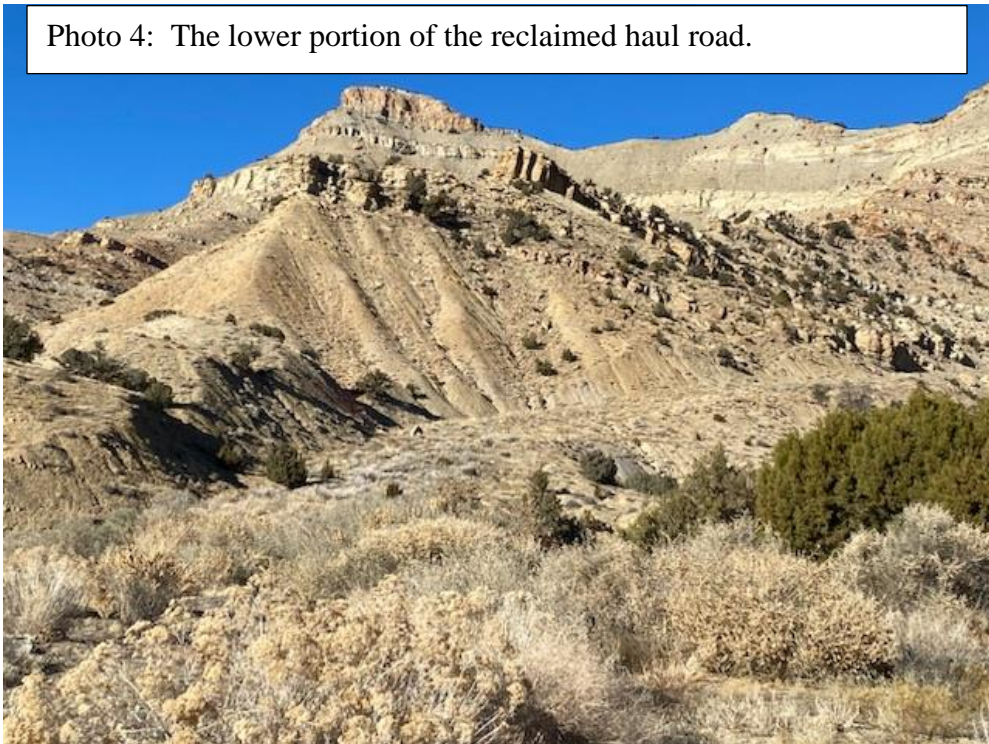
Photo 4: The lower portion of the reclaimed haul road.
