QUARTERLY SEDIMENTATION POND INSPECTION REPORT

Mine: New Elk WP Containment #1

Inspection Period: Fourth Quarter 2023

Inspection Date: 12/18/2023

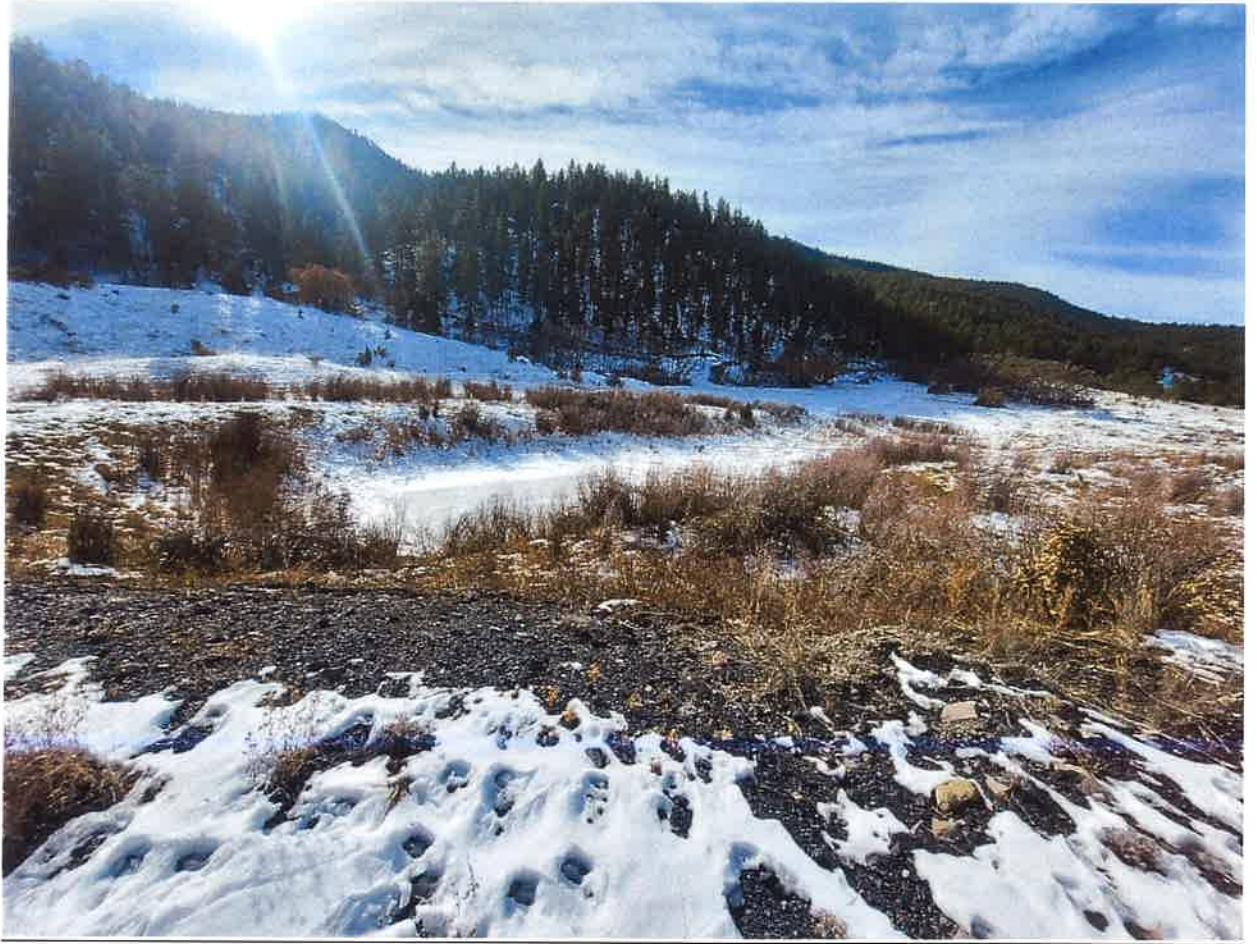
Containment was holding water and was Frozen at the time of inspection.

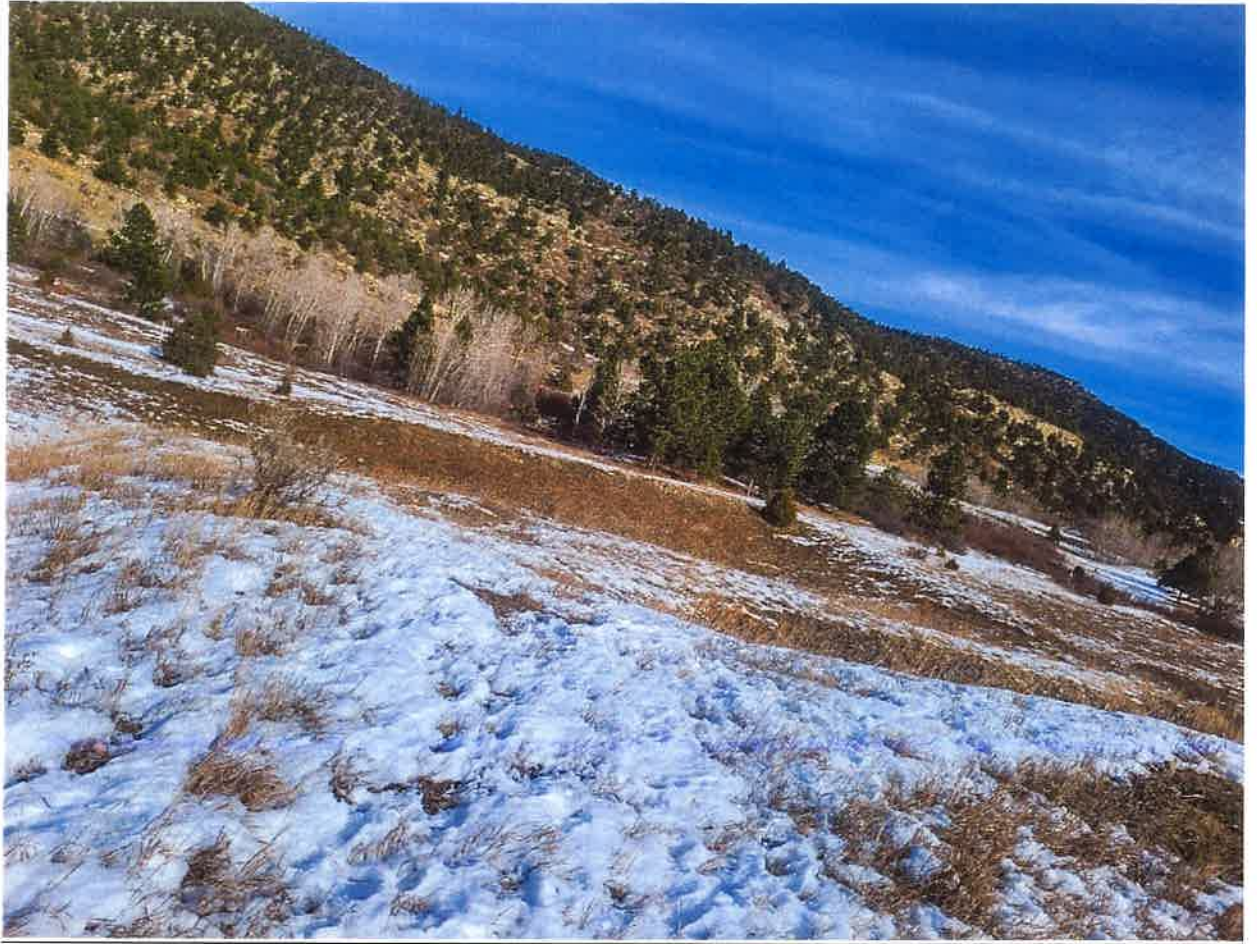
Mine: New Elk WP Containment #2

Containment was empty at time of inspection.

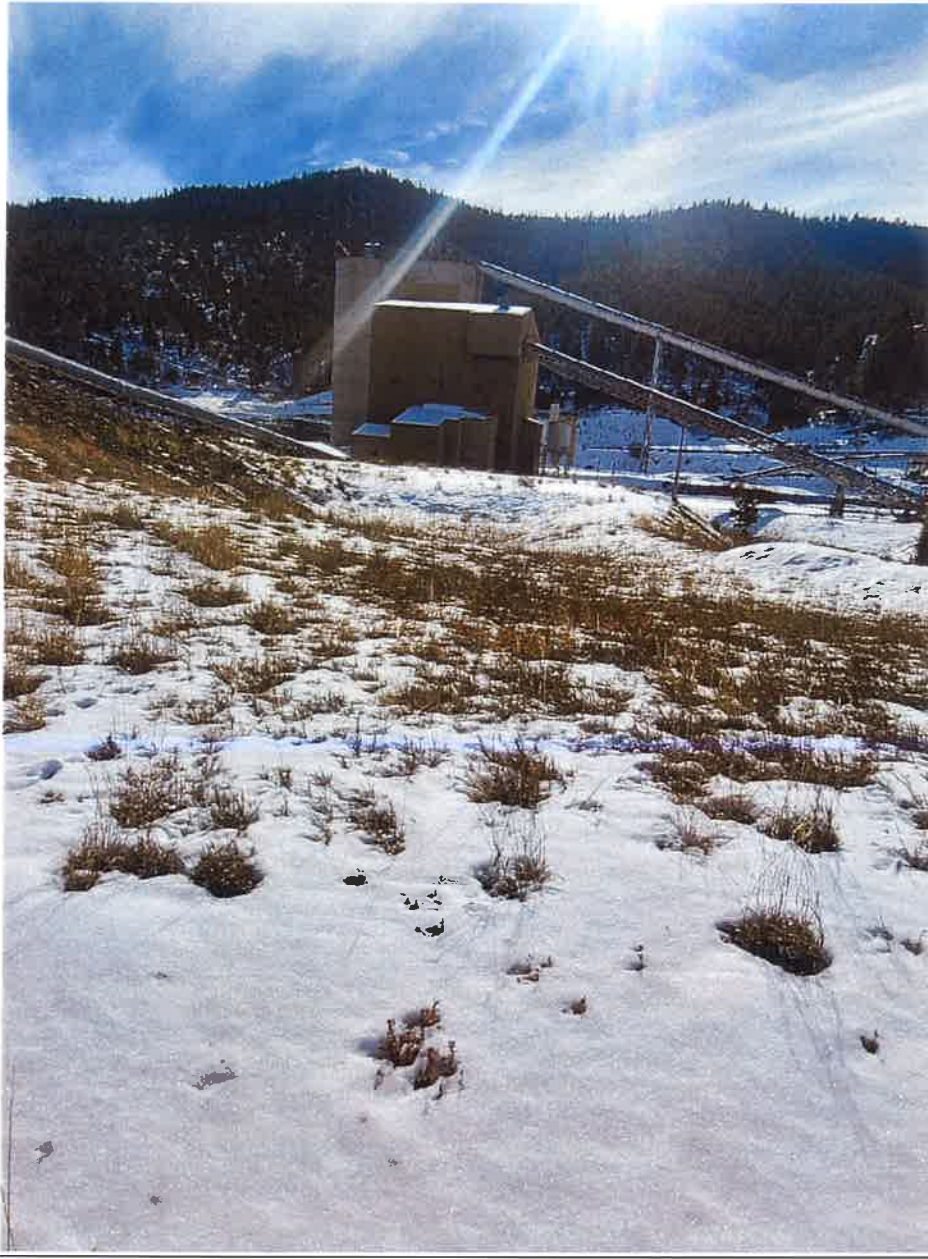
Mine: New Elk Containment #3

Containment Area was holding water and was frozen at time of inspection.

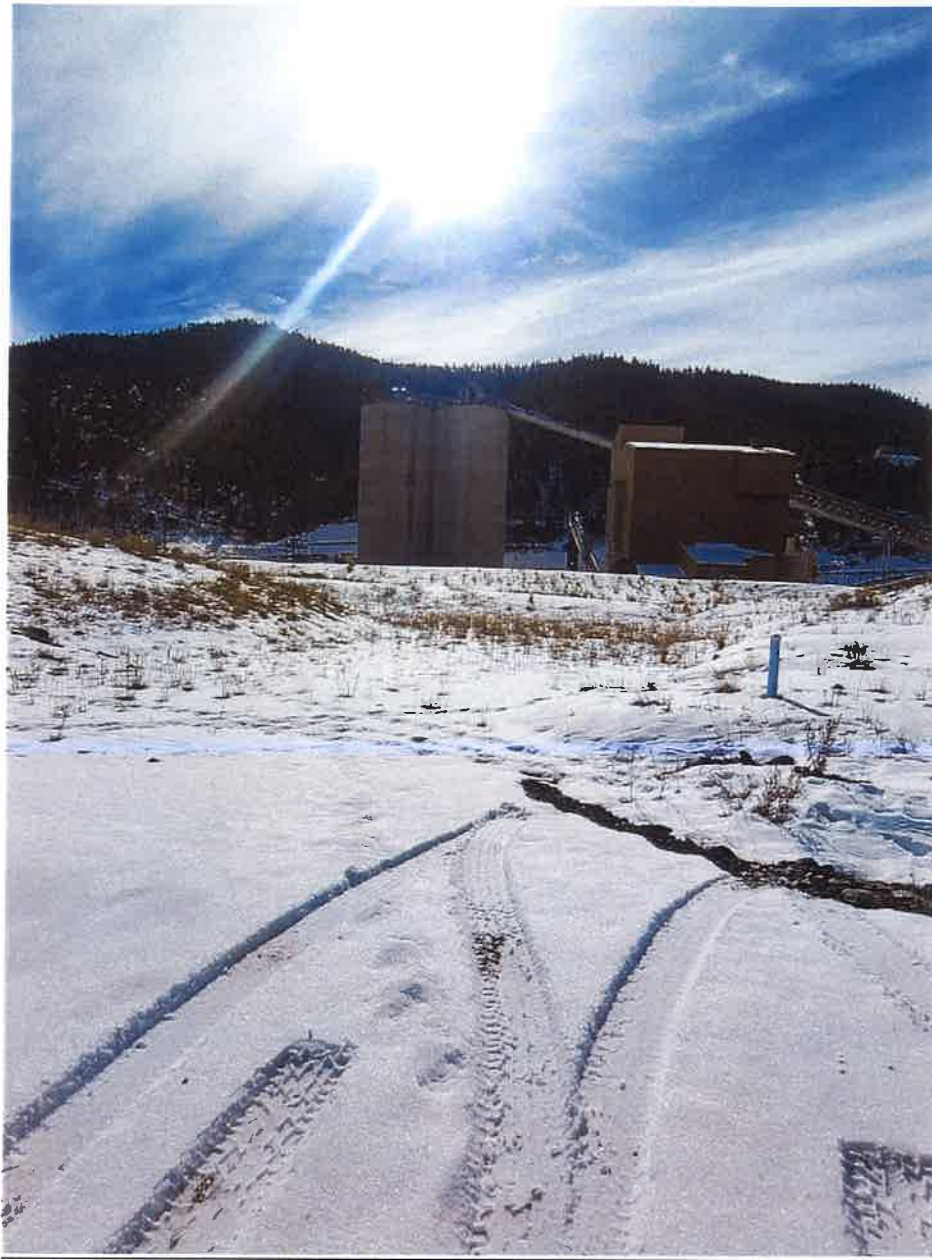
Containment Area was cover with snow at time of inspection.

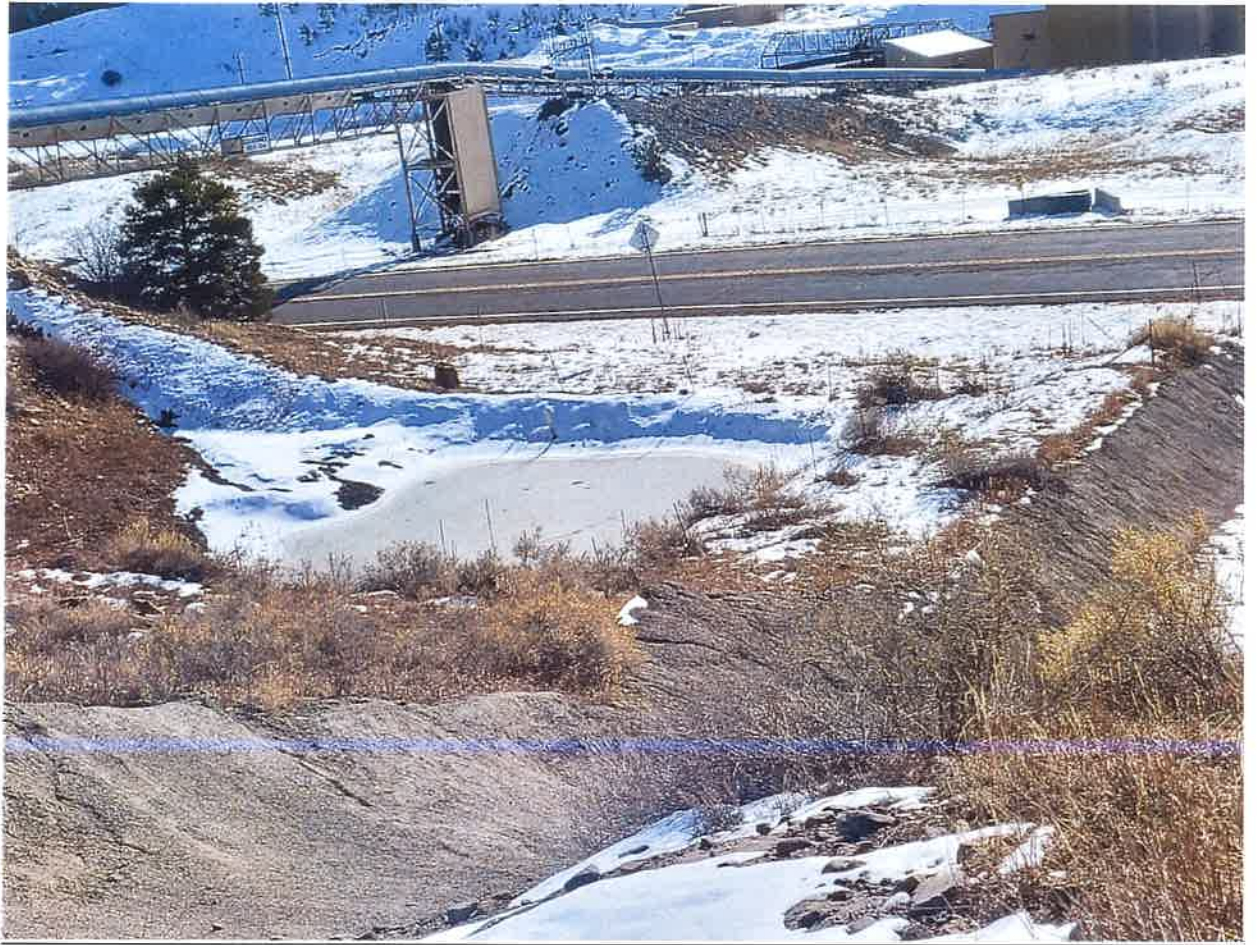
Mine: New Elk Containment #5

Containment Area was holding water and was Frozen over at time of inspection. It was cleaned in 2022 and will need to be cleaned of sediment in the coming months.

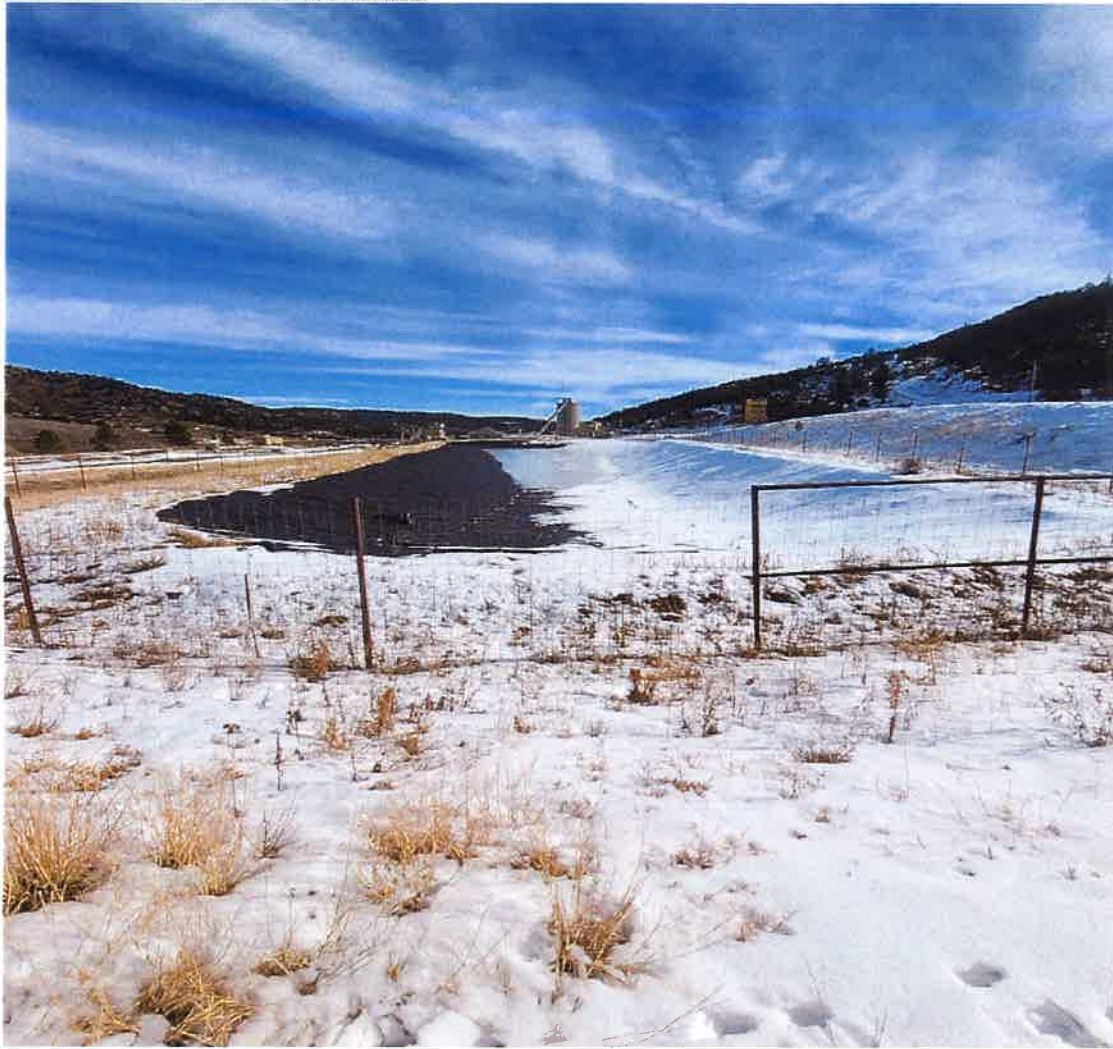
Pond liner is in good working condition at time of inspection. Pond was holding water and was frozen at time of inspection. No issues observed.

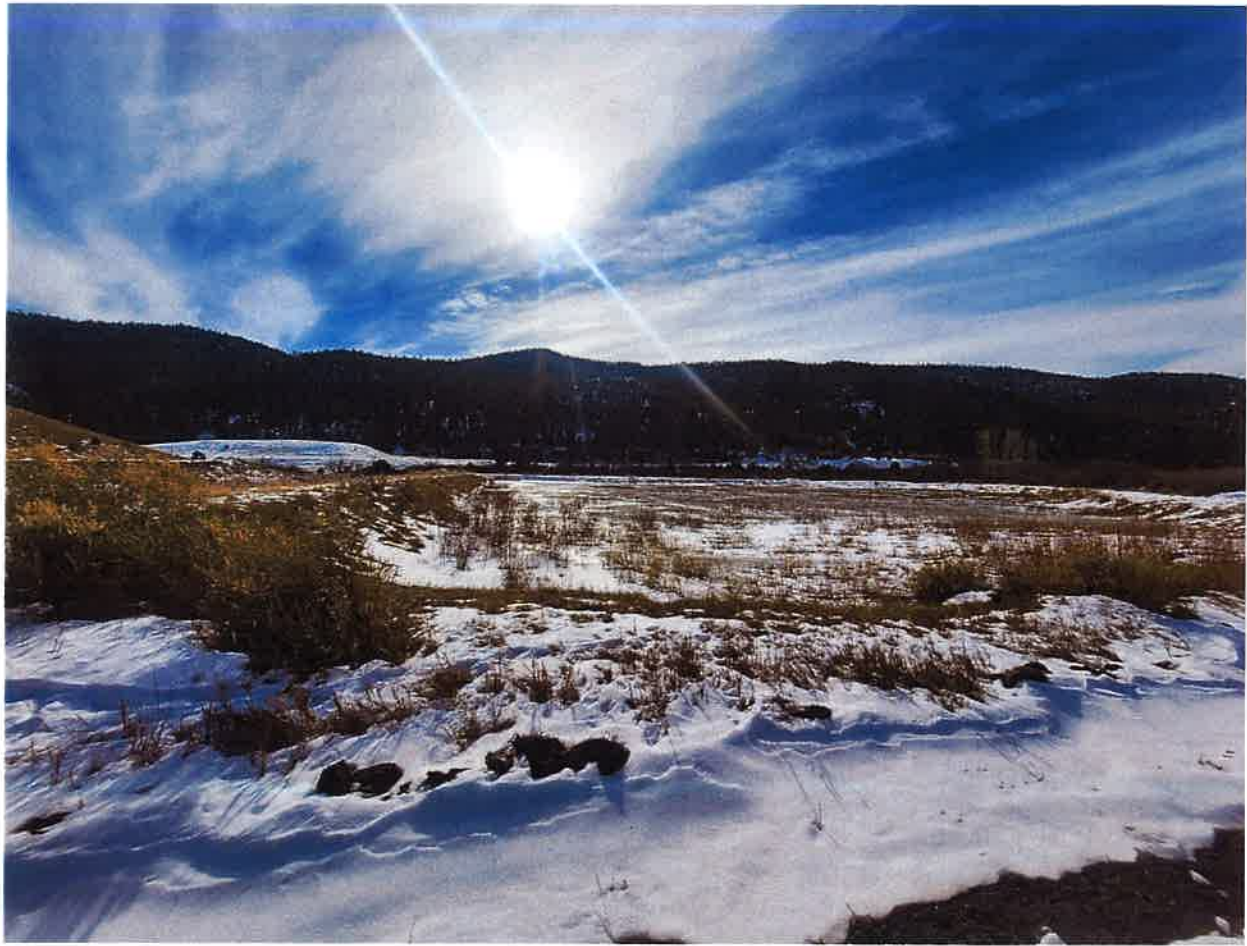
NPDES ID. No.: Pond #4

Pond was holding water and was frozen over at the time of inspection, not near the discharge level. No issues observed. Water has been pumped into the pond recently from pond 7 and pond 6.

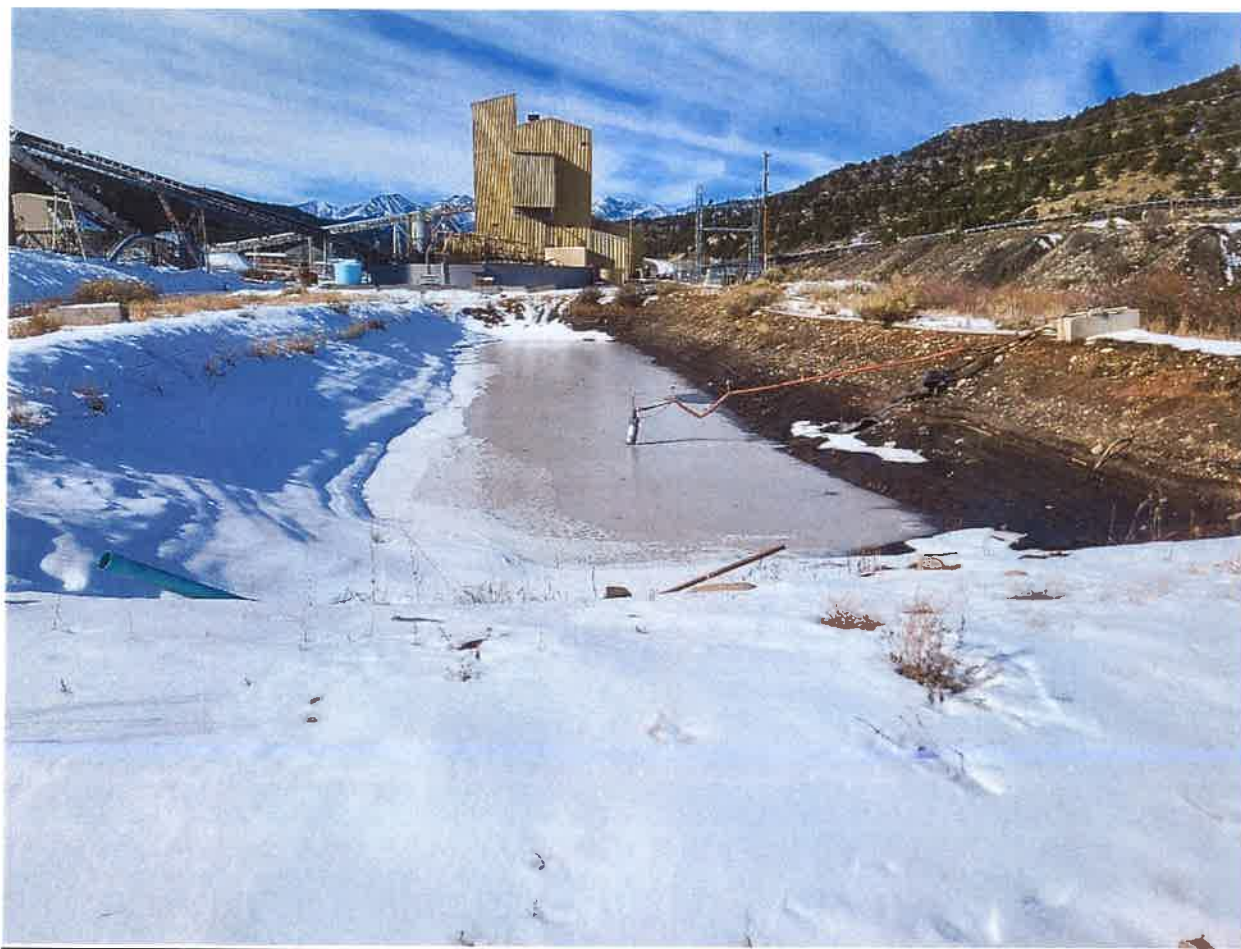
Pond is holding water at time of inspection; Water has been pumped to pond 4.

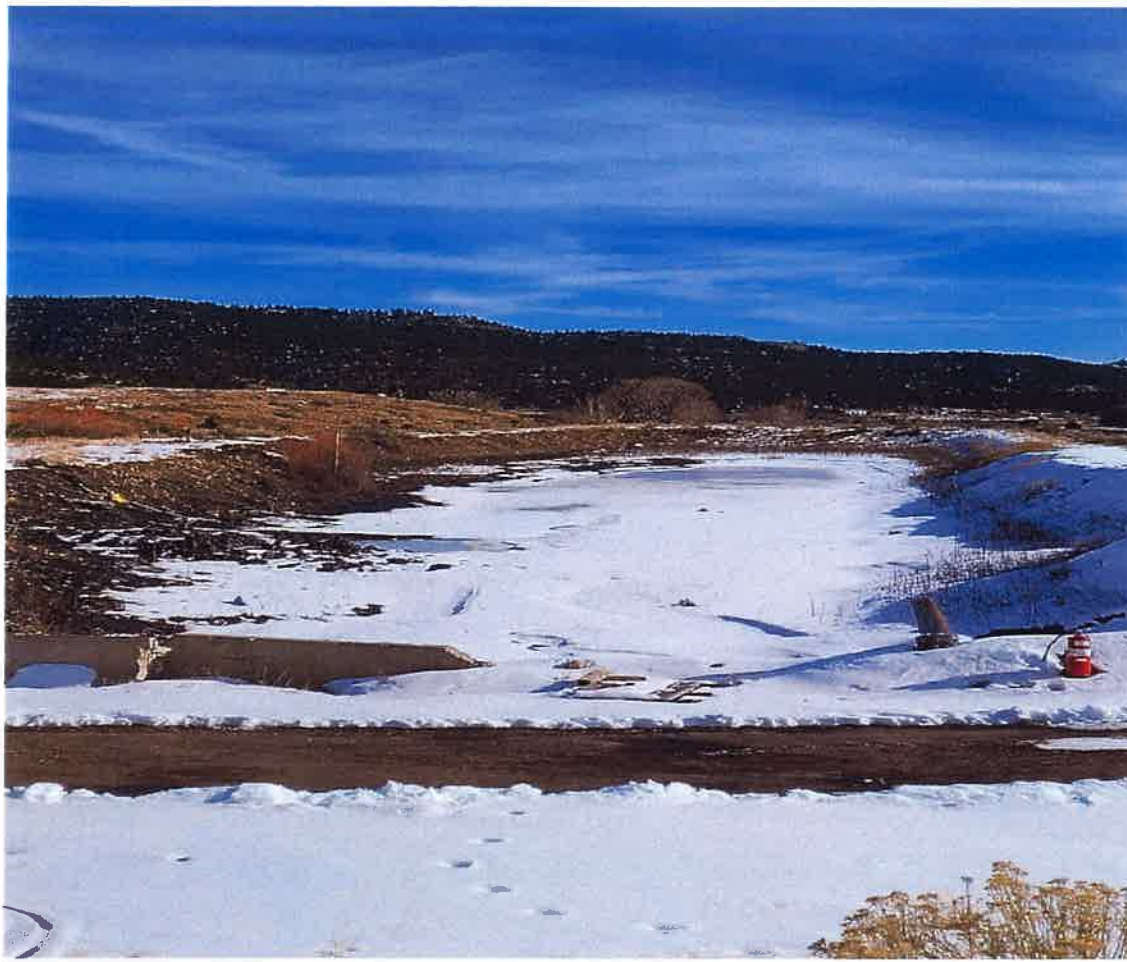
NPDES ID. No.: Pond #7

Pond is holding water and frozen at time of inspection, water has been pumped to pond 4. No issues observed. No discharges have occurred.

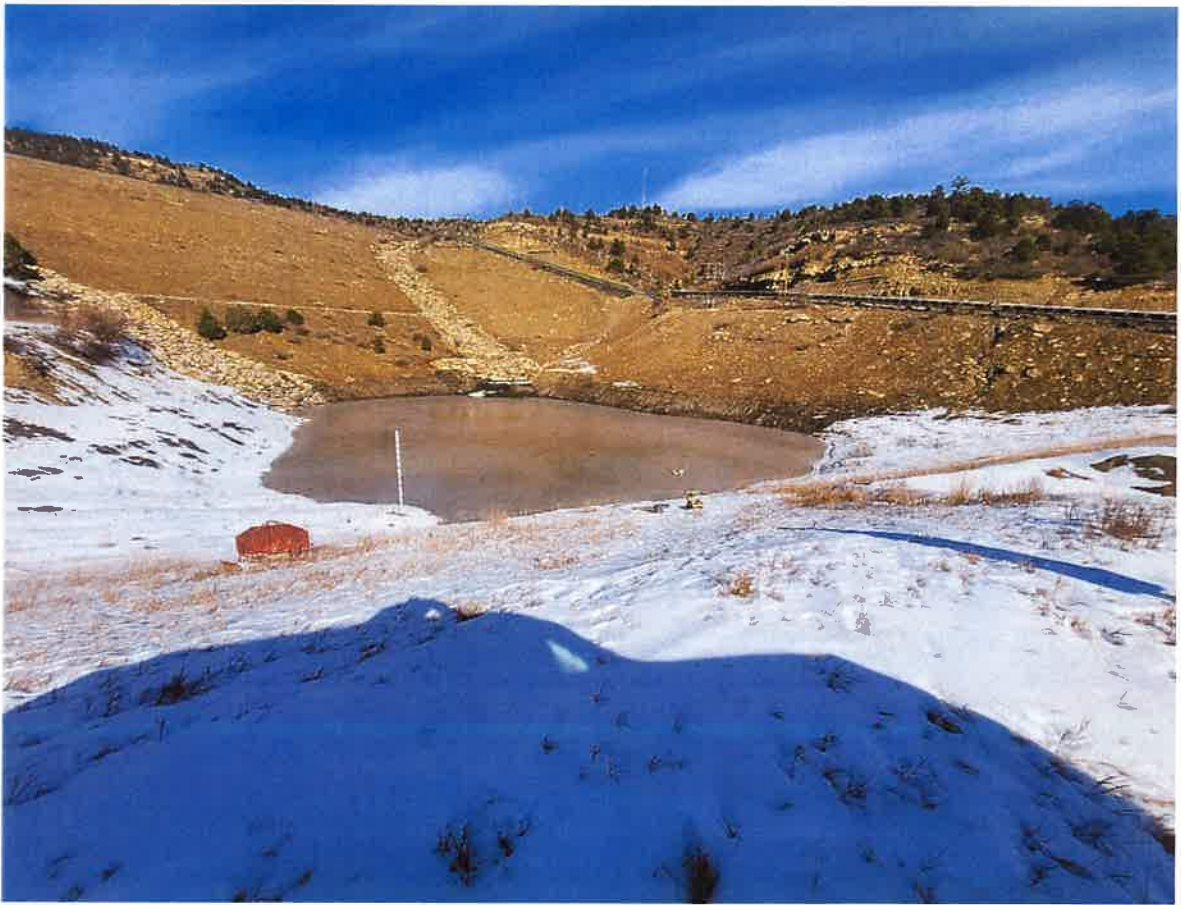
Pond is holding water and is frozen over. It has been pumped down. The water level is now about 2 to 3 feet below the measuring device and has more than the design compacity. No discharges have occurred and No issues were found during the inspection.
