**NEW ELK MINE**  
**Permit No. C-1981-012**

**QUARTERLY COAL WASTE BANK INSPECTION REPORT**  
**December 18, 2023**

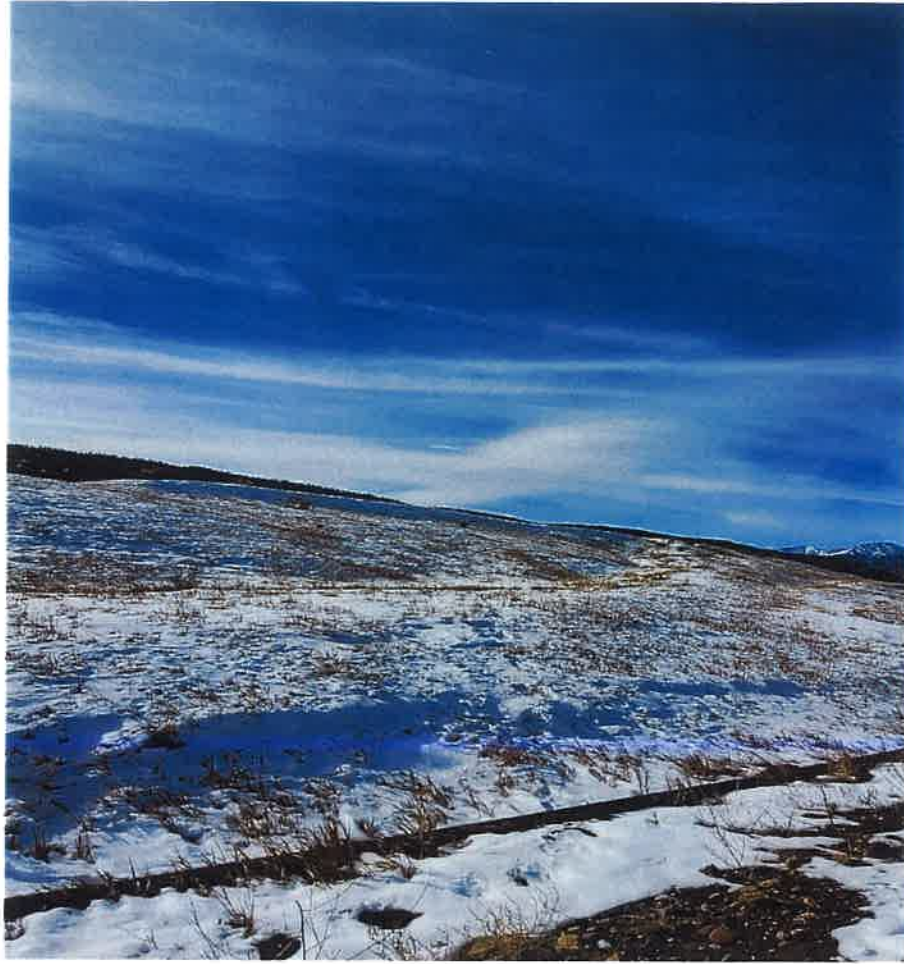
**DWDA #1 North Face**

Surface and out slopes of the pile were inspected for visible signs of potential failure or instability. None were observed.

Overall the disposal area is in good condition.

Ditch along base of DWDA 1 has been cleaned from the South West Corner around the western face to allow for positive drainage around the area and into Pond 4.

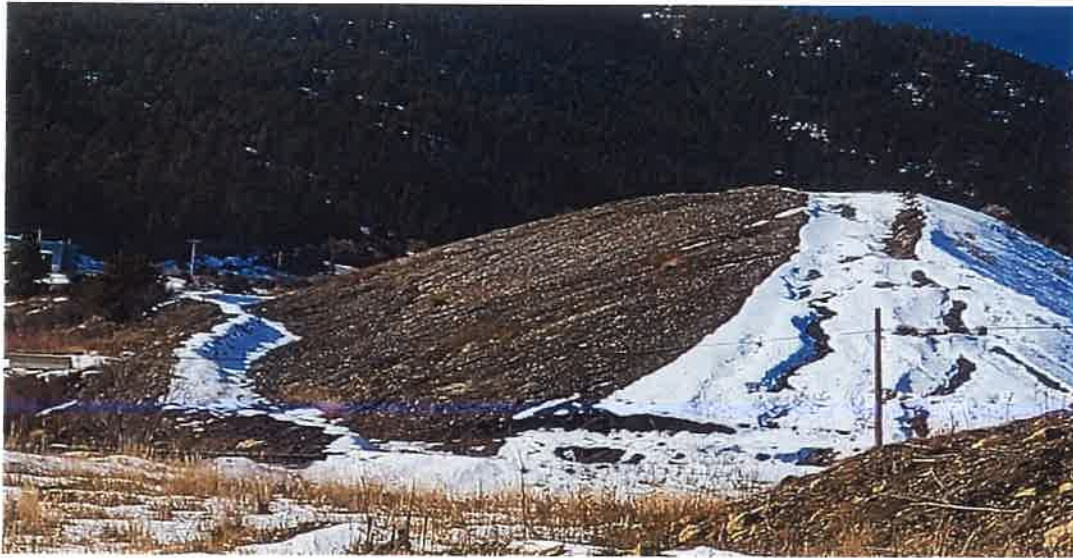
**DWDA #2 South Face**

Surface and out slopes of the pile were inspected for visible signs of potential failure or instability. There was some surface erosion but not enough to make the area unstable. In all no signs of failure or instability were observed.

Overall the disposal area is in good condition. The sign with the name of the area was recently replaced.

The Rills are being monitored and have not gotten any bigger and there is no sediment loading. Operator is evaluating either reclamation of the area or permitting alternative uses of the land north of the Purgatoire River and south of Highway 12. The ditch along the southern face has been cleaned and the berm between DWDA #2 and the river has been reinforced to prevent any run off to reach the river.

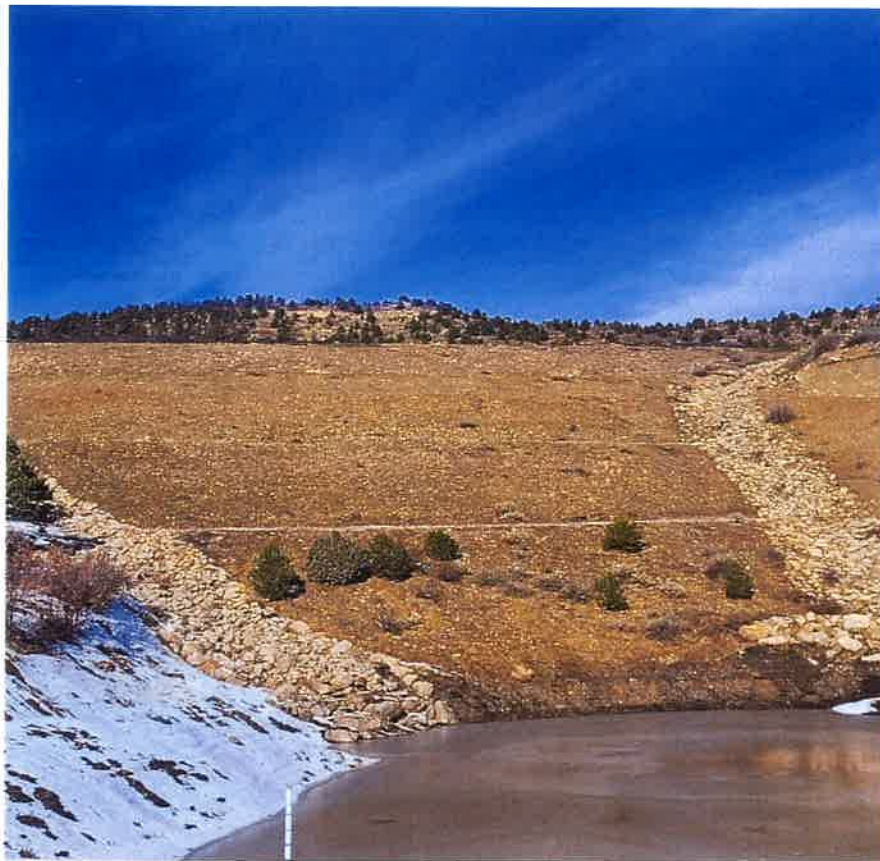
**Face of Refuse Disposal Area**

Overall the site is in good condition.

Work on the Clean Water Ditch above the RDA Area is in progress. Cleaning of the ditch to help prevent the clean water to flow on the RDA Area.
