**LORENCITO CANYON MINE**  
**Permit No. C-1996-084**

**INSPECTION OF EXCESS SPOIL-FILLS 7, 8, & 9**  
**December 15, 2023**

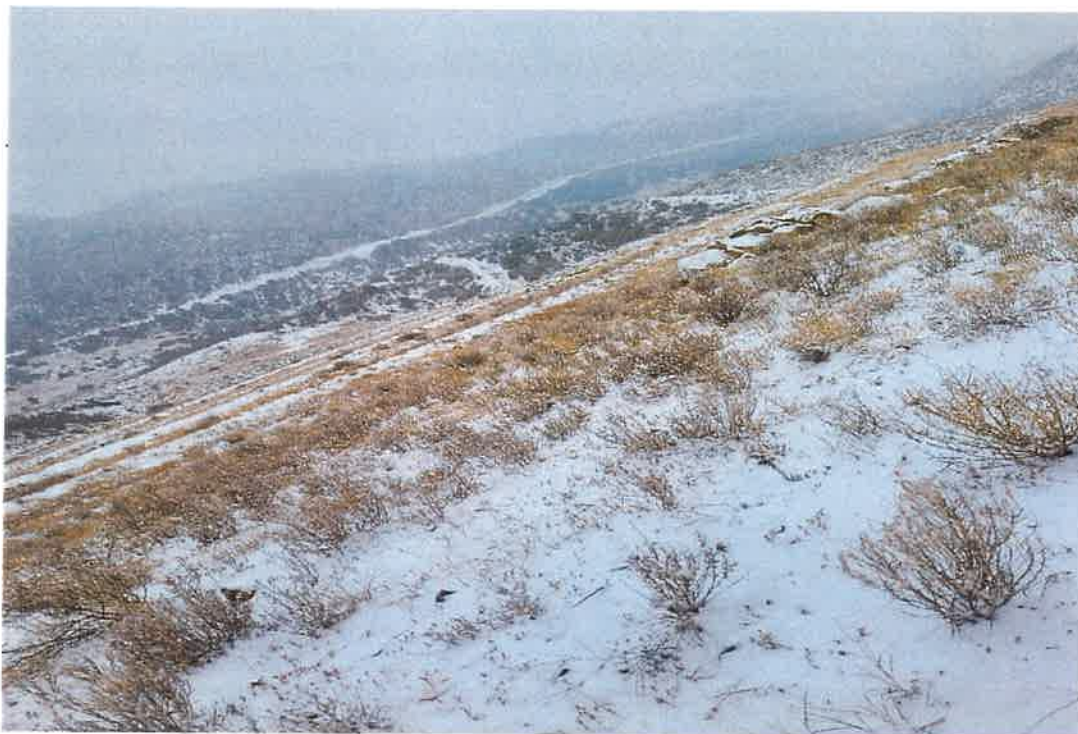
**Fill #7**

The entire excess spoil fill facility was examined for signs of failure and instability such as tension cracks, ground movement, springs and seeps, and standing water. There was no indication of potential instability at time of inspection.

East armored down drain needs to be monitored and might need a spot that is washed out to be re-armored. All else looks good.

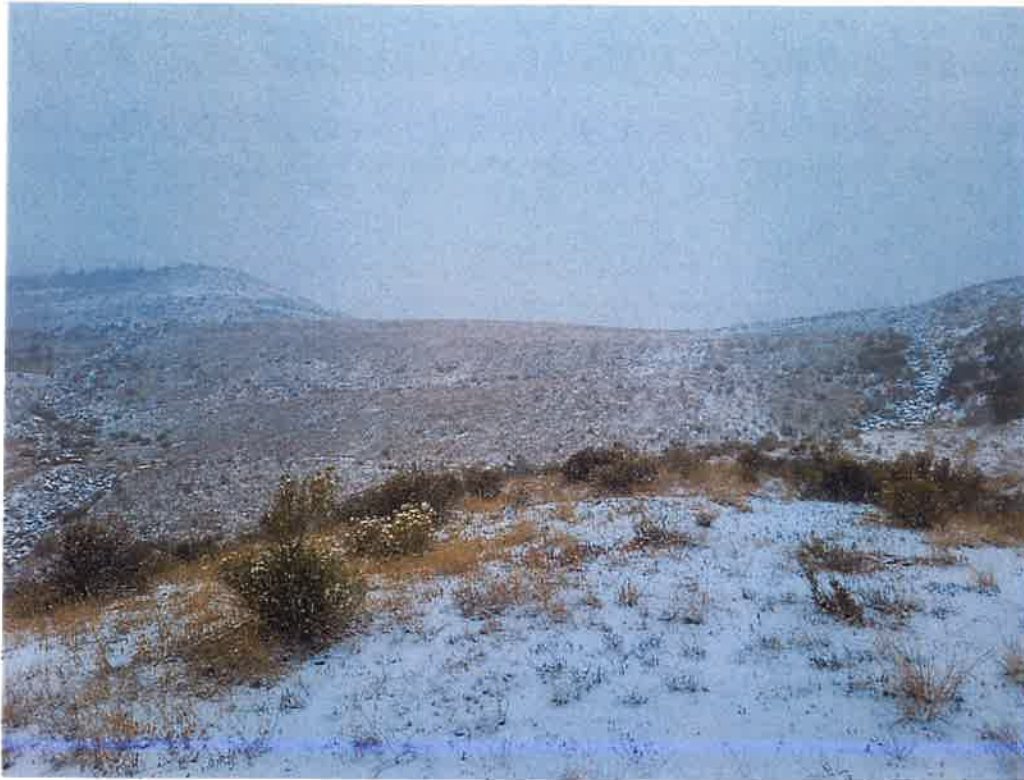
**Fill #8**

The entire excess spoil fill facility was examined for signs of failure and instability such as tension cracks, ground movement, springs and seeps, and standing water. There was no indication of potential instability at time of inspection.

Lower portion of East down drain needs to be monitored and may need additional rock in bare spots. All else is in good condition.

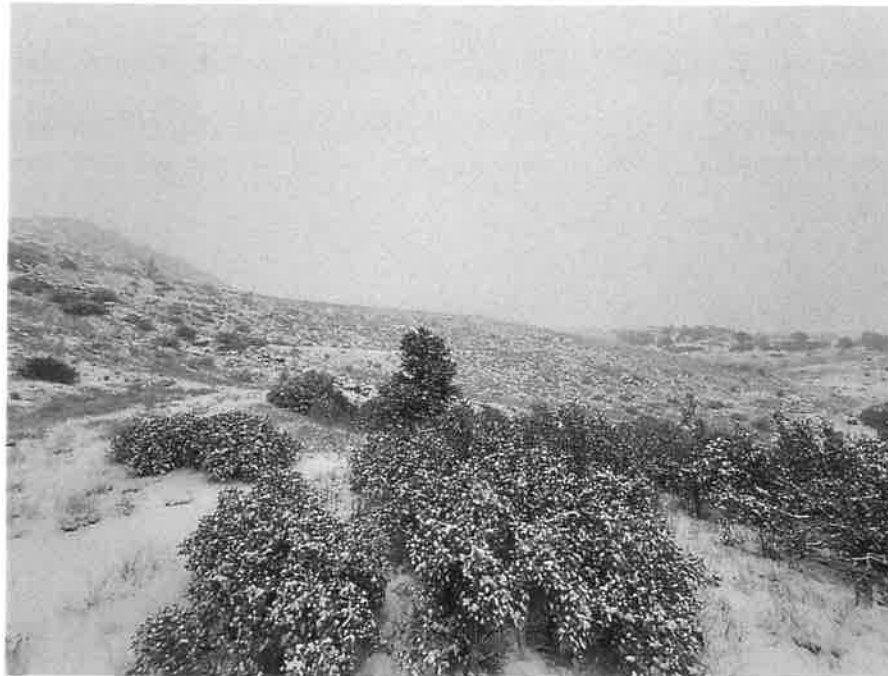
Fill #9

The entire excess spoil fill facility was examined for signs of failure and instability such as tension cracks, ground movement, springs and seeps, and standing water. There was no indication of potential instability at time of inspection.

Overall the site is in good condition.
