## QUARTERLY SEDIMENTATION POND INSPECTION REPORT

CDMR Rule 4.05.9(17)

Mine: Lorencito  
NPDES ID. No.: Pond #6  
Inspection Period: Fourth Quarter 2023  
Inspection Date: 12/13/2023

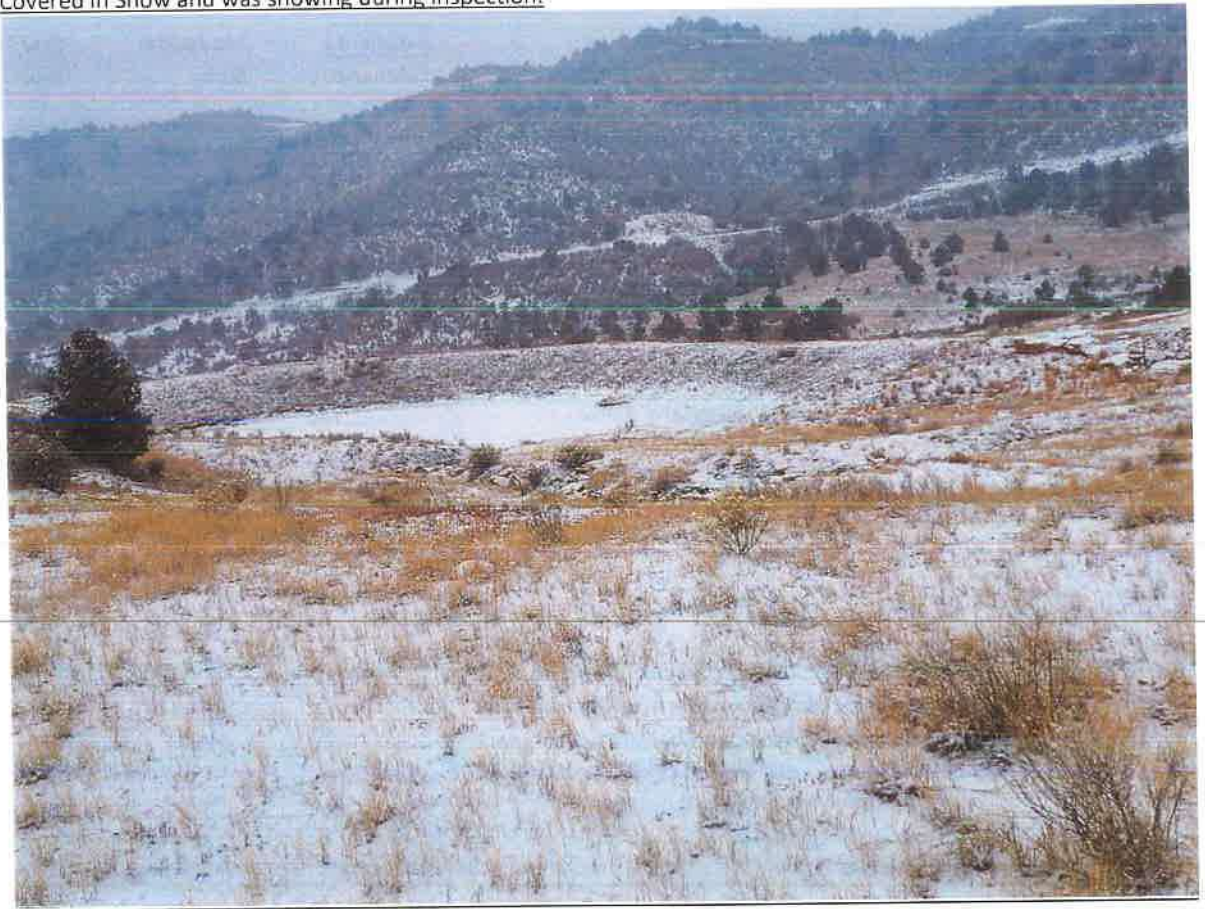
Pond was holding water and was frozen at time of inspection, not near the bottom of the decant. Ground Covered in Snow and was snowing during inspection.

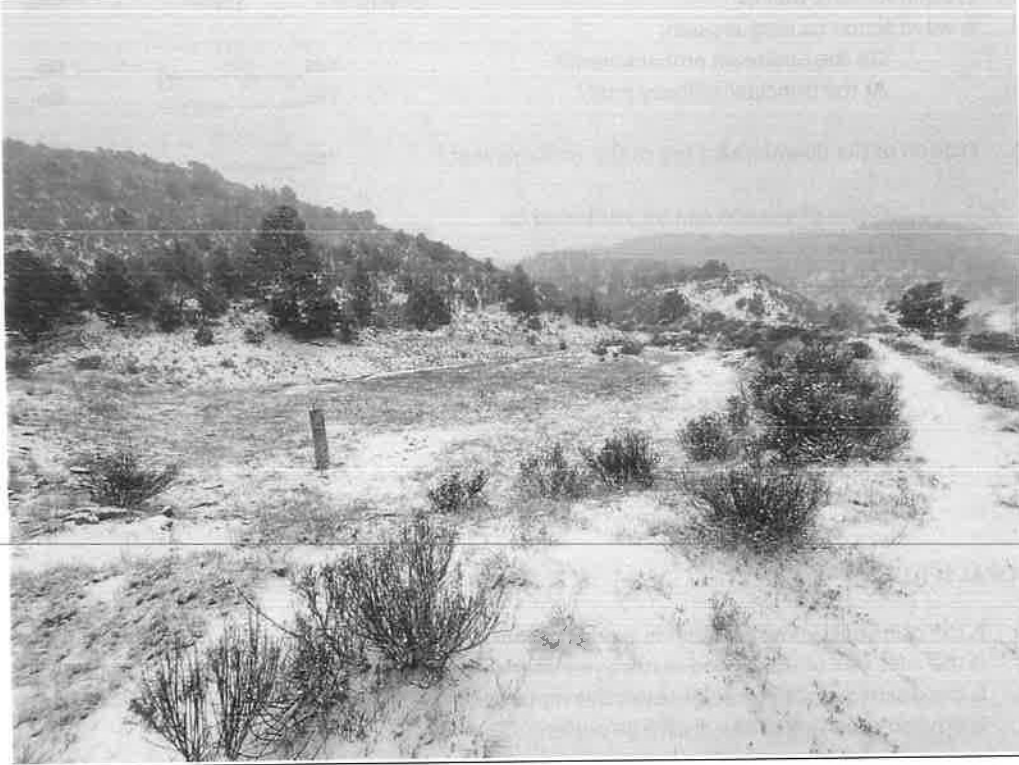
Pond was empty at time of inspection. Ground Covered in Snow and was snowing during inspection.

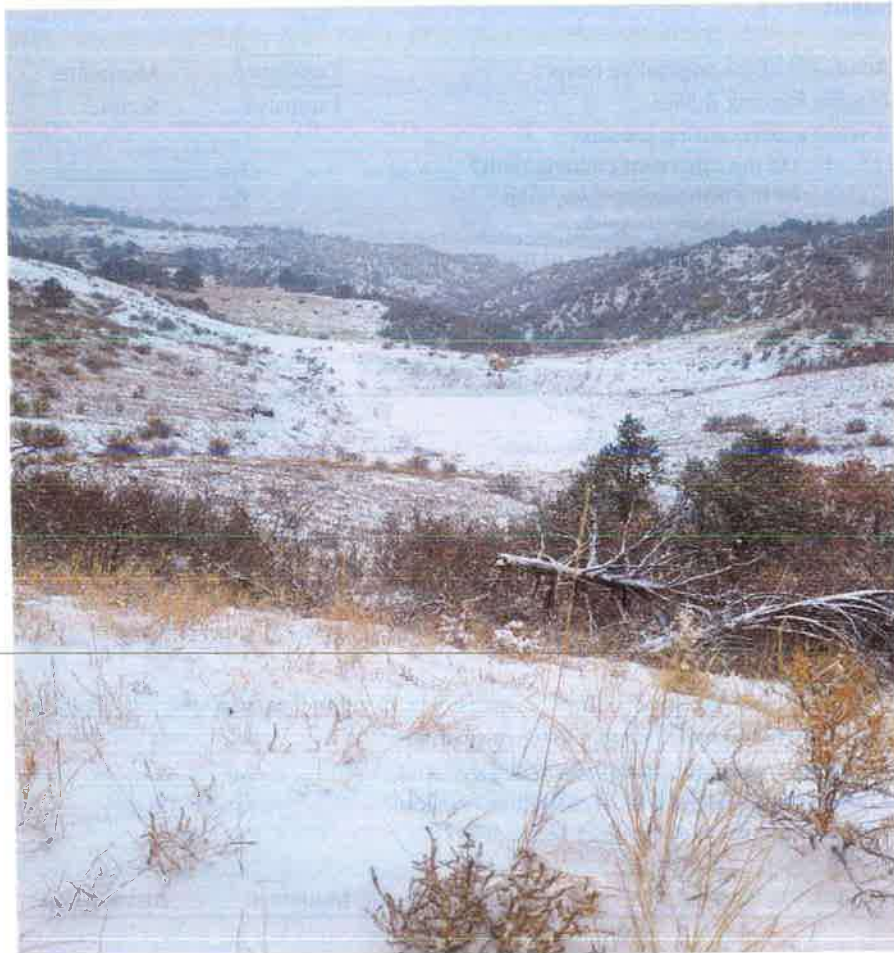
Pond was holding some water and was Frozen at time of inspection. Not near the level of the decant. Ground Covered in Snow and was snowing during inspection.

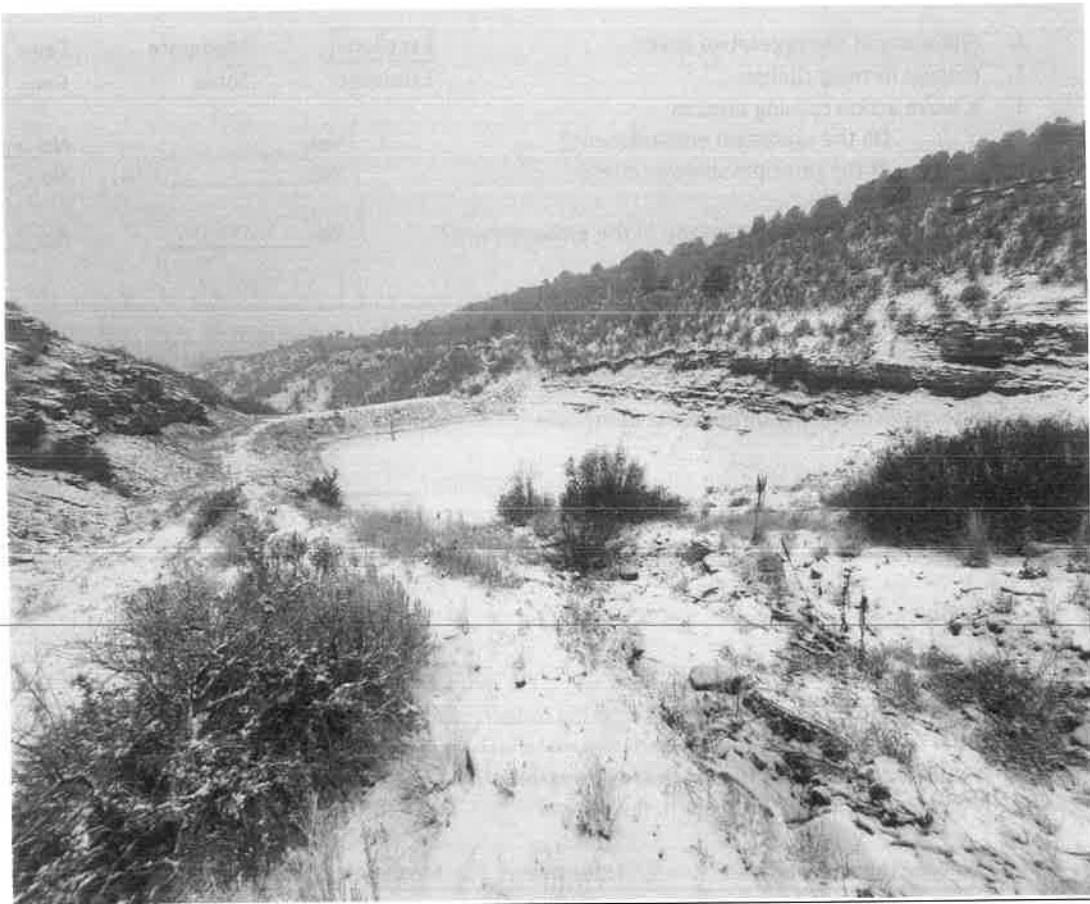
Pond was holding water and was frozen at the time of inspection. Appears to have not discharged recently. Ground Covered in Snow and was snowing during inspection.

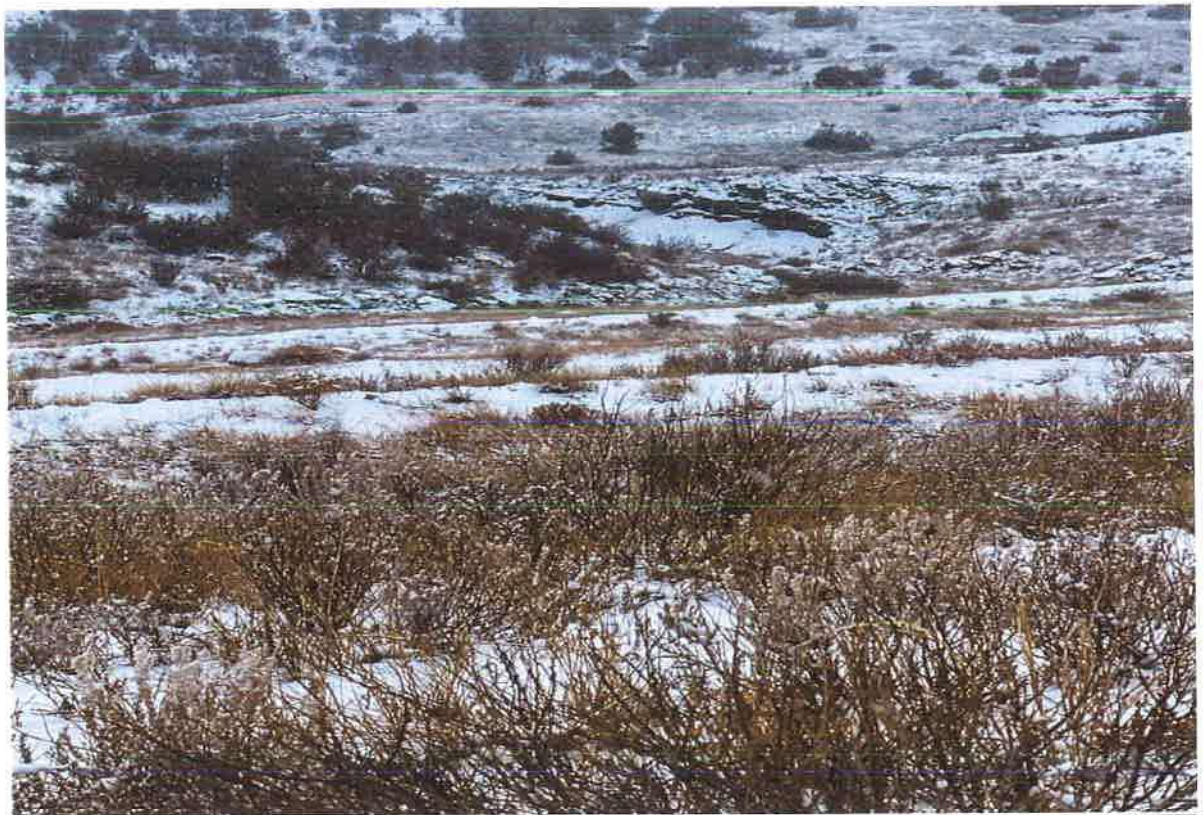
Pond was holding a small amount of water and was frozen at time of inspection. Not discharging. Ground Covered in Snow and was snowing during inspection.

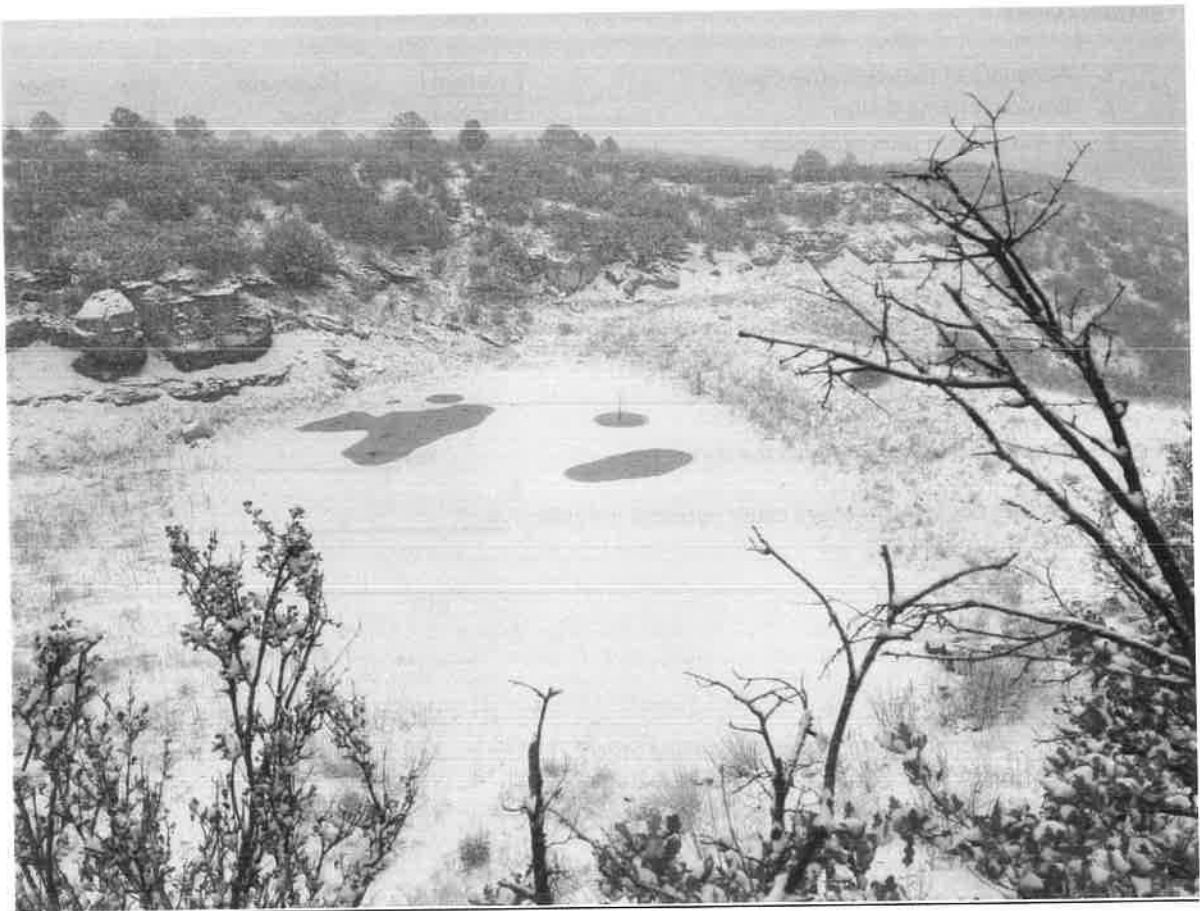
Pond was holding water and was frozen at time of inspection. Does not appear to have recently discharged. Ground Covered in Snow and was snowing during inspection.
