MINERALS PROGRAM INSPECTION REPORT
PHONE: (303) 866-3567

MINE NAME: Peak View Pit	MINE/PROSPECTING ID#: M-2014-028	MINERAL: Sand and gravel	COUNTY: Huerfano
INSPECTION TYPE: Monitoring	WEATHER: Clear	INSP. DATE: December 12, 2023	INSP. TIME: 10:45
OPERATOR: Huerfano County	OPERATOR REPRESENTATIVE: None	TYPE OF OPERATION: 112c - Construction Regular Operation

INSPECTION TOPIC: Gen. Compliance With Mine Plan

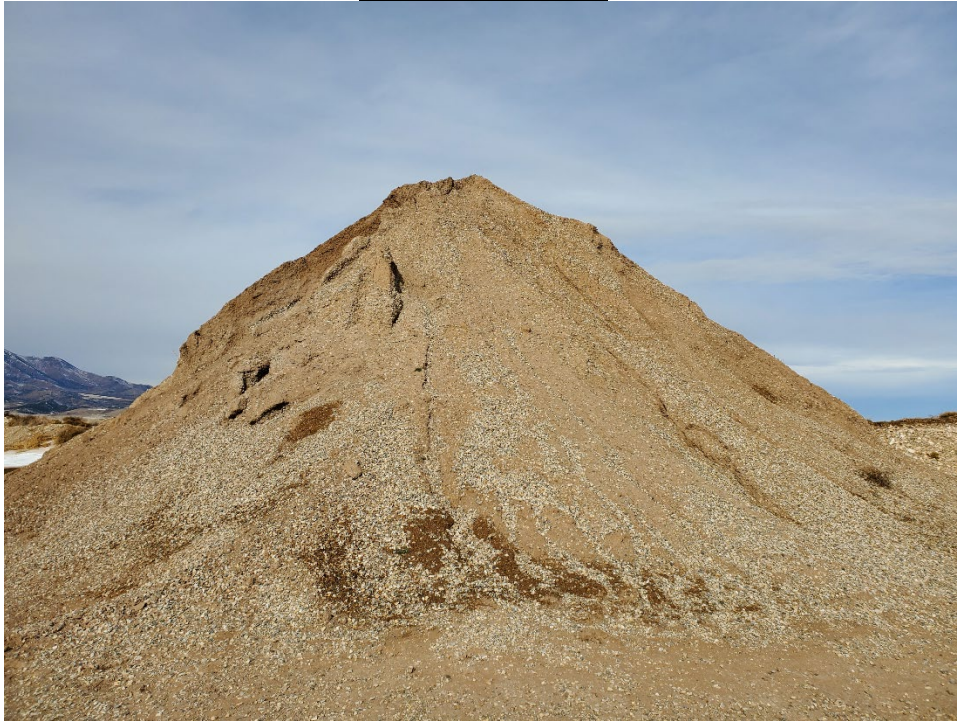
The Peak View Pit is a phased operation composed of three Phases. The Phases move from east to west, with Phase 1 encompassing about 12 acres, Phase 2 about 14.8 acres, and Phase 3 about 10 acres. Mining began in the north-east corner and is progressing to the west. Processing is done on-site in the north east portion of the pit, with the use of portable equipment. There was no equipment observed on-site at the time of the inspection. A large product stockpile was observed on-site (Photo 1: Map 1). There was also some remnant material/debris located near the pit entrance (Photo 2).

Photo 1: Looking north at a product stockpile.

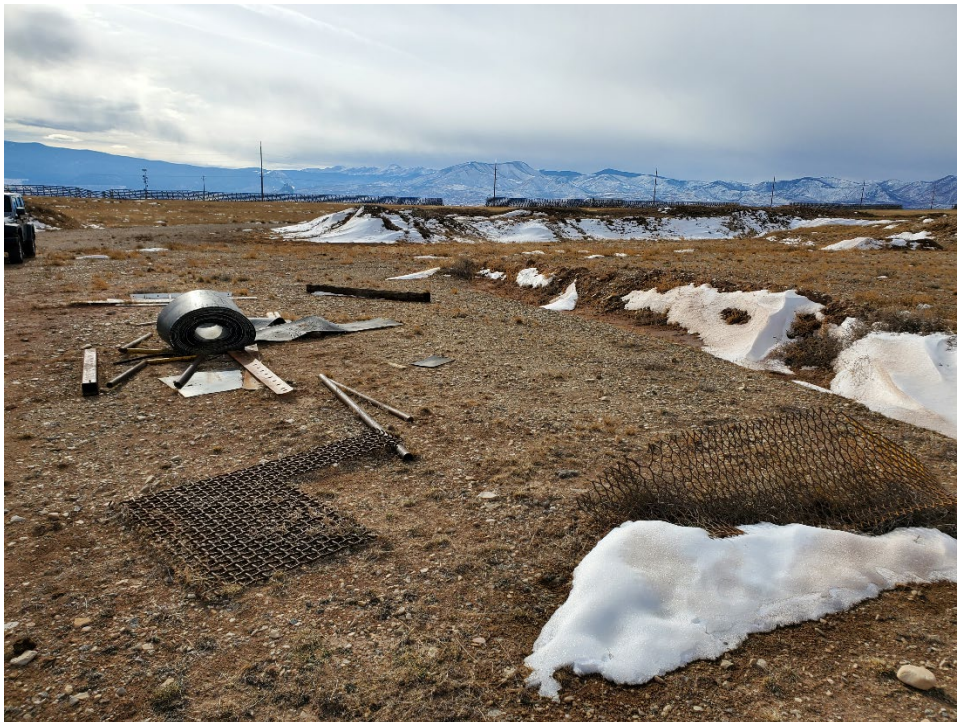
Photo 2: Looking south-west at debris onsite. Debris includes pieces of a screener, conveyor belt, wood planks etc.

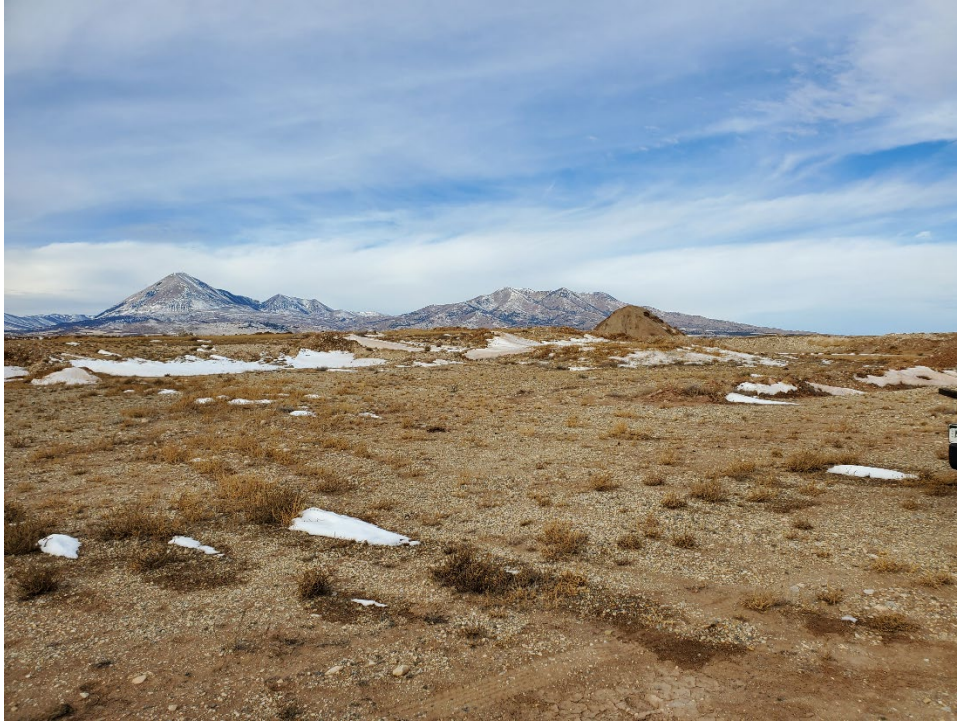
The Division walked the perimeter of disturbance around the pit (excluding the portion of the access road that lay further west than the western pit boundary) and logged it using Esri Field Maps (Photos 3-10: Map 1). The disturbance boundary is shown as a purple polygon on Map 1. The Division estimates that approximately 14.99 acres have been affected to date (~14.6 acres of disturbance in the pit area and ~0.39 acres of entrance road leading up to the western edge of the pit). The approved reclamation plan states that the maximum disturbance at any time will be 14.8 acres. Because this is the maximum Phased acreage, this likely did not account for the disturbance from the entrance road. Regardless, the plan also states that reclamation will be ongoing as soon as the first phase is deemed to be 'mined-out'. It appears that no reclamation has occurred at this time. Additionally, it appears that both Phase 1 and Phase 2 are currently open. The Division advises beginning reclamation to stay within the planned Phases and maximum disturbance area.

Photo 3: Looking northeast across pit.

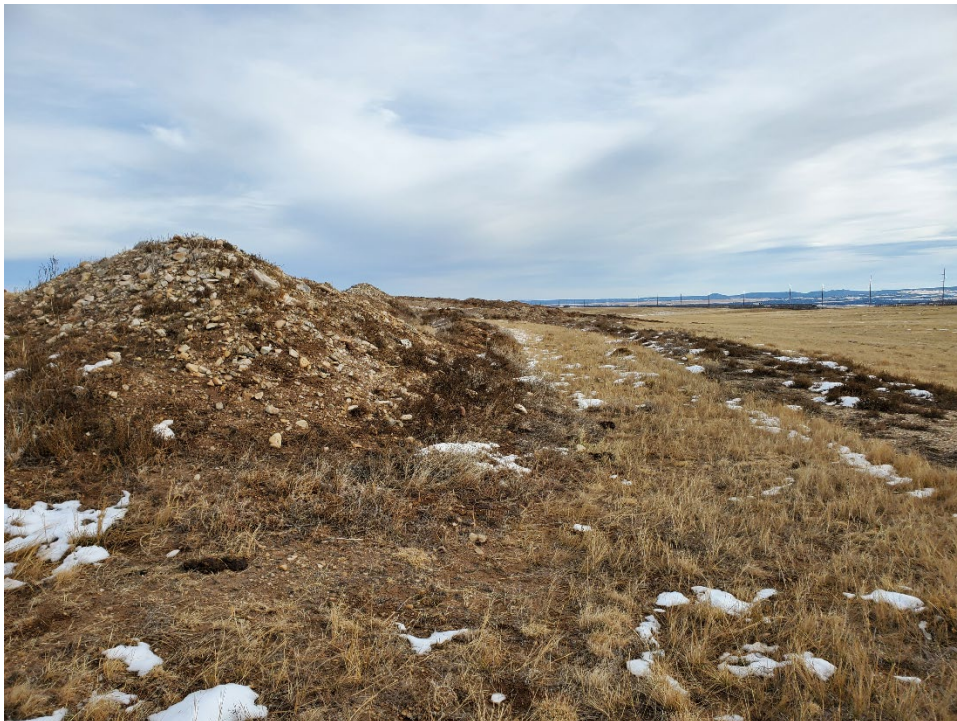
Photo 4: Looking east along southern disturbance boundary.

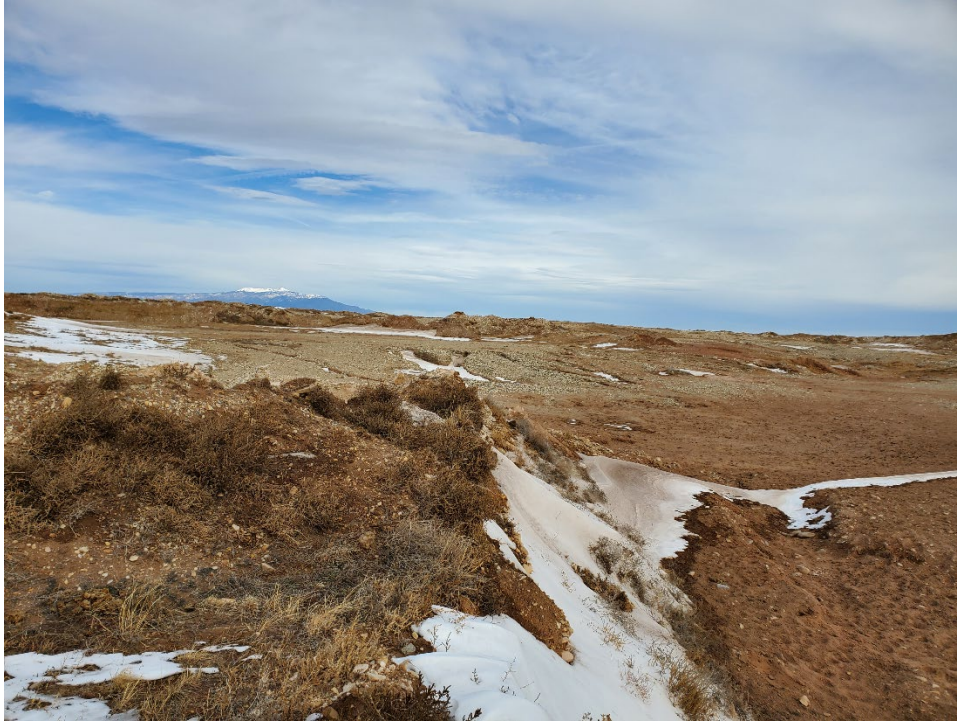
No off-site disturbance due to sediment run-off was observed during the inspection. There was evidence that surface water has run from the center portion of the permit, down to the southern portions, especially in Phase 1 (Photos 5, 18 & 19: Map 1). This run-off within the permit area has caused a few erosion ruts and gullies to form. This has been cited as a problem above for excess erosion. The Operator shall repair and stabilize the pit floor, and provide photos to the Division, by the corrective action date.

Photo 5: Looking northwest across pit.

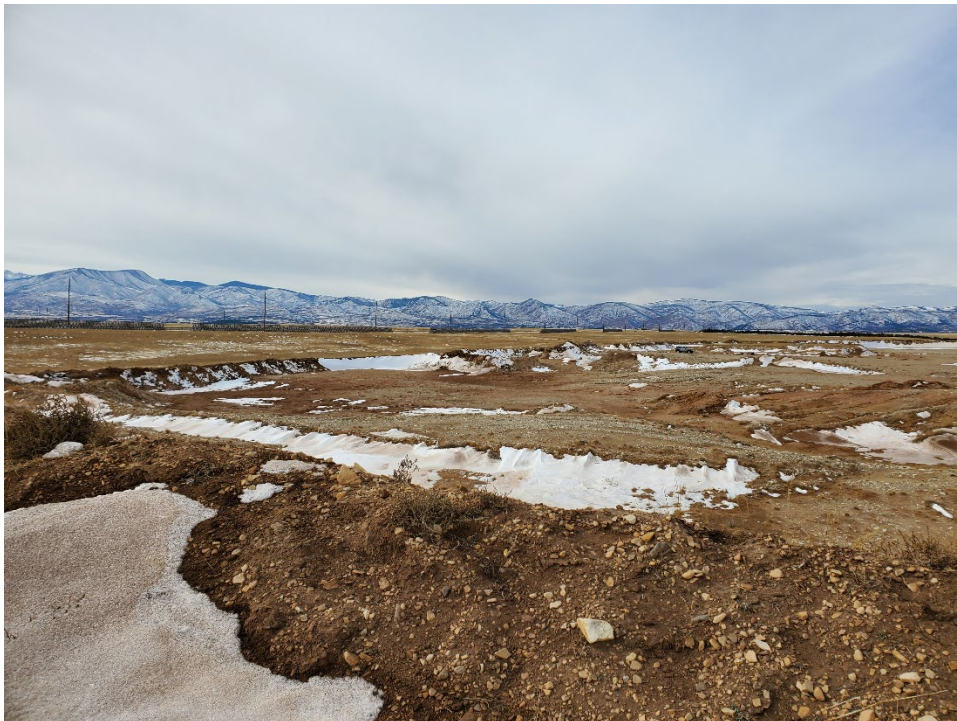
Photo 6: Looking west across the pit from the eastern boundary.

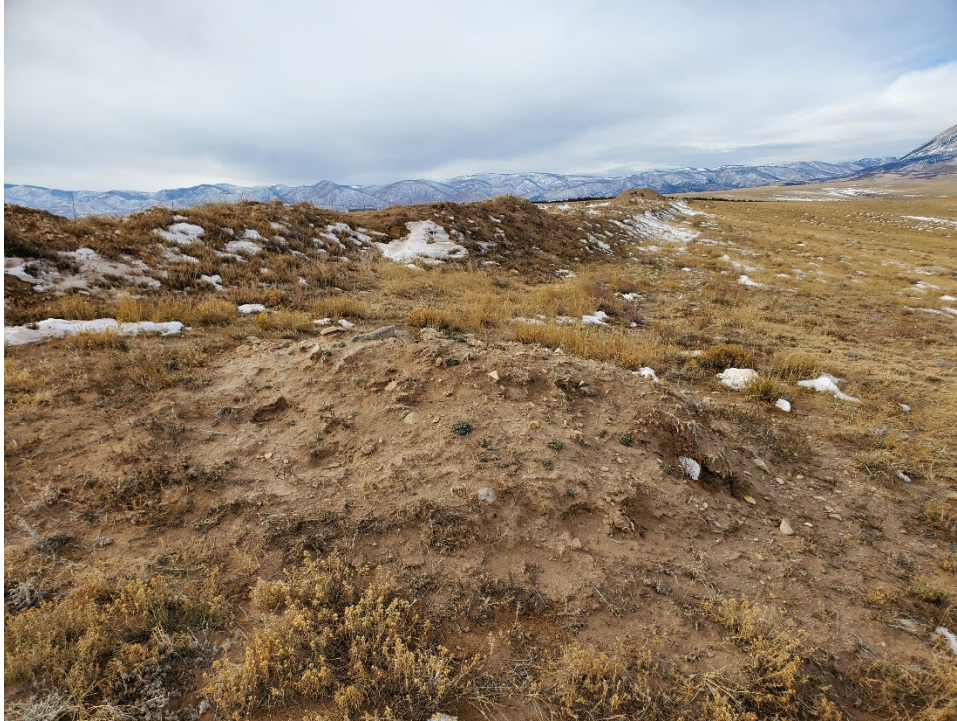
The extent of the disturbance appears to go off-site, in relation to the northern permit boundary, approximately 0.5 acres (Map 1). The off-site disturbance primarily consists of a berm along the perimeter of the pit, a 12 foot wide path, and a smaller berm along the north side of the path (see Photos 7 & 8: Map 1). A possible violation has been cited above for off-site disturbance, located north of the permit boundary. The Division has spoken to the Operator, who agrees that the disturbance extends north of the northern boundary. The Division will bring this matter before the Mined land Reclamation Board ("MLRB") for a hearing for consideration of a possible violation pursuant to C.R.S. 34-32.5-116(4)(i) for failure to protect areas outside of the approved affected land from slides or damages. The schedule and other details for the MLRB hearing will be provided under a separate document to be sent via certified mail to the Operator.

Photo 7: Looking west along the northern disturbance from the north-east corner.

CORRECTIVE ACTIONS: This possible violation will require a hearing before the Mined Land Reclamation Board. The schedule and other details for the MLRB hearing will be provided under a separate document to be sent via certified mail to the Operator.

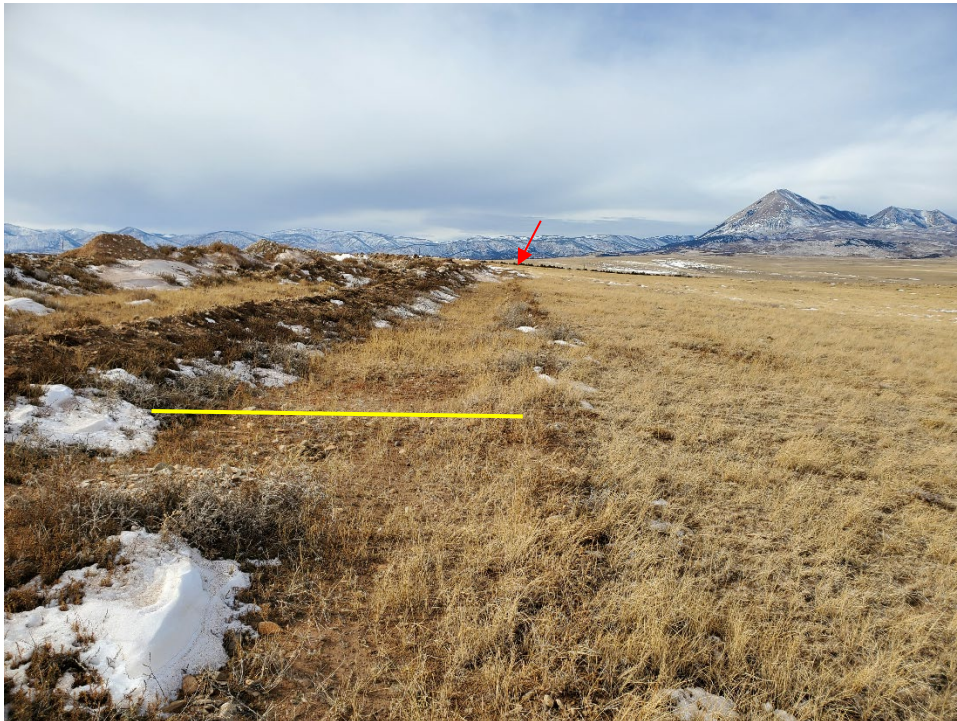
An additional t-post was also observed, located nearly halfway between the northeast and northwest markers. The additional post is located further north than the boundary (Photo 24: Map 1). After speaking to the Operator post inspection, it appears that this may have been mistaken as a permit boundary marker, which led to the off-site disturbance.

Photo 8: Looking west along the northern disturbance. Path from the berm on the left to a small berm on right of photo (yellow line) was measured in the field to be approximately 12 feet wide and extends the majority of the northern disturbance boundary. The red arrow points to the additional t-post's location.

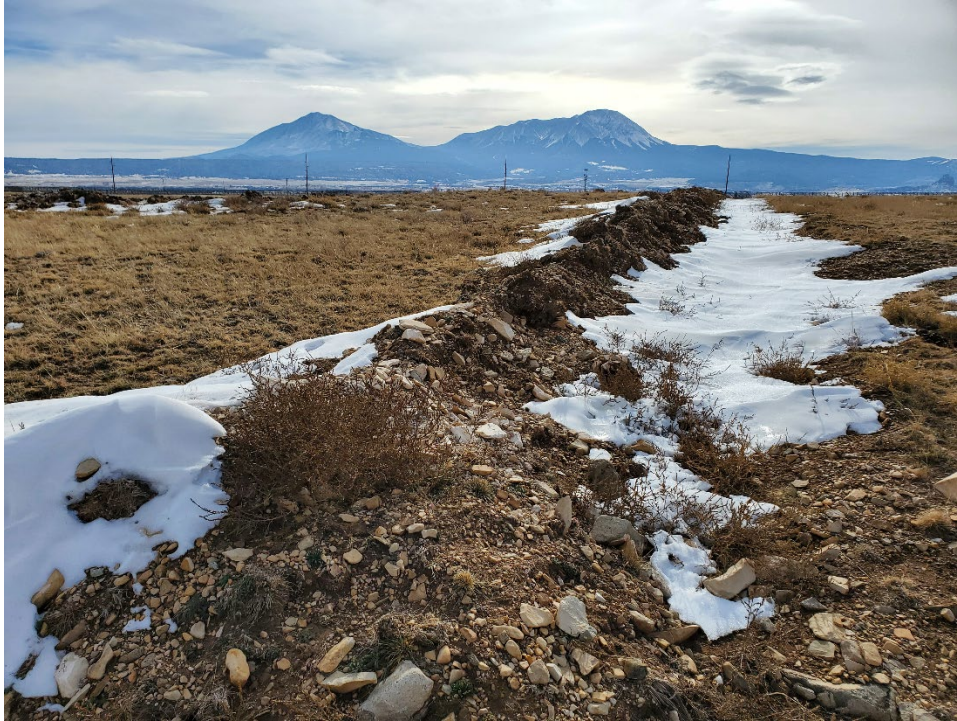
Photo 9: Looking south across western disturbance boundary.

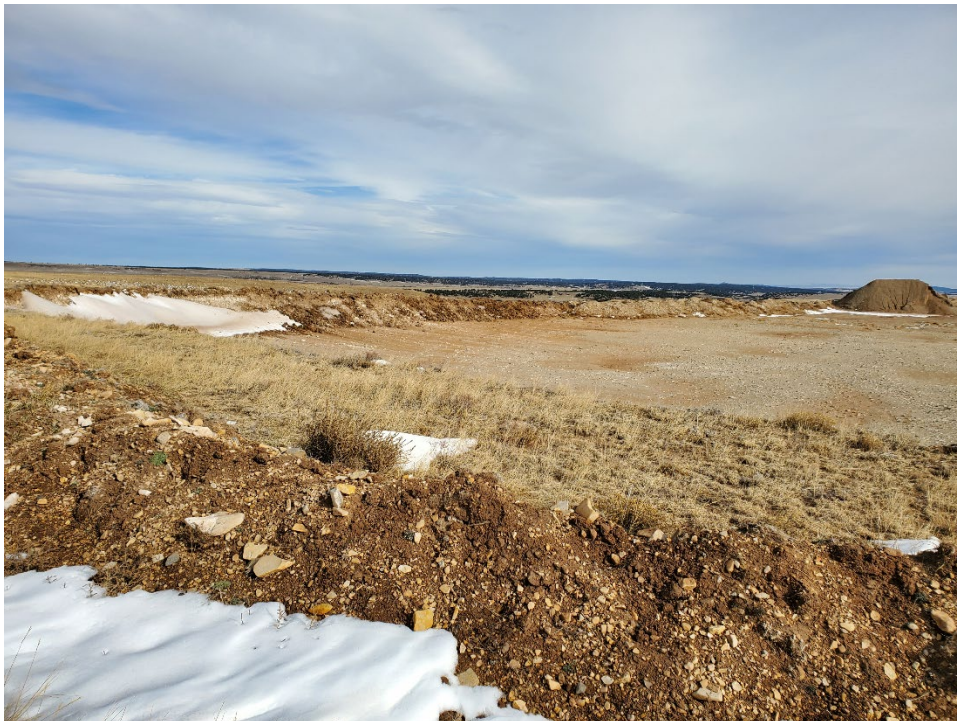
Photo 10: Looking north-east across the pit from the western disturbance boundary.

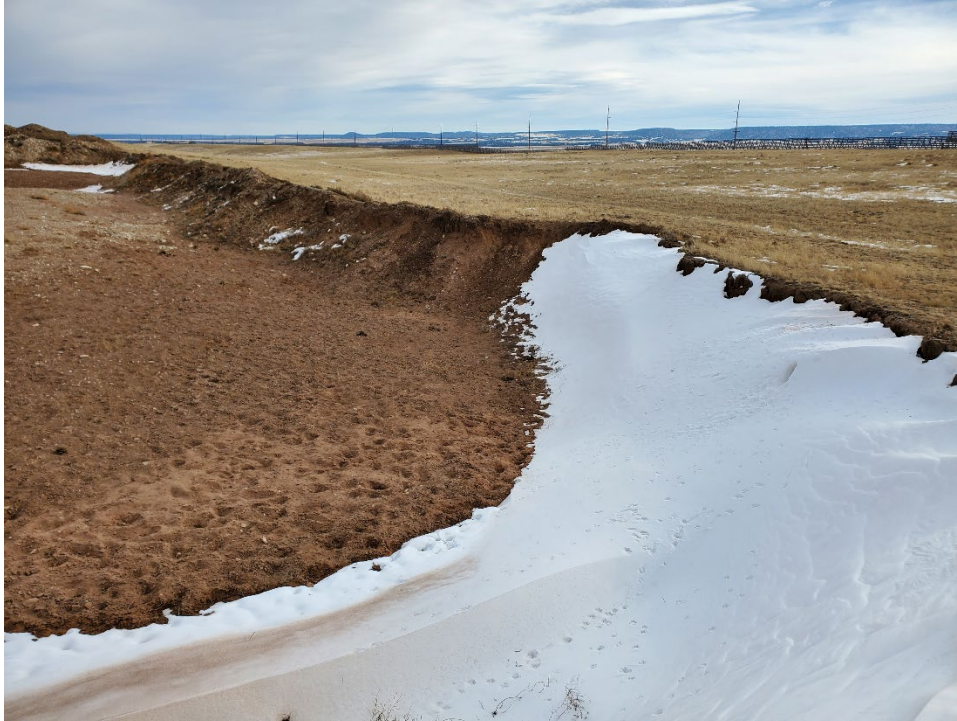
The majority of the highwalls around the pit appear to have been back-sloped to at least a 2H:1V slope (Photos 11-16: Map 1). However, some remain under a 1.5 slope. The most recent highwall, along the western border of the current pit, appears to be near vertical (Photo 17: Map 1). The most recent highwalls are the tallest highwalls on-site, estimated to be about 10 feet tall. The mining plan states that mining will be done at a 3H:1V slope and the reclamation plan explicitly states that there will be no highwalls at the pit (see excerpts below, ordered respectively).

Photo 11: Looking south-east from near the south-west corner of the disturbance boundary. Back-sloped highwalls.

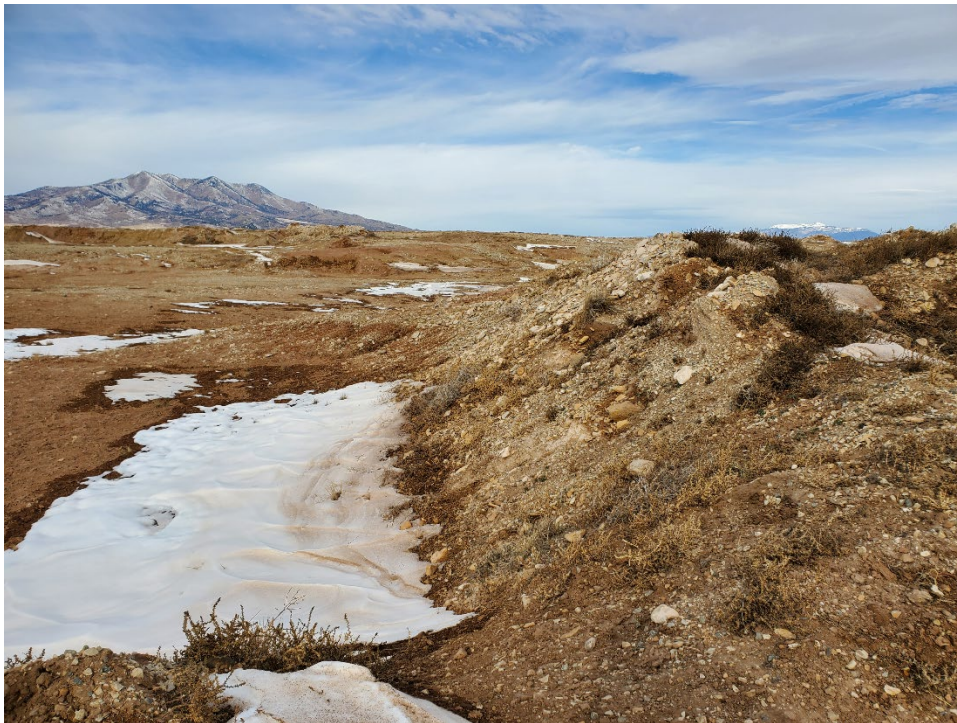
Photo 12: Looking north across pit at some back-sloped highwalls.

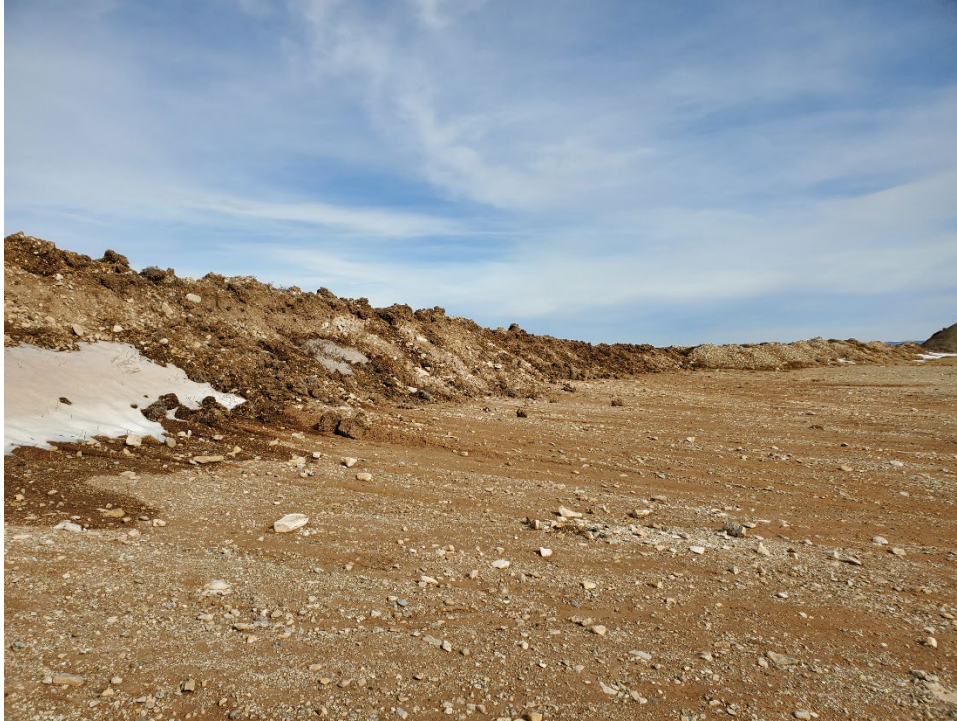
Photo 13: Back-sloped highwalls.

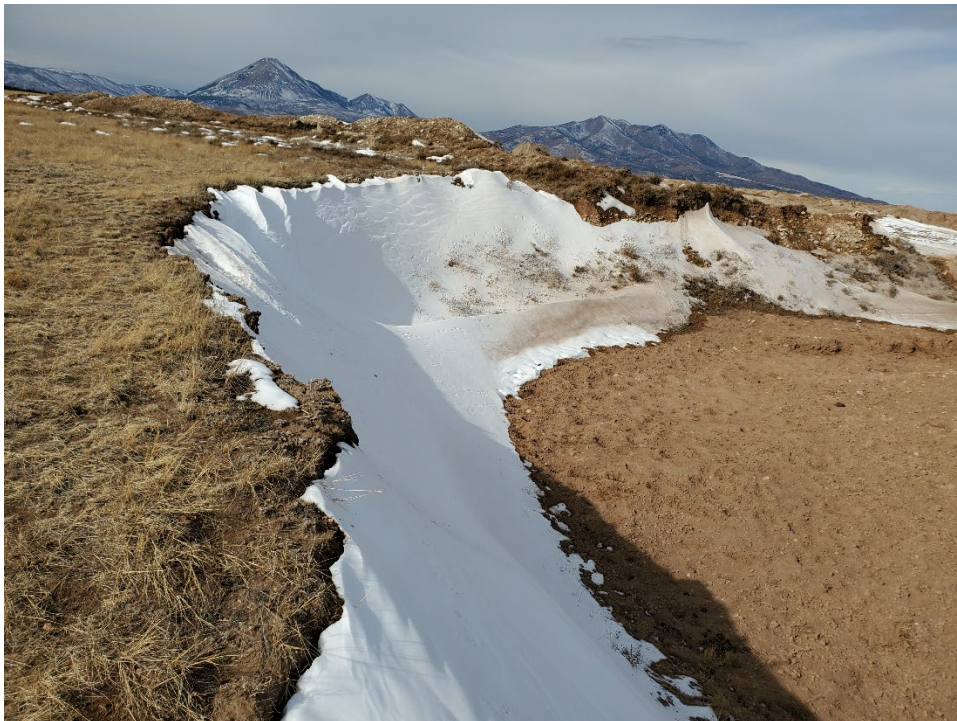
Photo 14: Back-sloped highwalls.

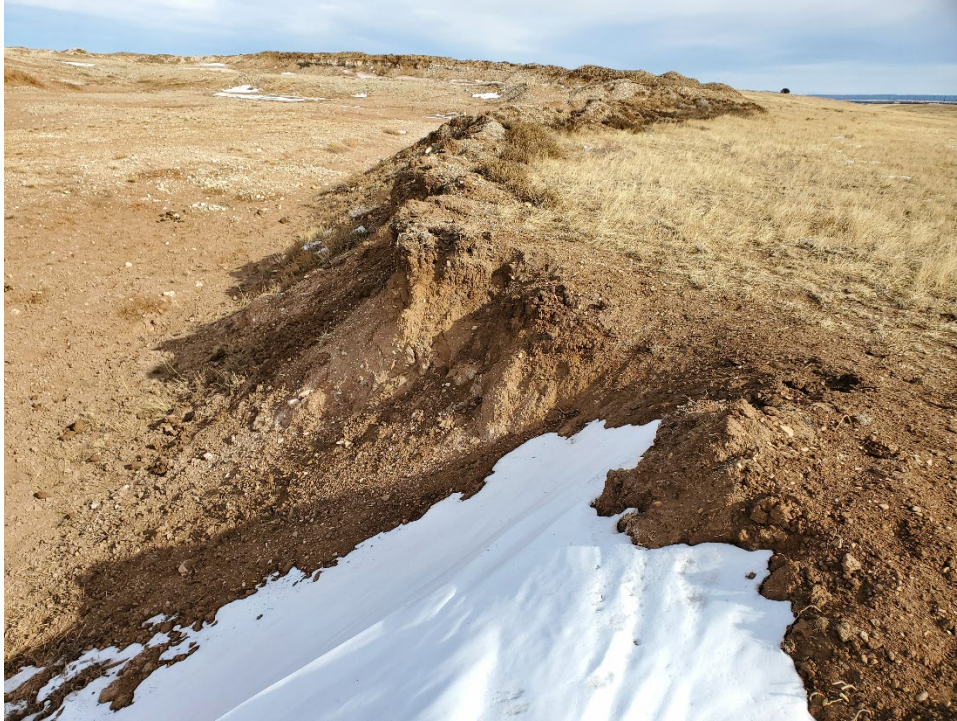
Photo 15: Back-sloped highwalls

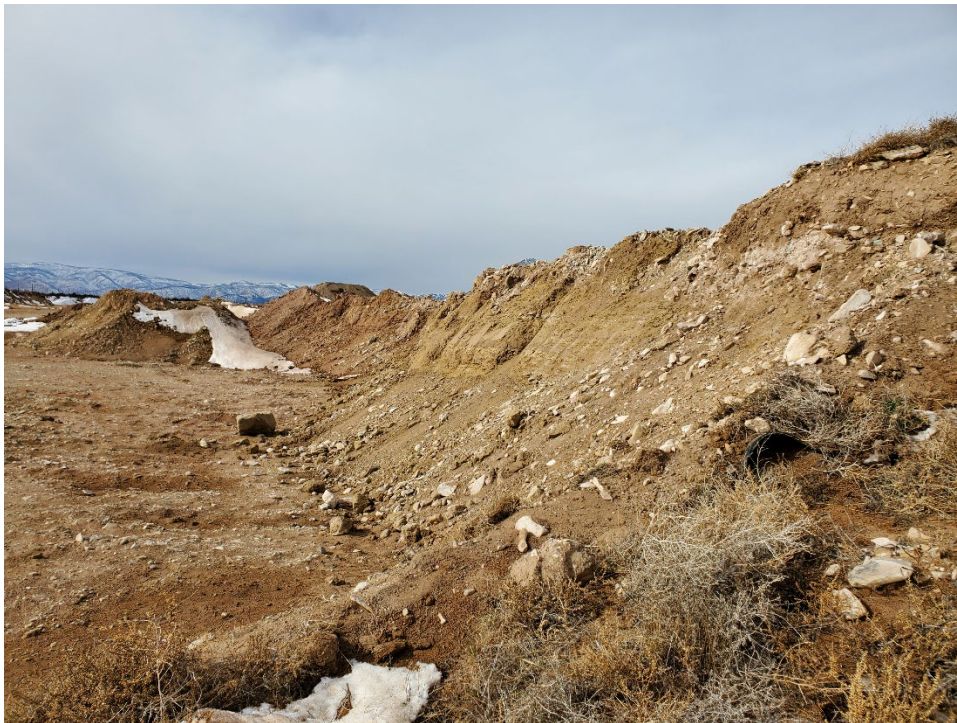
Photo 16: Back-sloped highwalls.

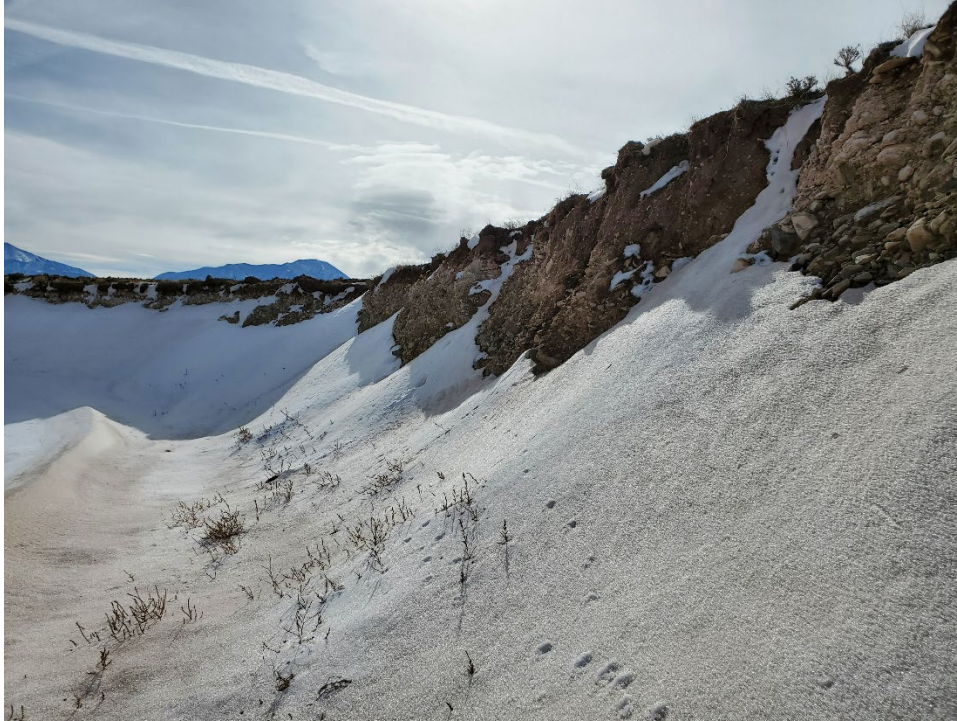
(3) All grading shall be done in a manner to control erosion and siltation of affected lands. All means will be taken to prevent soil erosion. No highwalls will be left after mining. Best Management Practices will be used to protect areas outside the affected land from slides and other damage. No highwalls are planned at this open pit mine.

Photo 17: Near vertical, 11' tall, highwalls along western disturbance.

This has been cited above as a problem. The Operator shall submit a revision to the current mining and reclamation plans to allow for the presence of highwalls, or submit proof to the Division that the highwalls have been backfilled, by the corrective action date.

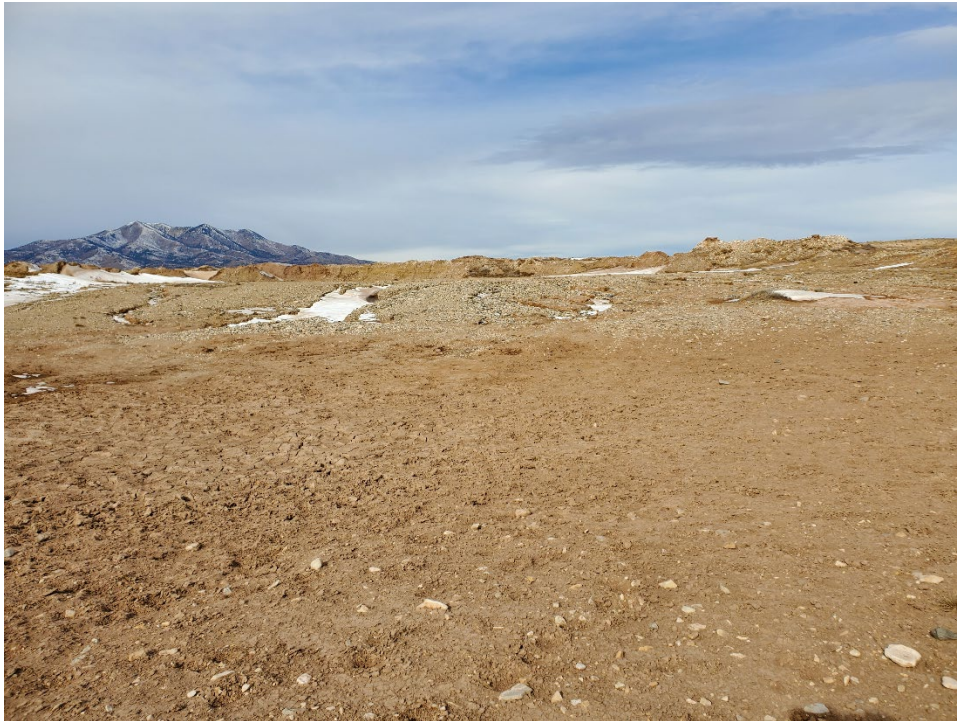
PROBLEM: Erosion gullies and ruts were observed on-site. This is a problem at this time for failure to protect the affected land from erosion pursuant to C.R.S. 34-32.5-116 (4) (j).

Photo 18: Mud cracks in foreground suggesting periods of standing water. Erosion ruts and gullies in background.

CORRECTIVE ACTIONS: The Operator shall provide photo documentation to the Division verifying erosion gullies and ruts have been repaired, and that the site has have been reconstructed and stabilized to prevent erosion damage by the corrective action date.

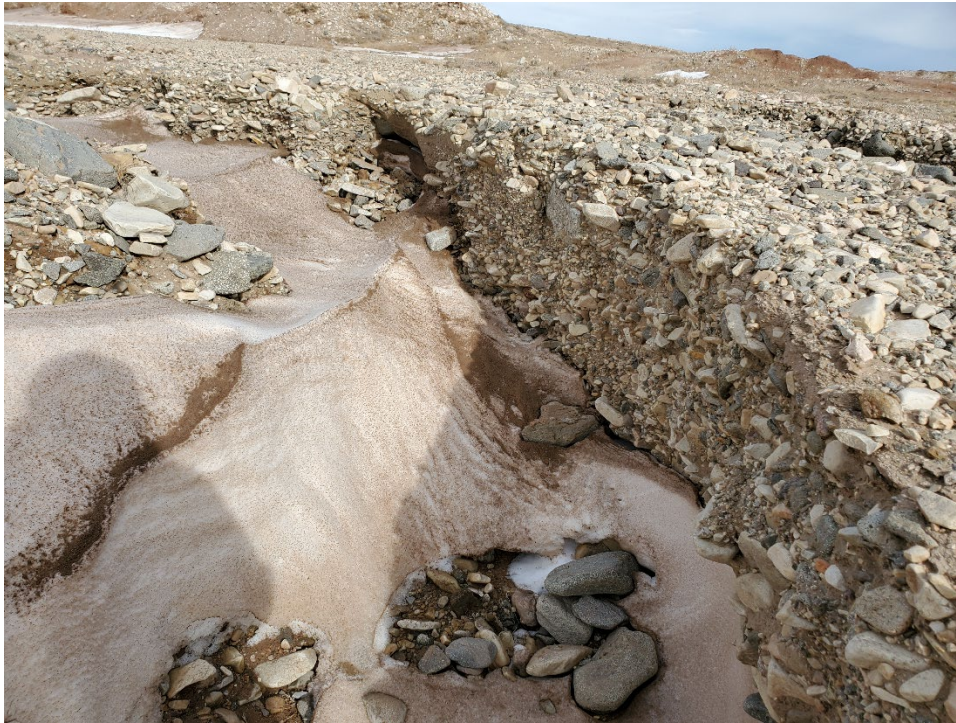
Photo 19: Photo taken from within an erosion gully that was approximately three feet tall.

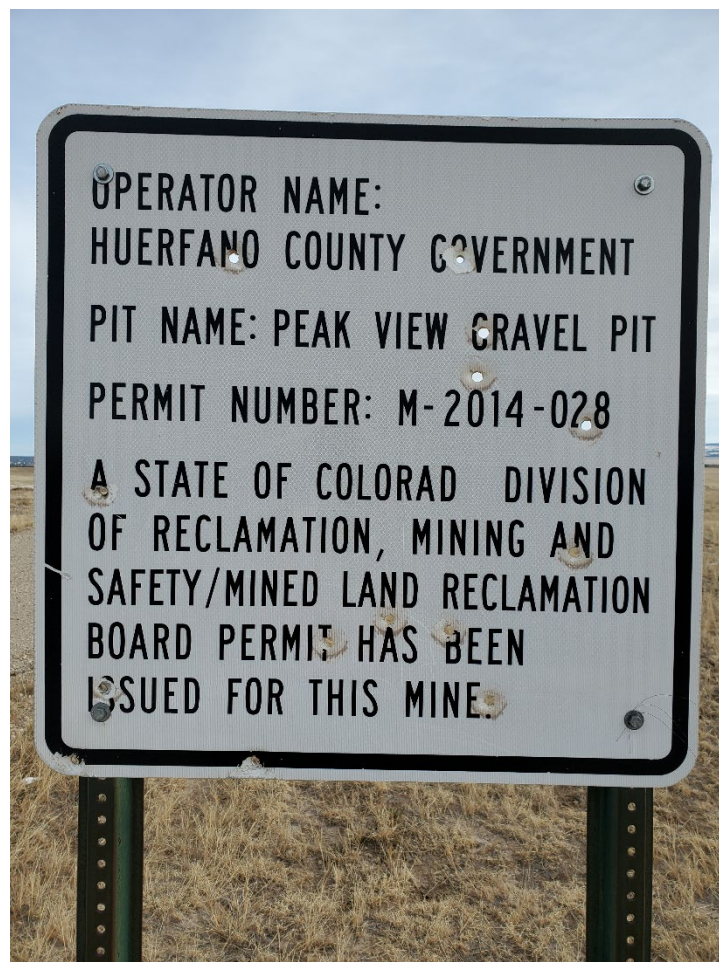
A sign was posted in compliance with Rule 3.12.1(1) at the entrance gate (Photo 20: Map 1).

Photo 20: Mine sign posted at the entrance gate.

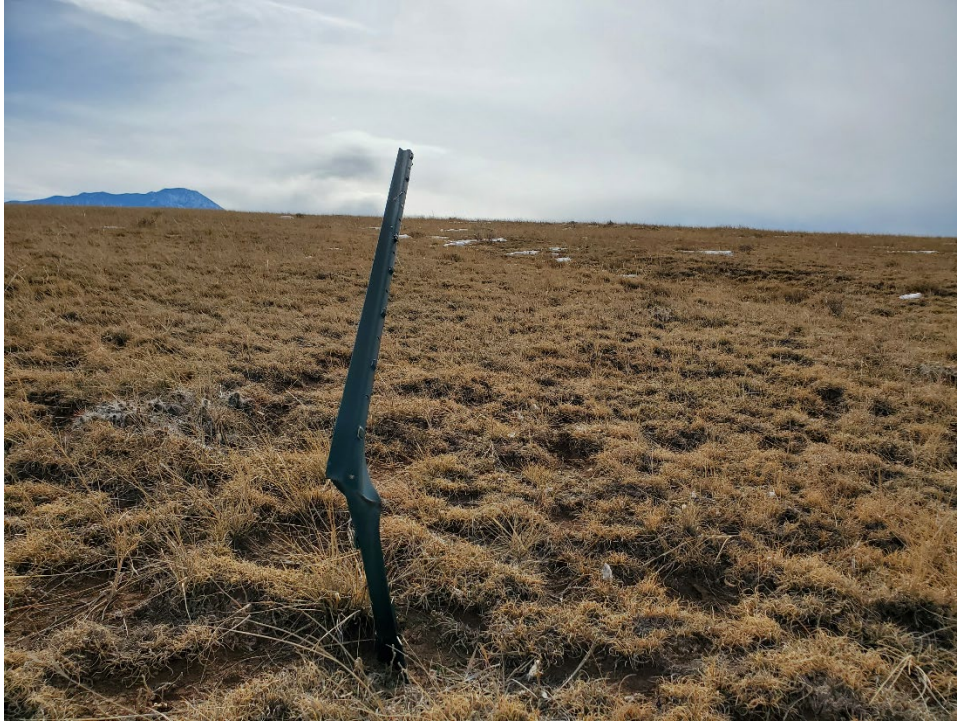
The northwest permit boundary marker was observed in place (Photo 21: Map 1). The northeast and southeast corner markers were located, but they had been knocked over (Photos 22 & 23: Map 1). The Division did not find the southwest marker. This has been cited above as a problem for missing/inaccurately placed markers. After speaking with the Operator post inspection, it is agreed that the replacement of the southern markers can wait until the Operators submit an amendment to encompass all of the off-site disturbance, and determine new permit boundaries. However, at least the northeast marker needs to be erected. The Operator shall send photo evidence to the Division that at least the northeast marker has been replaced by the corrective action date. The north and south sides of the entrance road were also logged by the Division using Esri Field Maps (see Map 1).

Photo 21: Looking north at the northwest permit boundary t-post.

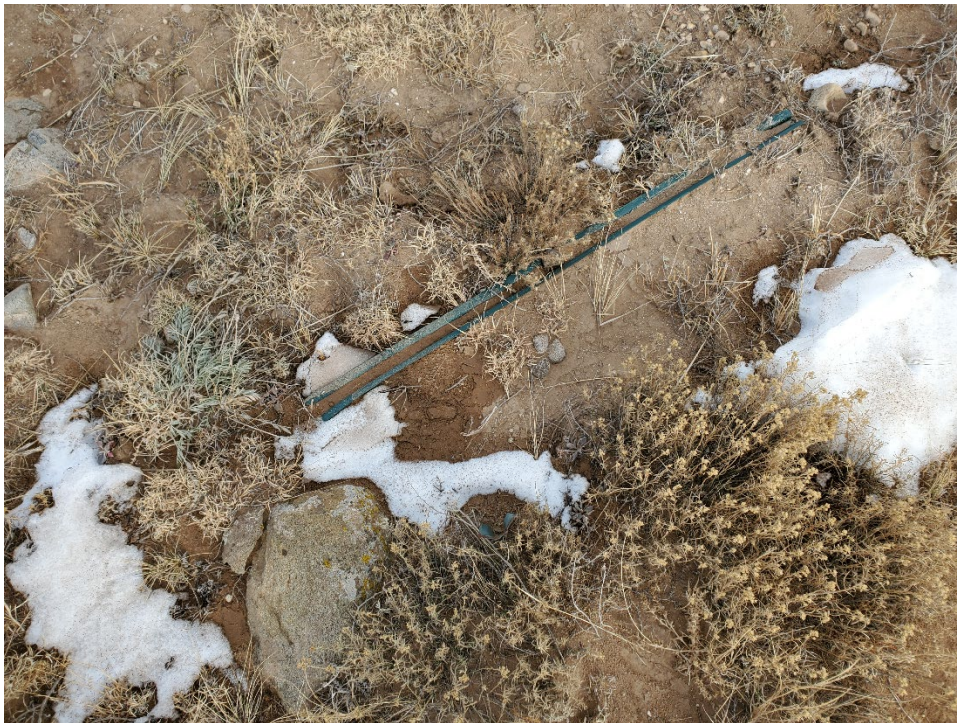
PROBLEM: The majority of the affected area boundary markers are missing or incorrectly placed. This is a problem for failure to maintain boundary markers around the affected area as required by Section 3.1.12(2) of the rule.

Photo 22: Looking over the knocked down north-east boundary marker.

CORRECTIVE ACTIONS: The Operator shall use the survey map provided with their TR1 application to replace the boundary markers in the correct locations. The Operator shall provide proof to the Division that this has been done by the corrective action date.

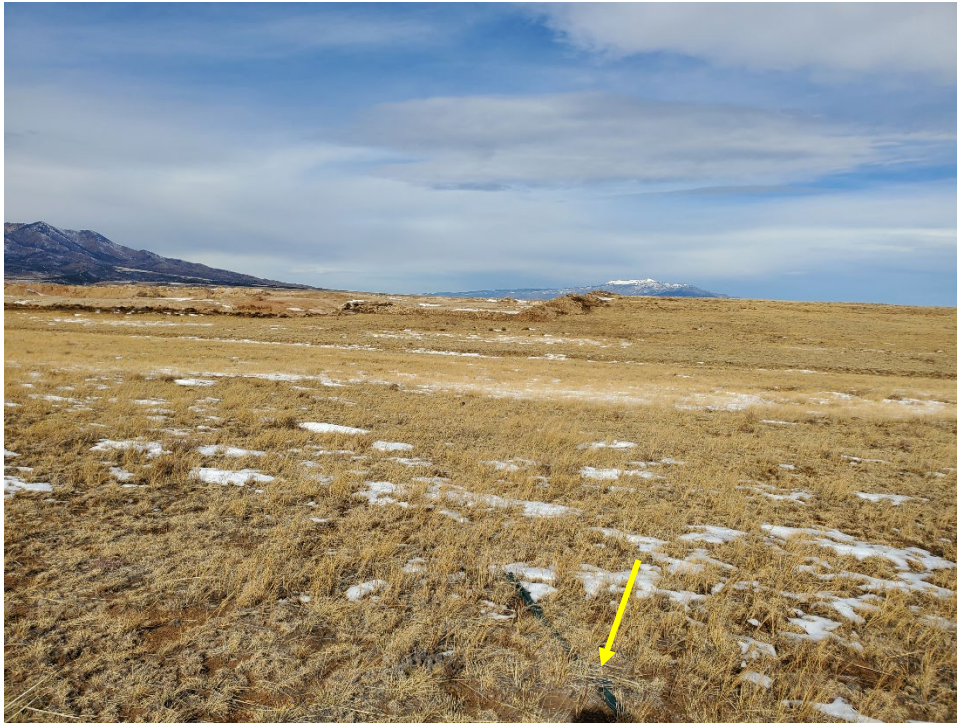
Photo 23: Looking north from behind the southeast knocked over marker.

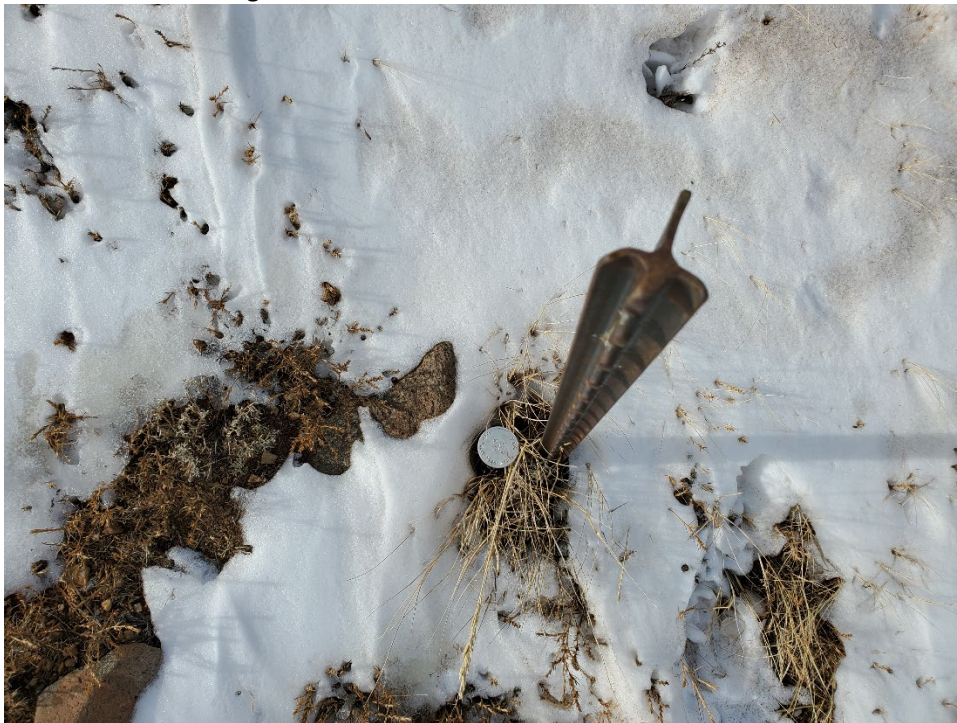
Photo 24: Standing above the extra marker located north of the permit boundary.

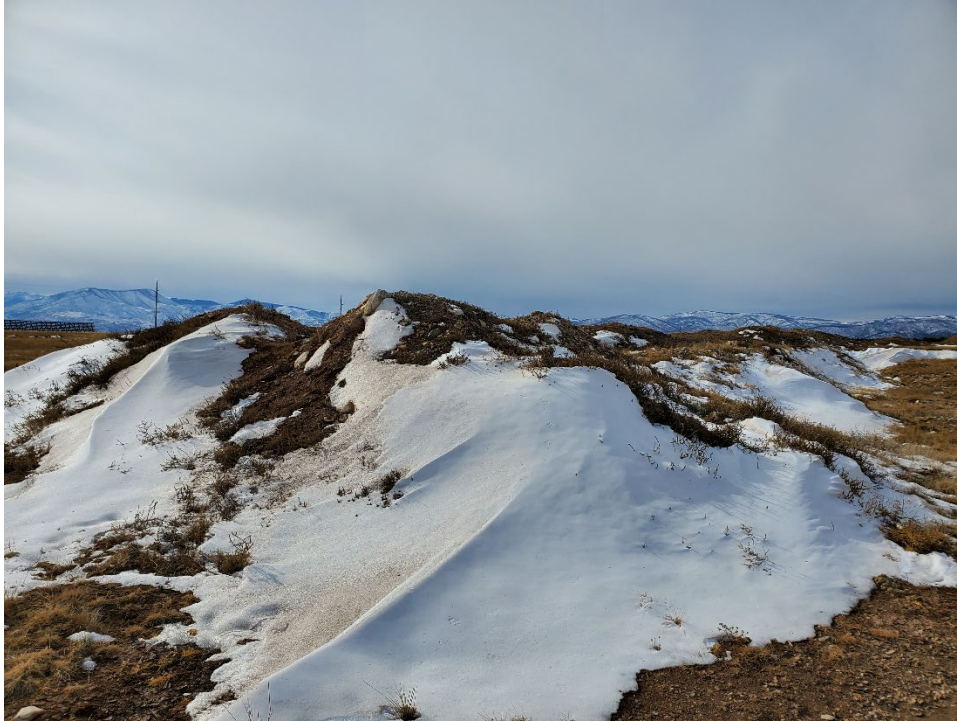
Topsoil piles were observed along the south-side of the pit (Photo 25: Map 1). The piles appear to be stable at this time.

Photo 25: Looking west at the topsoil placed south of the pit.

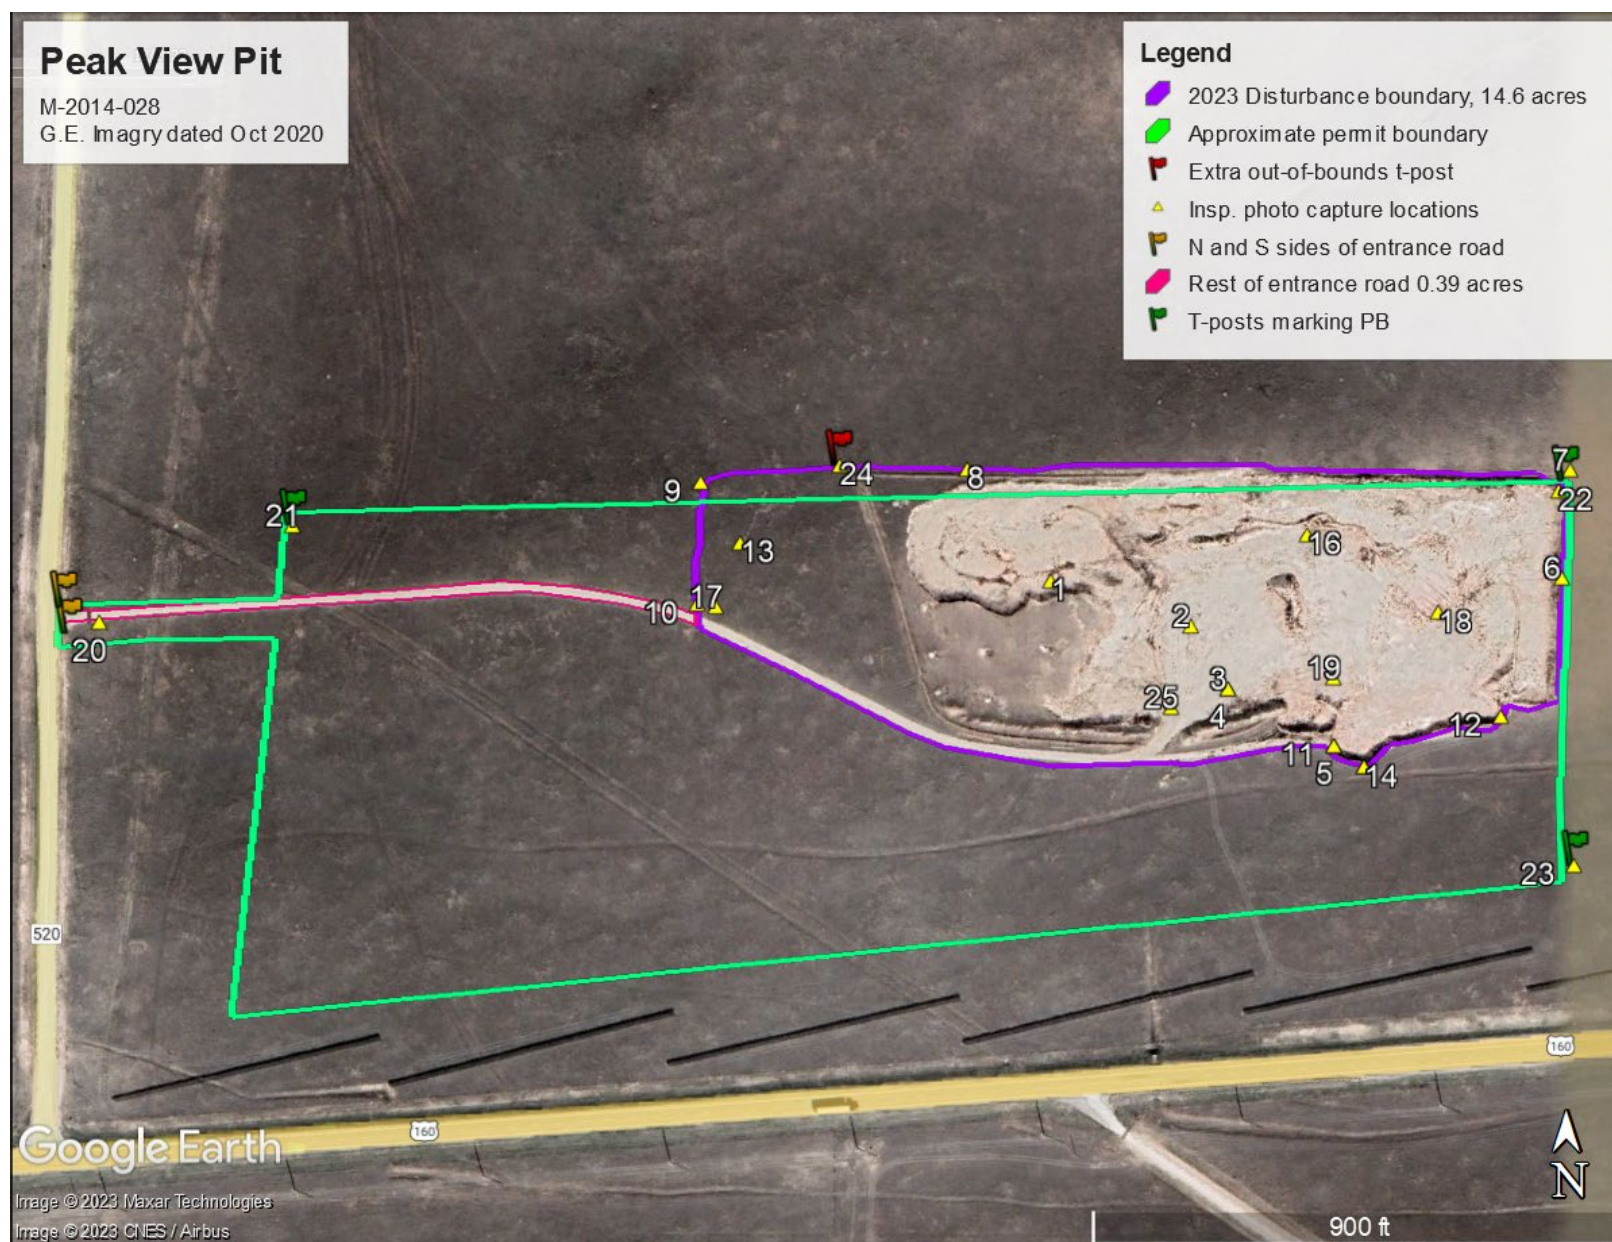
Map 1: This map was generated in Google Earth Pro to illustrate where inspection photos were taken, where the disturbance boundary was walked, where field markers were located, and where off-site disturbance occurred.
