MINERALS PROGRAM INSPECTION REPORT
PHONE: (303) 866-3567

MINE NAME: Peak View Pit	MINE/PROSPECTING ID#: M-2014-028	MINERAL: Sand and gravel	COUNTY: Huerfano
INSPECTION TYPE: Monitoring	WEATHER: Clear	INSP. DATE: December 12, 2023	INSP. TIME: 10:45
OPERATOR: Huerfano County	OPERATOR REPRESENTATIVE: None	TYPE OF OPERATION: 112c - Construction Regular Operation

INSPECTION TOPIC: Gen. Compliance With Mine Plan

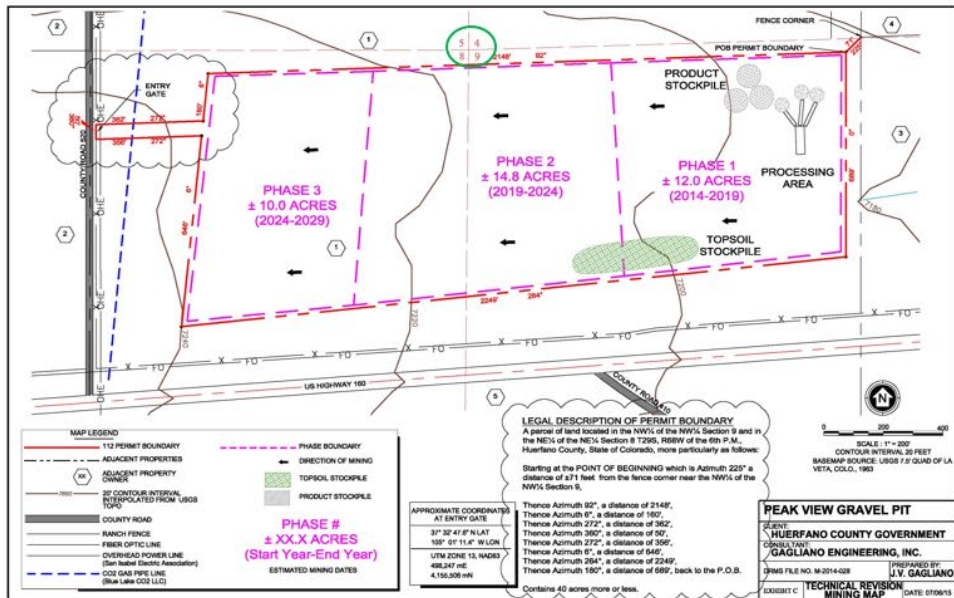
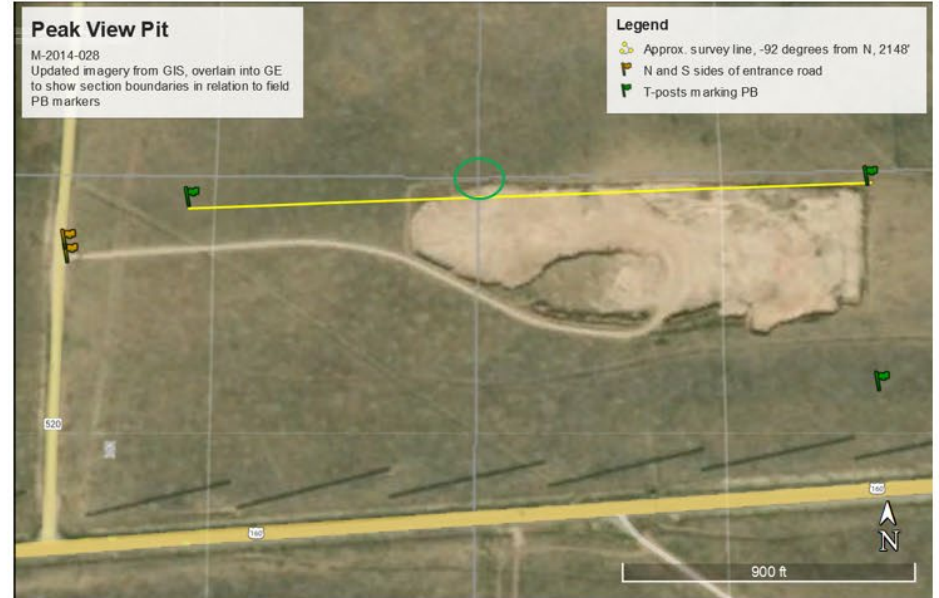
The annual report, map, and fee are paid through September 2, 2024. A Technical Revision (TR1) moved the entrance of the site south of what was originally planned, but made no other boundary adjustments (see Map 2). There are no outstanding infractions.

Map 2: Image on the left is the TR1 map included with the TR1 application that requested to shift the entrance road south of where it was originally proposed. The image on the right was sourced from the DRMS GIS webpage, with the township, range, and section data layer turned on. The GIS image was overlain into Google Earth Pro to illustrate the relationship between the field markers, the survey line information, section boundaries, and the off-site disturbance. The green circles in each image highlights where the corner of Section 4, 5, 8, and 9 intersect.
