**PERMIT INFORMATION**

<b>Permit Number:</b> C1981033 <b>Mine Name:</b> Bear Mine <b>Operator:</b> N/A <b>Operator Address:</b> N/A	<b>County:</b> Gunnison <b>Operation Type:</b> Underground <b>Permit Status:</b> Revoked <b>Ownership:</b> Private
	<b>Operator Representative Present:</b>  N/A
<b>Operator Representative Signature: (Field Issuance Only)</b>

<b>Inspection Start Date:</b> December 13, 2023 <b>Inspection Start Time:</b> 15:00 <b>Inspection End Date:</b> <b>Inspection End Time:</b>	<b>Inspection Type:</b> Coal Complete Inspection <b>Inspection Reason:</b> Normal I&E Program <b>Weather:</b> Cloudy
<b>Joint Inspection Agency:</b>  None	<b>Joint Inspection Contacts:</b>
<b>Post Inspection Agency:</b>  None	<b>Post Inspection Contacts:</b>
<b>Inspector(s):</b>  Leigh Simmons	<b>Inspector's Signature:</b>

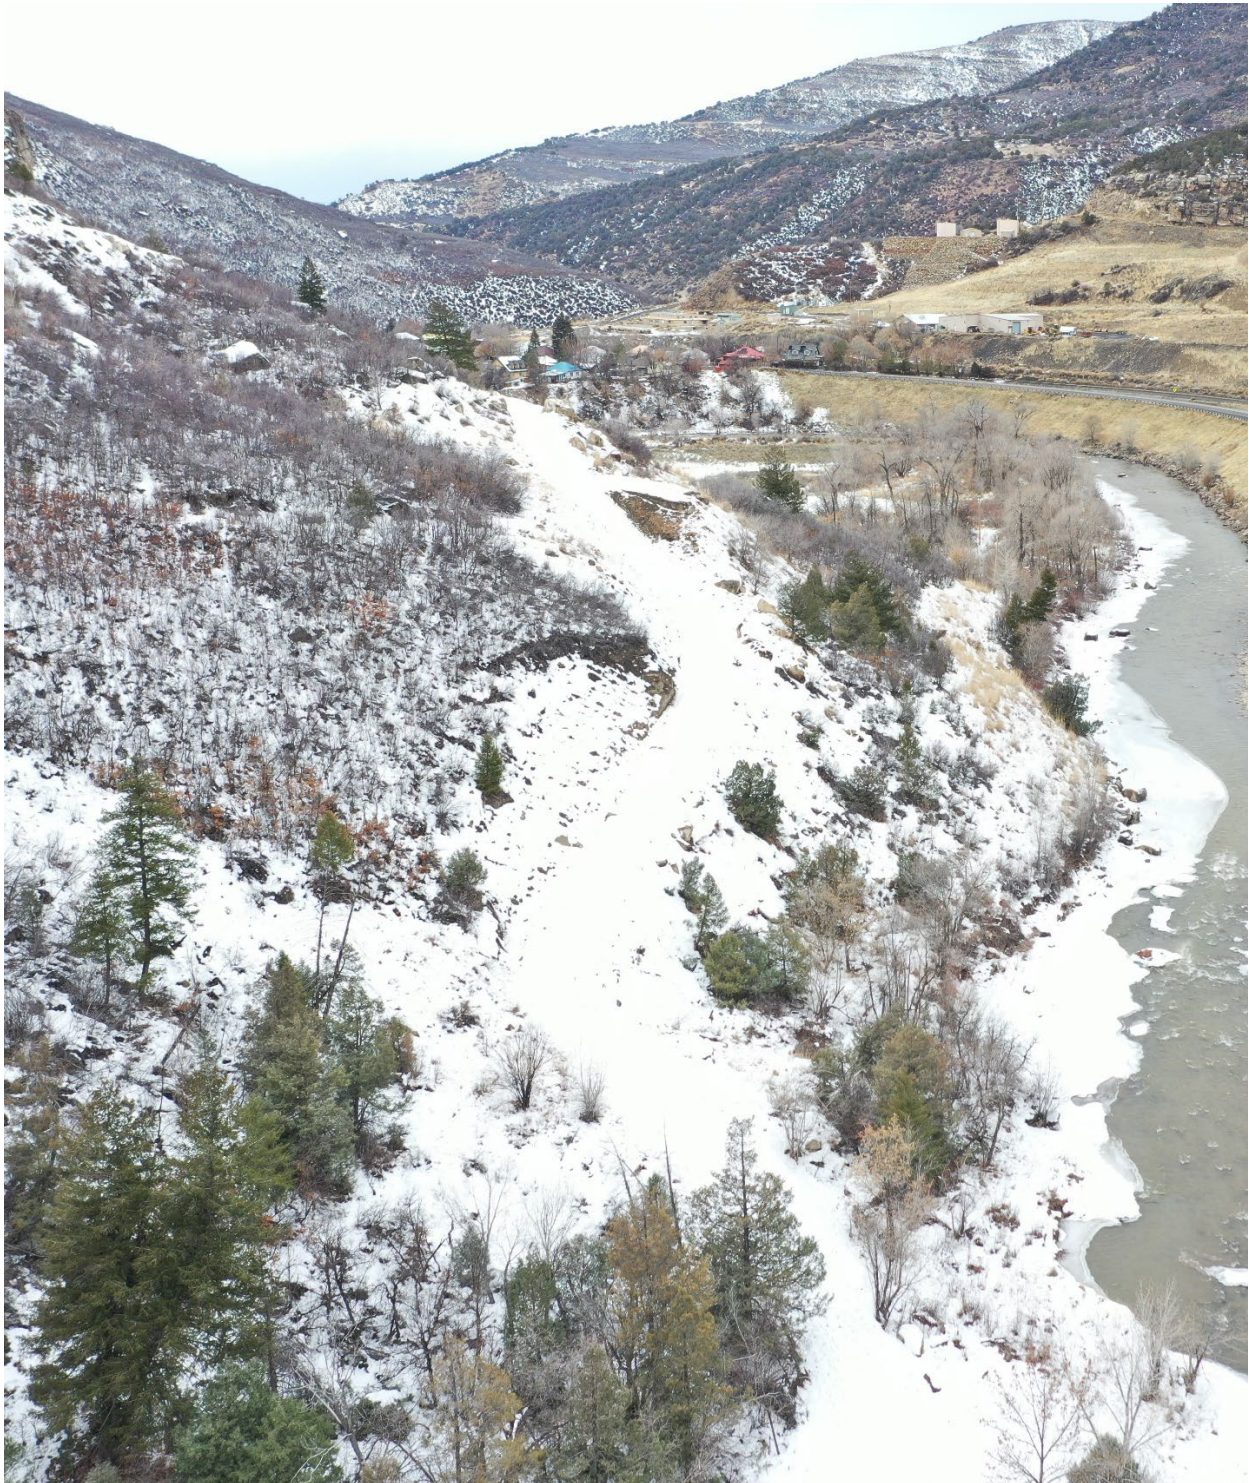
The temporary road to the top of the bench was snow-covered. No attempt was made to drive up it. Work was done in November to prepare the road for winter through the addition and definition of rolled dips on the road surface, improved drainage in the roadside ditch and the installation and maintenance of silt fence on the downslope side.

*Figure 1: Lower road*

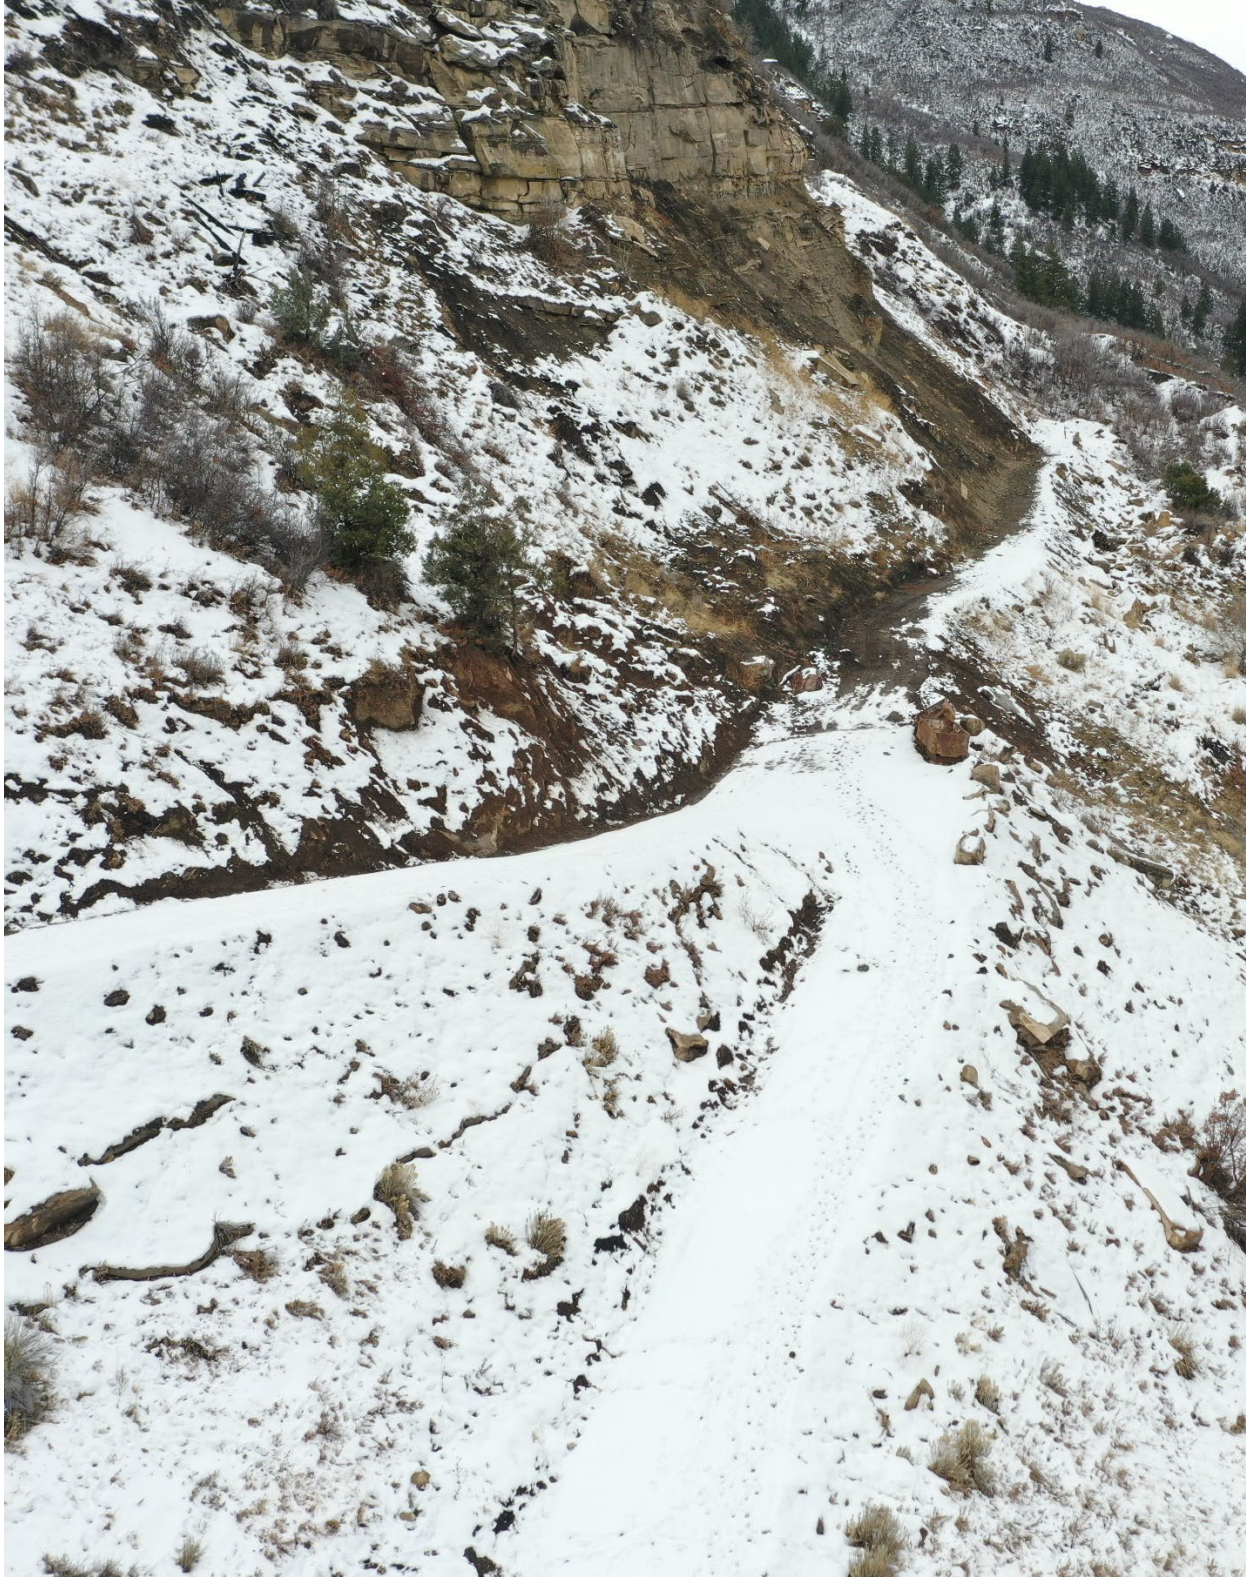
*Figure 2: First hairpin and access below scarpe*

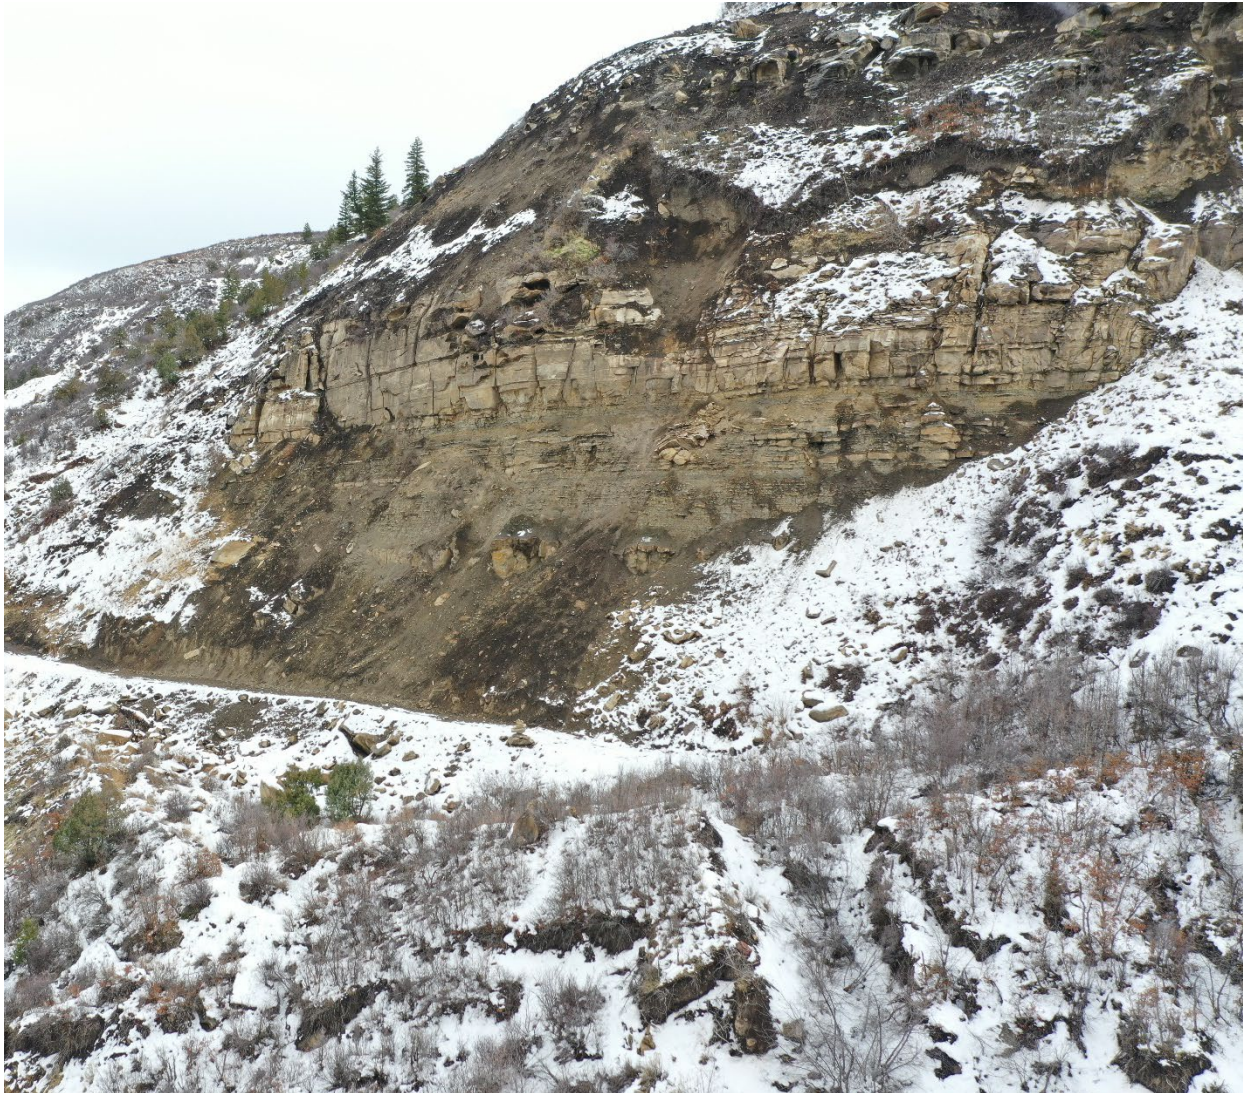
The images below show clearly where the ground surface is warmer as a result of the underground fire. Snow was largely melted between the bench and the scarp below it; whereas above the bench and below the scarp the ground was mostly snow-covered (at least on north facing aspects). Numerous vents can be seen in the images, with green vegetation around the edges in contrast to the dormant vegetation on the surrounding slope.

*Figure 3: Scarpe*

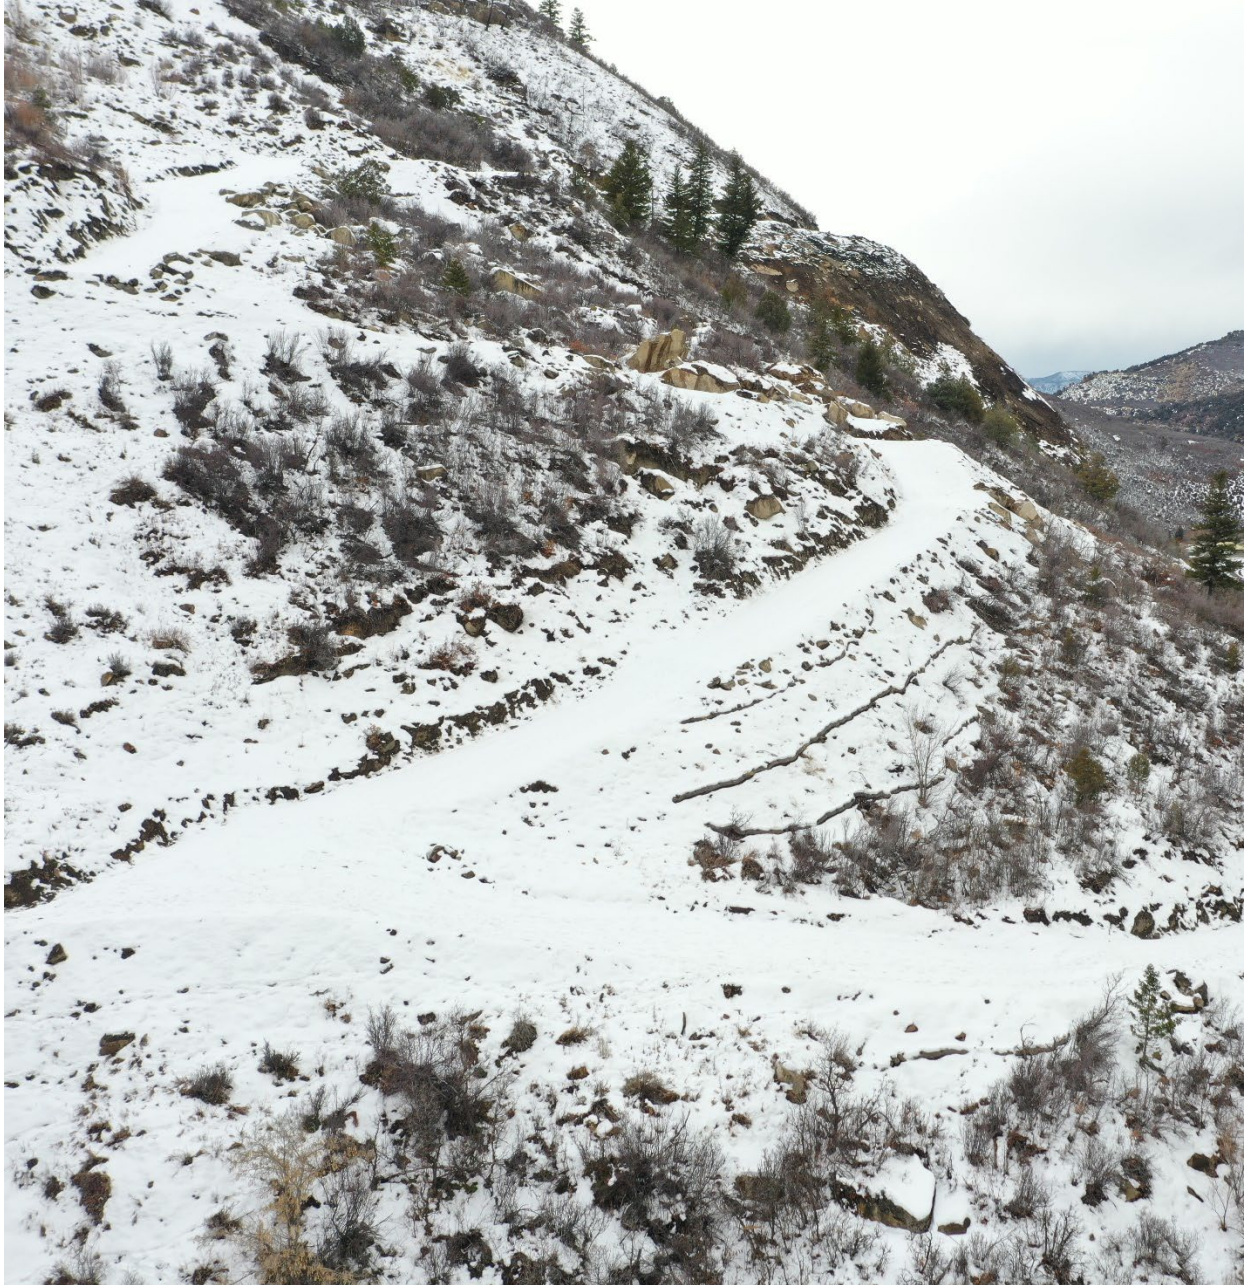
*Figure 4: Upper road, with sediment control on downslope side*

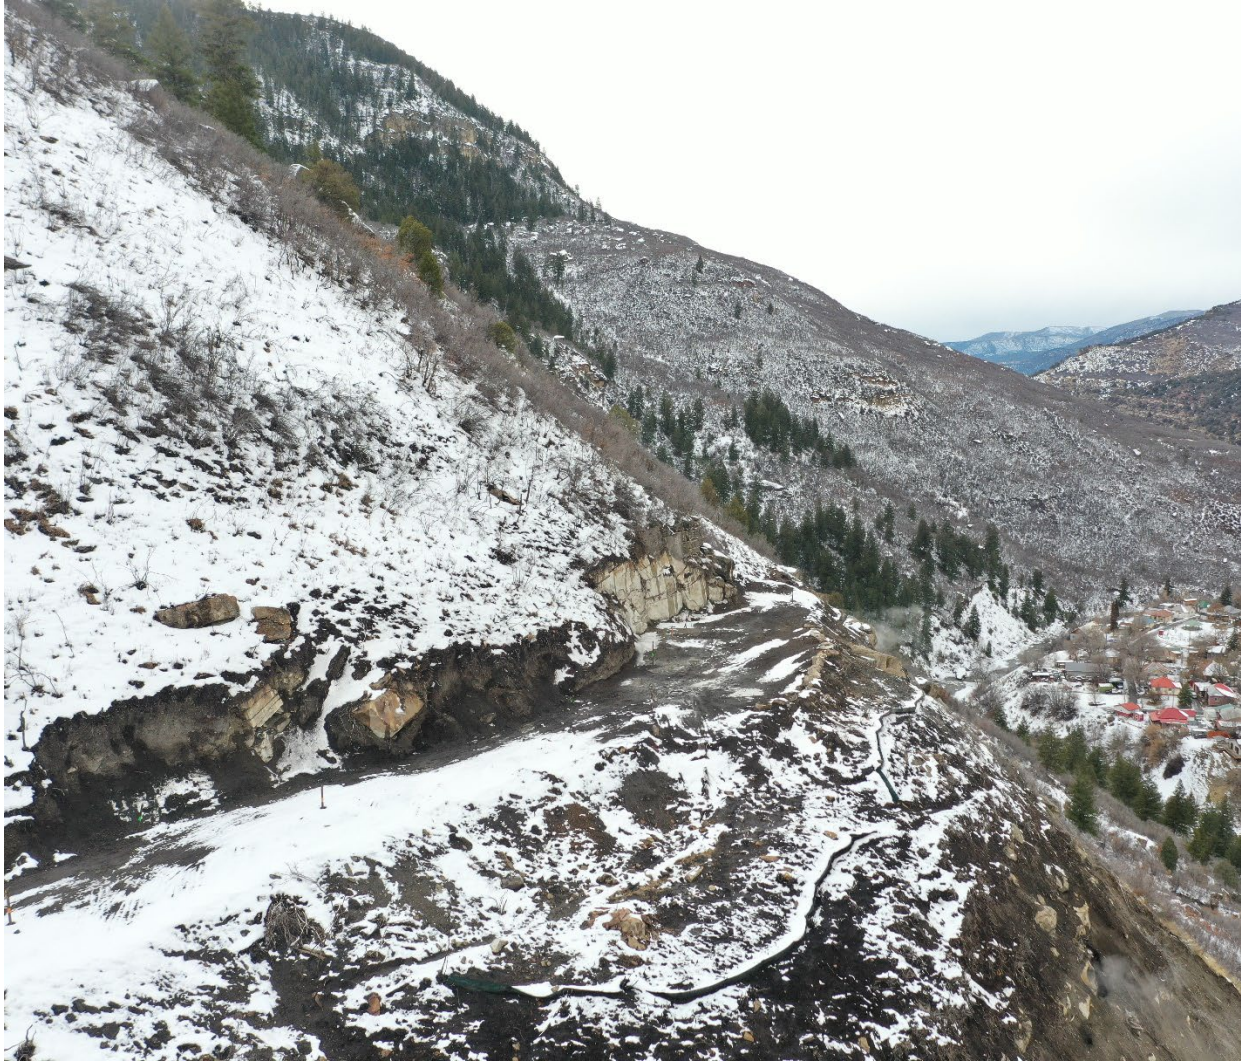
*Figure 5: Road onto bench above scarpe*

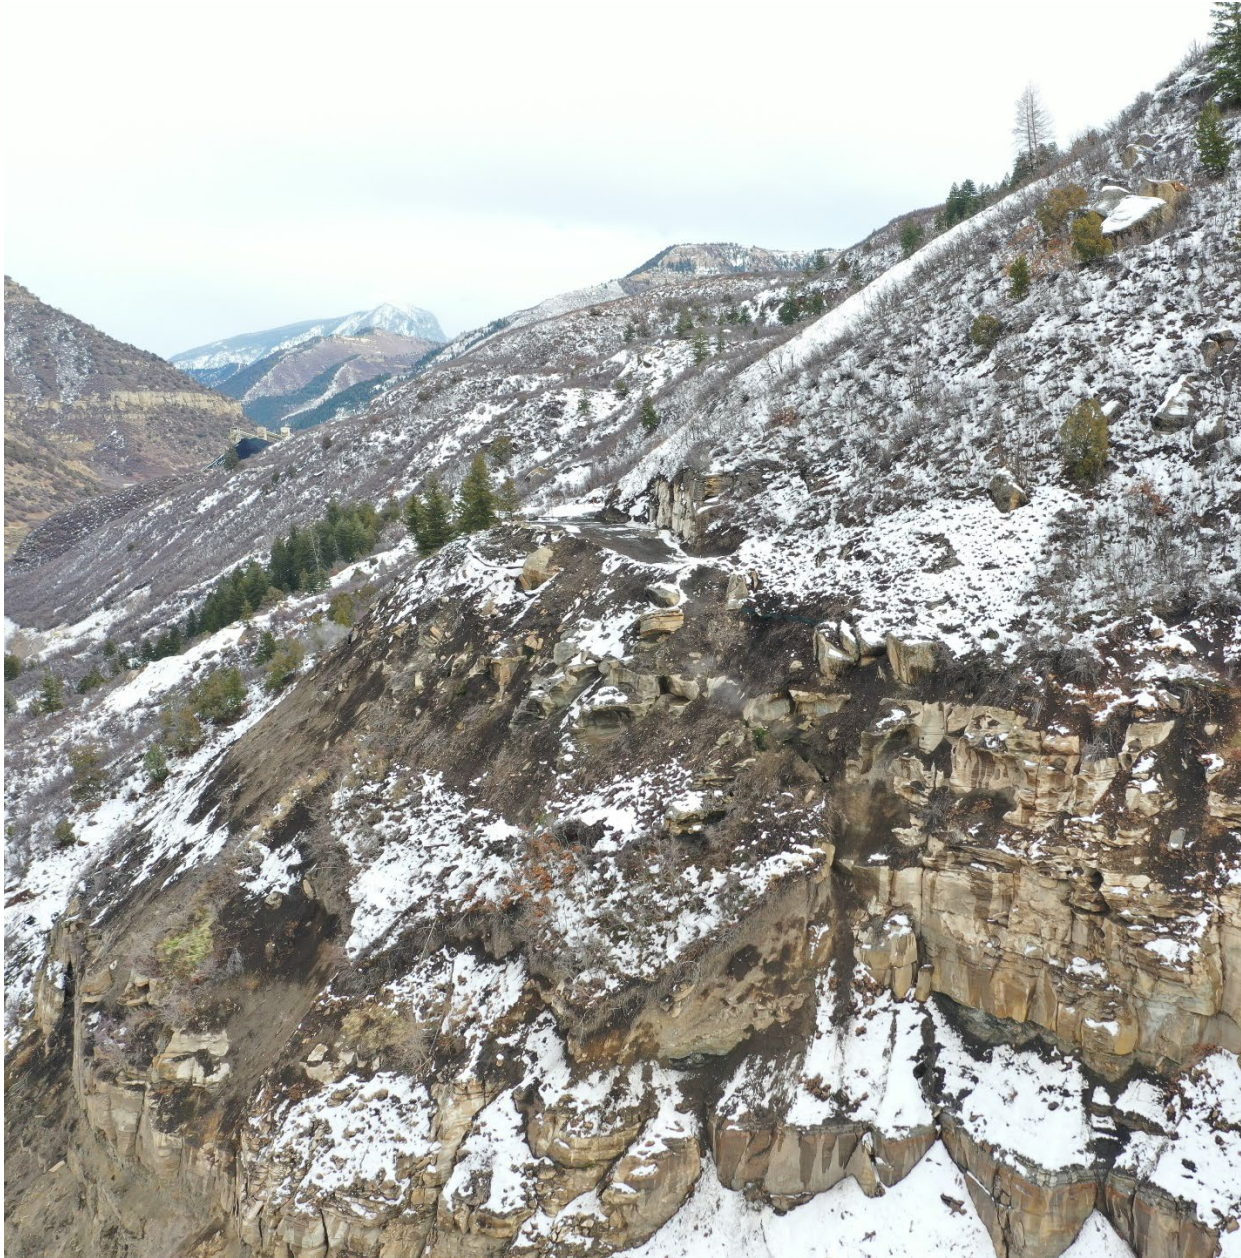
*Figure 6: Scarpe*

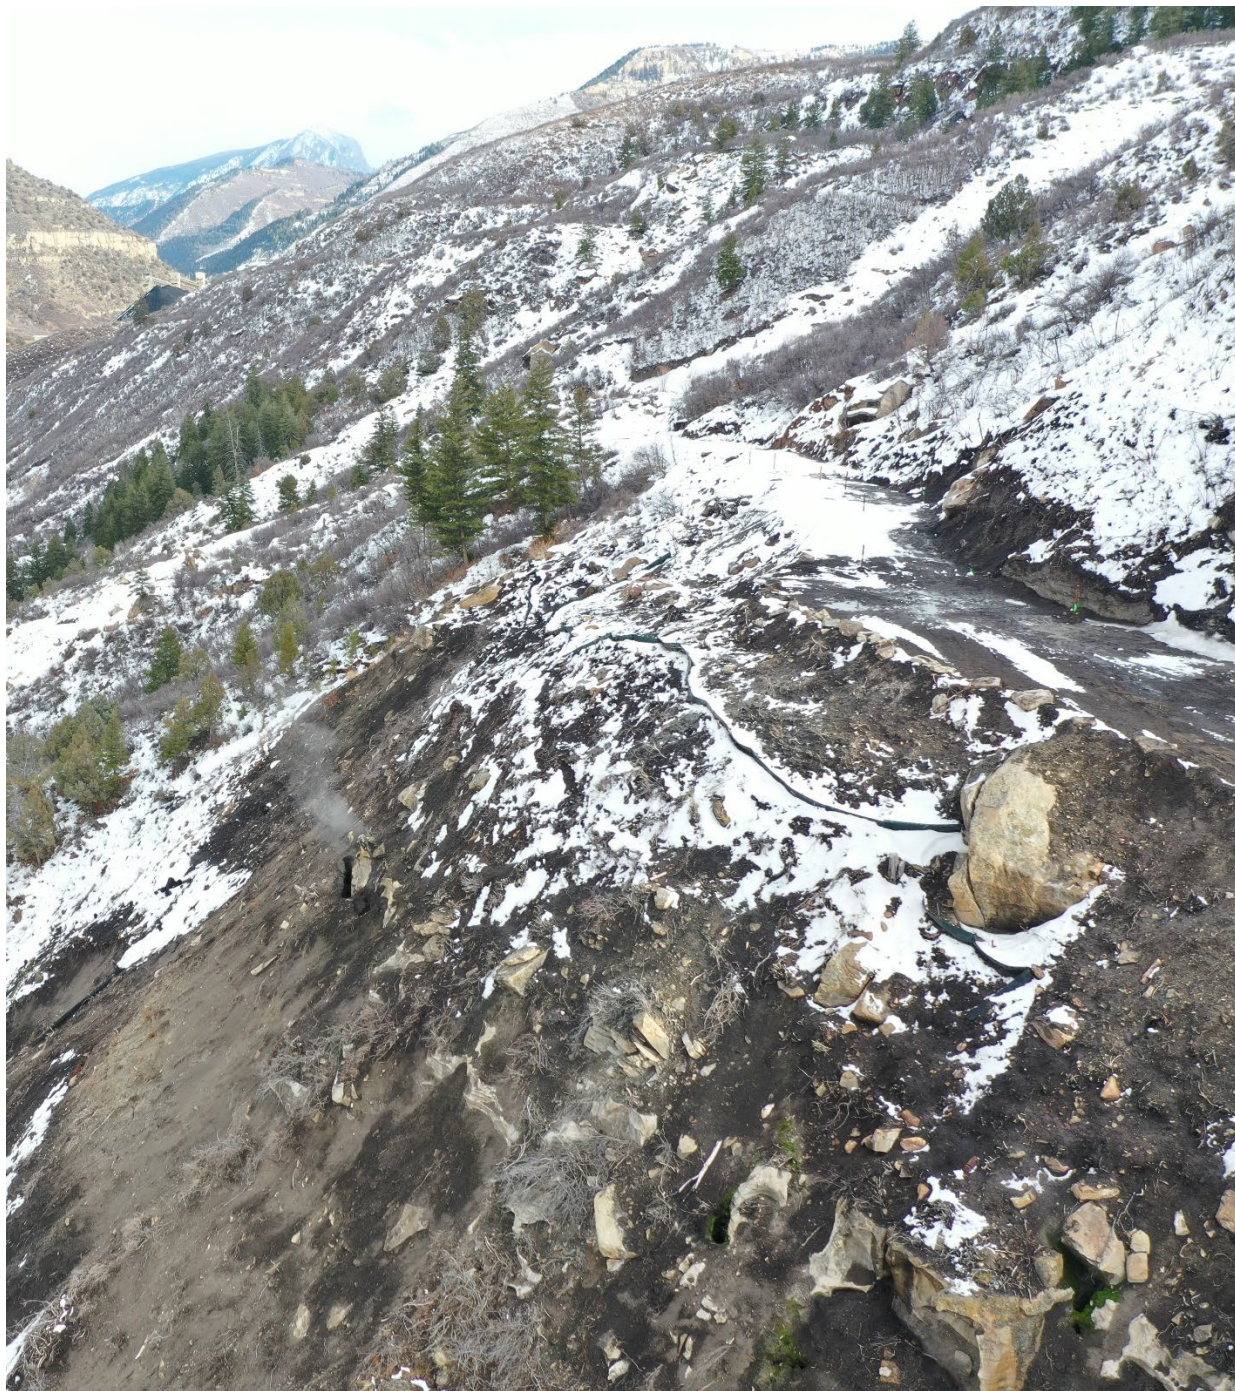
*Figure 7: Vents below bench. Sediment control also visible*

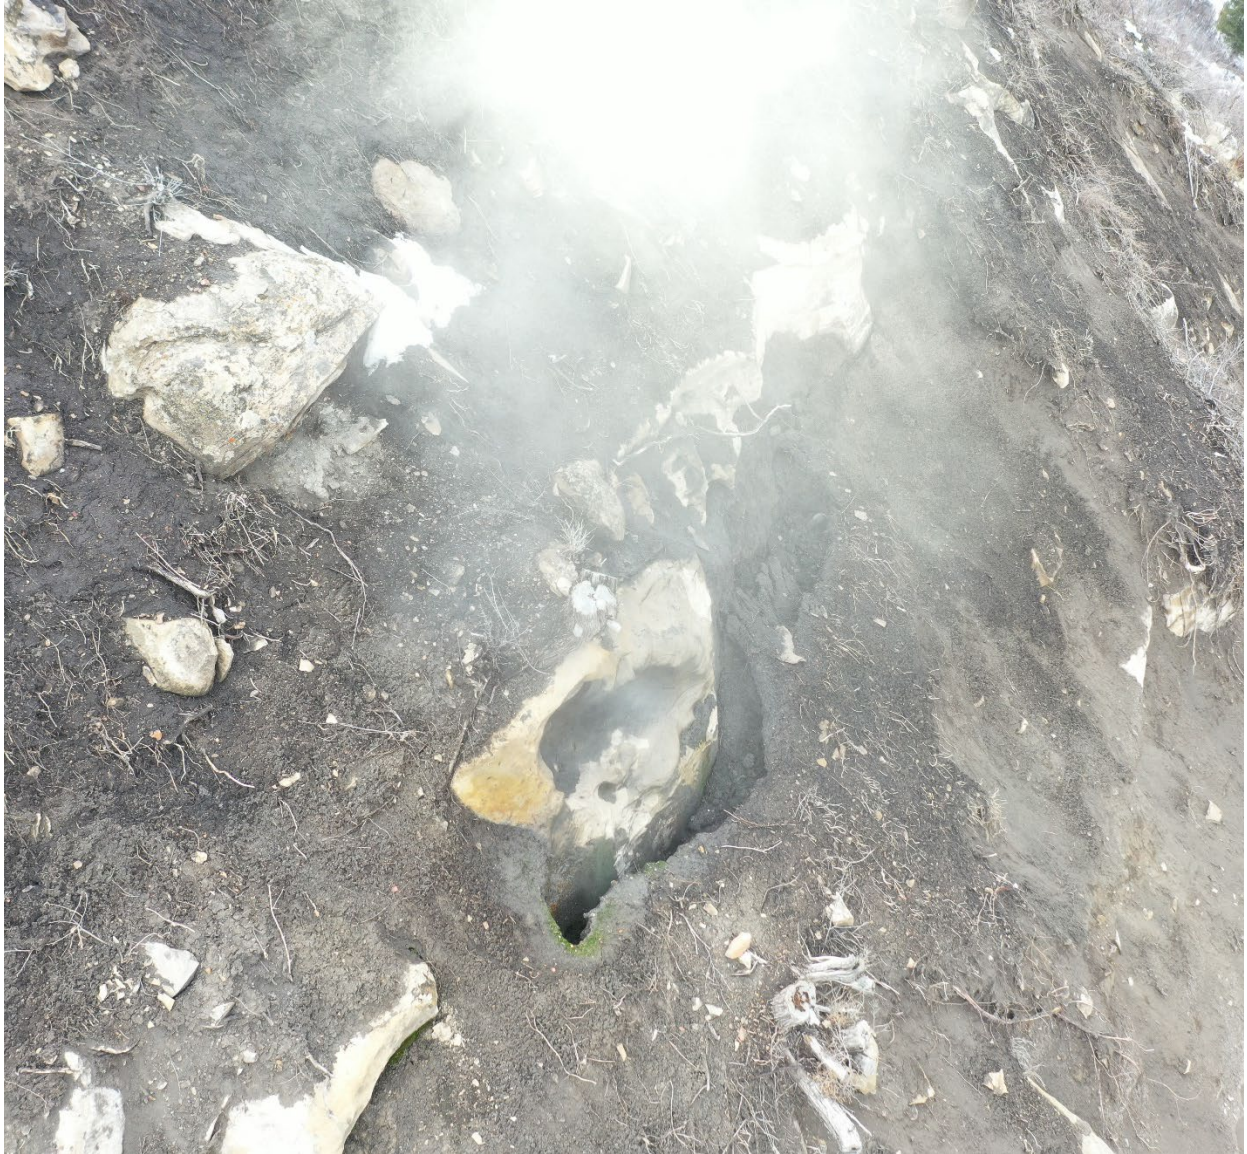
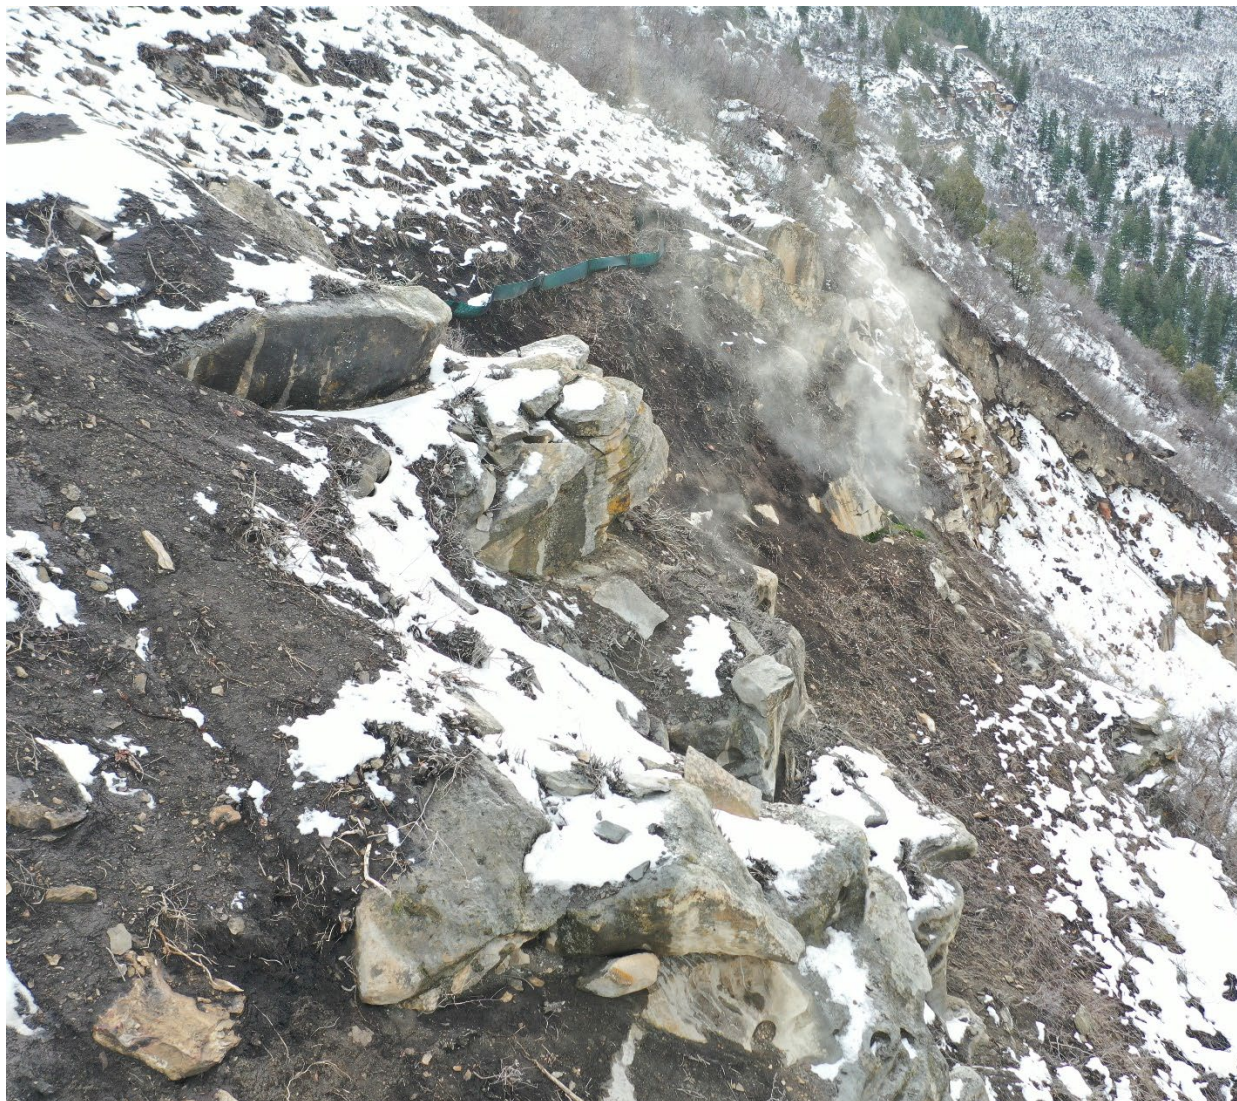
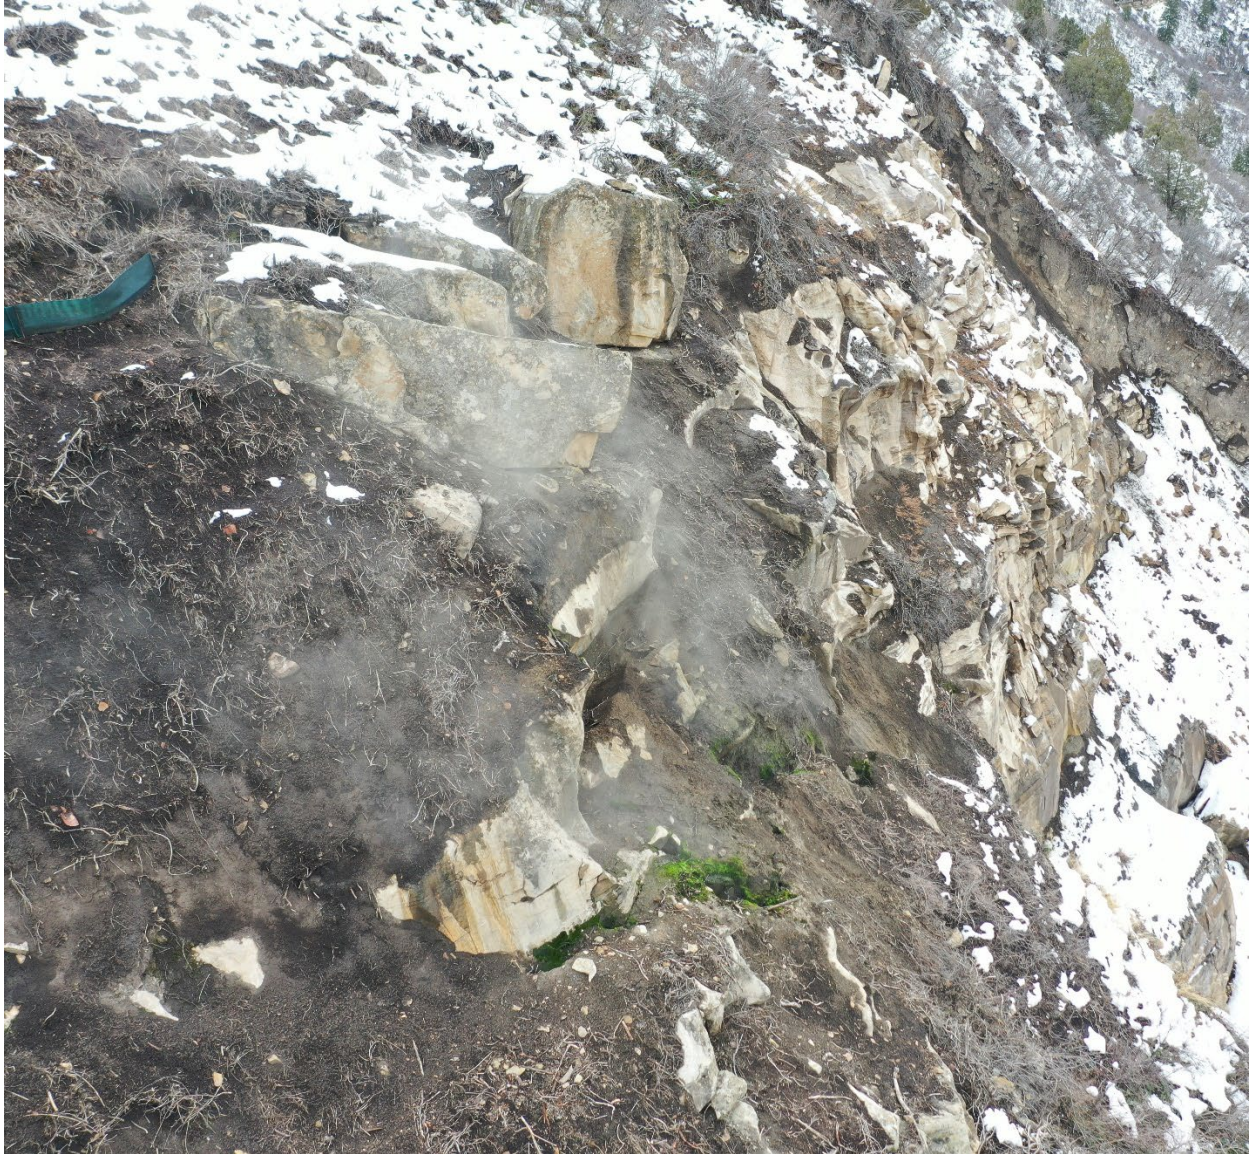
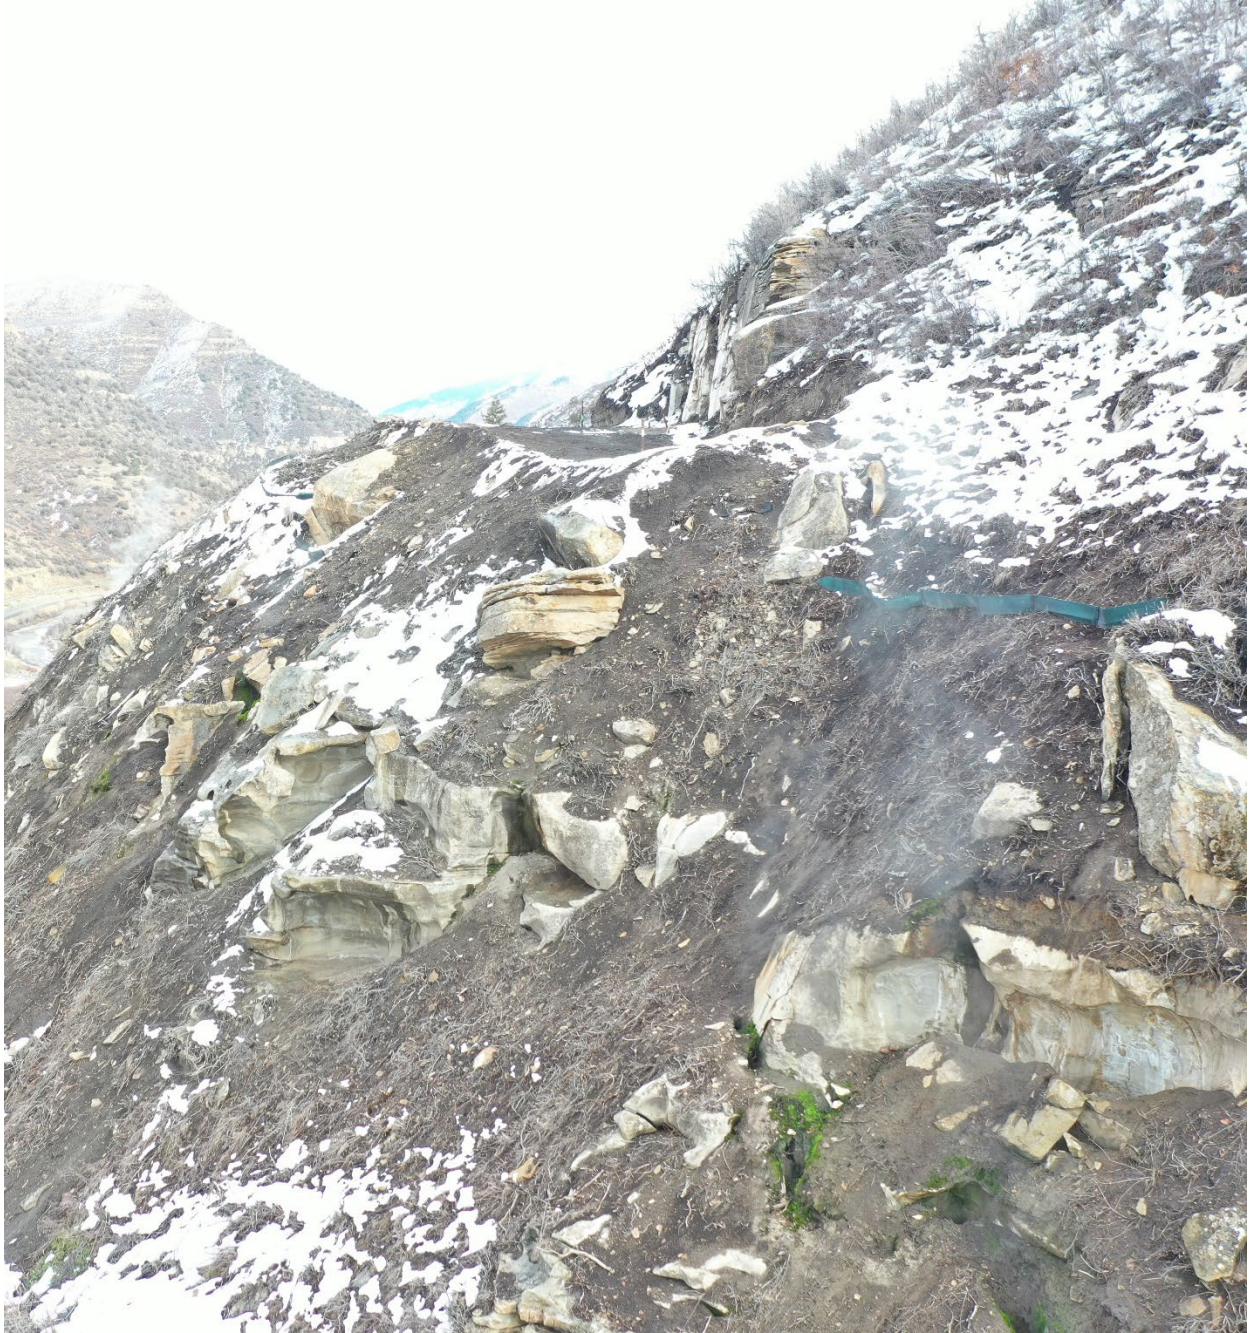
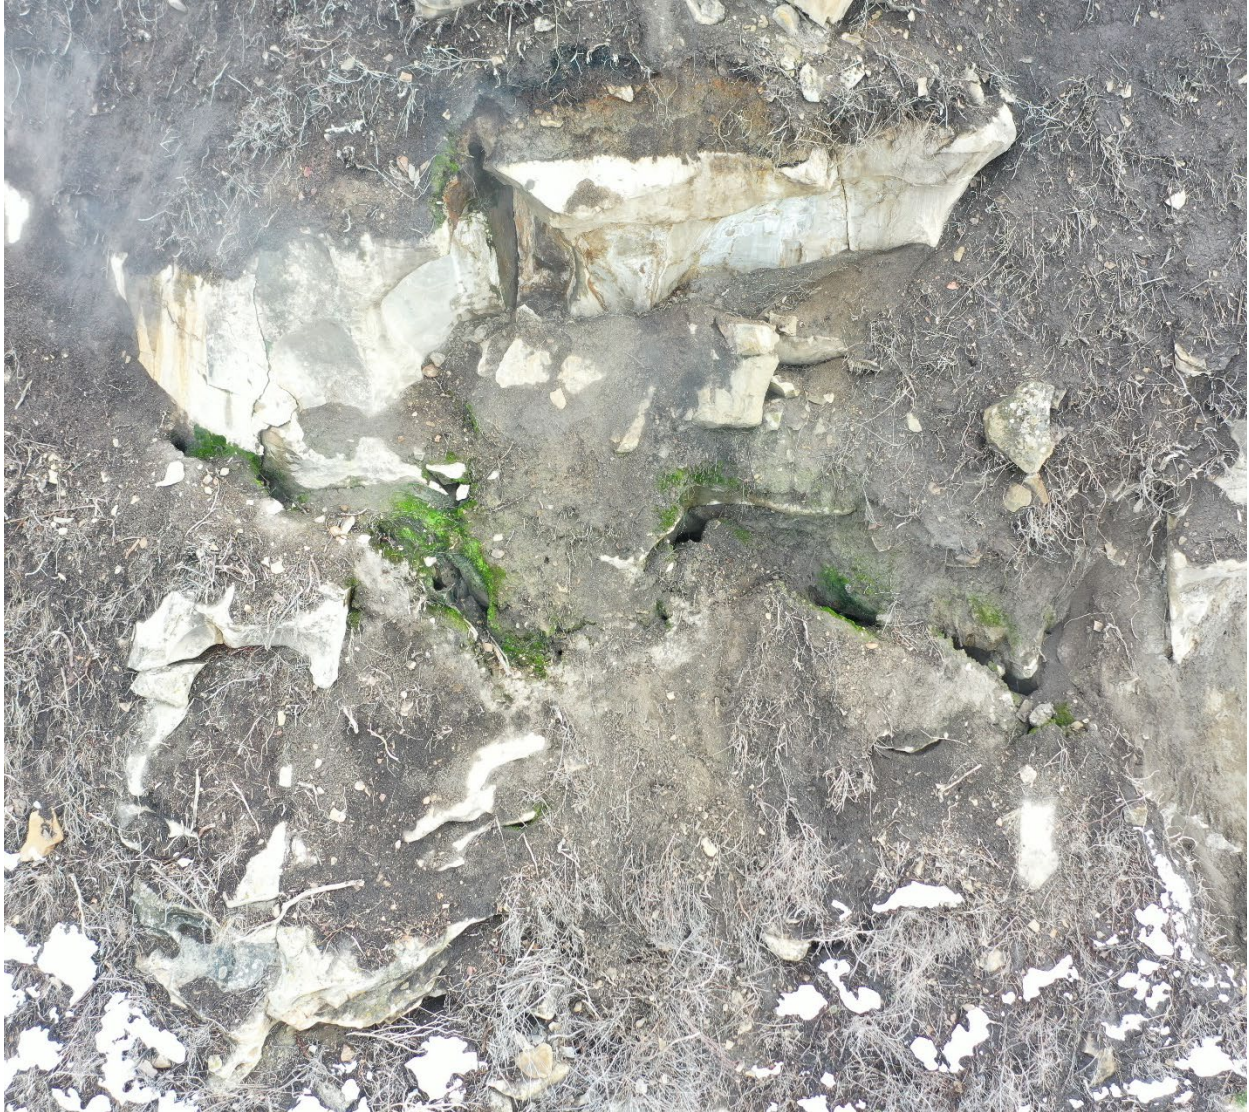
Figure 8: Vents (1 of 5)

Figure 9: Vents (2 of 5)

Figure 10: Vents (3 of 5)

*Figure 11: Vents (4 of 5)*

Figure 12: Vents (5 of 5)

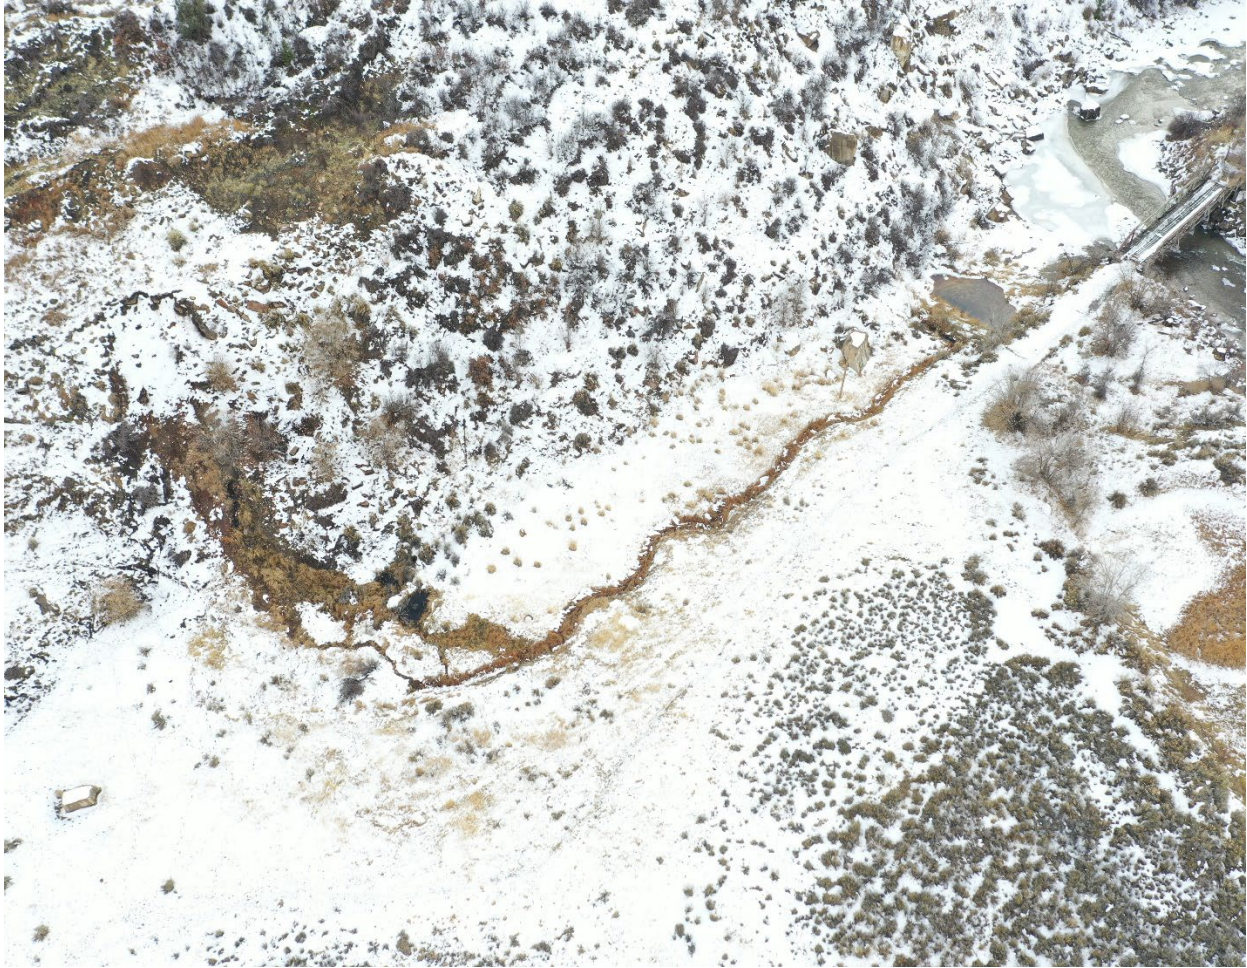
*Figure 13: Groundwater seep*
