**MINERALS PROGRAM INSPECTION REPORT**  
**PHONE: (303) 866-3567**

<b>MINE NAME:</b> Pikeview Quarry	<b>MINE/PROSPECTING ID#:</b> M-1977-211	<b>MINERAL:</b> Limestone (general), granite gneiss and do	<b>COUNTY:</b> El Paso
<b>INSPECTION TYPE:</b> Monitoring	<b>WEATHER:</b> Cloudy	<b>INSP. DATE:</b> December 20, 2023	<b>INSP. TIME:</b> 10:00
<b>OPERATOR:</b> Riverbend Industries Inc.	<b>OPERATOR REPRESENTATIVE:</b> Jerry Schnabel	<b>TYPE OF OPERATION:</b> 112c - Construction Regular Operation	
<b>REASON FOR INSPECTION:</b> Normal I&E Program	<b>BOND CALCULATION TYPE:</b> None	<b>BOND AMOUNT:</b> \$13,389,784.00	
<b>DATE OF COMPLAINT:</b> NA	<b>POST INSP. CONTACTS:</b> None	<b>JOINT INSP. AGENCY:</b> None	
<b>INSPECTOR(S):</b> Timothy Cazier, P.E. Hunter Ridley	<b>INSPECTOR'S SIGNATURE:</b>

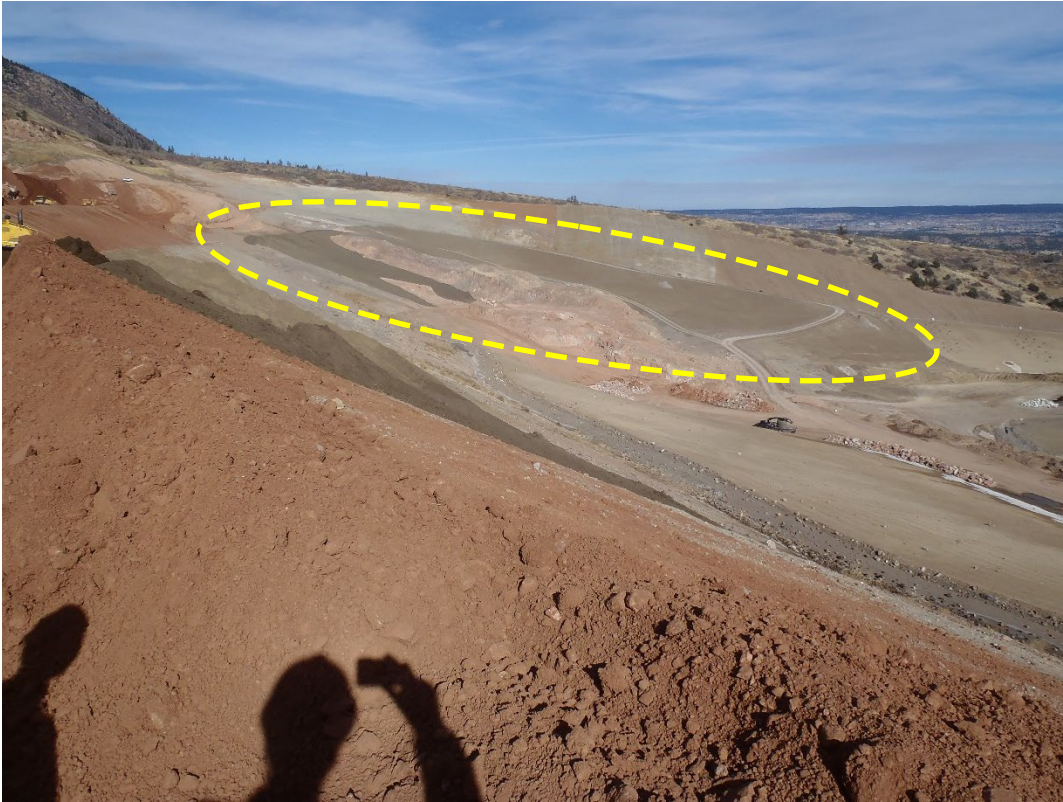
**Backfilling and Grading:** Material removal and final subgrade contouring appeared to complete in the north borrow area, as growth media had been placed since the November 16<sup>th</sup> inspection (**Photo 1**). A Dozer was observed spreading growth media on the recently completed second level (**Photo 2**) and the scraper access road had been completed from the uppermost pit area (**Photo 3**). Scrapers using this road and dozer activity to push backfill material down from above the slide have moved a considerable amount of material (**Photo 4**). Mr. Schnabel assured the DRMS that no loose material would be accepted, and all placed backfill would be tested for compaction in accordance with the approved specifications.

Photo 1. Recently placed growth media in the North borrow area (looking north).

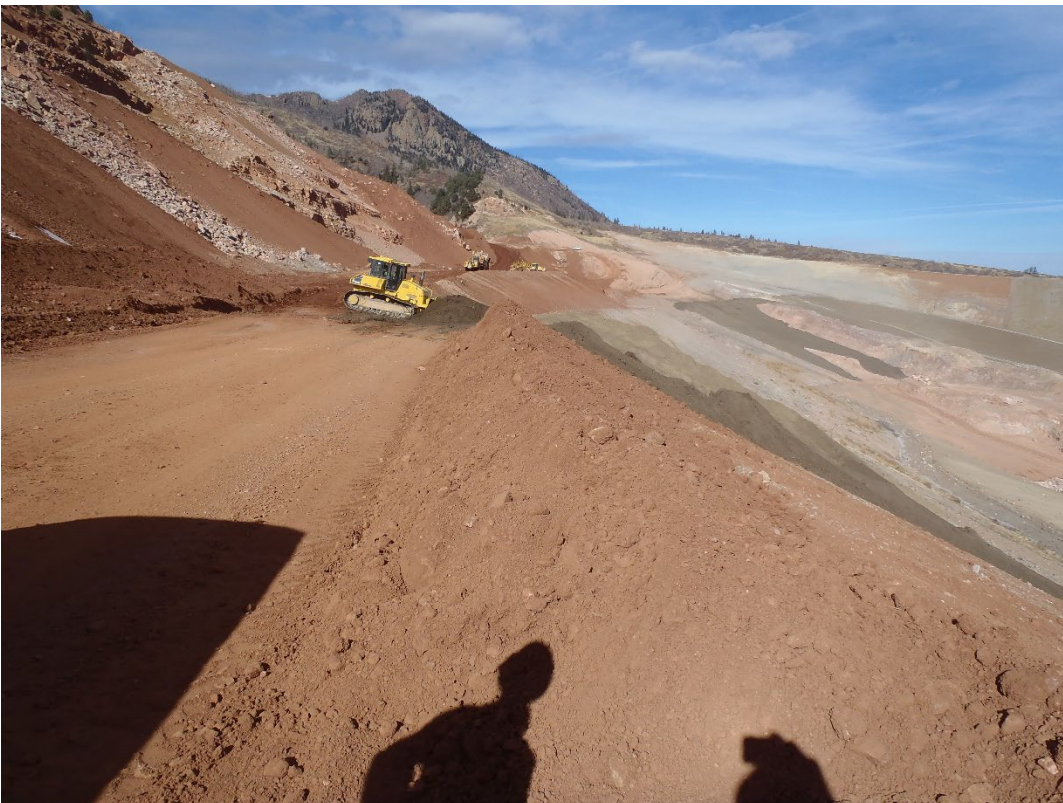
Photo 2. Dozer spreading growth media from Level 2 (looking north).

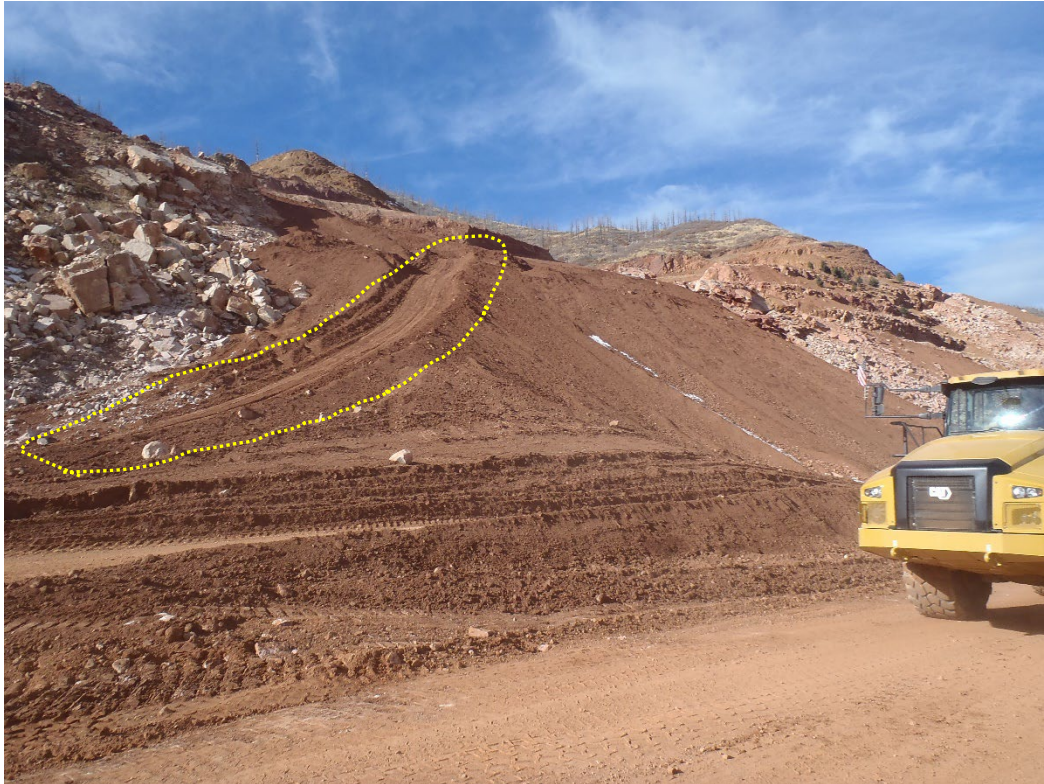
Photo 3. Scraper access road from above the slide area (looking NW).

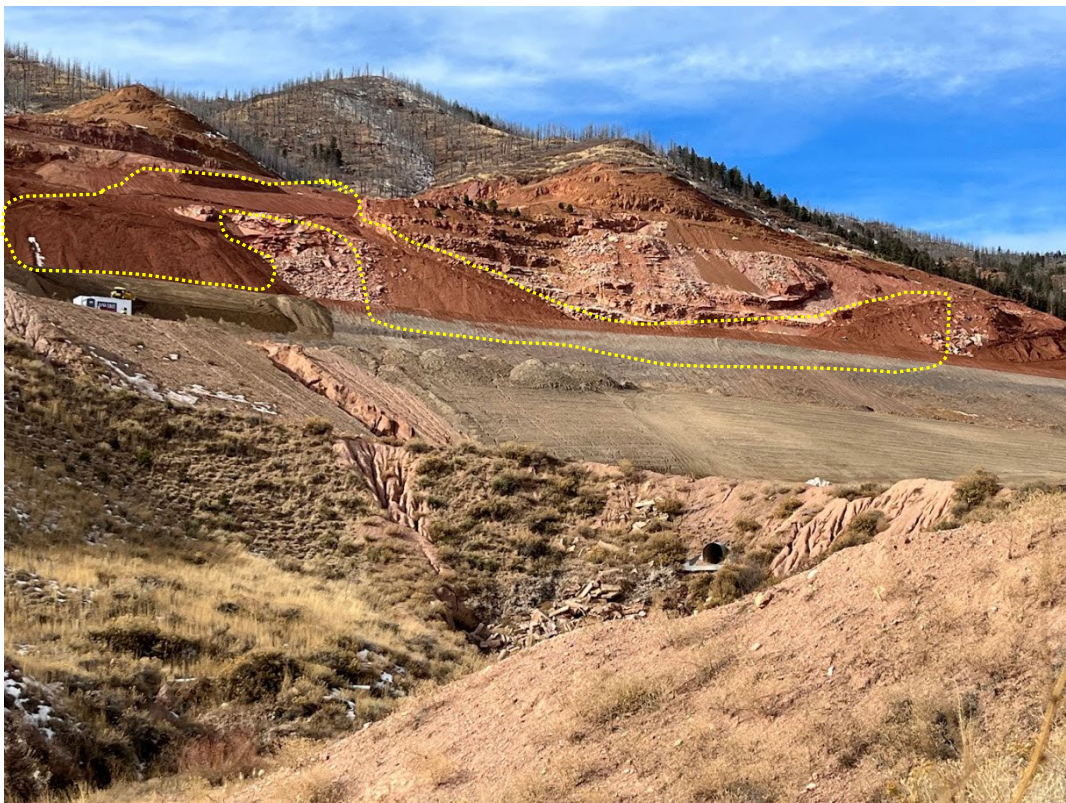
Photo 4. Material pushed down from above slide area (looking NW).

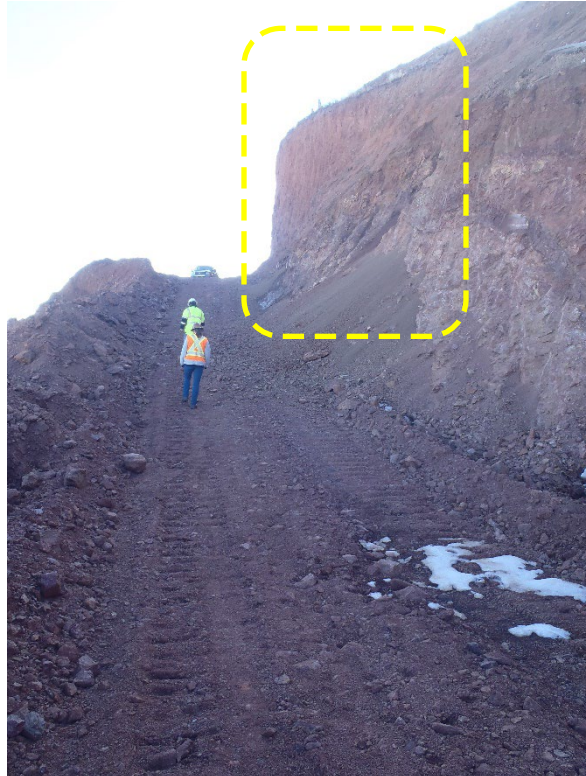
**Explosives:** Mr. Schnabel indicated the highwall on the "South Peak" (**Photo 5**) would likely need to be blasted to achieve a stable landform safely. The DRMS approved the blasting plan technical revision (TR-23) request on December 19<sup>th</sup>. Mr. Schnabel expected blasting activities would begin in January of 2024.

Photo 5. South Peak highwall likely to require some blasting work (looking south).

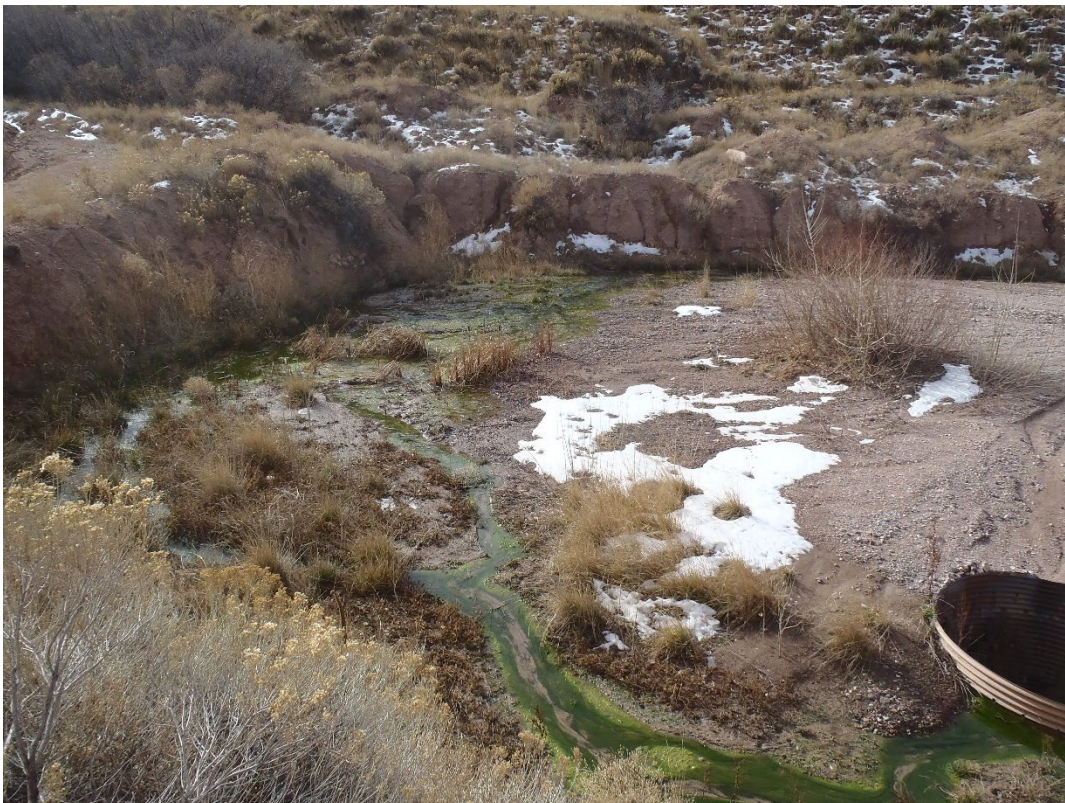
**Hydrologic Balance:** Discharge from the French drain (**Photo 6**) continues to be observed, demonstrating this system is functioning as designed.

Photo 6. Clear water flowing from the French drain (near standpipes near office building).
