**PERMIT INFORMATION**

<b>Permit Number:</b> C-1981-008 <b>Mine Name:</b> New Horizon Mine <b>Operator:</b> Elk Ridge Mining and Reclamation, LLC <b>Operator Address:</b> Mr. Tony Tennyson P.O. Box 628 27646 West 5th Avenue Nucla, CO 81424	<b>County:</b> Montrose <b>Operation Type:</b> Surface <b>Permit Status:</b> Active <b>Ownership:</b> Private
	<b>Operator Representative Present:</b>  Mindy Sickles
<b>Operator Representative Signature: (Field Issuance Only)</b>

<b>Inspection Start Date:</b> December 11, 2023 <b>Inspection Start Time:</b> 11:45 <b>Inspection End Date:</b> December 11, 2023 <b>Inspection End Time:</b> 13:15		<b>Inspection Type:</b> Coal Complete Inspection <b>Inspection Reason:</b> Normal I&E Program <b>Weather:</b> Clear	
<b>Joint Inspection Agency:</b>  None		<b>Joint Inspection Contacts:</b>  None	
<b>Post Inspection Agency:</b>  None		<b>Post Inspection Contacts:</b>  None	
<b>Inspector(s):</b>  Clayton Wein	<b>Inspector's Signature:</b>  <i>Clayton Wein</i>  <b>Signature Date:</b> 12/26/2023

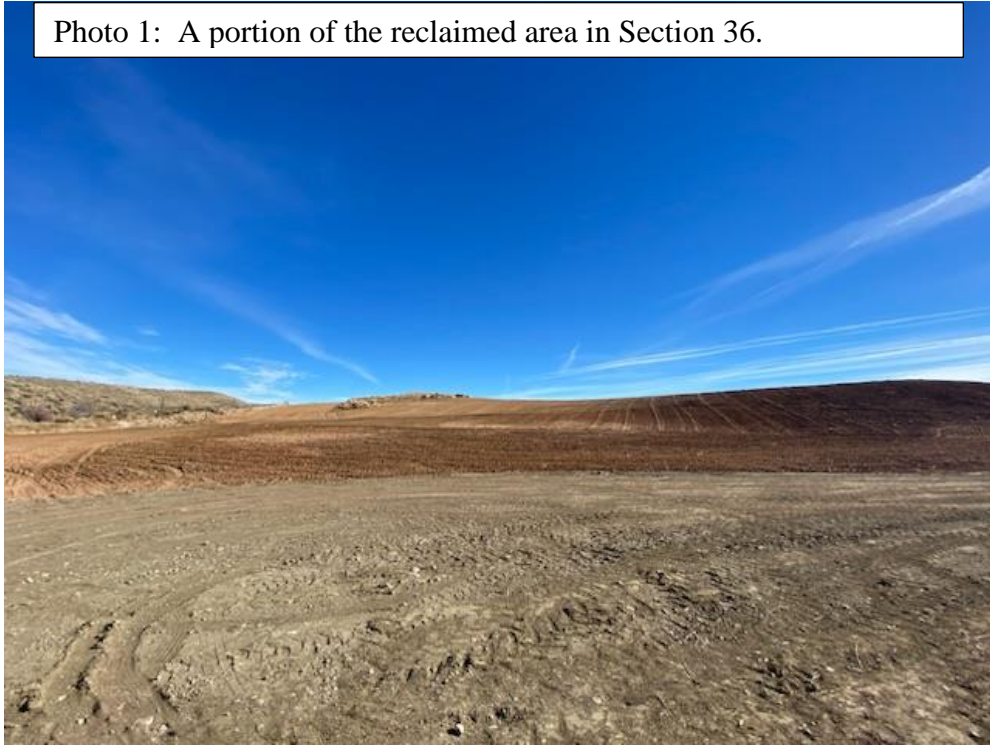
During the inspection, much of the reclamation work located within Section 36 had been completed (Photo 1). Only the eastern most portion required the completion of spreading and grading topsoil. The remainder of the reclamation had been backfilled with Bench 1 material and then covered with topsoil. The area had been graded to the approved post-mining contours. There were no indications of differential settling or erosion. The area adjacent and east of the Johnson Access Road was actively being seeded during the inspection (Photo 2). Discussions with the operator's representative indicated that the last of the grading and seeding would likely occur in the following couple of weeks.

Photo 1: A portion of the reclaimed area in Section 36.

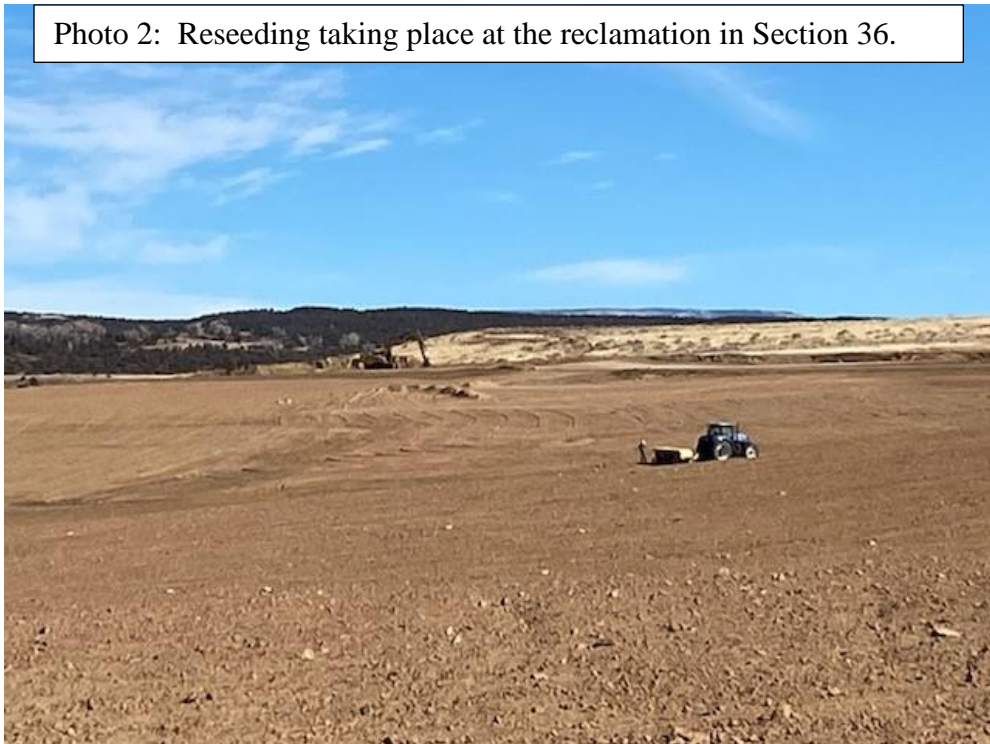
Photo 2: Reseeding taking place at the reclamation in Section 36.

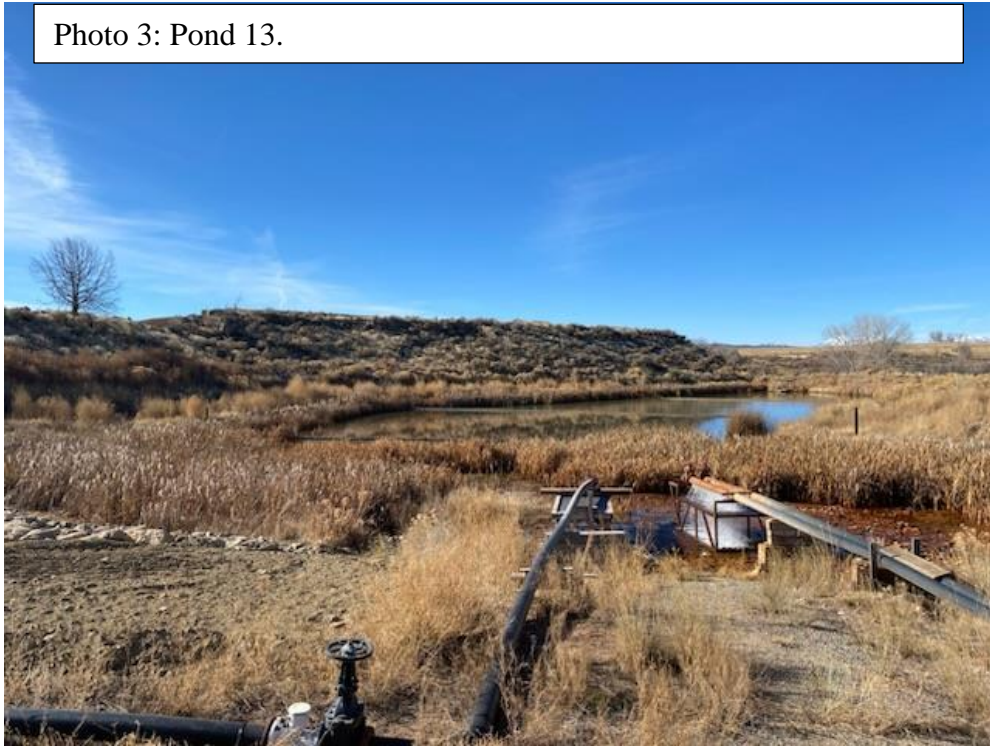
Pond 13 was impounding water during the inspection (Photo 3). The inlets for the pond were clear of debris and functioning as designed. The pond's embankment was stable with vegetative cover. There were no erosional features identified. The outlet for Pond 13 was unobstructed and discharge was occurring.

Photo 3: Pond 13.

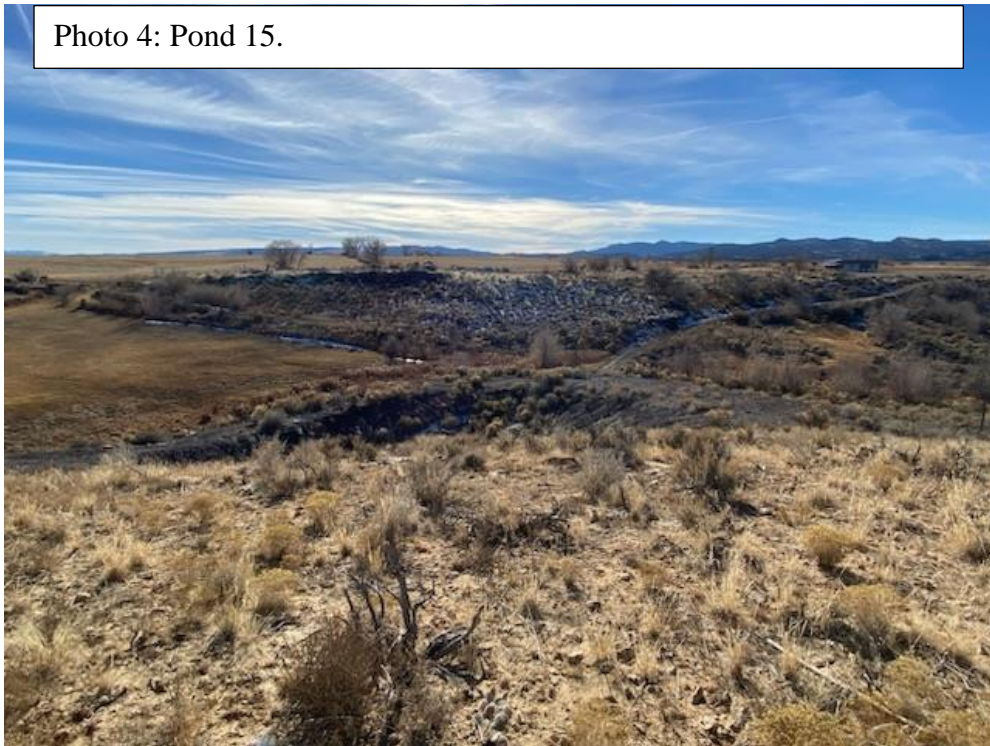
Pond 15 was also dry. The pond's embankments were stable with vegetative cover. No new erosional features were noted. The small rills on the inside of the pond's embankments had not enlarged since the previous inspection (Photo 4). These rills have been documented in the Division's previous inspection reports.

Photo 4: Pond 15.

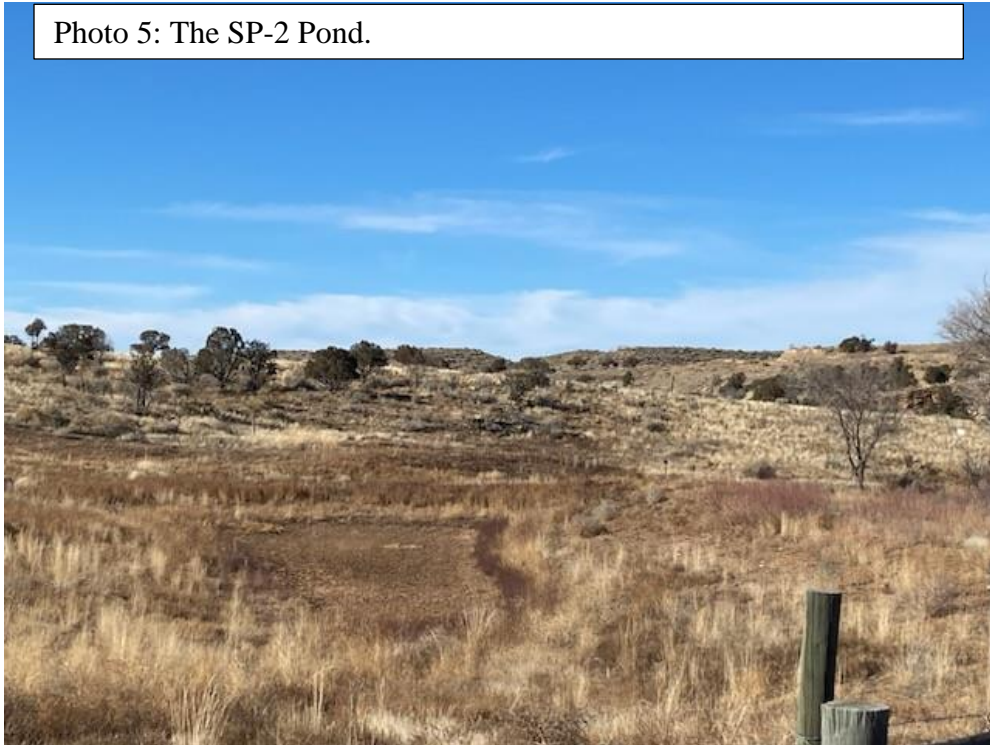
The SP-2 Stock Pond was not holding any water in it during the inspection (Photo 5). The embankment was stable and covered with vegetation. The inlet to the pond and the outlet were unobstructed. There were no erosional features identified.

Photo 5: The SP-2 Pond.

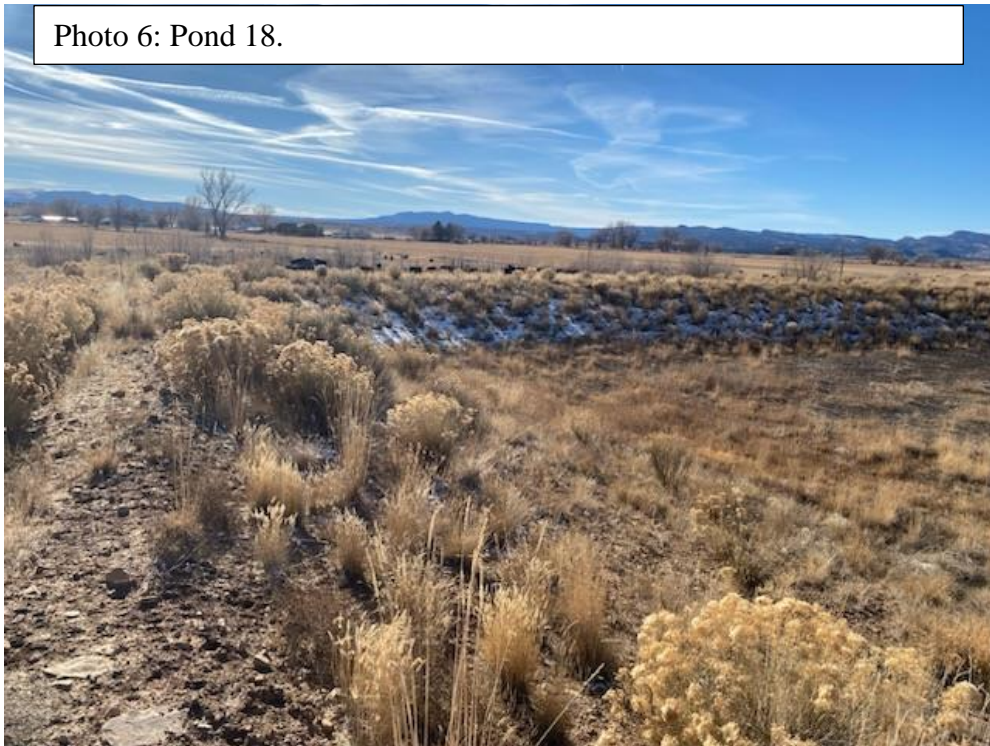
Pond 18 is located just south of the Mine office. The pond was dry at the time of the inspection (Photo 6). The inlet and outlet for the pond were observed to be clear of debris. The embankment was covered with vegetation and stable. There were no indications of erosional features.

Photo 6: Pond 18.

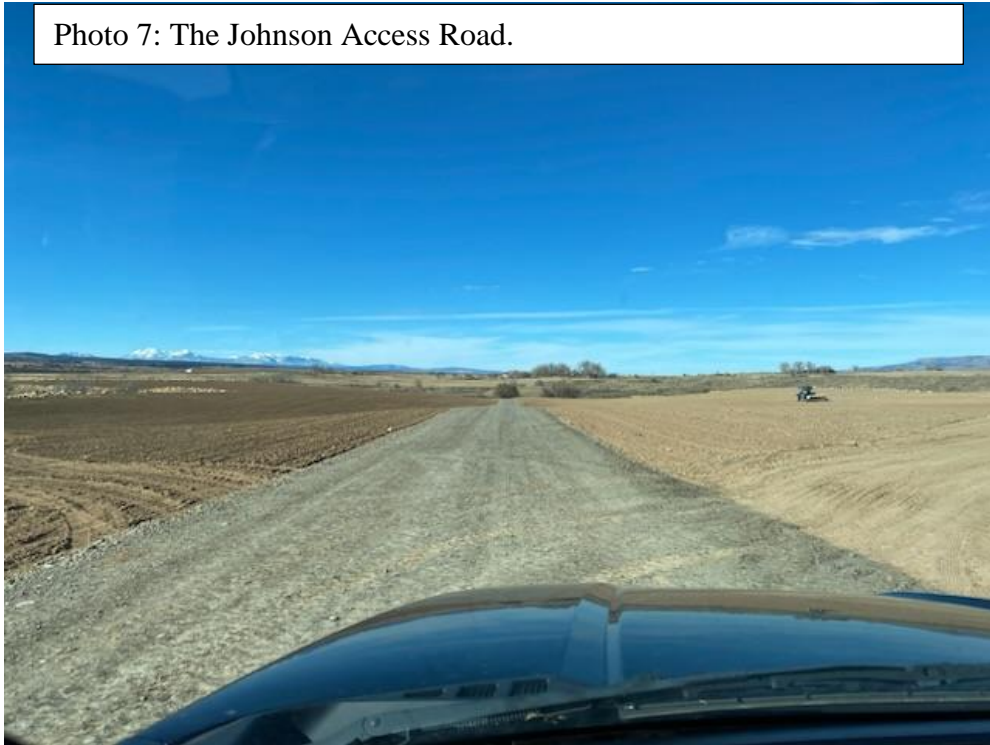
The Johnson Access Road provides access to Pond 13 from BB Road. The road was stable with no erosional features observed (Photo 7). Culverts for the access road were unobstructed and the inlets and outlets for the culverts were clear (Photo 8).

Photo 7: The Johnson Access Road.

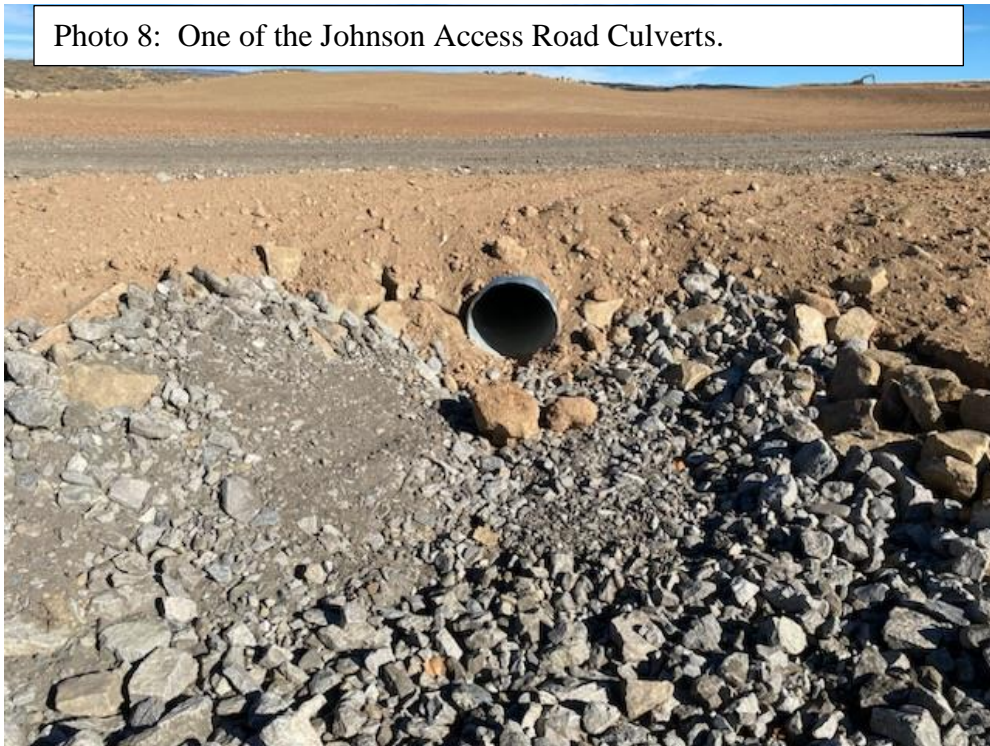
Photo 8: One of the Johnson Access Road Culverts.

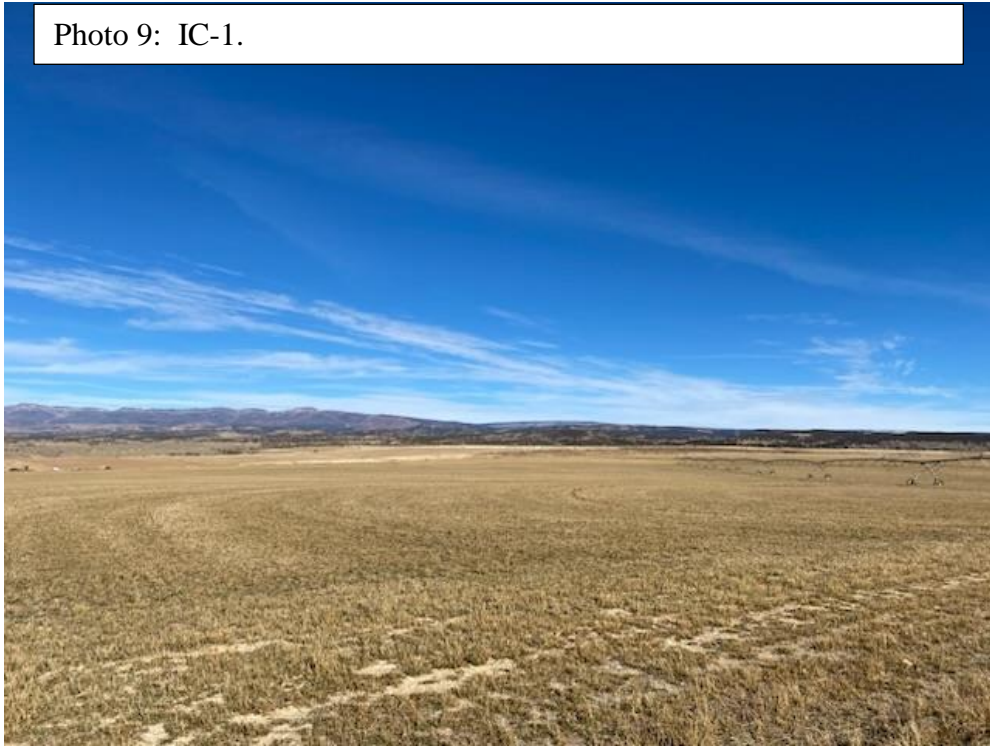
The IC-1, irrigated cropland is located on the southwest corner of the intersection of 2700 Road and BB Road (Photo 9). The field was stable and covered with vegetation. There were no indications of differential settling or erosion observed.

Photo 9: IC-1.

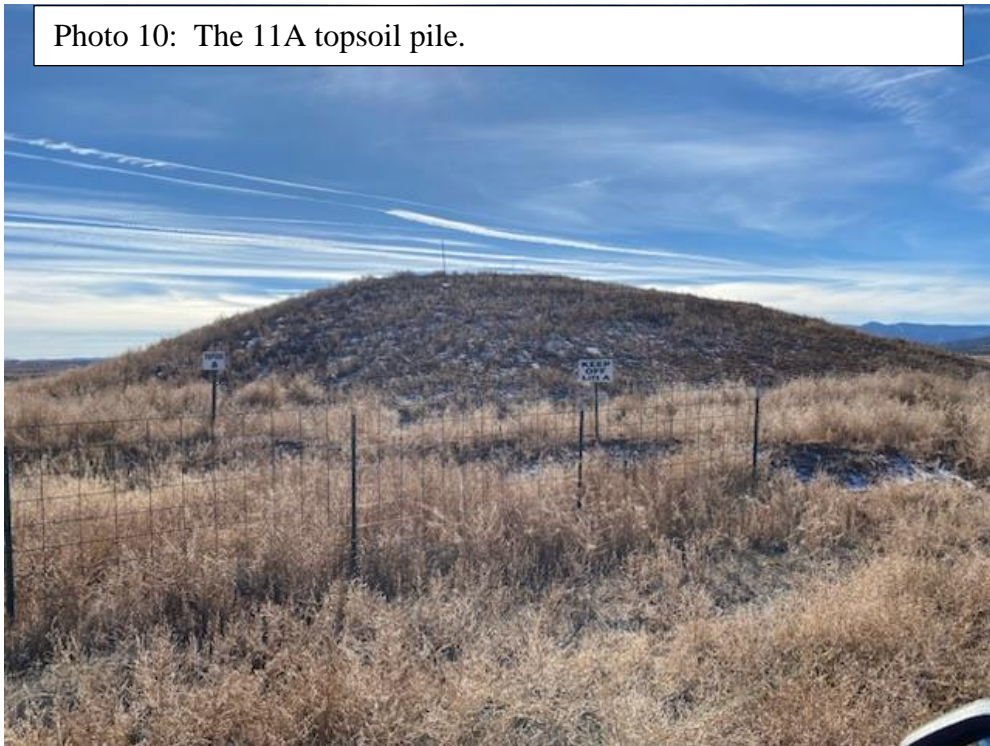
Topsoil Piles 11A (Photo 10) and 11B are located on the south side of IC-1. The topsoil piles were stable and had sufficient vegetative cover. There were no erosional concerns identified. The perimeter ditches were stable and vegetated. No loss of topsoil resource was observed.

Photo 10: The 11A topsoil pile.
