PERMIT INFORMATION

Permit Number: C-1981-035 Mine Name: King Coal Mine Operator: GCC Energy, LLC Operator Address: Mr. Jordan McCourt 6473 County Road 120 Hesperus, CO 81326	County: La Plata Operation Type: Underground Permit Status: Active Ownership: Private
	Operator Representative Present: Michael Dickson
Operator Representative Signature: (Field Issuance Only)

INSPECTION INFORMATION

This report documents the Division's observations taken during a complete inspection of the King Mine on December 12, 2023. The inspection was conducted by Clayton Wein of the Division. The operator, GCC, was represented during the inspection by Michael Dickson. The weather was clear with a temperature of 38° F. The ground conditions were partly covered with snow on north-facing areas and dry/wet on the south-facing areas.

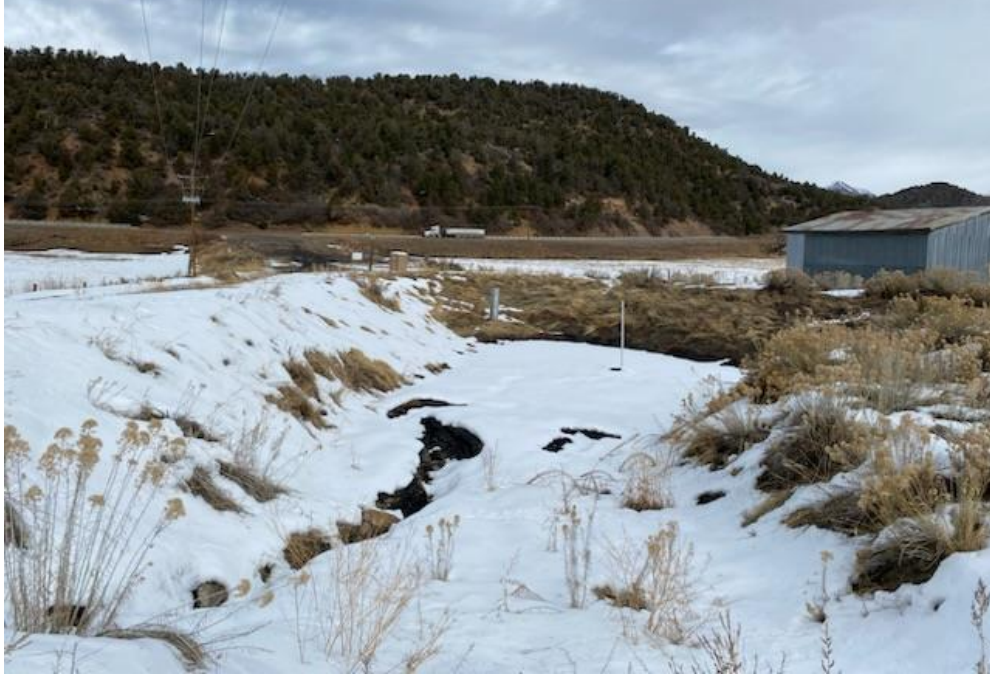
There are two ponds located at the King I Mining Area. The East Pond (Photo 1) and the West Pond (Photo 2). These ponds collect runoff from the refuse disposal area and the mining facilities north of the refuse piles. The East Pond was covered with snow at the time of the inspection. The embankment was stable with no erosional

features. The inlet and outlet for the pond were clear of obstructions. The sediment marker was observed to be posted. The West Pond was also covered with snow. The pond's embankment was stable and there were no erosional issues identified. The inlet and outlet for the pond were clear of debris. The sediment marker was intact.

Photo 1: The King I East Sediment Pond

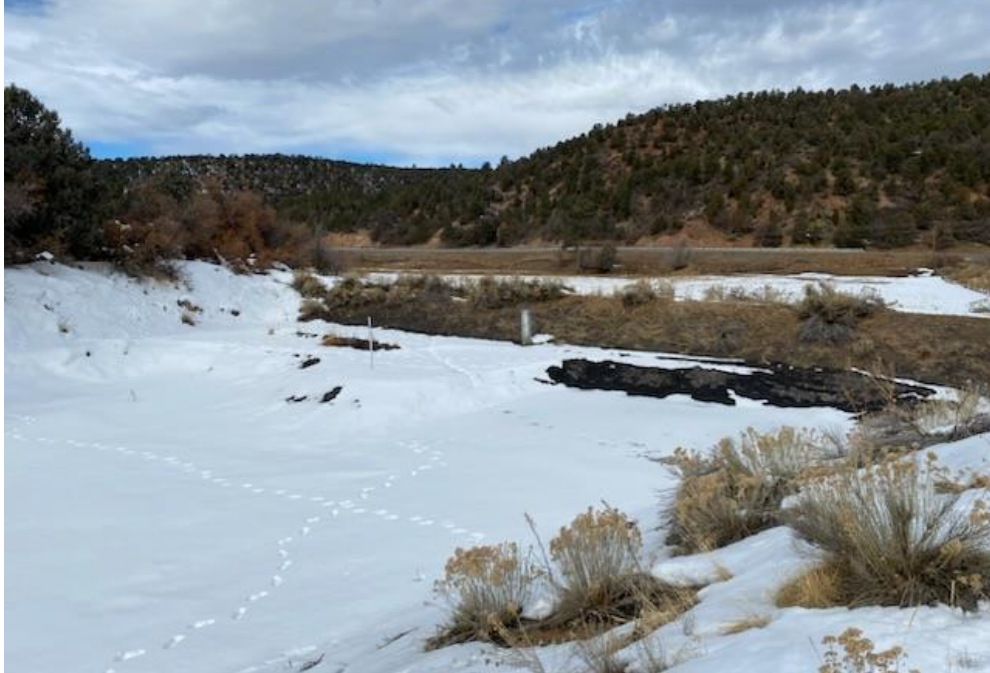
Photo 2: The King I West Sediment Pond.

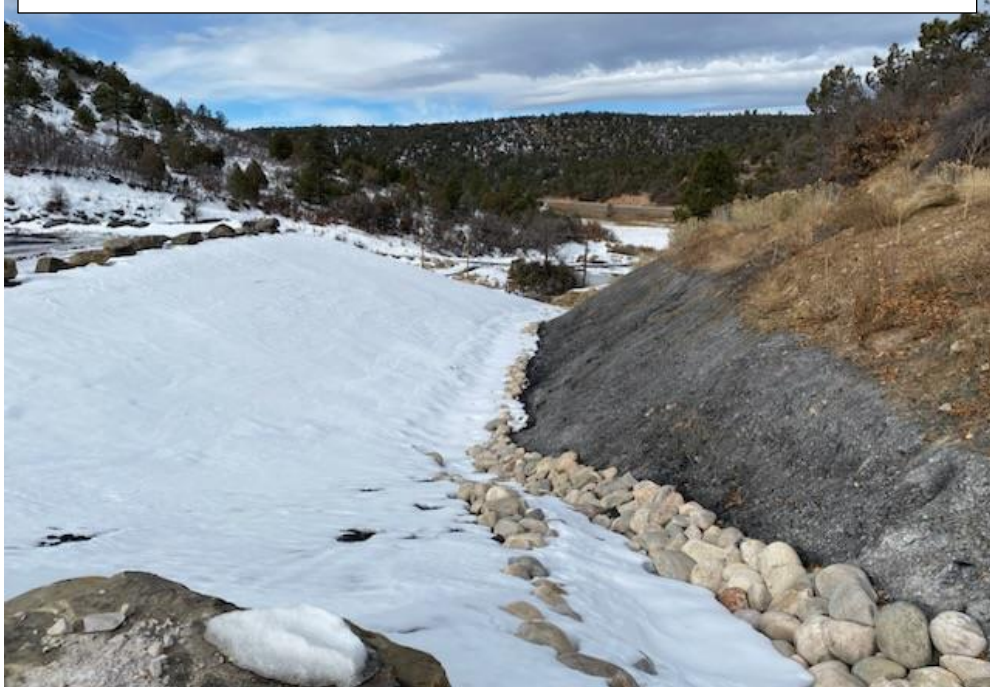
Reach 10 and Reach 13 were repaired in the fall of 2023 due to maintenance work being required on the Lower Refuse Disposal Area (LRDA). Reach 10 was returned to the configuration outlined on KI Map 007. The upper portion of Reach 10 is on the western section of the pile next to the haul road. This section of the ditch was clear of debris and stable. No erosional concerns were identified. The lower portion of Reach 10 parallels the haul road to the base of the LRDA. This section of the ditch was stable and there were no obstructions observed. No indications of erosion were seen. Reach 13 was mostly covered with snow at the time of the inspection. The ditch was stable with no erosional concerns identified (Photo 3). No blockages were observed. Reach 13 matched the location and design outlined on KI Map 007.

Photo 3: The recently completed maintenance on Reach 13.

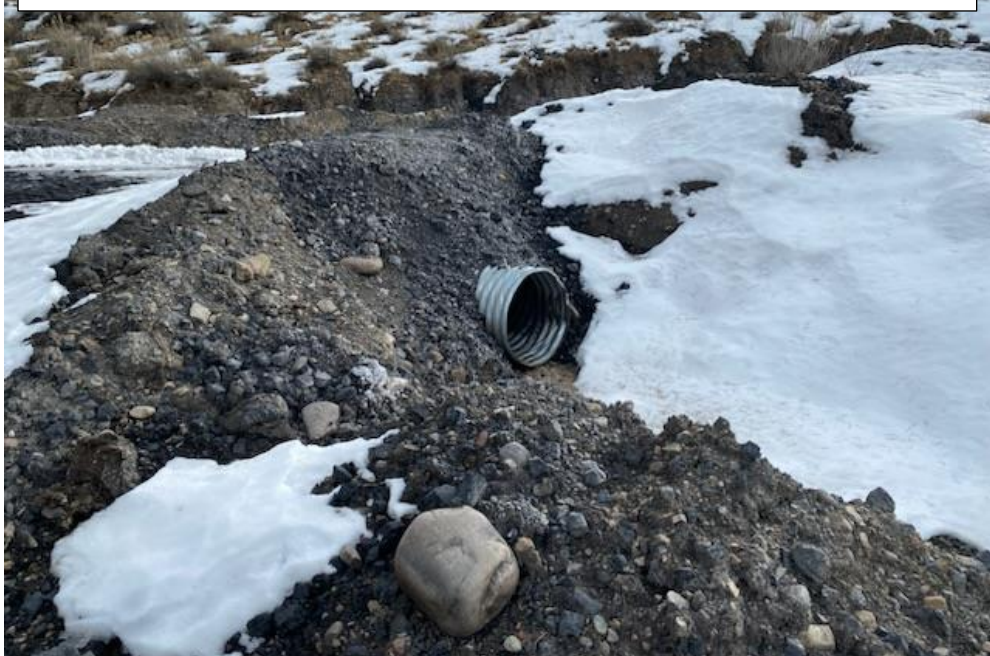
The Drainage ditches along the haul road were clear of debris and covered with snow. There were no indications of instability or erosion. Culverts along the haul road were clear of debris and unobstructed (Photo 4).

Photo 4: The lower culvert outlet along the Haul Road In-between the URDA and LRDA.

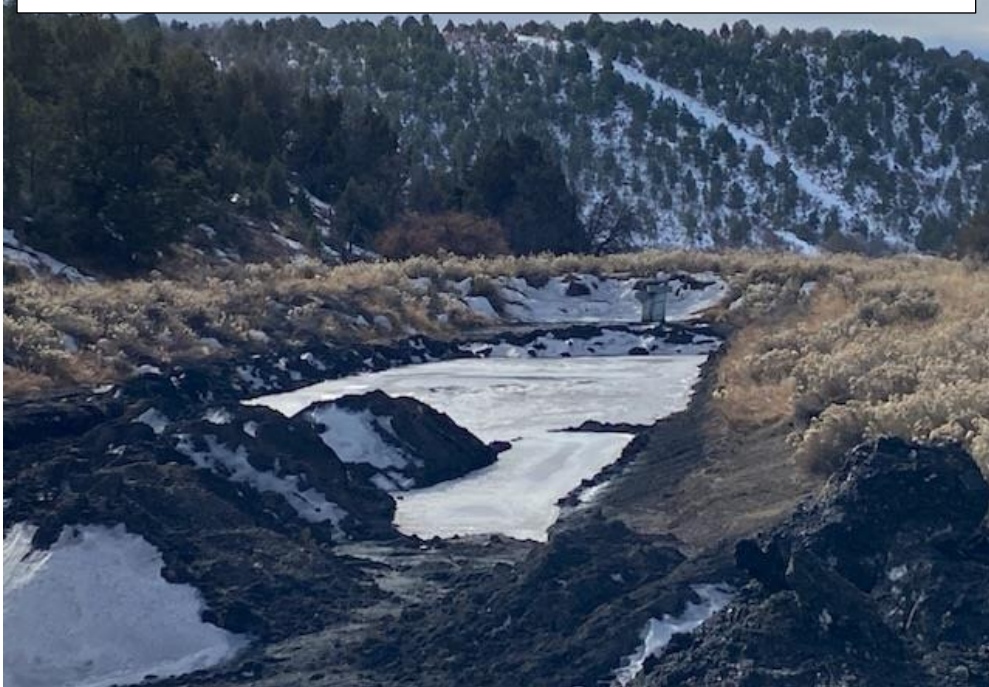
One sediment pond is located at the southern end of the King II Mining Area. The pond collects all runoff from the mining area. Pond cleaning has progressed since the previous inspection. The pond often becomes too saturated to clean and can only be conducted when conditions allow. The remaining capacity in the pond is sufficient to treat runoff. The sediment pond was holding some water below the level of the discharge outlet (Photo 5). The inlets and outlet for the pond were clear of obstructions. The pond's embankment was stable with vegetative cover. No erosional features were identified.

Photo 6: The King II Sediment Pond.

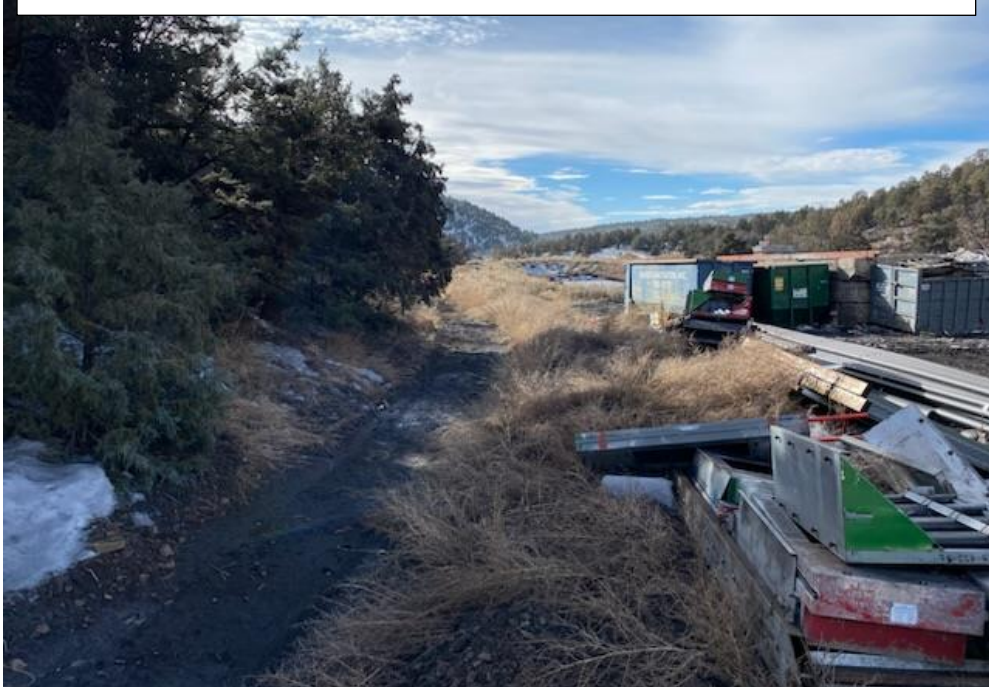
Two clear water ditches divert upstream runoff around the King II Area. The ditches were observed to be clear of debris and stable (Photo 6). There were no indications of instability.

Photo 6: The west Clearwater ditch at the King II Mining Area.

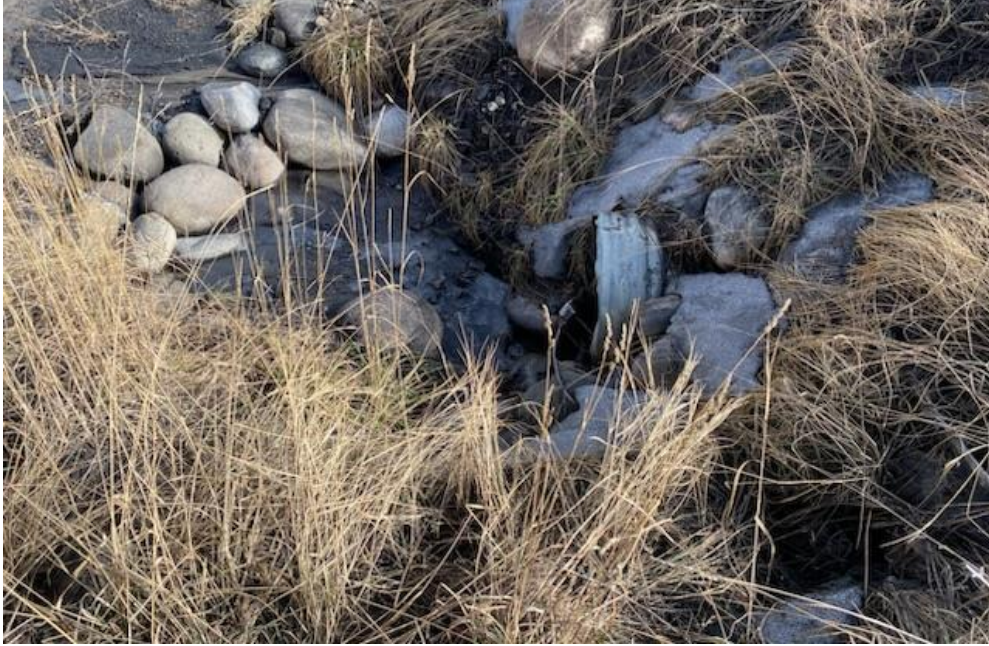
Various ditches and culverts (Photo 7) throughout the King II Area were functioning properly to convey water to the sediment pond. No obstructions or erosional features were identified.

Photo 7: The inlet to a culvert underneath the access road to the King II Sediment Pond.

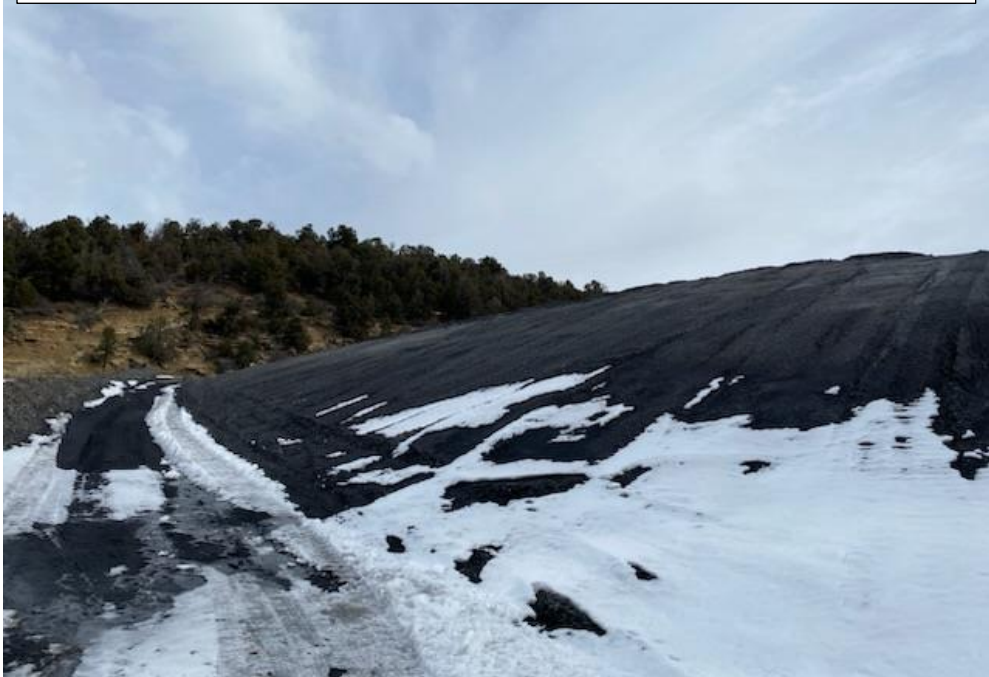
The coal waste disposal piles are located at the King I Mining Area. The Upper Refuse Disposal Area (URDA) was stable and partly covered with snow (Photo 8). A winter stockpile of refuse material was located on the southern end of the pile away from the front slope. There was ample room left to store more material when the URDA is accessible. The LRDA was also partly covered with snow during the inspection. Refuse material was actively being placed in a stockpile towards the middle of the LRDA. The slope of the LRDA was stable and there were no indications of erosion. The northeast section of the Pile was reshaped during a maintenance project in the

Photo 8: The URDA north slope.

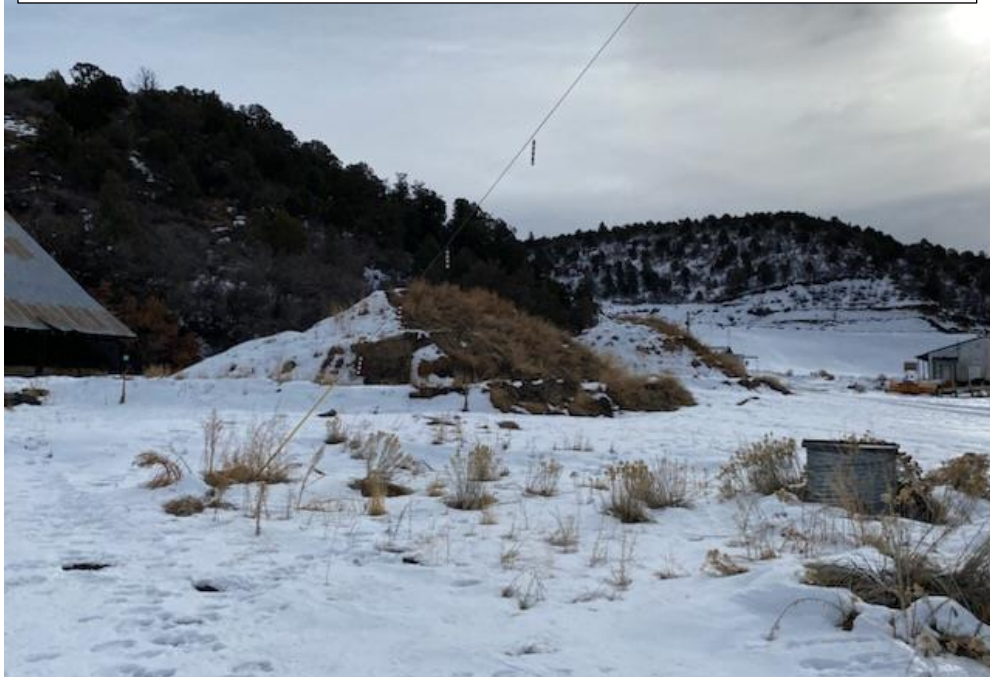
The topsoil stored at the King I Mining area was mostly covered with snow (Photo 9). The pile was stable with no indications of erosion. No loss of topsoil resource was observed. The topsoil stored at the King II Mining Area was stable with vegetative cover (Photo 10). The perimeter ditch was stable and clear of debris. No loss of topsoil resource was observed. All topsoil pile markers were observed to be intact and located on top of the piles.

Photo 9: The King I Topsoil Stockpile.

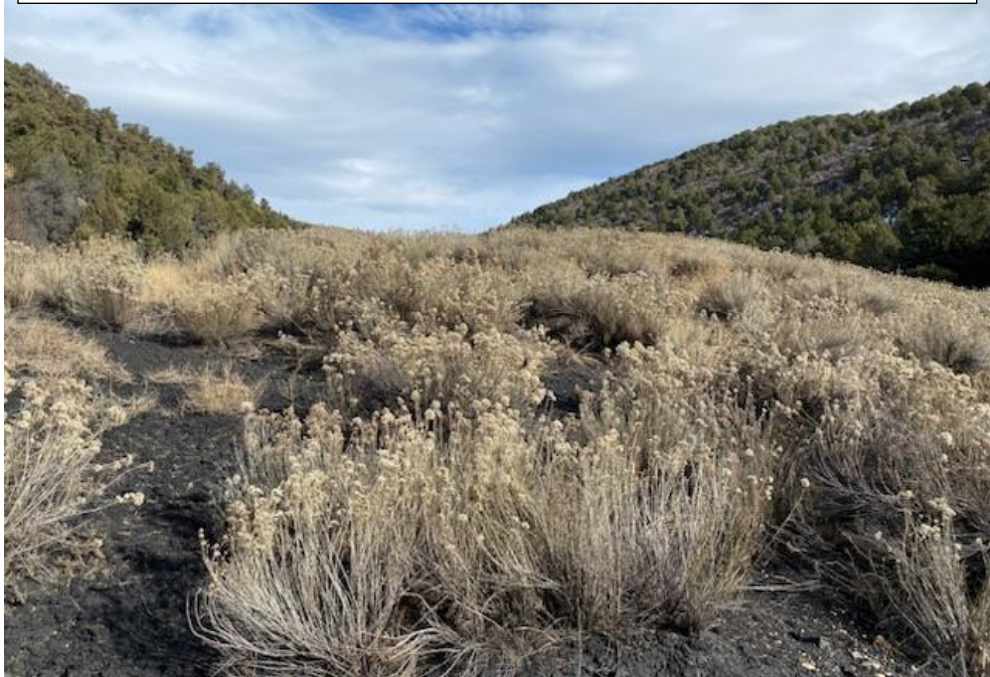
Photo 10: The King II Topsoil Stockpile.
