RE: Upland Gravel Pit No. 3, Permit No. M-2005-077, Unresolved Problem(s) Noted in a Past Inspection Report

MINERALS PROGRAM INSPECTION REPORT
PHONE: (303) 866-3567

MINE NAME: Upland Gravel Pit No. 3	MINE/PROSPECTING ID#: M-2005-077	MINERAL: Sand and gravel	COUNTY: Mesa
INSPECTION TYPE: Monitoring	WEATHER: Clear	INSP. DATE: July 5, 2023	INSP. TIME: 12:30
OPERATOR: Upland Gravel, LLC	OPERATOR REPRESENTATIVE: Jason Rinderle	TYPE OF OPERATION: 112c - Construction Regular Operation	
REASON FOR INSPECTION: Normal I&E Program	BOND CALCULATION TYPE:	BOND AMOUNT: \$57,785.00	
DATE OF COMPLAINT: NA	POST INSP. CONTACTS: DRMS	JOINT INSP. AGENCY: U.S.BLM	
INSPECTOR(S): Amy Yeldell	INSPECTOR'S SIGNATURE:

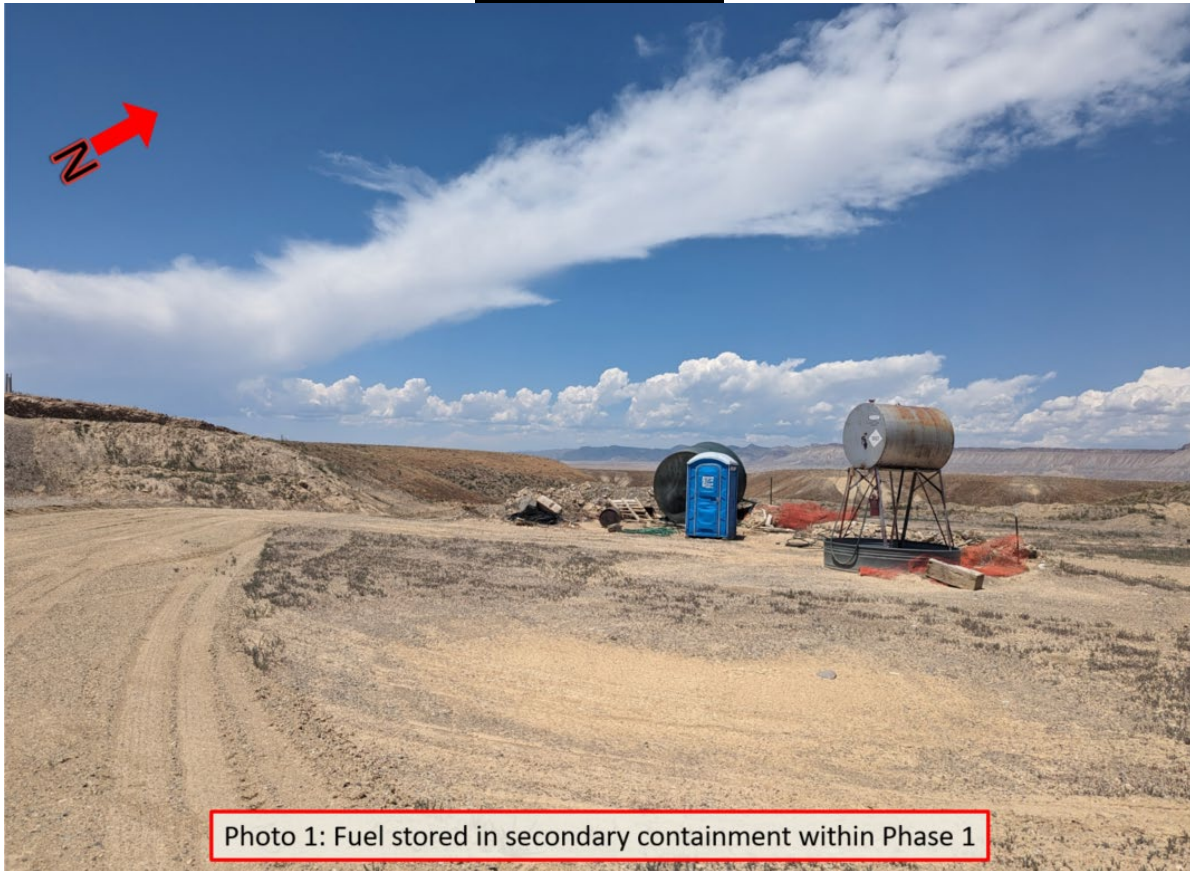
All fuel is stored within secondary containment. The primary fuel storage is located in Phase 1 (Photo One). No other hazardous or toxic materials were observed on site.

Photo 1: Fuel stored in secondary containment within Phase 1

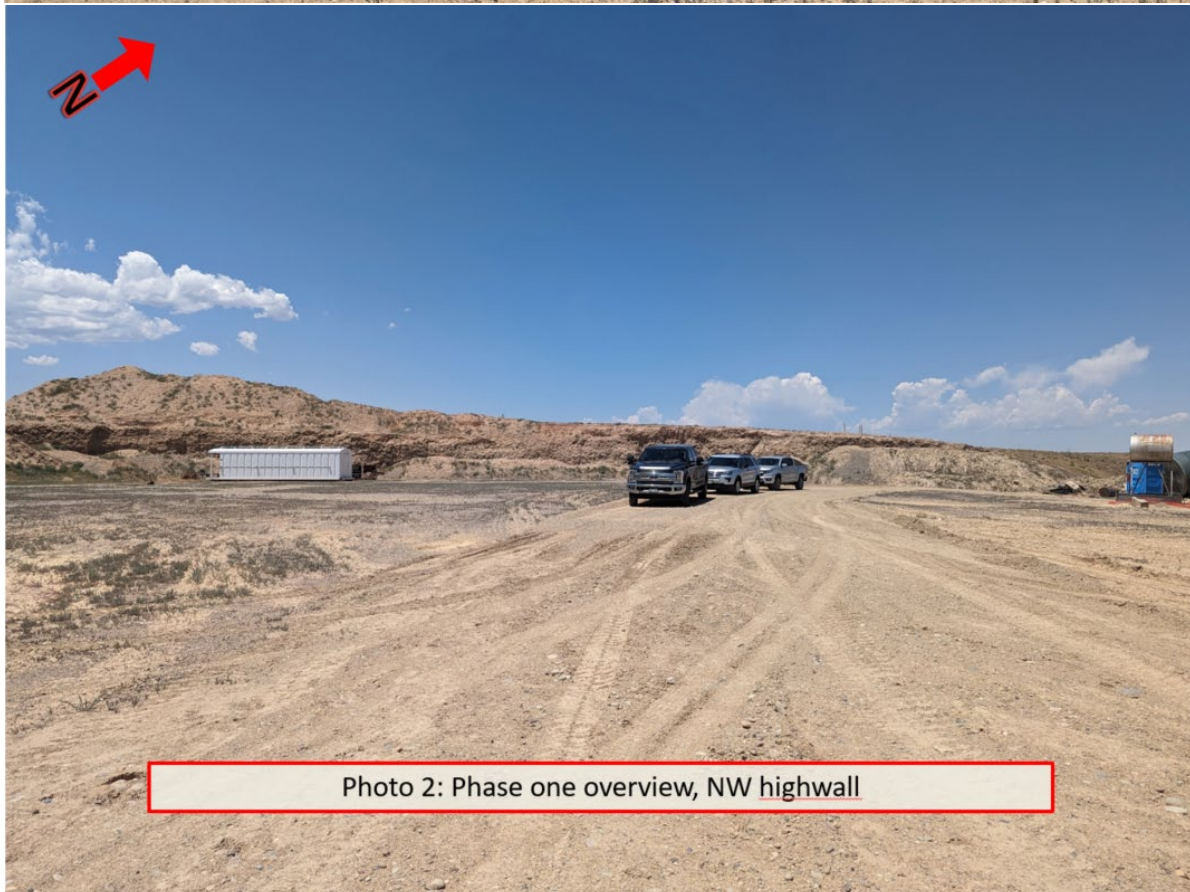
Phase 1, 2 and 4 are generally mined out with a flat pit floor remaining. The northwest highwall of Phase 1 and 2 adjacent to phase 9 is near vertical and 15 feet high by approximately 500 linear feet. Slope may be cut/fill. Overburden is stored above the highwall along Phase 9 (Photo Two). All other overburden is stored on the pit floor on the south side of Phase 2. The Northeast sloped of phase 1 and 2 are generally slopes at a 3H: 1V with only minor grading left to achieve final contour and smooth out adjacent stockpiles (Photo Three). The north edge of phase 1 near the road will need to be pulled back to blend naturally, approximately 300 LF at a 1H: 1V, 15 feet high.

Photo 2: Phase one overview, NW highwall

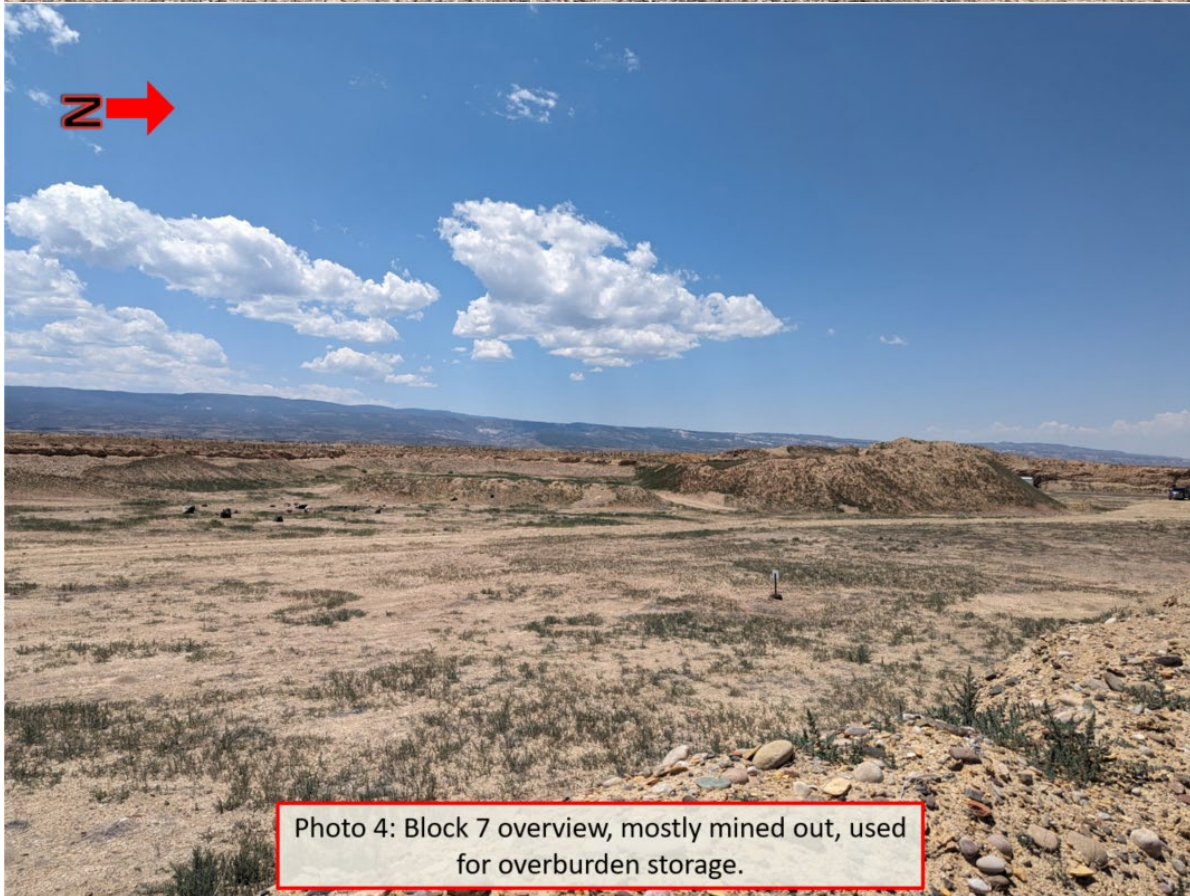
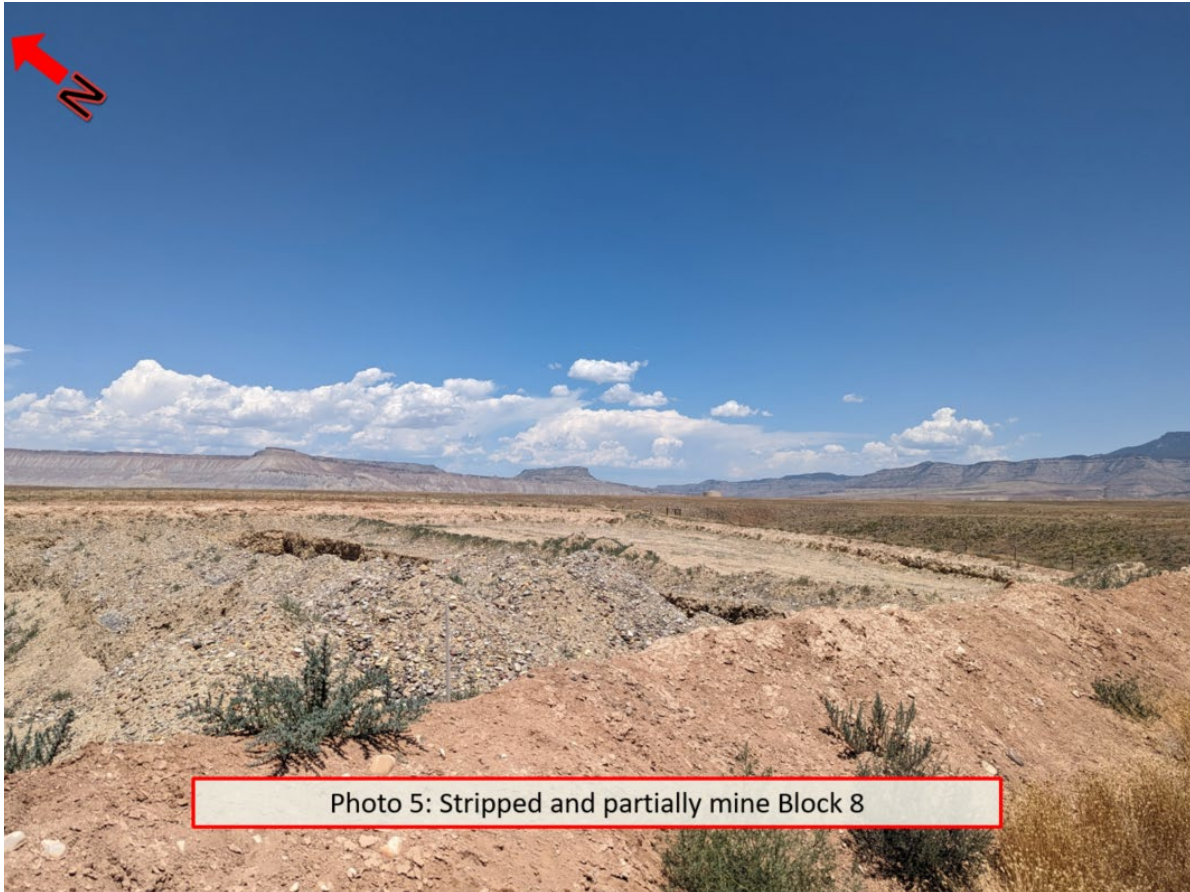
Phase 4 is completely stripped with approximately 0.8 acres left of mineable materials in Block 8 (Photos Four and Five). 1300 linear feet of slopes are all near vertical. Slopes are adjacent to a future mining phase and can be cut/fill.

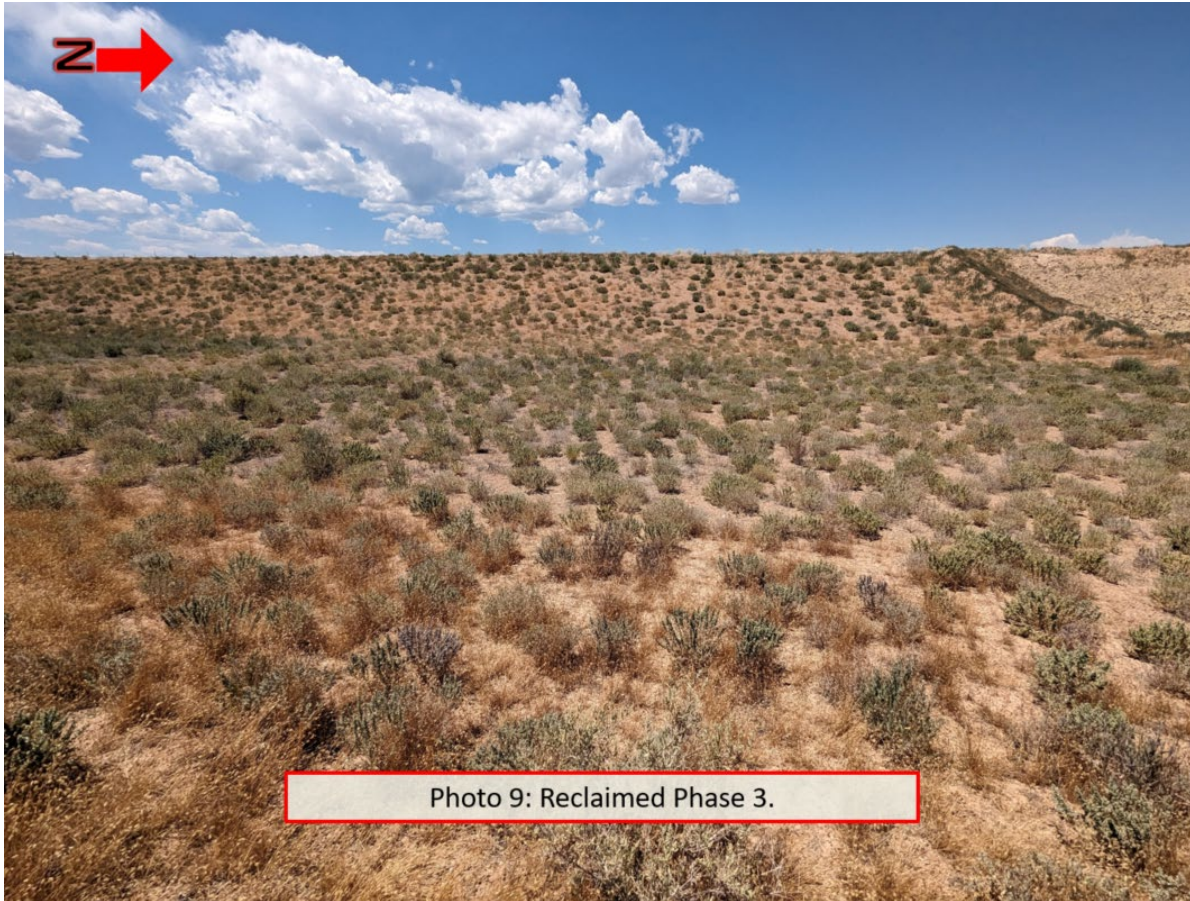
This site has a post mine land use of rangeland. Phase 3 blocks 5 and 6 were mentioned by the operator as having been previously released. There are no release revisions for this permit to date. However Phase 3, Blocks 5 and 6 have been successfully reclaimed (Photos Eight and Nine). This area consists of mostly saltbush. Overall cover of the reclaimed areas is significantly higher than that of the adjacent unaffected lands. No weeds were observed in this area.

Photo 9: Reclaimed Phase 3.
