To: Jerald Schnabel  
Castle Aggregate Industries Inc.  
File: November 2023 Monitoring Summary

**Reference: November 2023 Geotechnical Monitoring Summary Pikeview Quarry**

Client/Project  
CASTLE AGGREGATE  
PIKEVIEW QUARRY SLOPE  
MONITORING  
Project No.  
2057288200

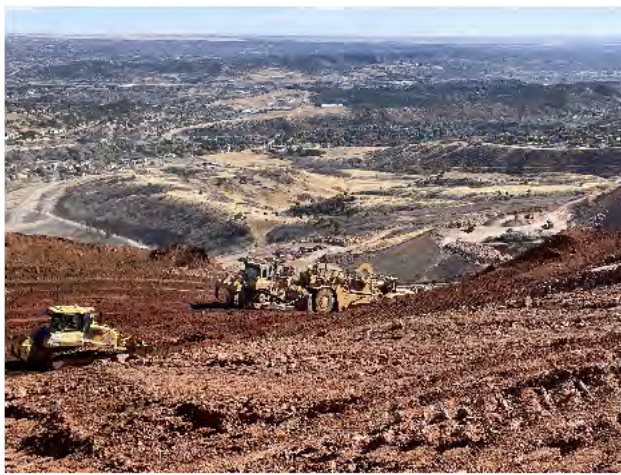
6. Dozers grading down from haul road.

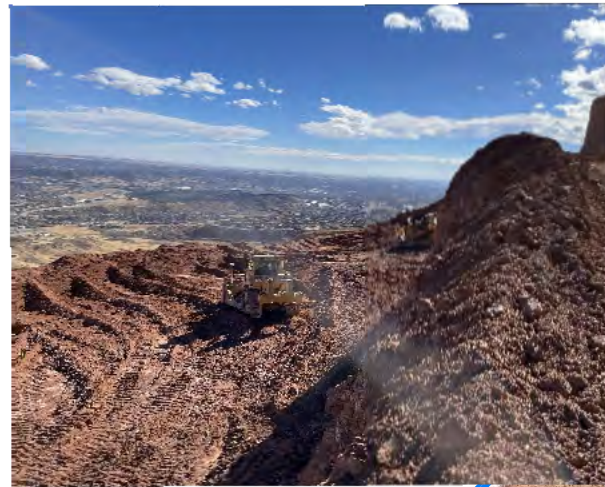
5. Dozers working near top of haul road.

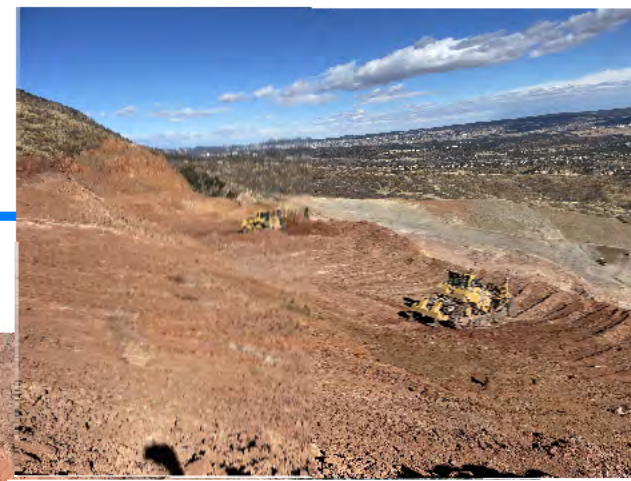
4. Dozers pushing material down slope.

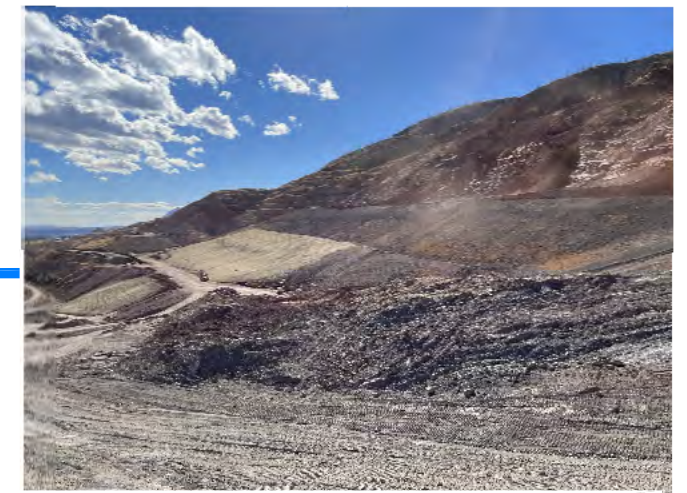
3. First bench seen from North Borrow Area.

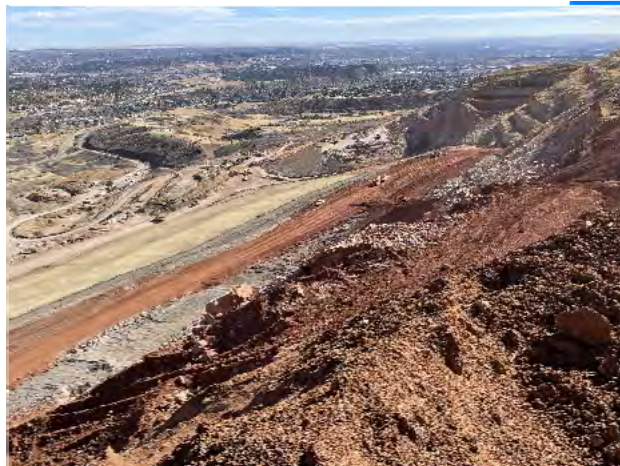
7. Compacted pit floor seen from haul road .

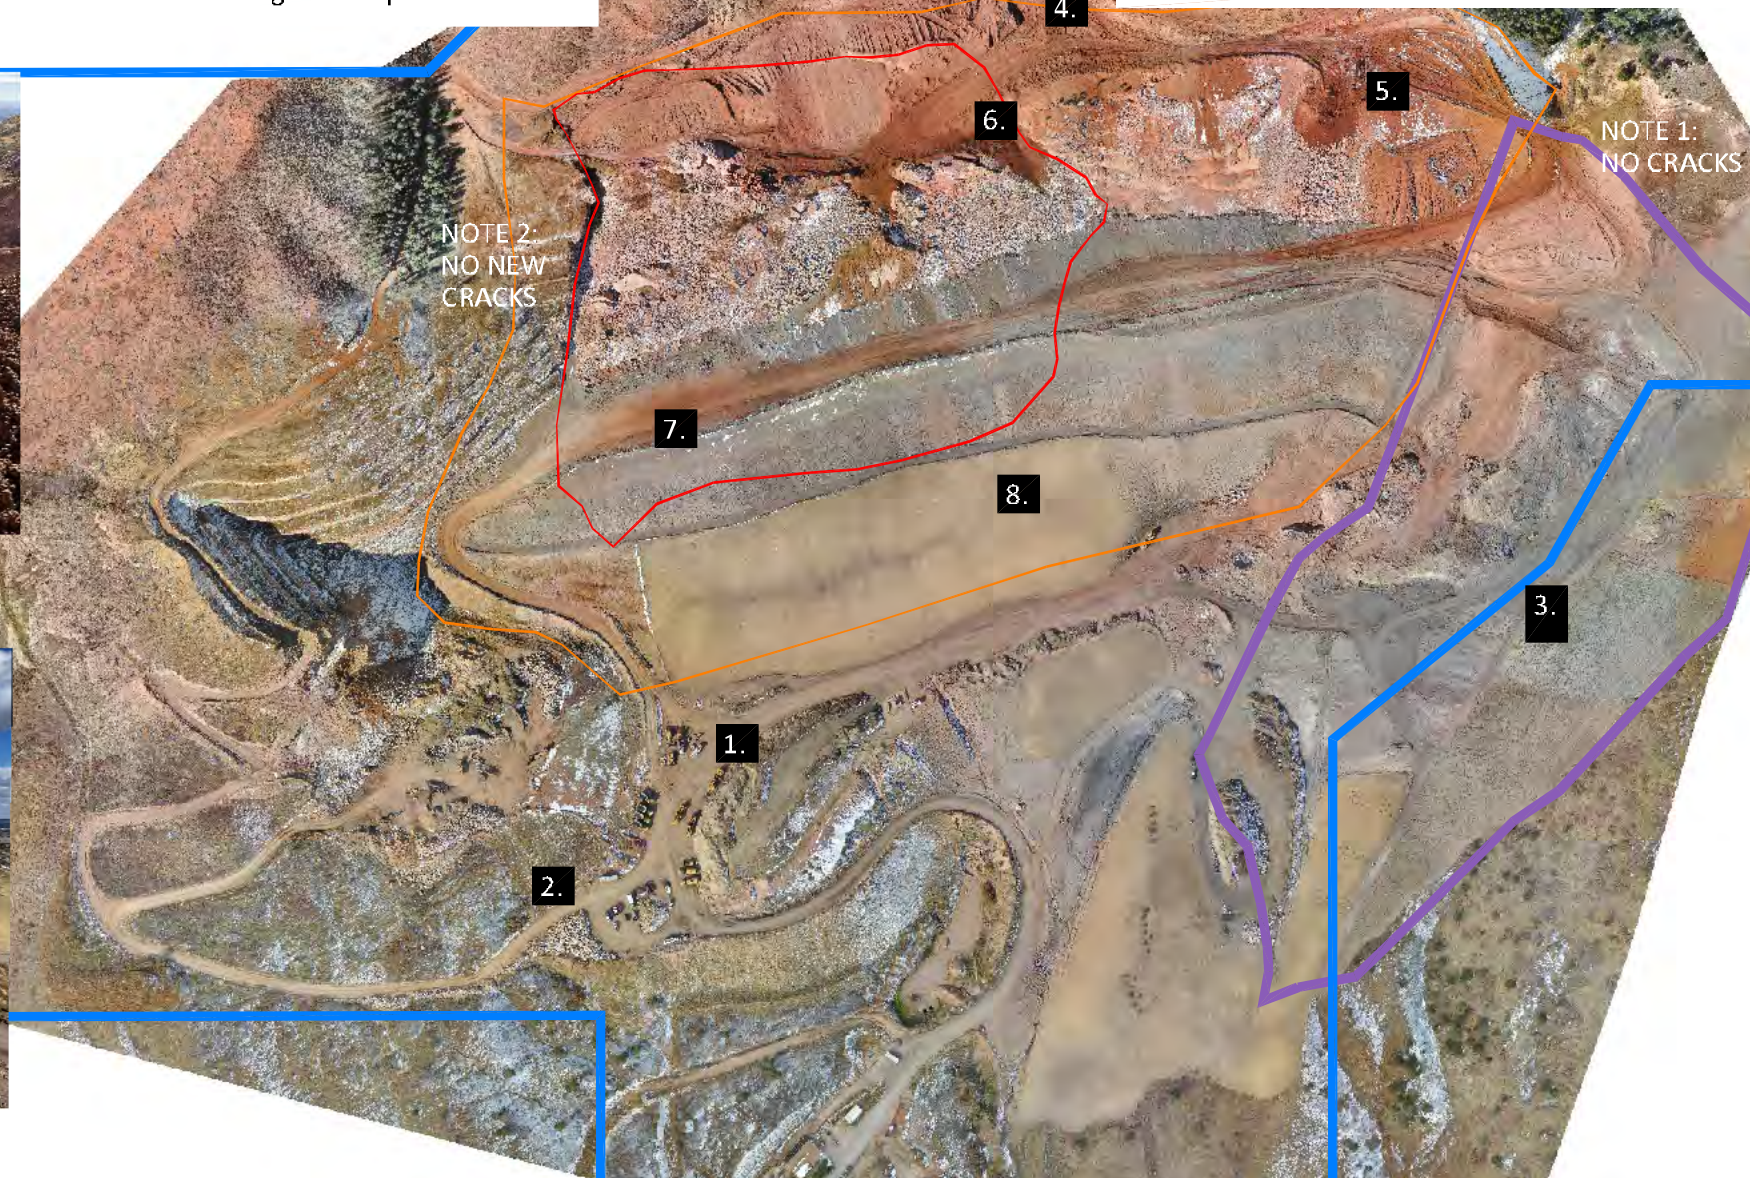
NOTE 1:  
NO CRACKS

NOTE 2:  
NO NEW  
CRACKS

- NO CRACKS OBSERVED IN THIS AREA.
- NO NEW CRACKS OBSERVED IN THIS AREA.
- PHOTOS TAKEN ON NOVEMBER 16, 2023.

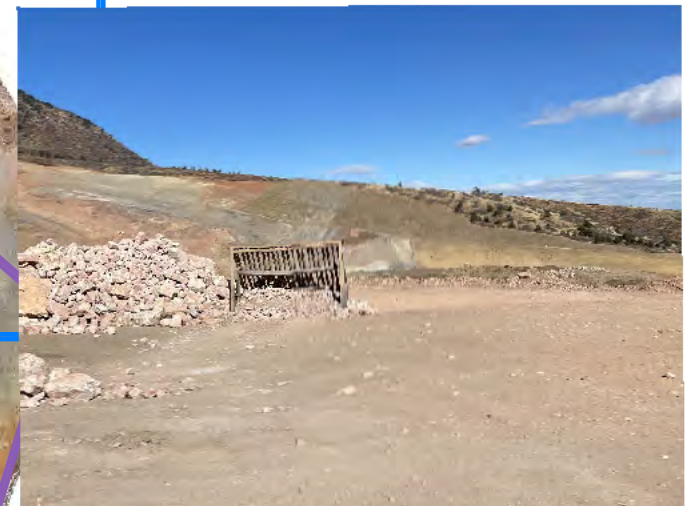
2. Riprap stockpile.

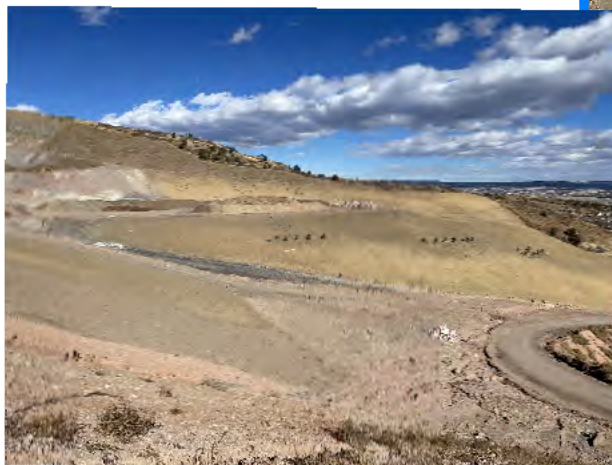
8. North Borrow Area with growth medium.

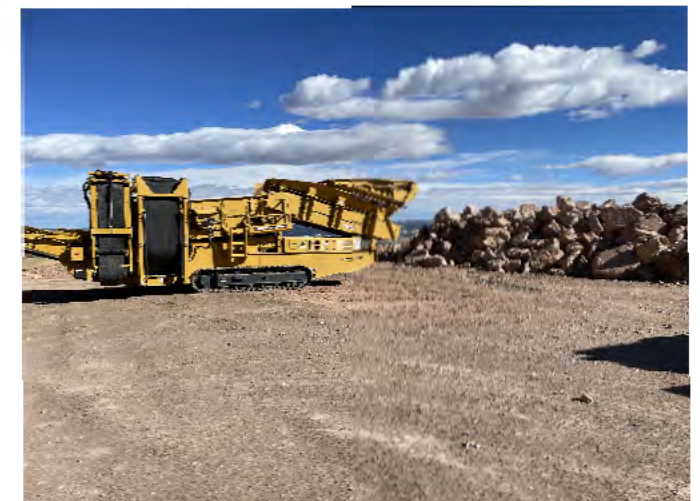
1. Astec sorting riprap.

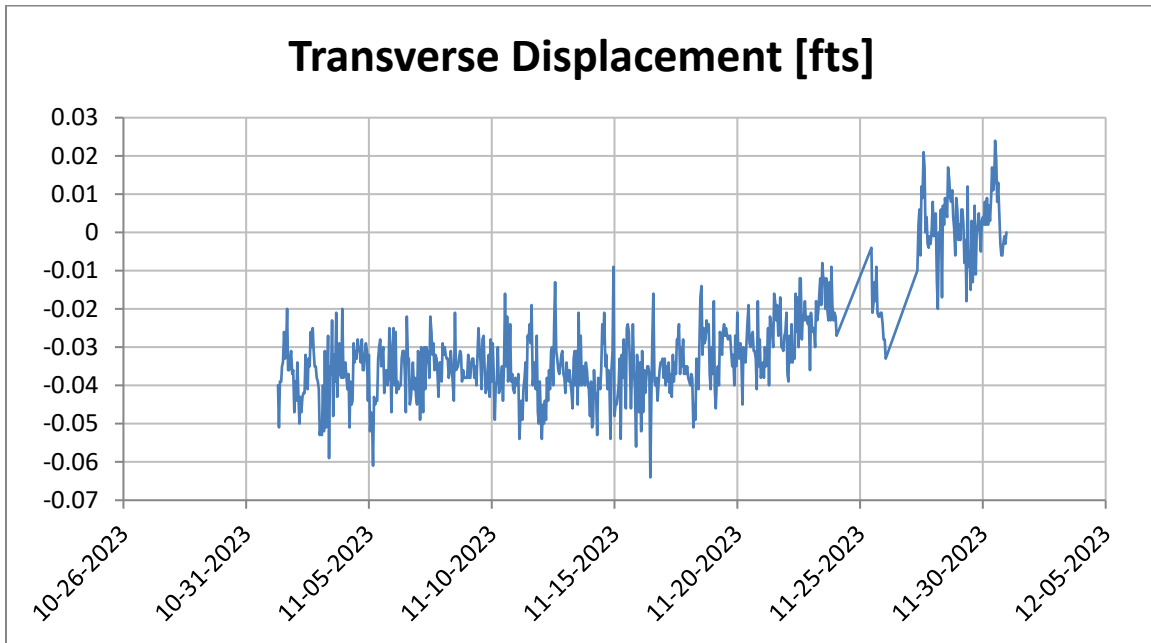
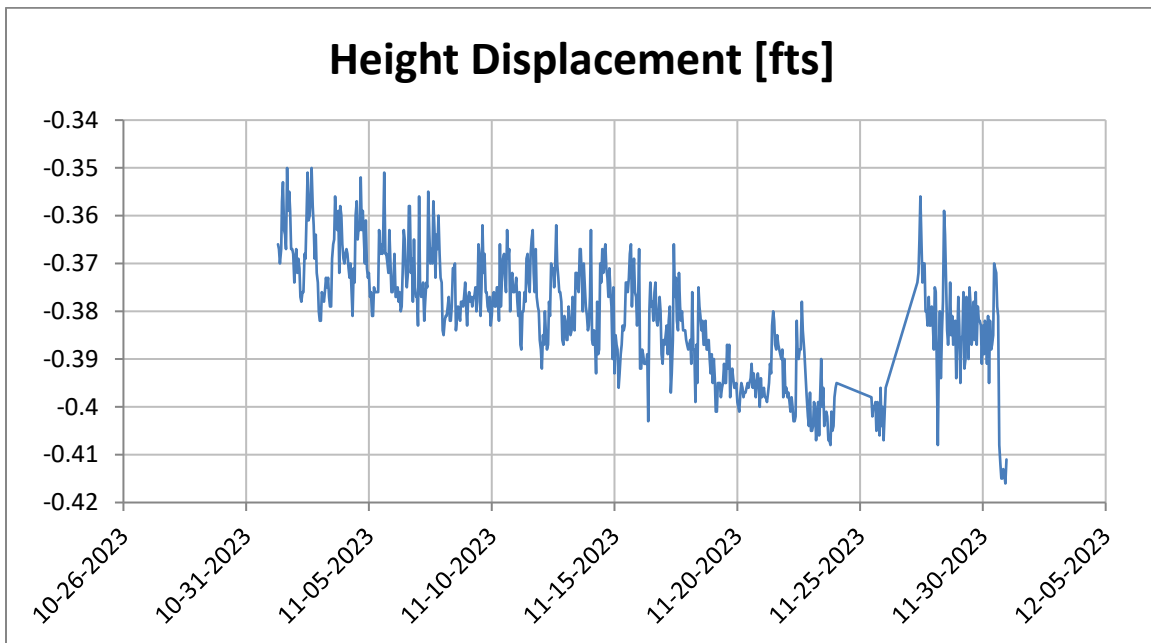
## Prism BR1

| Prism ID | Cumulative Transverse Displacement (ft) | Cumulative Height Displacement (ft) | Monthly Delta (ft) | Cumulative Delta (ft) | Notes / Recommendations |
|---|---|---|---|---|---|
| BR1 | 0.000 | -0.411 | 0.0761 | 0.7716 | Slope creep movements |

The data show stable conditions with no movements at 18 of 20 prisms with recorded displacements limited to data scatter and not actual movements. Prisms BR1 and NP66 are located above the landslide, and these prisms recorded slope creep movements at slow velocity. This settlement was likely related to loose fill or landslide material consolidating under its own weight. These prisms were placed in areas where slope creep movements are likely to occur; therefore, movements being recorded is expected. Similar movements are expected at prism BR3, but the movements are not yet apparent with the limited data set. Almost all of the prism data indicate a data shift in November; these shifts have previously occurred during the colder fall and winter months and are not an indication of actual movements. Plots of the transverse and height displacements for each prism are included in Appendix B.

1. Survey accuracy is  $\pm 0.016$  feet.
2. Alert threshold is  $\pm 0.35$  feet.
3. Transverse displacement is in the horizontal direction. Positive direction means closer to the robotic station.
4. Height displacement is in the vertical direction. Positive direction means higher in elevation.
5. Prism records slope creep movements.

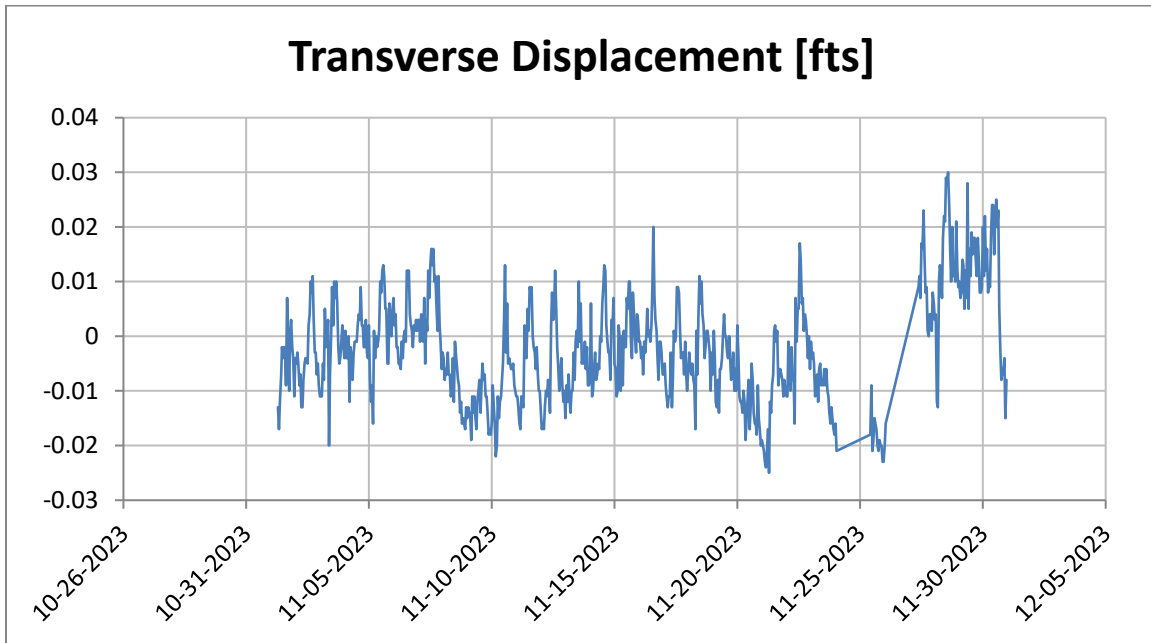
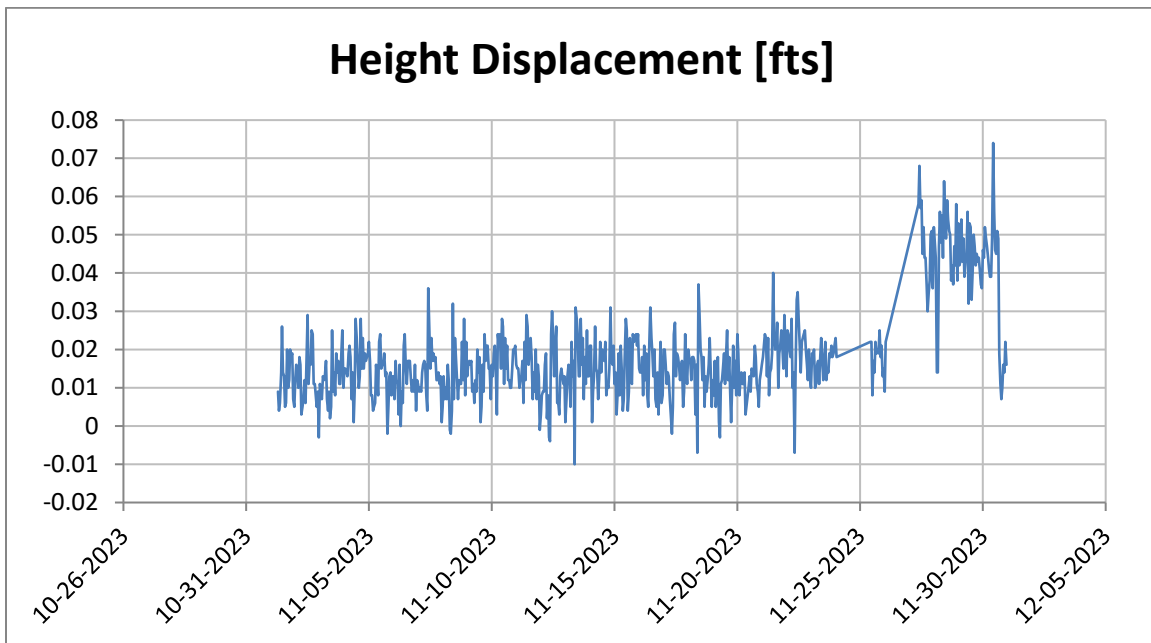
## Prism P25

| <b>Date(s)</b> | <b>Alert</b> | <b>Cause/Actions taken</b> | <b>Resolved</b> |
|---|---|---|---|
| 30-Nov | P25 regression limits received | No work being performed at time of alert. No sign of movements when area was inspected. Believed to be a data error from heater in prism building. | 30-Nov |

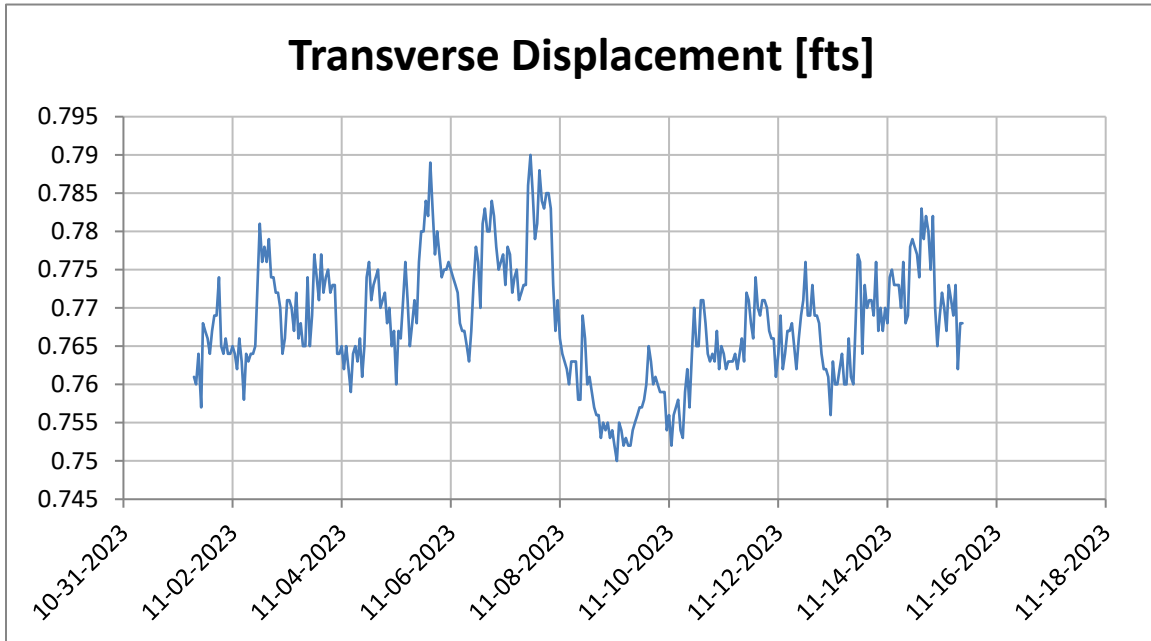
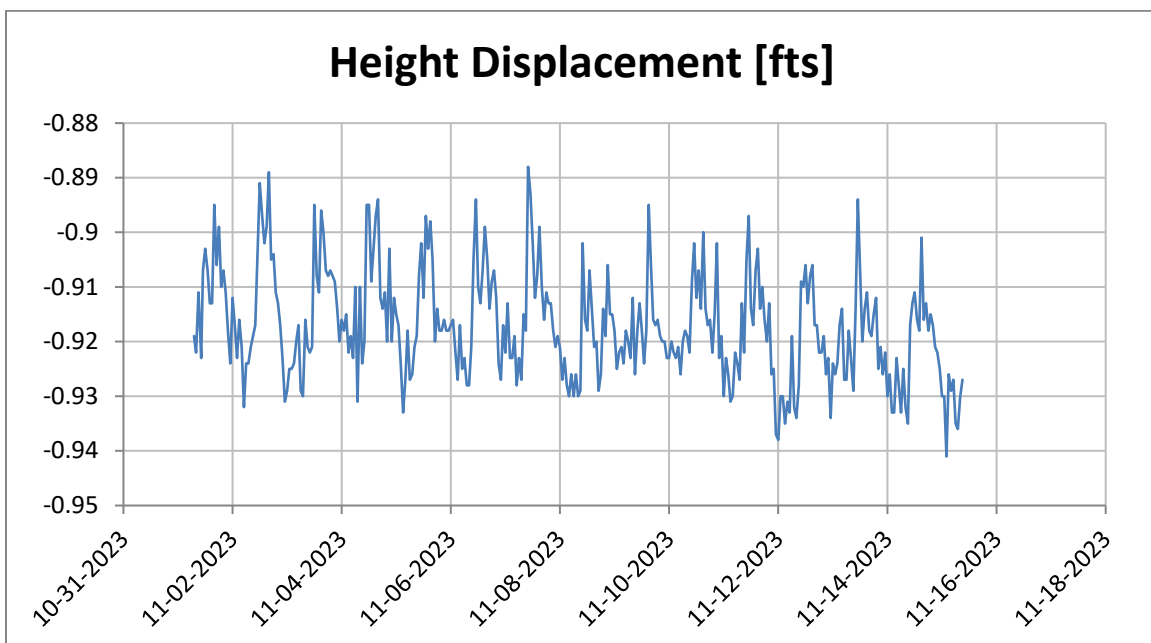
## NP66

| Prism ID | Cumulative Transverse Displacement (ft) | Cumulative Height Displacement (ft) | Monthly Delta (ft) | Cumulative Delta (ft) | Notes / Recommendations |
|---|---|---|---|---|---|
| NP66 | 0.768 | -0.927 | 0.0181 | 1.2688 | Prism removed on 11/15. Slope creep movements. |

| Prism | Date | Action | Comment |
|---|---|---|---|
| NP66 | 15-Nov-23 | Prism Removed | Reclamation grading to affect prism in near future |

1. Survey accuracy is  $\pm 0.016$  feet.
2. Alert threshold is  $\pm 0.35$  feet.
3. Transverse displacement is in the horizontal direction. Positive direction means closer to the robotic station.
4. Height displacement is in the vertical direction. Positive direction means higher in elevation.
5. Prism records slope creep movements.
