MINERALS PROGRAM INSPECTION REPORT
PHONE: (303) 866-3567

MINE NAME: Schubert Ranch Sand Resource	MINE/PROSPECTING ID#: M-2018-063	MINERAL: Aggregate	COUNTY: El Paso
INSPECTION TYPE: Monitoring	WEATHER: Cloudy	INSP. DATE: January 24, 2023	INSP. TIME: 11:00
OPERATOR: Ellicott Sand & Gravel LLC	OPERATOR REPRESENTATIVE: Steve O'Brian	TYPE OF OPERATION: 112c - Construction Regular Operation	
REASON FOR INSPECTION: Normal I&E Program	BOND CALCULATION TYPE: None	BOND AMOUNT: \$138,200.00	
DATE OF COMPLAINT: NA	POST INSP. CONTACTS: None	JOINT INSP. AGENCY: None	
INSPECTOR(S): Timothy Cazier, P.E.	INSPECTOR'S SIGNATURE:

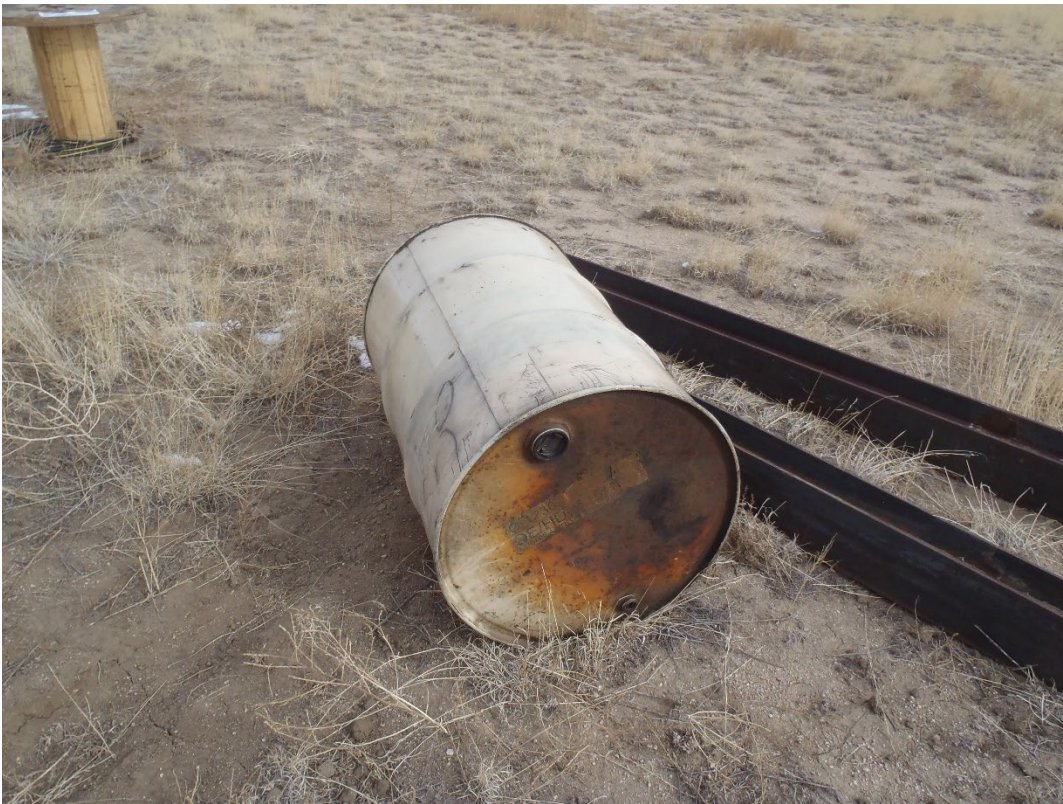
Acid And Toxic Materials: A 55-gallon drum was observed near the scale house (see **Photo 1**). It did not appear to be leaking. Speculation was that it was filled with sand. Mr. O'Brian contacted the Operator subsequent to the inspection, who told him the drum was filled with water for setting posts. No acid or toxic materials were observed.

Photo 1. 55-gallon drum filled with water (near scale house).

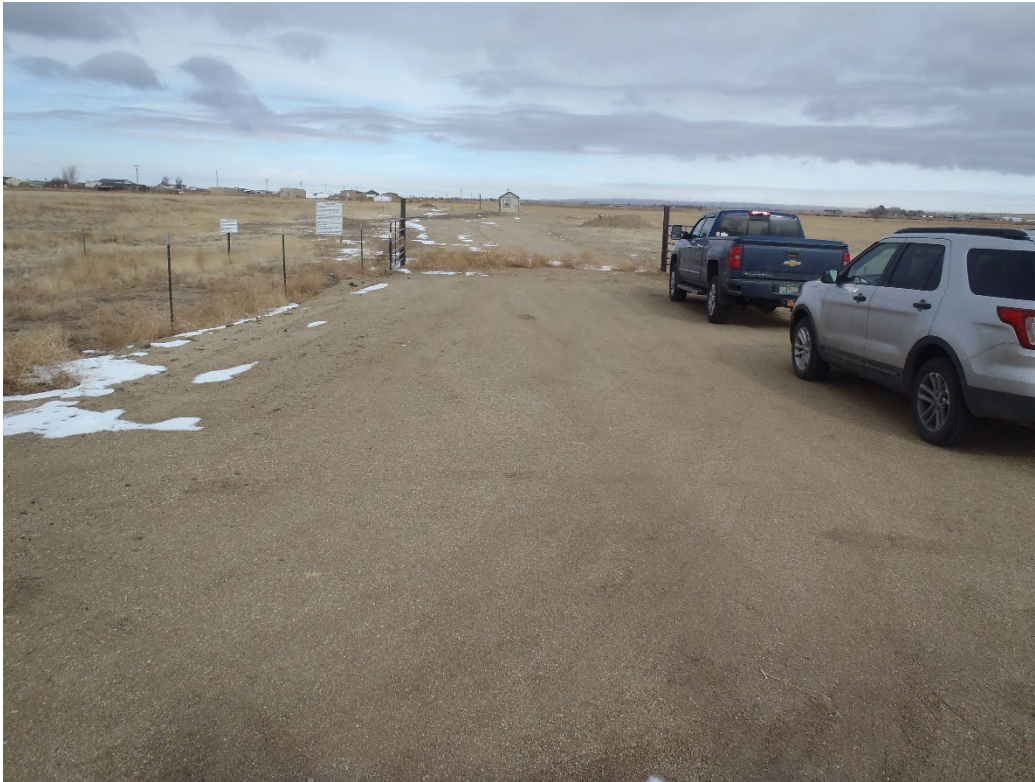
Financial Warranty: The \$138,200 bond held by the DRMS was last updated in 2019 as part of the permit review process. The bond is for a phased operation and included 30 acres of reseeded. This amount is adequate for the observed disturbance: ~600 feet of access road off Sanborn Rd. (see **Photo 2**), truck scale (see **Photo 3**) and scale house (see **Photo 4**).

Photo 2. Access road from Sanborn Rd to truck scale (looking north from Sanborn Rd).

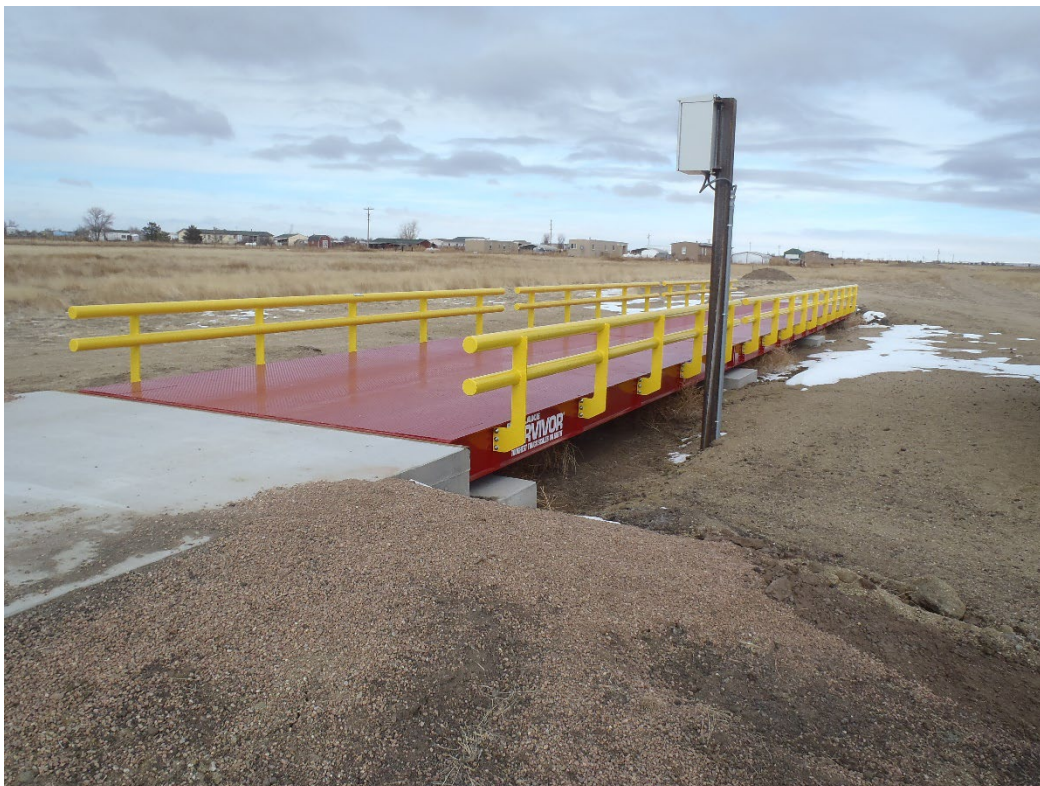
Photo 3. Truck scale (looking NW).

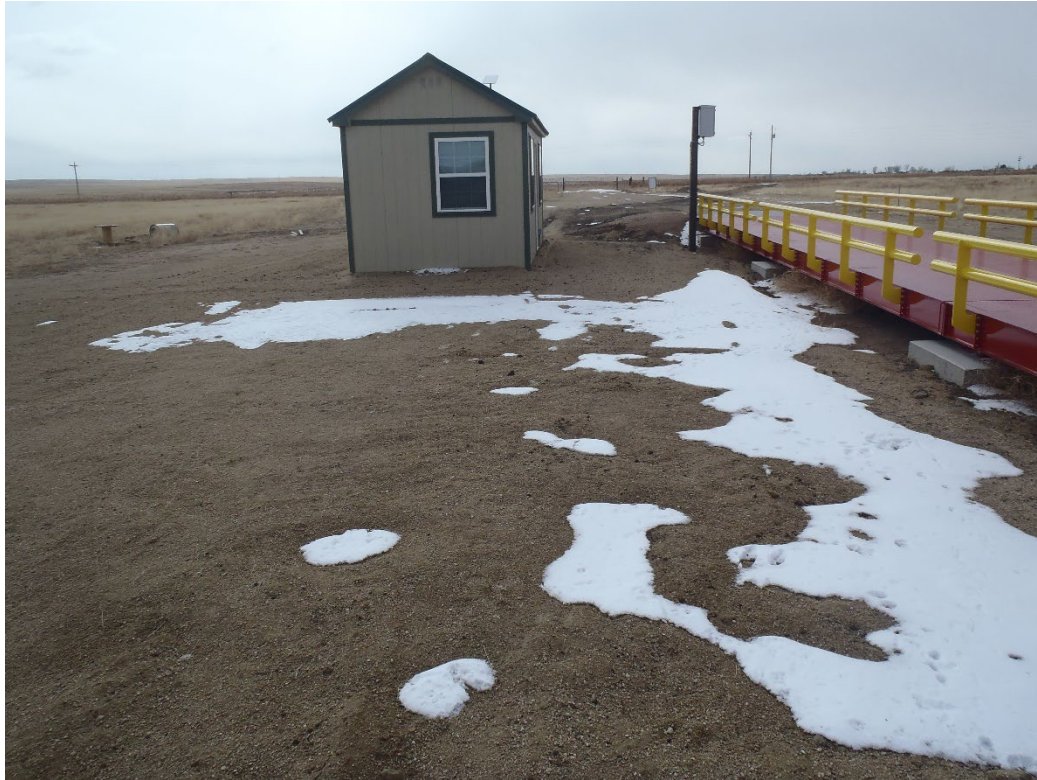
Photo 4. Scale house & truck scale (looking south).

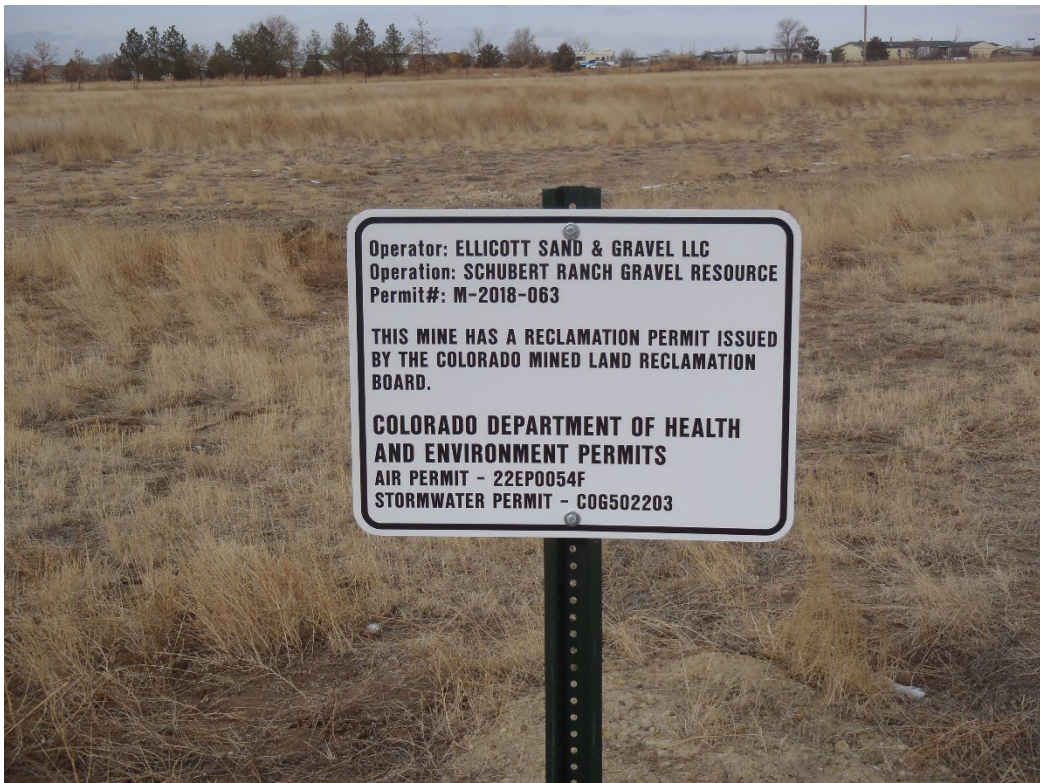
Signs and Markers: The permit sign was properly posted (see **Photo 5**).

Photo 5. Permit sign (near entrance off Sanborn Rd.).
