MINERALS PROGRAM INSPECTION REPORT
PHONE: (303) 866-3567

MINE NAME: Cresson Project	MINE/PROSPECTING ID#: M-1980-244	MINERAL: Gold and silver	COUNTY: Teller
INSPECTION TYPE: Monitoring	WEATHER: Clear	INSP. DATE: November 2, 2023	INSP. TIME: 10:00
OPERATOR: Cripple Creek & Victor Gold Mining Company	OPERATOR REPRESENTATIVE: Brian Doering Joshua Adams	TYPE OF OPERATION: 112d-3 - Designated Mining Operation	
REASON FOR INSPECTION: Normal I&E Program	BOND CALCULATION TYPE: None	BOND AMOUNT: \$209,491,188.00	
DATE OF COMPLAINT: NA	POST INSP. CONTACTS: None	JOINT INSP. AGENCY: None	
INSPECTOR(S): Patrick Lennberg	INSPECTOR'S SIGNATURE:

This was a routine monitoring inspection of the Cresson Project (Permit No. M-1980-244) conducted by Patrick Lennberg of the Division of Reclamation, Mining and Safety (Division/DRMS). The Division was accompanied by Brian Doering, Josh Adams, and others during the inspection. This is a 112d-3 Designated Mining Operation (DMO) permitted for 6,007 acres to mine and process gold ore. The site is located between the towns of Cripple Creek and Victor in Teller County. The approved post-mining land use is a combination of rangeland and wildlife habitat. Photo

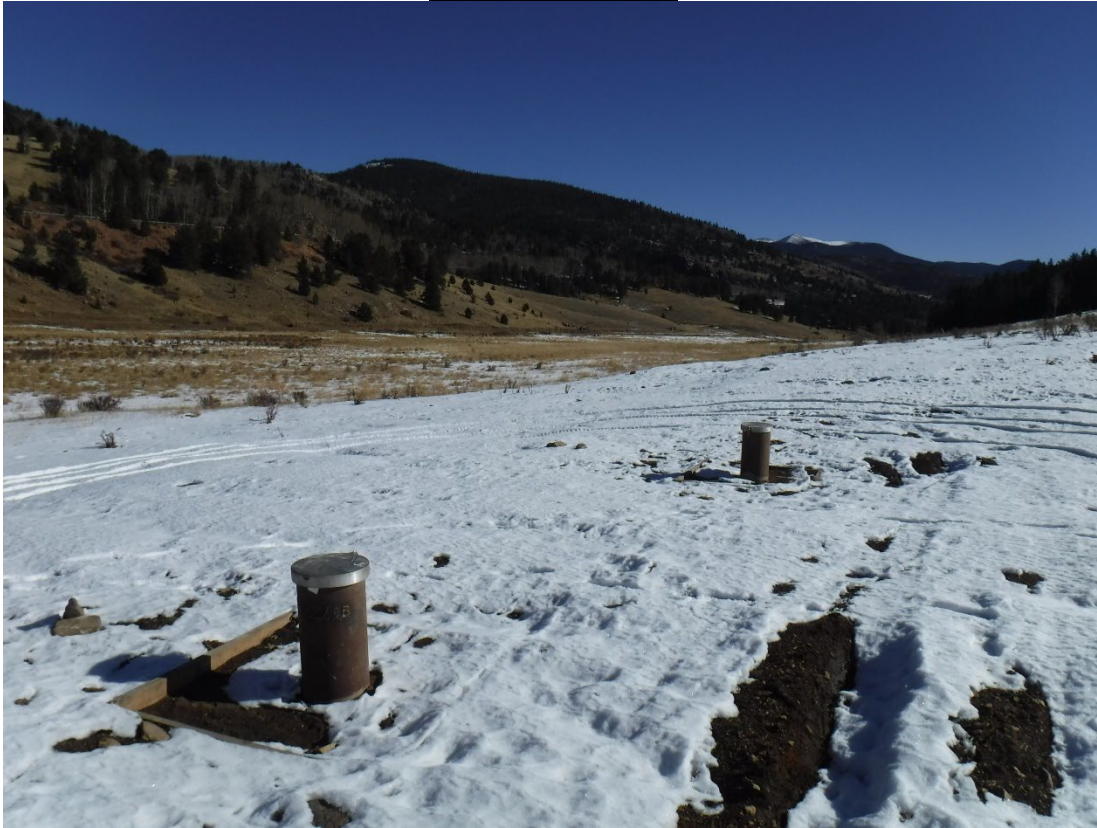
The Division inspected the Grassy Valley point-of-compliance (POC) wells GVMW-26 A and -26B. The wells were installed in July earlier this year as part of TR129. On August 31, 2023 the Operator submitted a Well Drilling and Installation Report for all POC wells installed in relation to TR129. The first samples collected from GVMW-26A and -26B and reported to the Division were collected during the August 2023 Grassy Valley Monthly Sampling event. The sample results indicate that the wells are screened in different groundwater strata and both are currently in compliance with Reg. 41 standards.

Photo 1: Well pair GVMW-26A(background) and GVMW-26B(foreground)

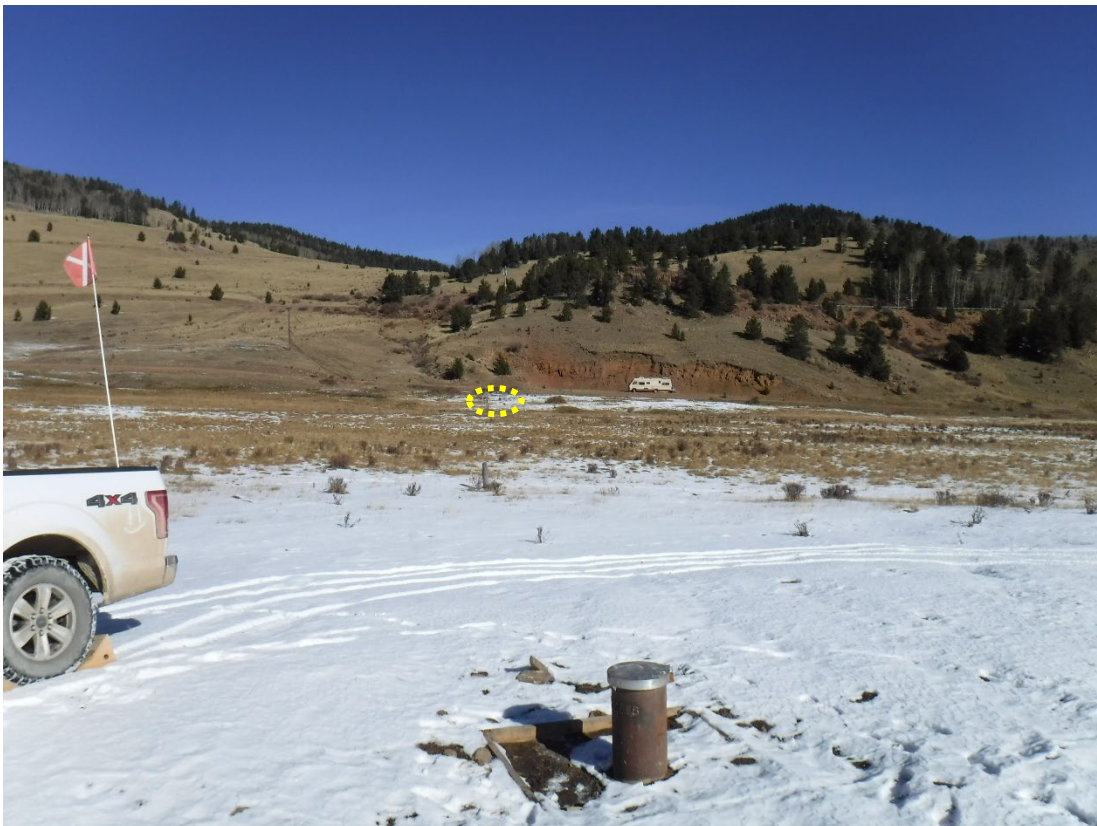
Photo 2: Looking north from GVMW-26B to GVMW-22A and -22B (yellow circle)

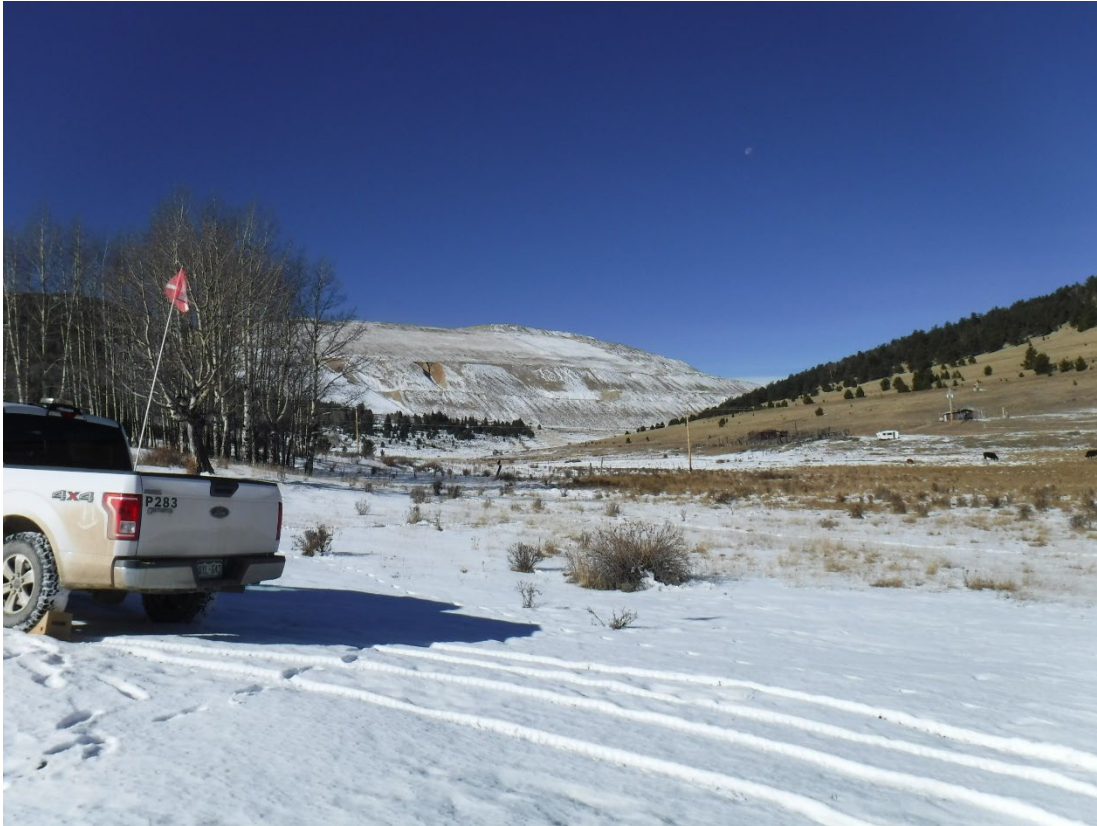
Photo 3: Looking west from GVMW-26B to the ECOSA

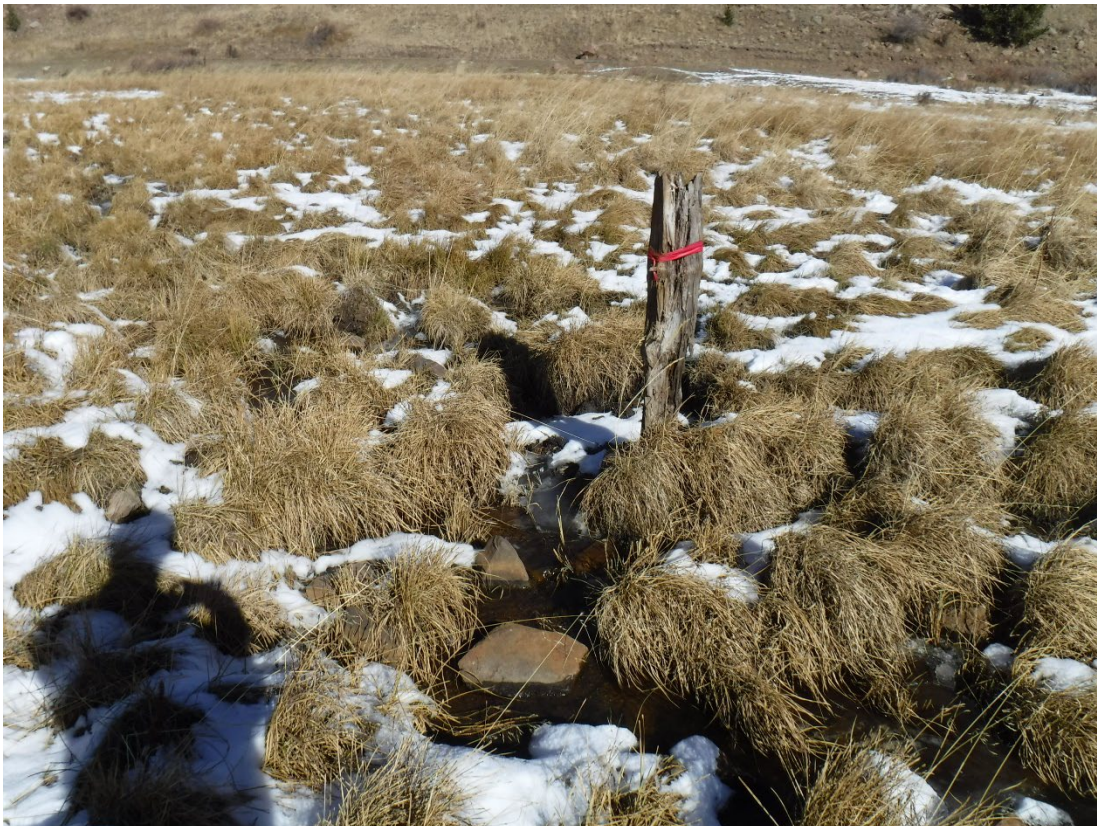
After viewing the GVMW-26 well pair the Division hiked out to the GV-06 surface water sampling location. While there was snow on the ground there was flowing at the location.

Photo 4: GV-06 surface water sampling location

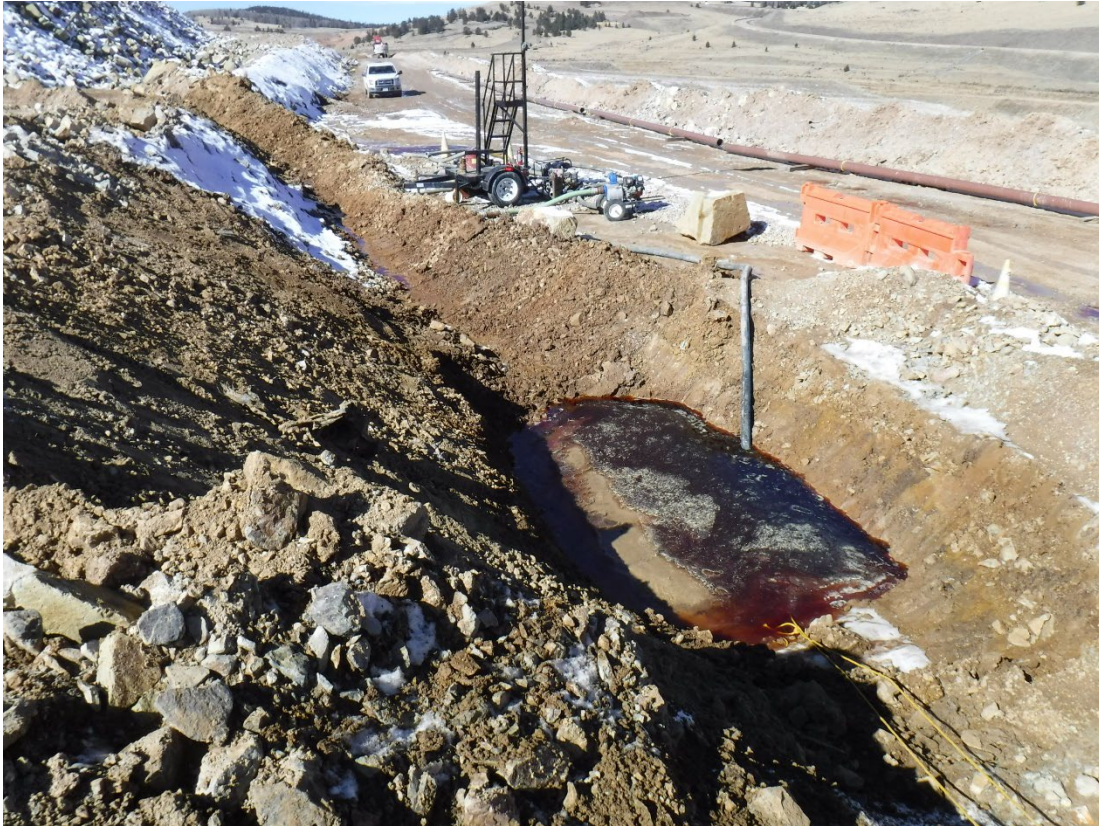
The Division inspected the seep areas located along the eastern toe of the East Cresson Overburden Storage Area (ECOSA). Both seep locations were holding water. The water was reddish-brown in color at both locations and for the north location, Seep 2, it was difficult to determine the depth of water. The southern seep, Seep 1, configuration has a capacity of 2,305 cubic feet or 17,200 gallons. The staff gauge that was present indicated there was approximately 1 foot or more of water in the basin. Water was observed flowing into the trench from the south/southeast. Seep 2 has been reconfigured to allow seepage from an upper area to be conveyed to the recently enlarged basin. Water removed from the seeps is transported and dumped onto a lined facility (one of the valley leach facilities).

a break in the steel waterline located along the toe of the ECOSA. According to the Operator, it was unclear if a weld had failed at a joint or if low pH groundwater had corroded the weld or a combination of the two factors. The Division was then informed that the Operator had decided to replace the entire steel waterline located at the toe with a coated steel alternative that is more resistant to corrosive water.

Photo 5: Seep 2 current configuration, ditch draining area of seepage discovered during the summer, coated steel waterline in the background

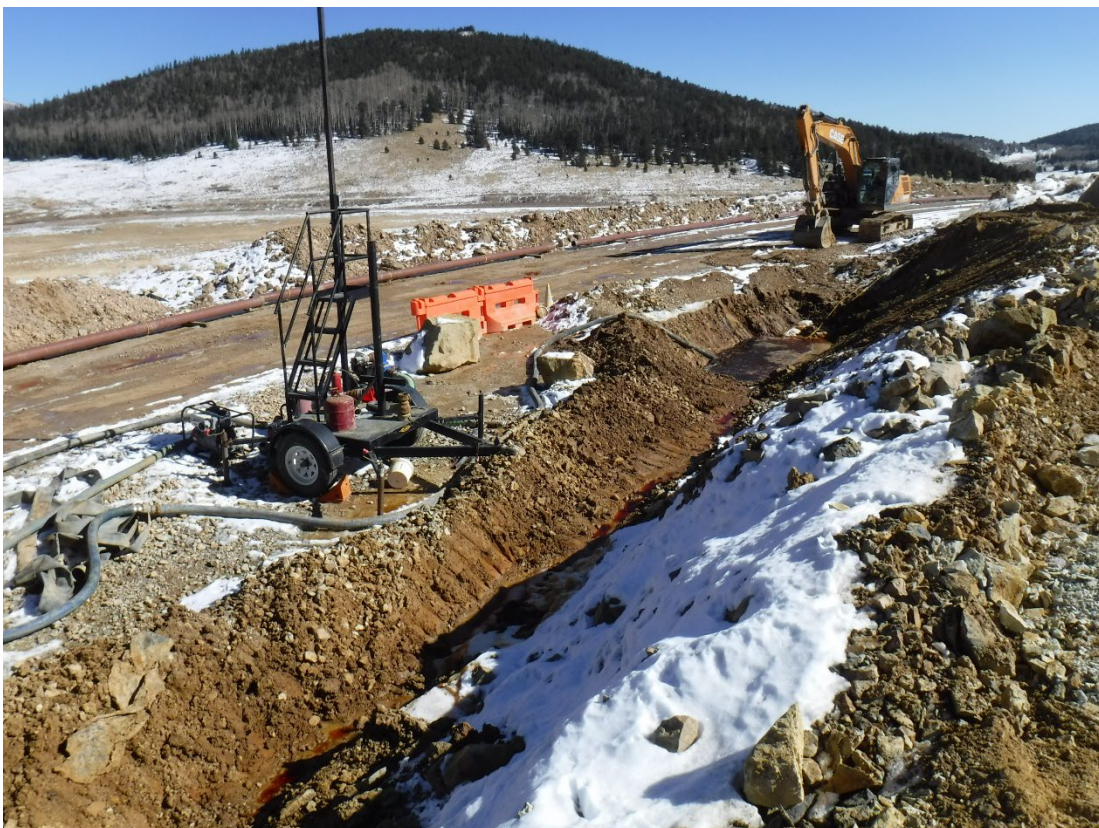
Photo 6: Seep 2 looking west

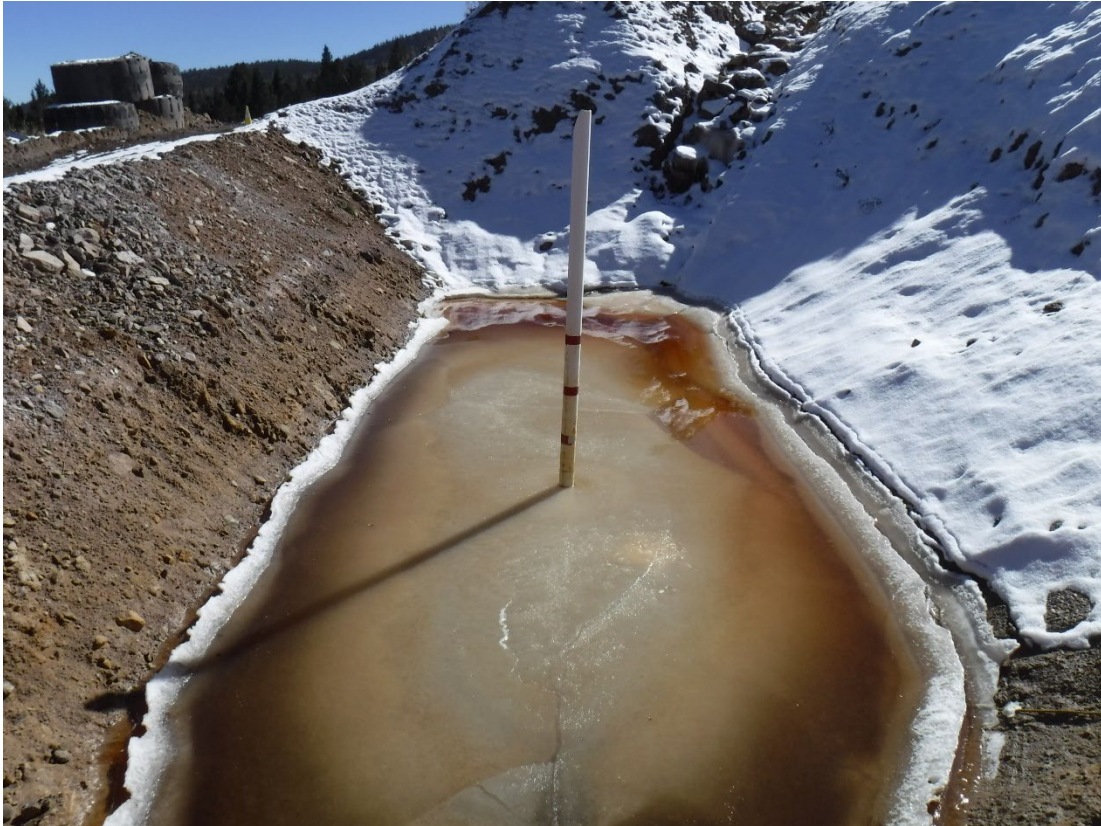
Photo 7: Seep 1

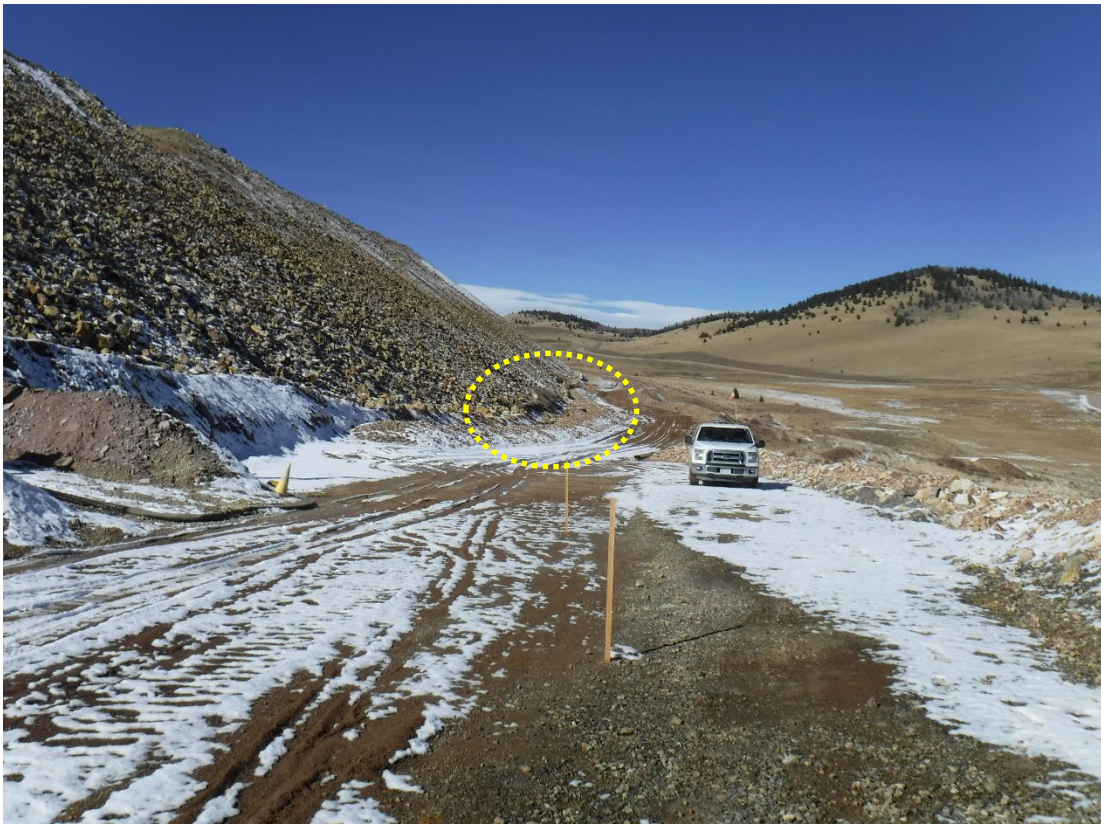
The Division was informed by the Operator they intend on developing another seep location, Seep 3. The Seep 3 collection basin is tentatively planned to be developed 100 to 200 feet northeast from Seep 1 where there is a low point in the road along the toe of the ECOSA. The Seep 3 location is being developed due to the quantity of seepage occurring in the area that was discovered this past summer.

Photo 8: Looking NW from Seep 1 to where Seep 3 (yellow circle) is to be located

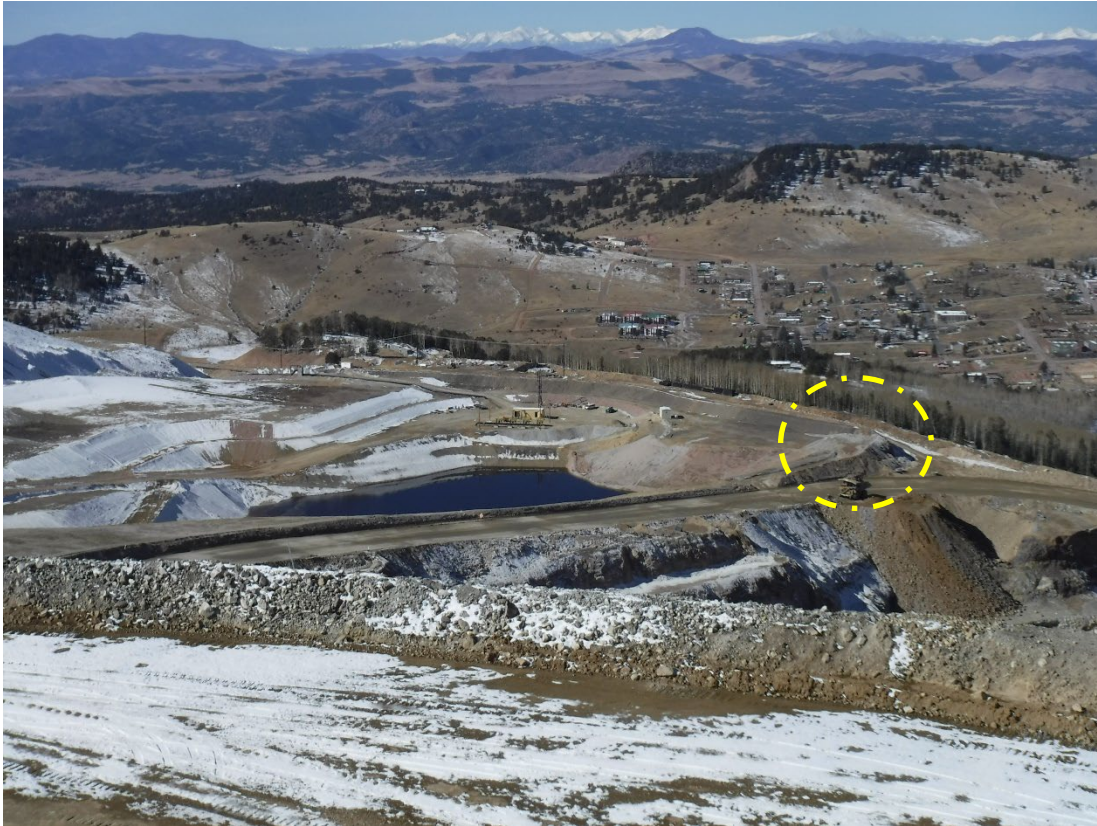
The Division observed the VLF2 Phase III Process Solution Storage Area (PSSA). At the time of inspection a platform of material was being constructed to allow for the placement of ore material. The platform was needed to allow for safer placement of ore material by the trucks and to ensure the truck had the appropriate thickness under them to ensure no damage was done to the liner.

Photo 9: VLF 2 Phase 3 PSSA pad being created for haul trucks in yellow circle

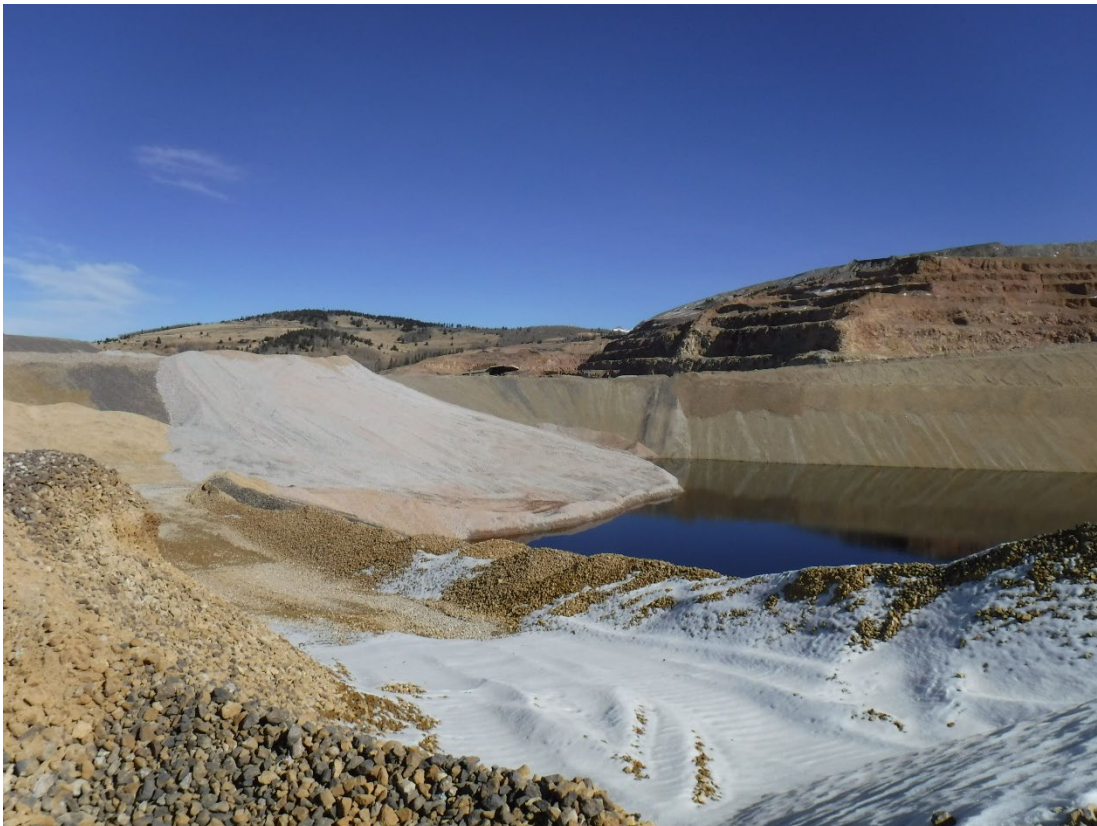
Photo 10: View of the pad being created VLF 2 Phase 3 PSSA

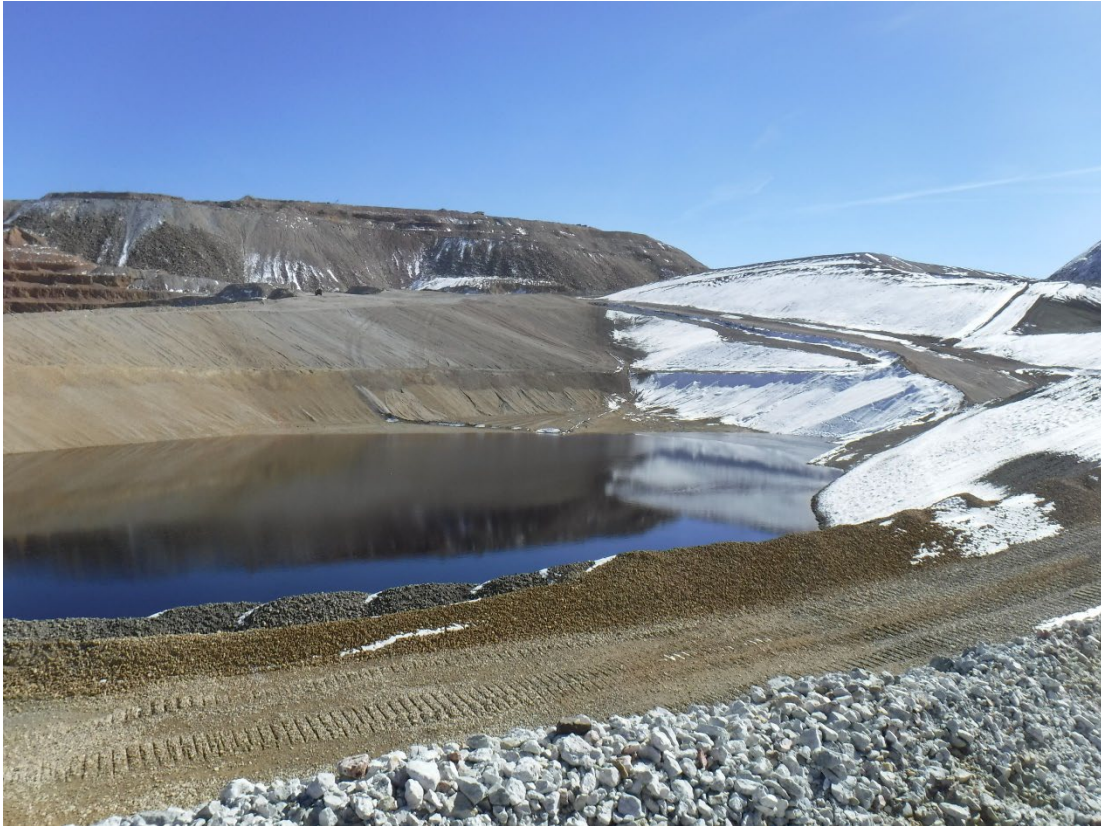
DCF placement was completed the week prior to this inspection. While liner placement was completed the first part of September. Contractors were working on completing electrical wiring for the PSSA pumps. Pumps are scheduled to be installed sometime around November 13th.

Photo 11: VLF 2 Phase 3 PSSA

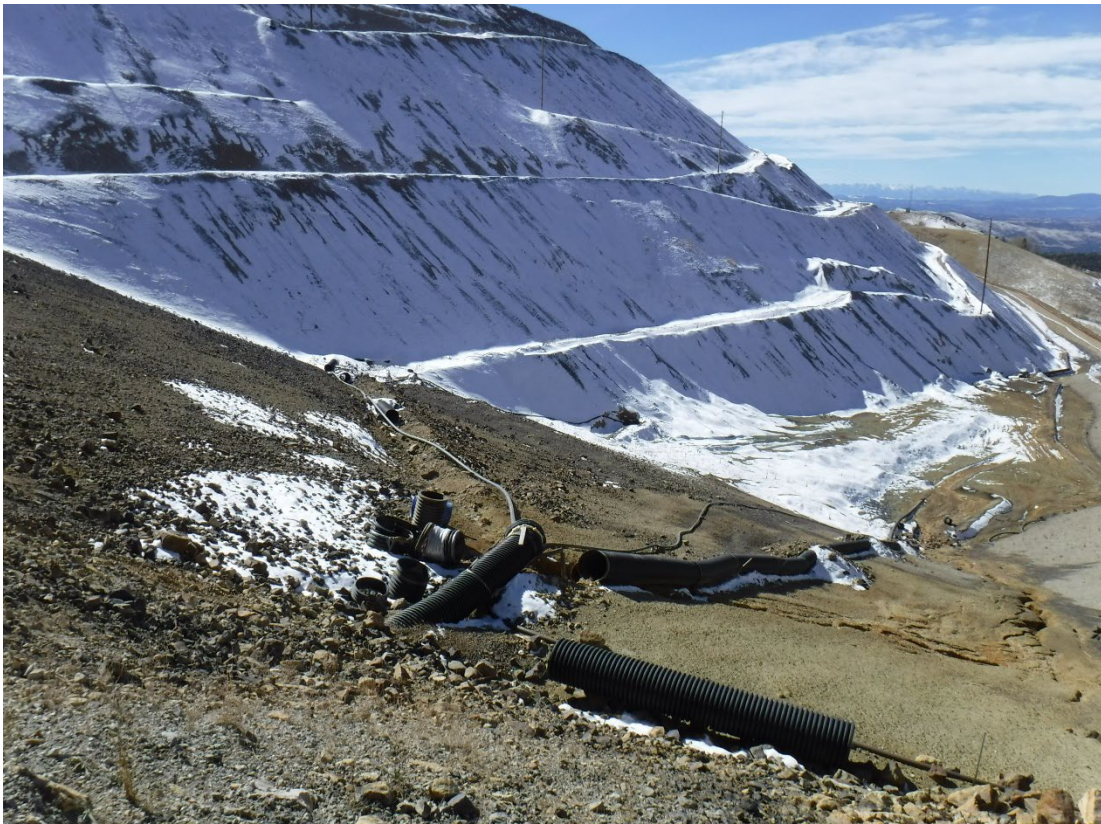
The Division viewed the High Grade Mill stormwater sump area which had been recently reconfigured. The Operator installed piping at the inlet along the berm at the High Grade Mill area that conveys water to a newly dug sump. The sump has been dug into ore material that has been previously leached. At the time of inspection the pipe outlet was actively discharging water into the sump and the water was rapidly infiltrating into the sub-surface.

Photo 12: Looking at the HGM stormwater management drain, corrugated pipe has been disconnected and can longer convey water

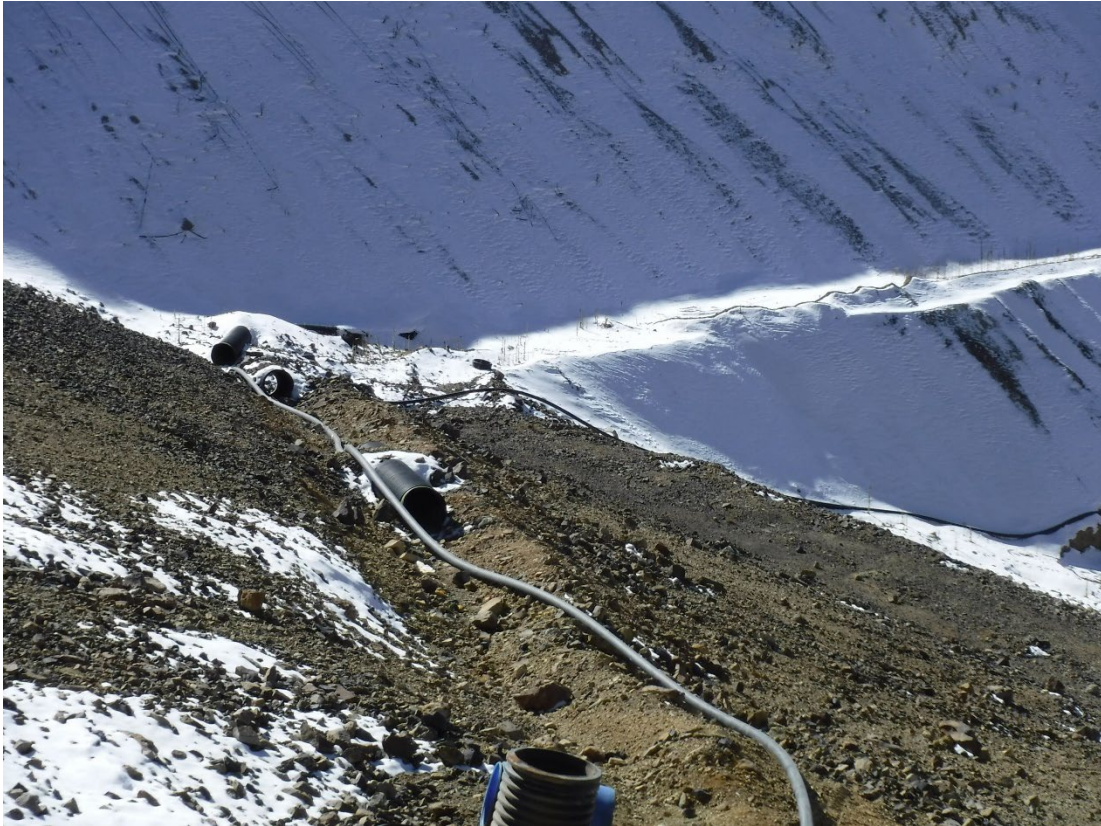
Photo 13: Welded plastic pipe that now conveys water to sump

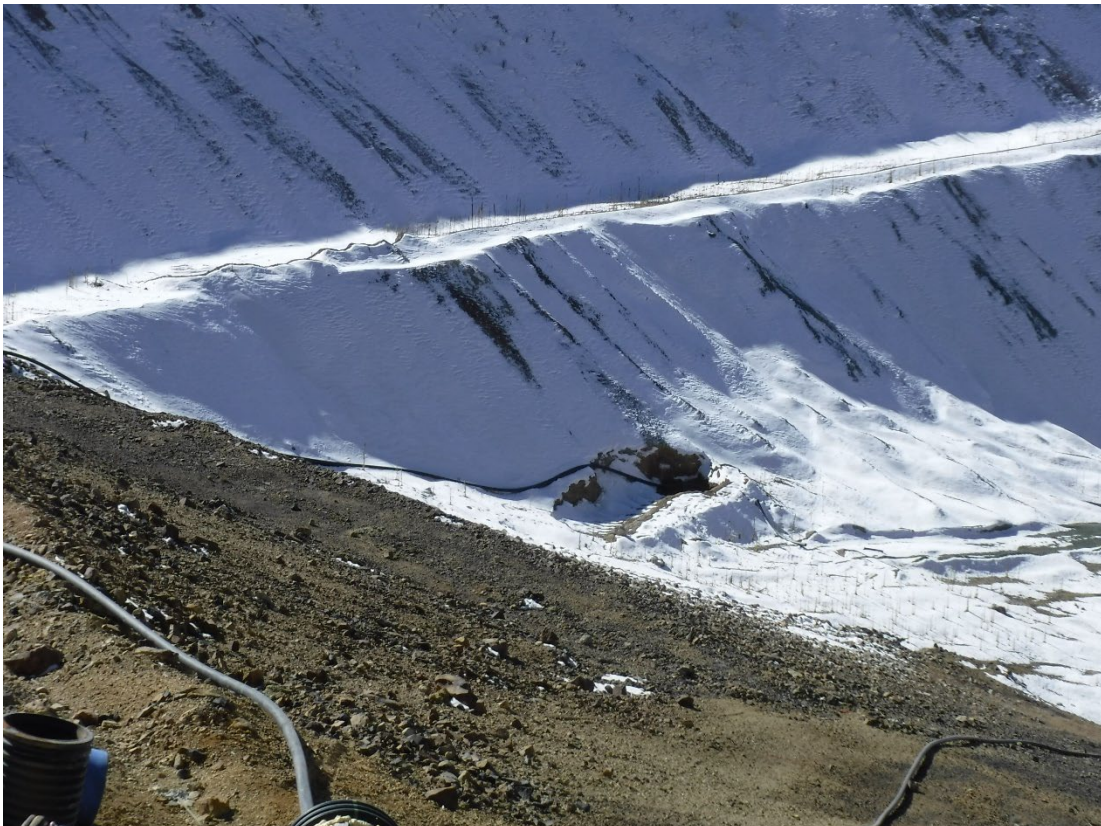
Photo 14: Welded plastic pipe to sump

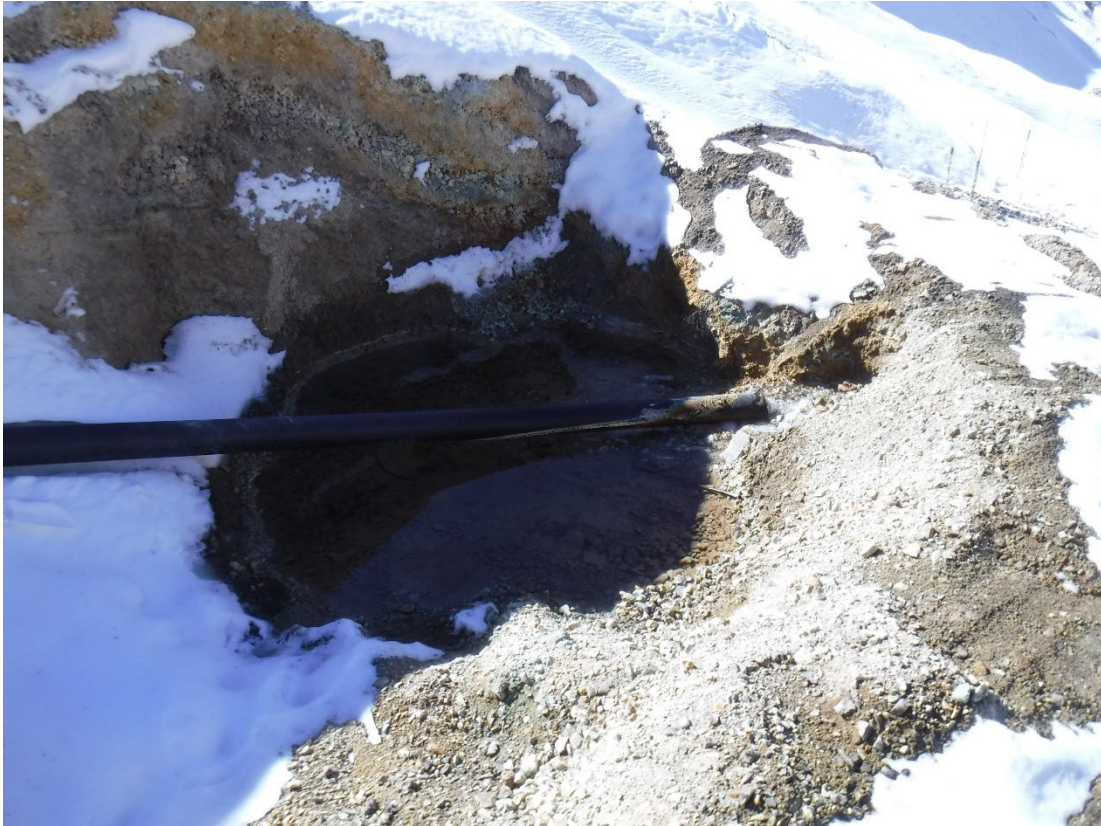
Photo 15: New sump

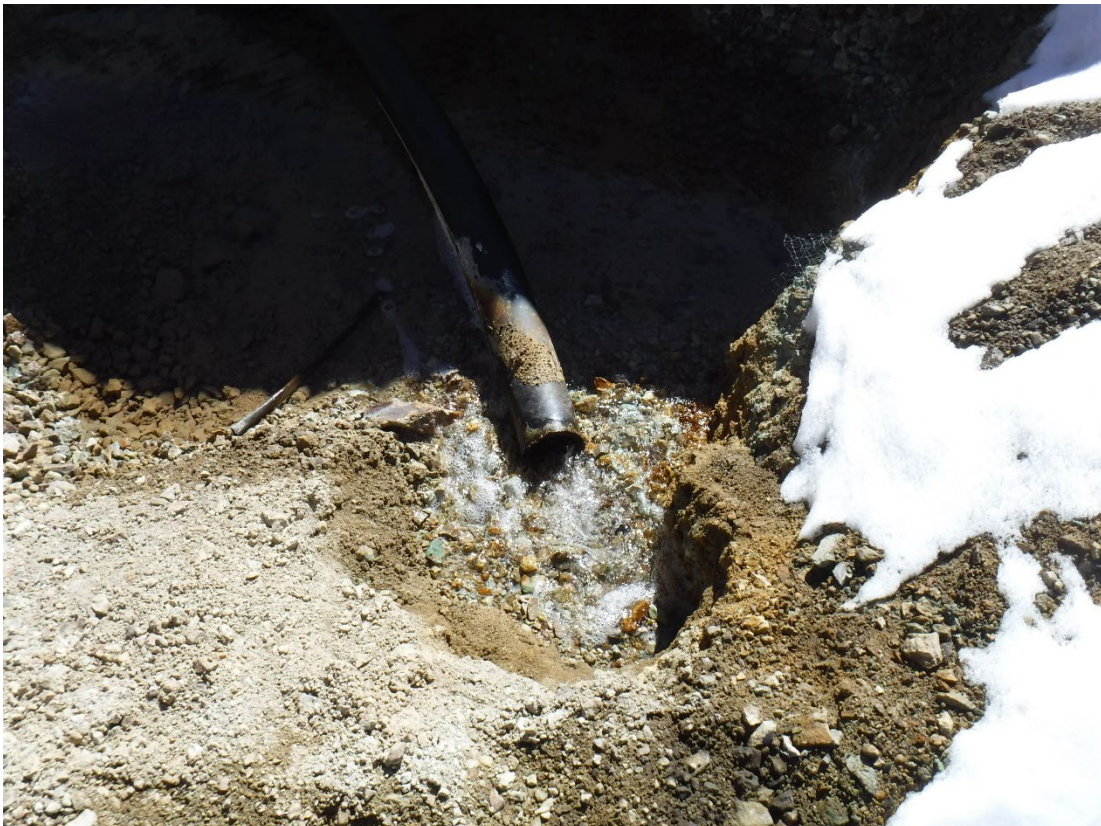
Photo 16: Discharge into the new sump
