MINERALS PROGRAM INSPECTION REPORT
PHONE: (303) 866-3567

MINE NAME: Cheyenne County State Land Board Pit	MINE/PROSPECTING ID#: M-2022-030	MINERAL: Aggregate	COUNTY: Cheyenne
INSPECTION TYPE: Monitoring	WEATHER: Clear	INSP. DATE: December 5, 2023	INSP. TIME: 11:30
OPERATOR: A&S Construction Company	OPERATOR REPRESENTATIVE: Jodi Schreiber	TYPE OF OPERATION: 111 - Construction by Government Agency	
REASON FOR INSPECTION: Normal I&E Program	BOND CALCULATION TYPE: None	BOND AMOUNT: \$75,000.00	
DATE OF COMPLAINT: NA	POST INSP. CONTACTS: None	JOINT INSP. AGENCY: None	
INSPECTOR(S): Nikie Gagnon	INSPECTOR'S SIGNATURE:

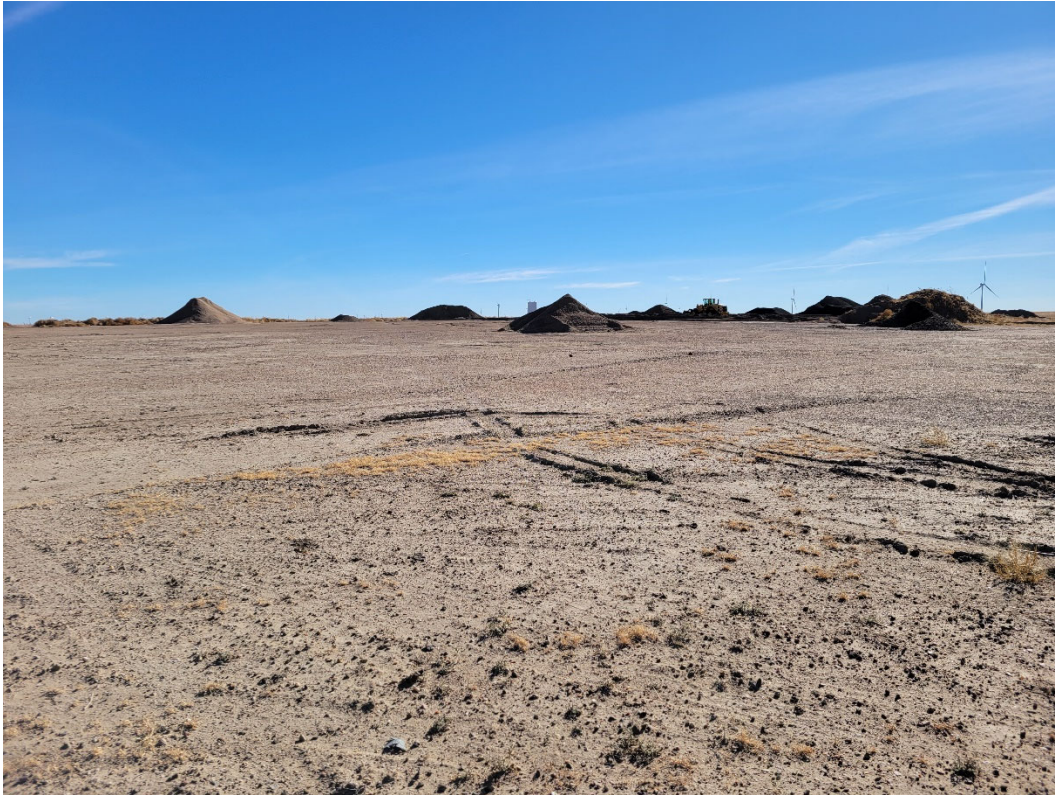
Photo 1: View looking southeast from the northwest corner of the processing pad. Small aggregate stockpiles were observed in this area.

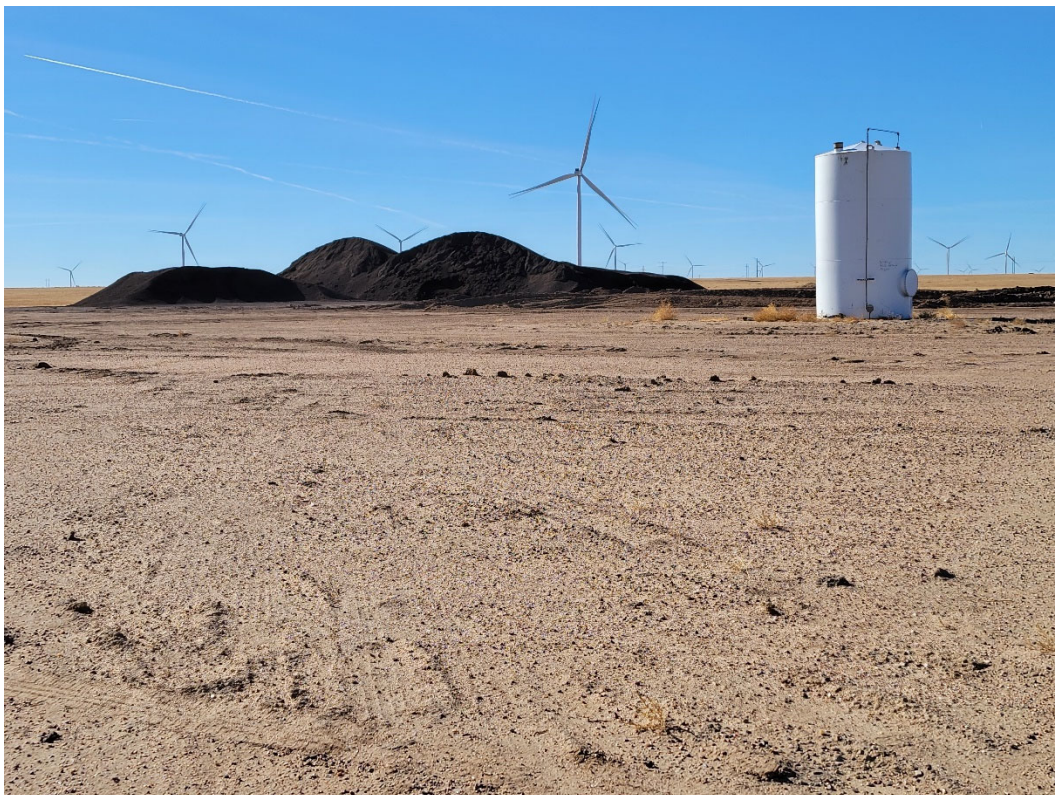
Photo 2: View looking southwest from the northeast corner of the processing pad. Material stockpile and water tank observed in the center of the pad.

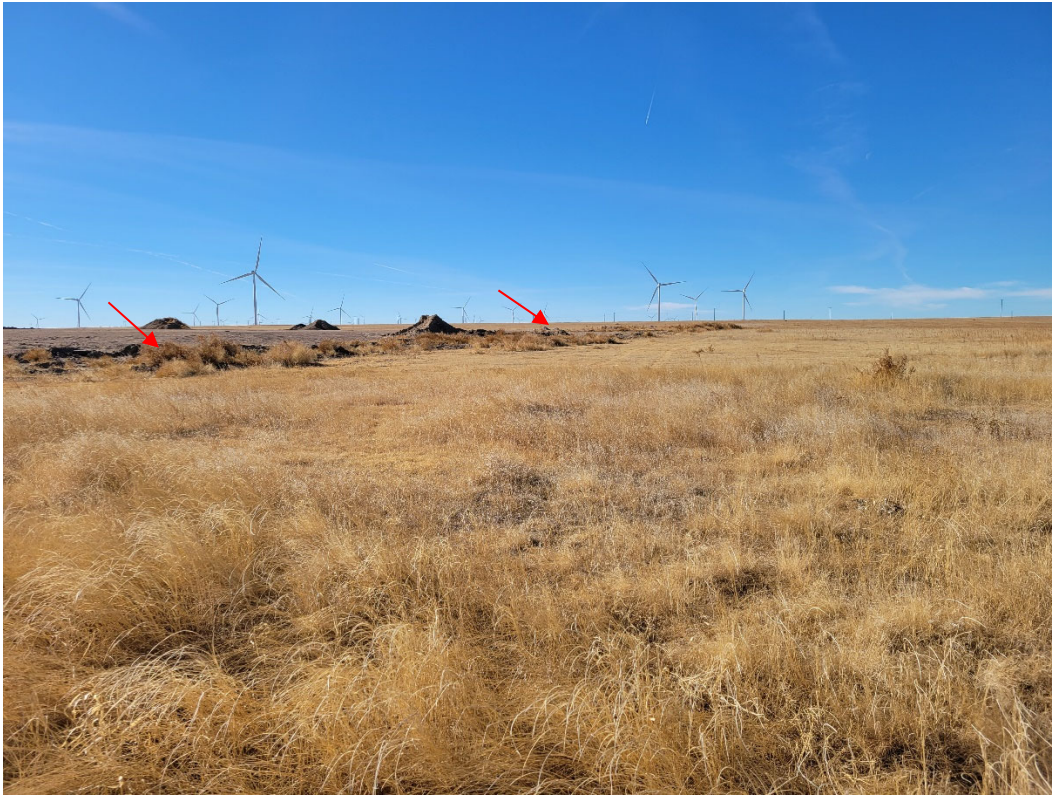
Topsoil/overburden is stored in berms surrounding the processing area. The approved reclamation plan calls for replacing topsoil to 3 inches on average across the disturbance area.

Photo 3: View looking along the northern edge of the 15-acre processing area. Topsoil berm noted by red arrows surrounds the pad.

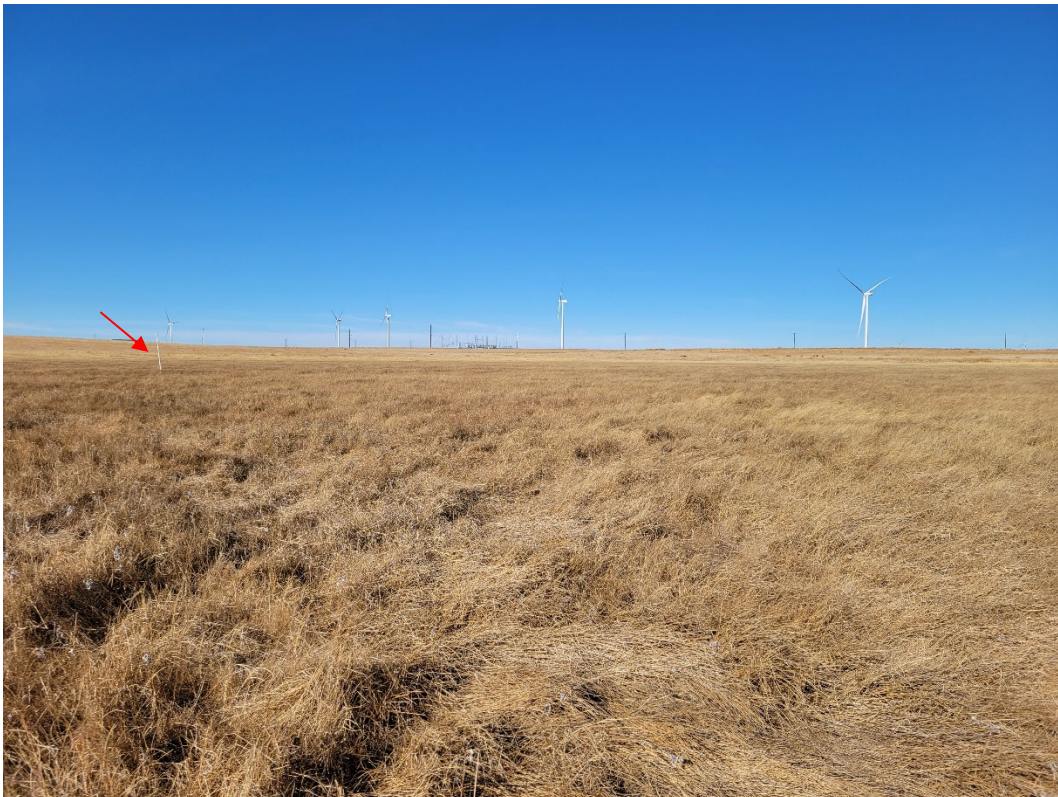
White posts were observed around the perimeter of the permit area and along the access road. Pursuant to Rule 3.1.12(1) a mine sign was in place at the entrance to the pit.

Photo 4: View looking west across undisturbed rangeland inside the permit boundary. Red arrow points to northwest corner boundary marker.

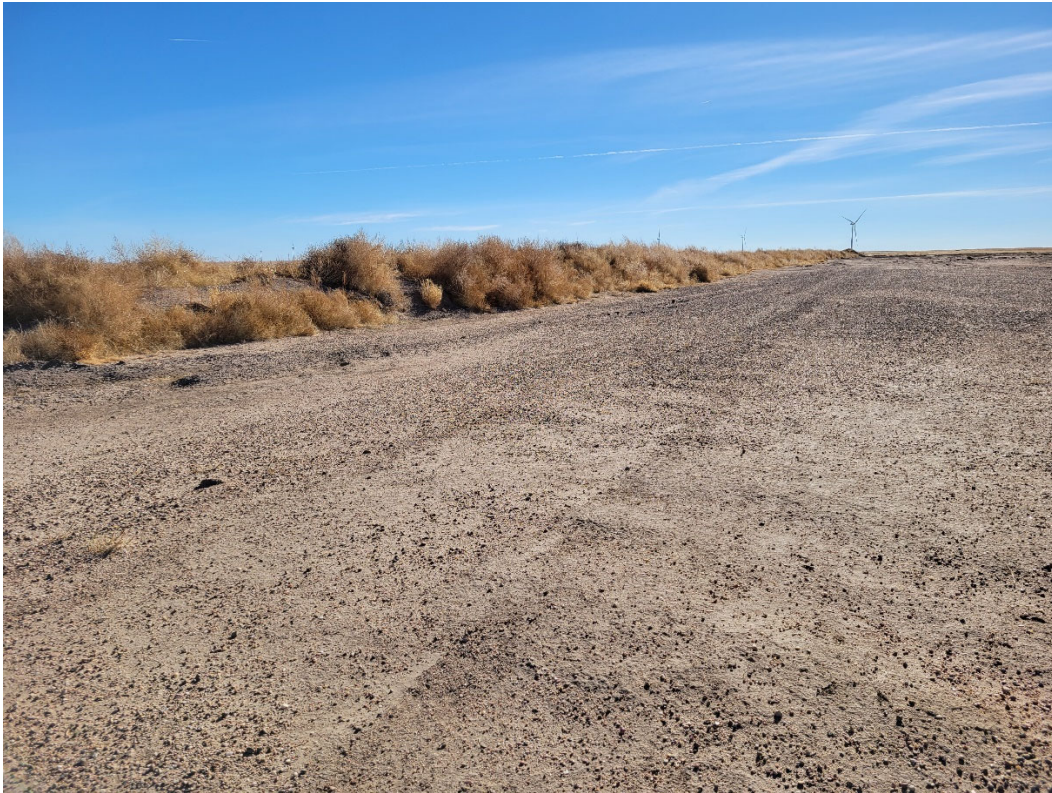
Photo 5: View looking down the eastern edge of the processing pad. Topsoil berm runs along the edge of the pad.

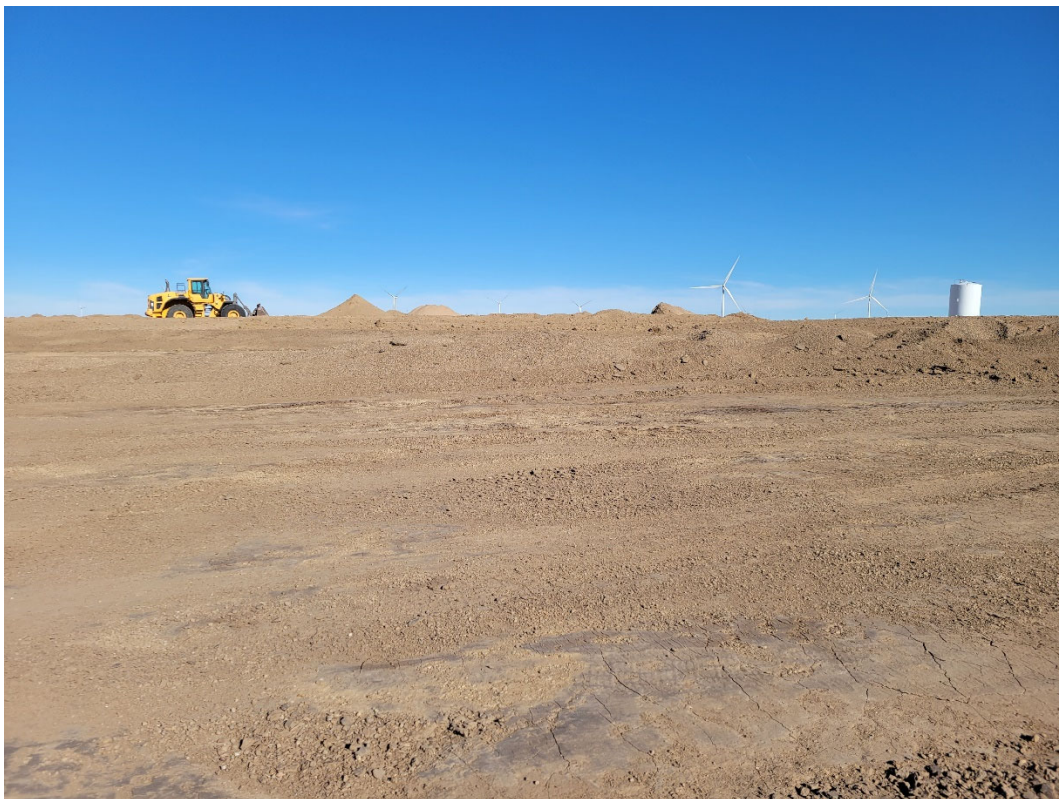
Evidence of recent grading was noted on the northwest side of the 15-acre pad. The approved reclamation plan calls for regrading the slopes to 3H:1V or shallower, retopsoiling and disking to loosen surficial soil, and drill seeding with the approved seed mix.

Photo 6: Idle front-end loader observed in the northwest corner of the pad. Recent grading observed here.

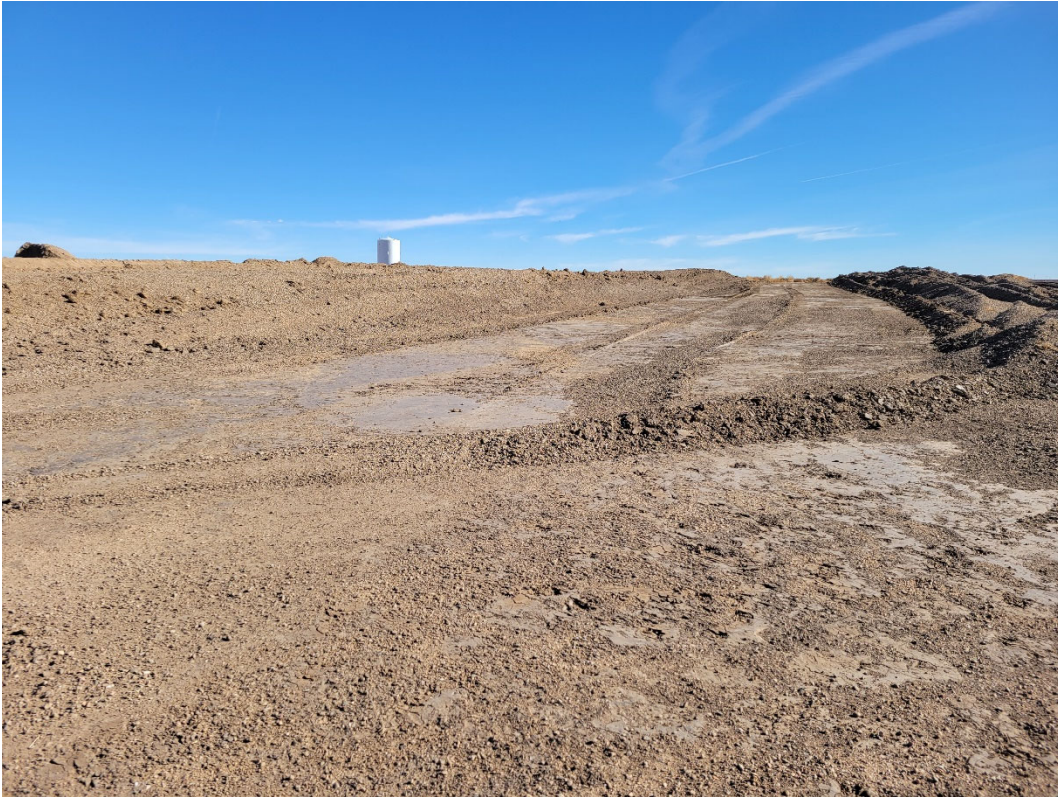
Photo 7: Recent grading observed on the north side of the pad.

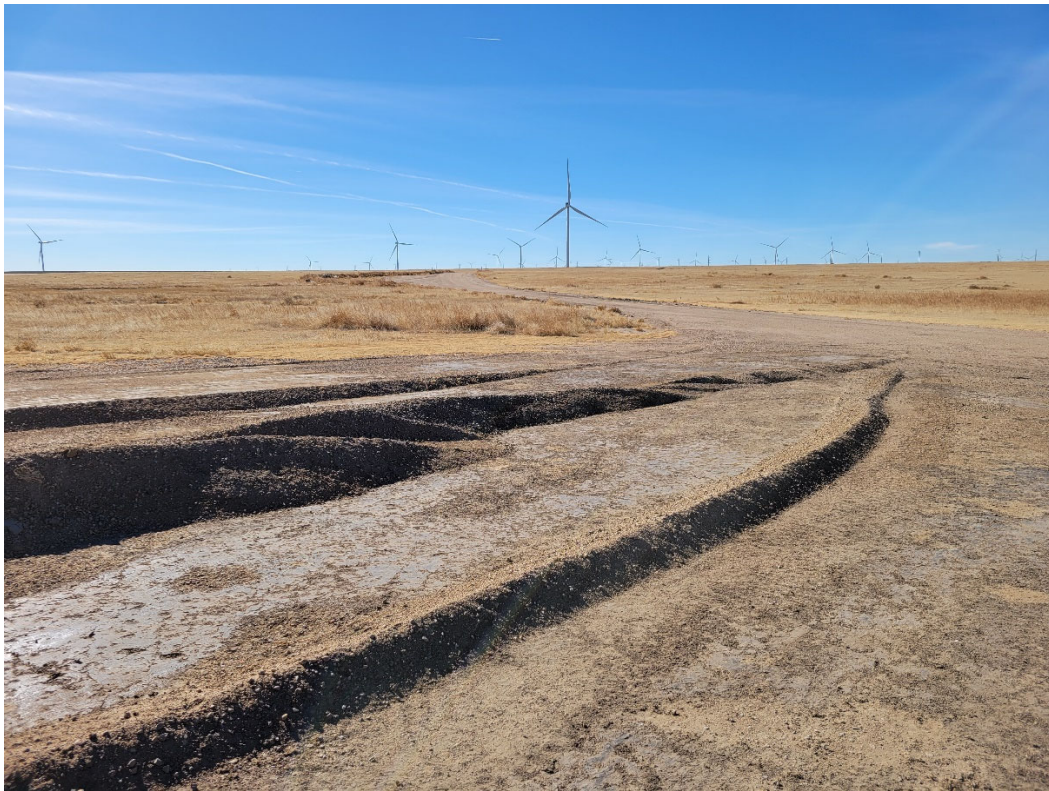
A graded access road leads to the processing area. The approved reclamation plan calls for regrading, topsoiling and seeding all interior roads prior to seeking a release.

Photo 8: View looking southwest at the access road to the site.

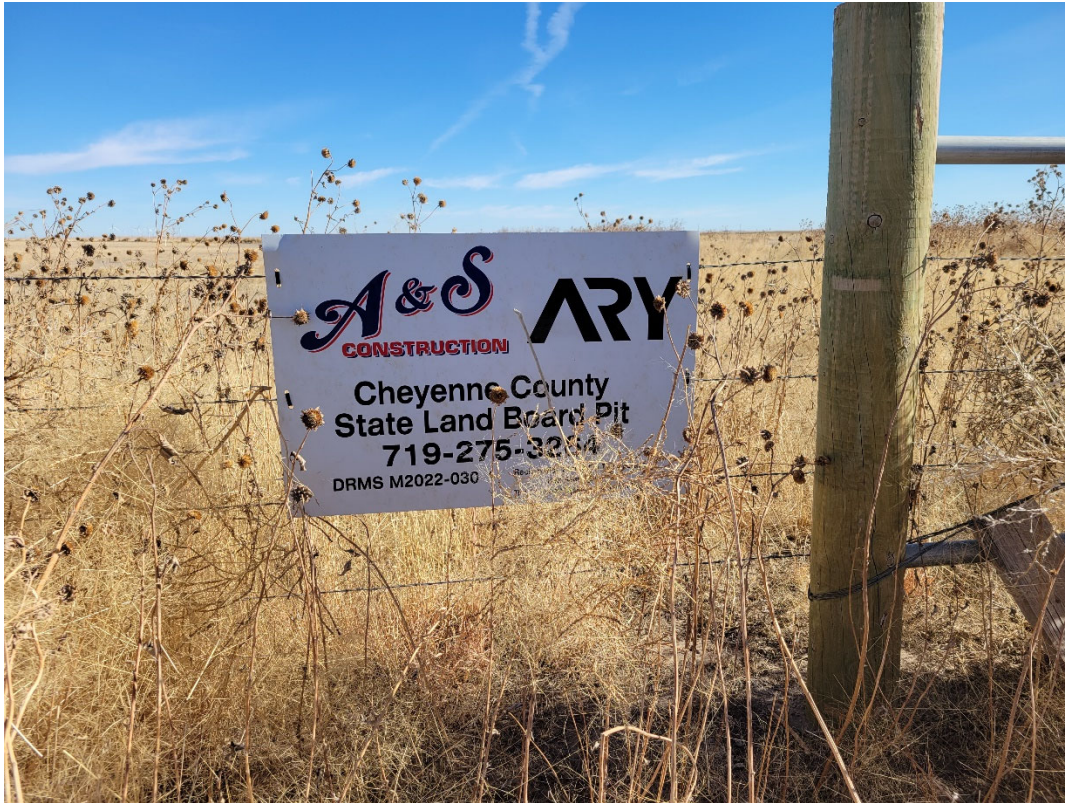
Photo 9: Mine sign posted at the entrance to the site.
