MINERALS PROGRAM INSPECTION REPORT
PHONE: (303) 866-3567

| MINE NAME: Moore's Pit | MINE/PROSPECTING ID#: M-1980-178 | MINERAL: Sand and gravel | COUNTY: Mesa |
| INSPECTION TYPE: Monitoring | WEATHER: Clear | INSP. DATE: December 19, 2023 | INSP. TIME: 09:50 |

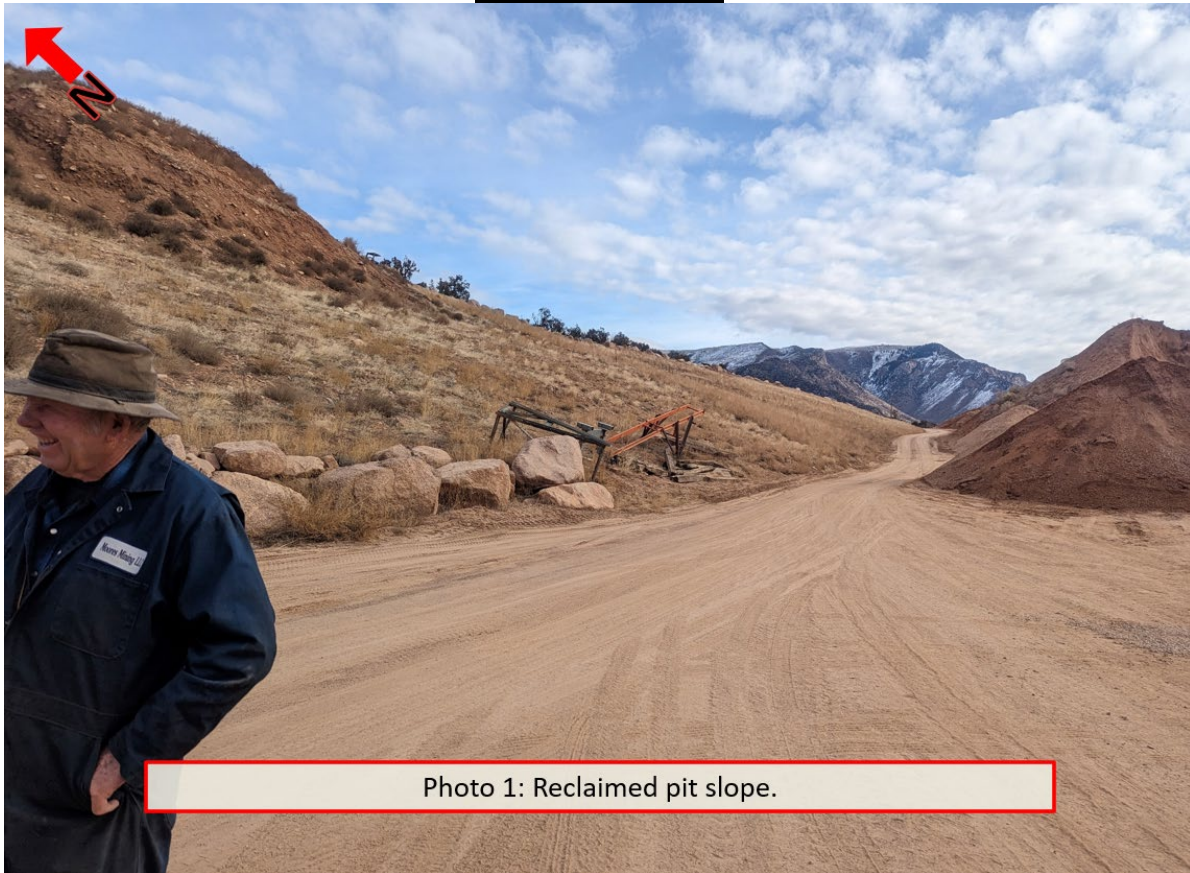
Approximately 900 linear feet of the northeastern highwall (~ 2 ac) as you enter the pit floor has been reclaimed. Slopes have been graded and seeded (Photo One and Two). Vegetative cover decreased over last summer according to Mr. Moores. Sprinklers were in place but not in use at the time of the inspection. Some Russian Thistle was observed, the Division recommends treating these noxious species to avoid delays in establishing desirable species. Some slopes along the southern edge have been graded and partially reclaimed. Those areas have good volunteer vegetation while others will require actual seeding. Any slopes steeper than a 3H:1V will require grading prior to seeding.

Photo 1: Reclaimed pit slope.

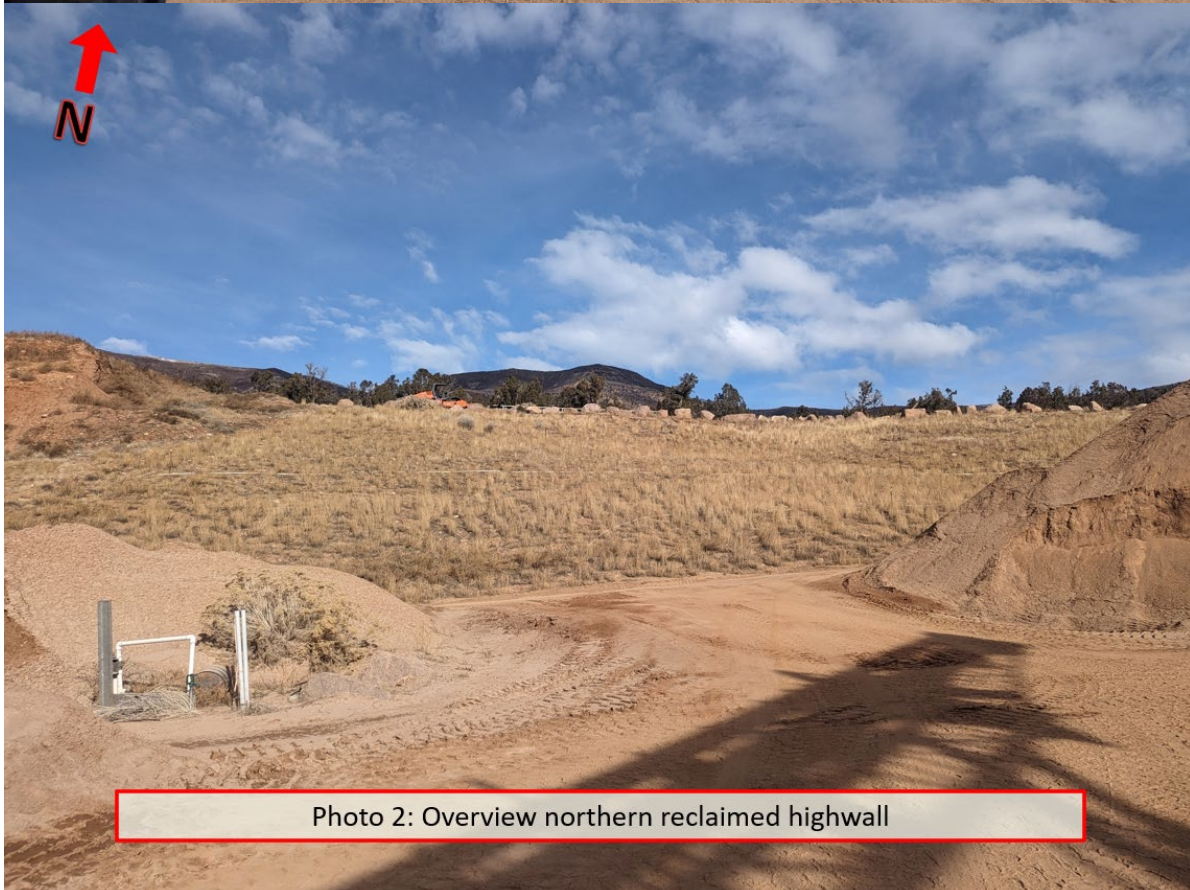
Photo 2: Overview northern reclaimed highwall

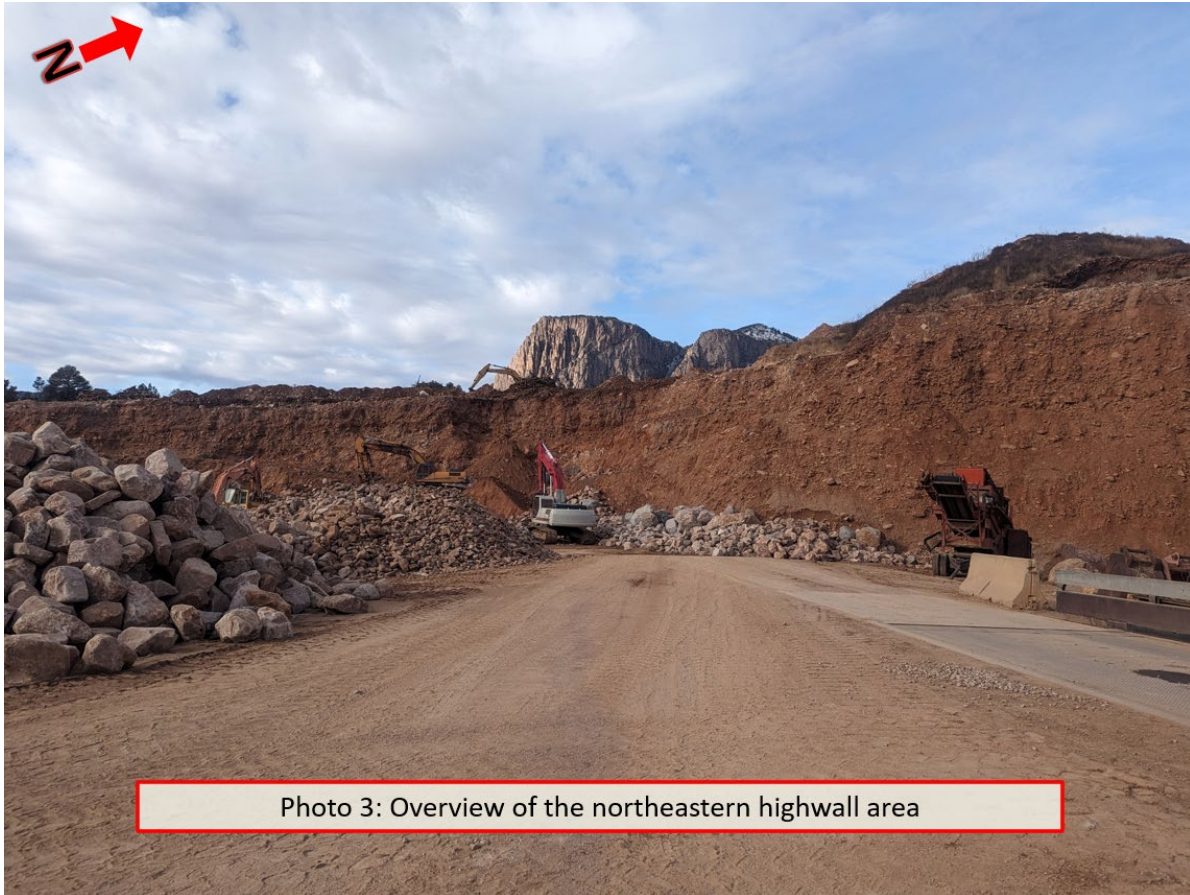
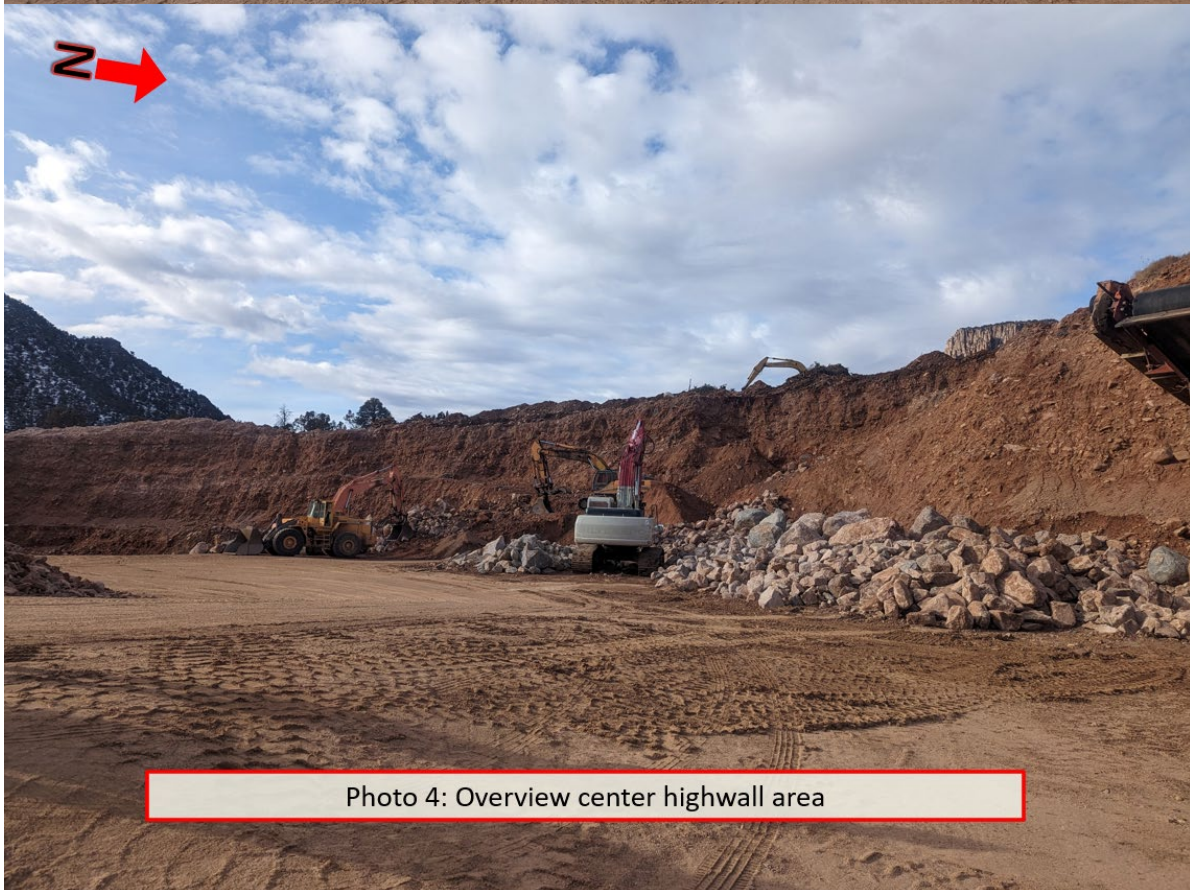
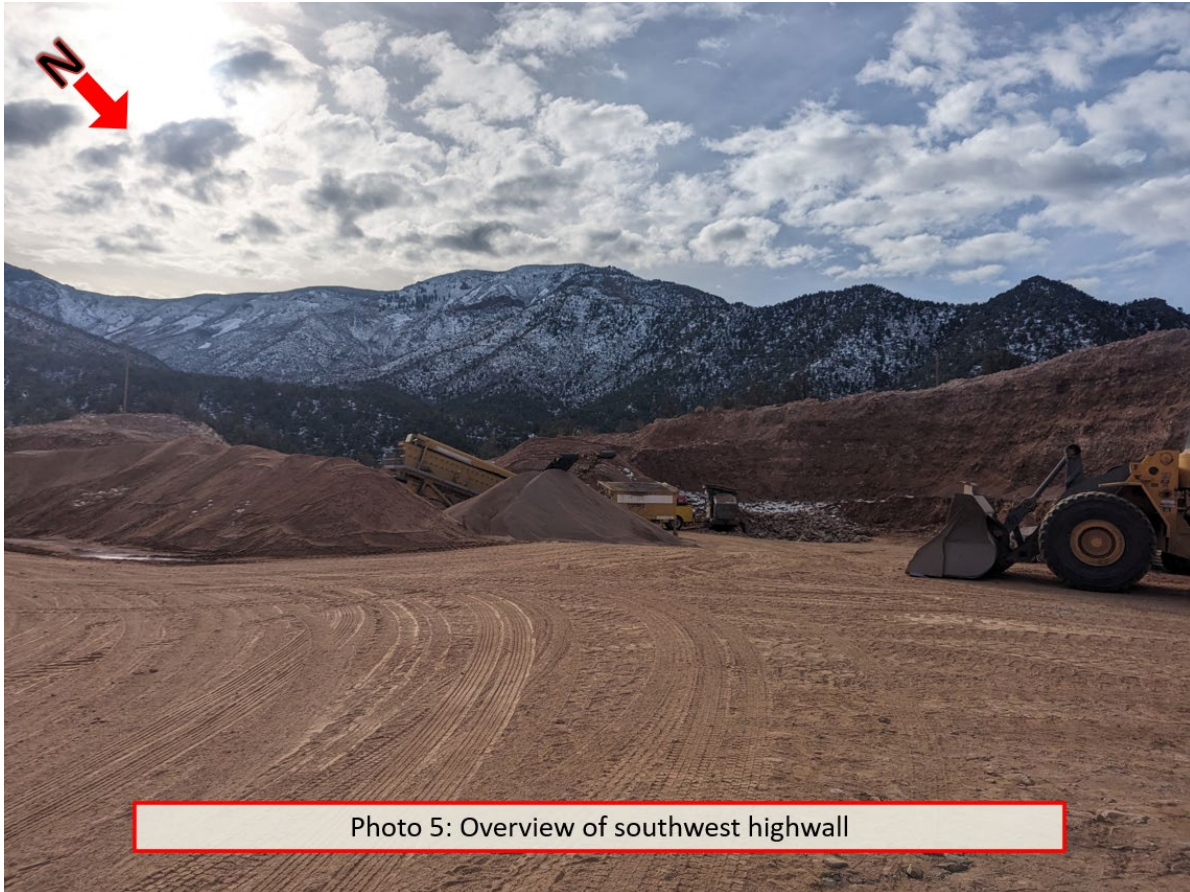
The active highwall is approximately 500 LF and averages 45 feet high (Photos Three - Five). There are several smaller near vertical interstitial benches on the highwall approximately 15 feet high. The overall slope is approximately 1H:1V. Material is pushed down using dozers and excavators. These slopes can be regraded using cut/fill method. There is some limited perimeter highwall grading which is also primarily cut/fill.

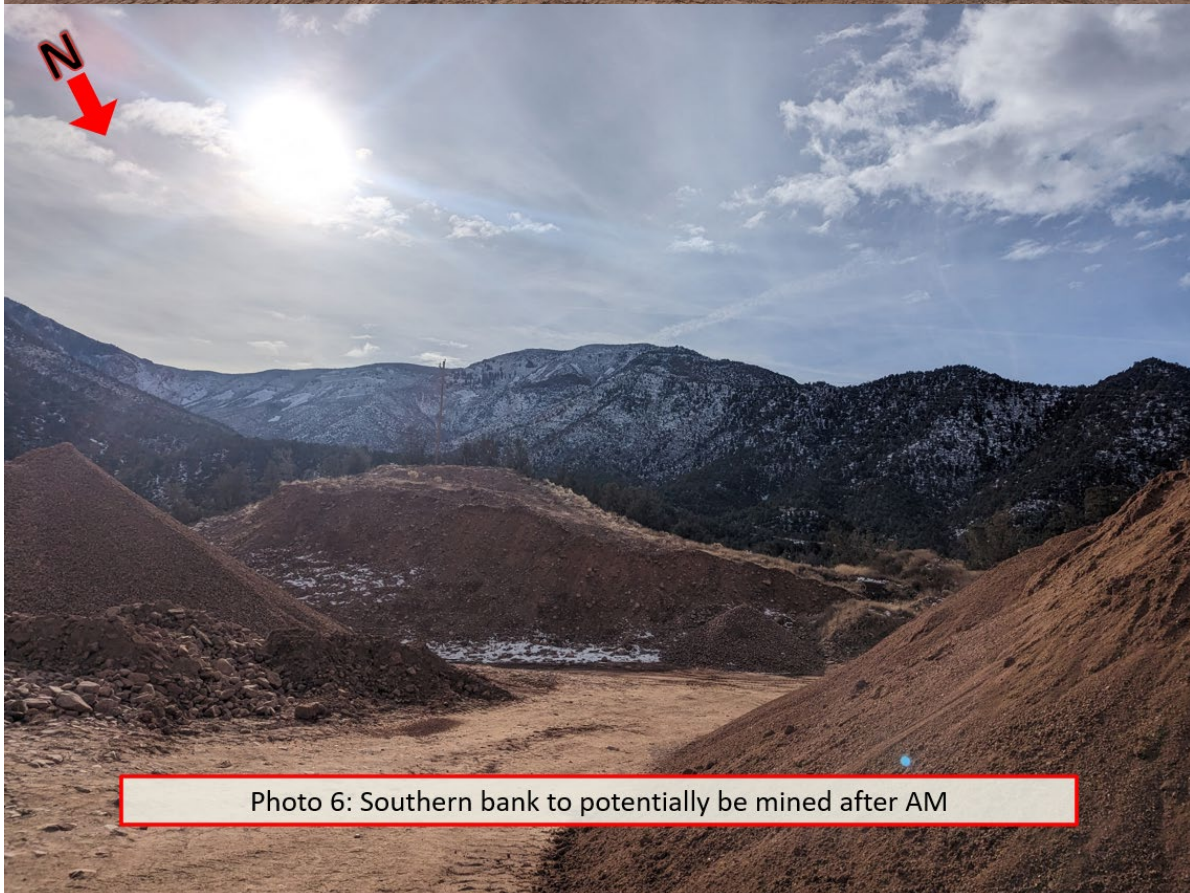
There was a discussion about possibly doing an amendment in the future to add the land to the south in the right of way. This would allow the pit floor to daylight out to the south (Photo Six). It would also decrease the risk of rock falling onto highway 141 from the hillside above. The rock fall is not mining related, but mining could help mitigate this problem. As a reminder, structure agreements will be required for all permanent manmade features within 200 feet of the affected lands.

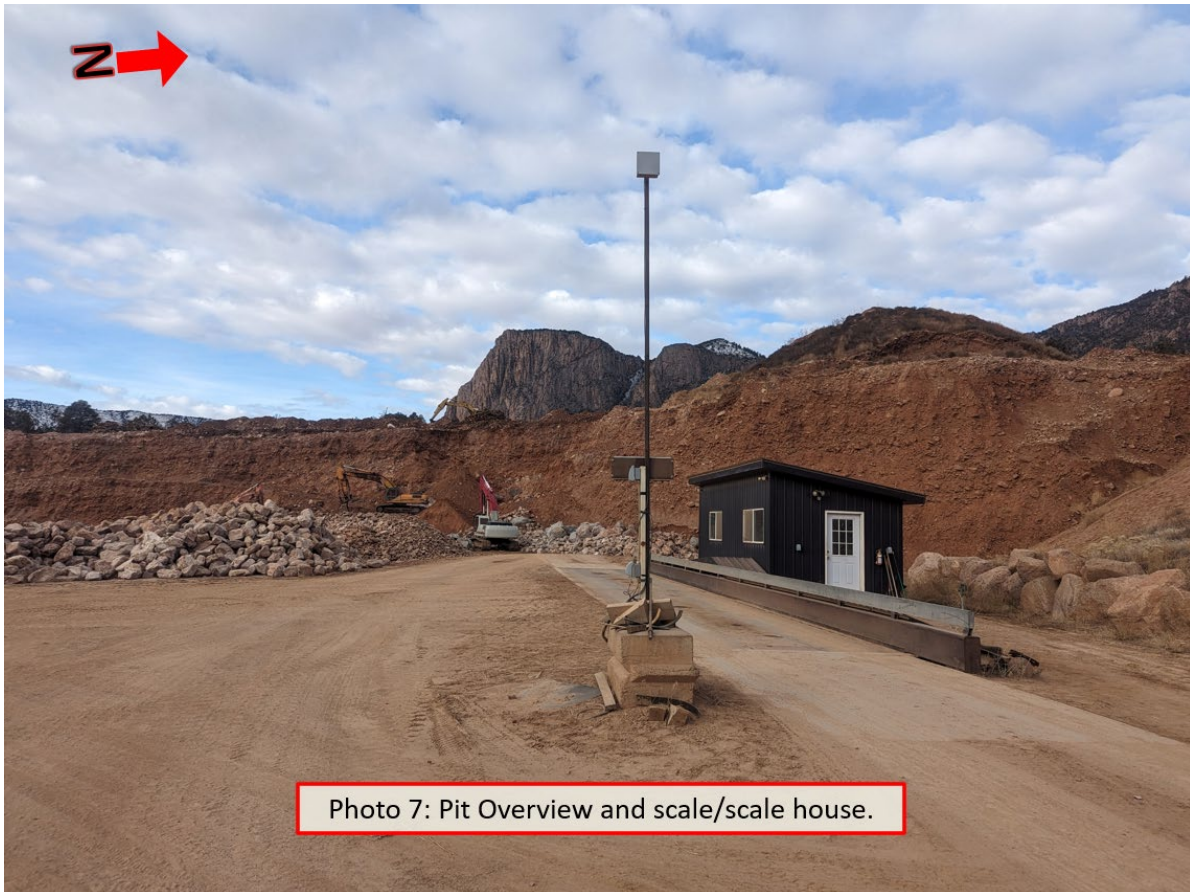
There are several crushers and other miscellaneous heavy equipment located throughout the pit floor area. No washing occurs at this site. The upper scale noted in the previous inspection report has been removed. The lower scale house and office remain on site (Photo Seven). Several fuel tanks are in portable secondary containments (Photo Eight). Currently the fuel is in the southeast corner of the active phase 2 area.

Photo 7: Pit Overview and scale/scale house.

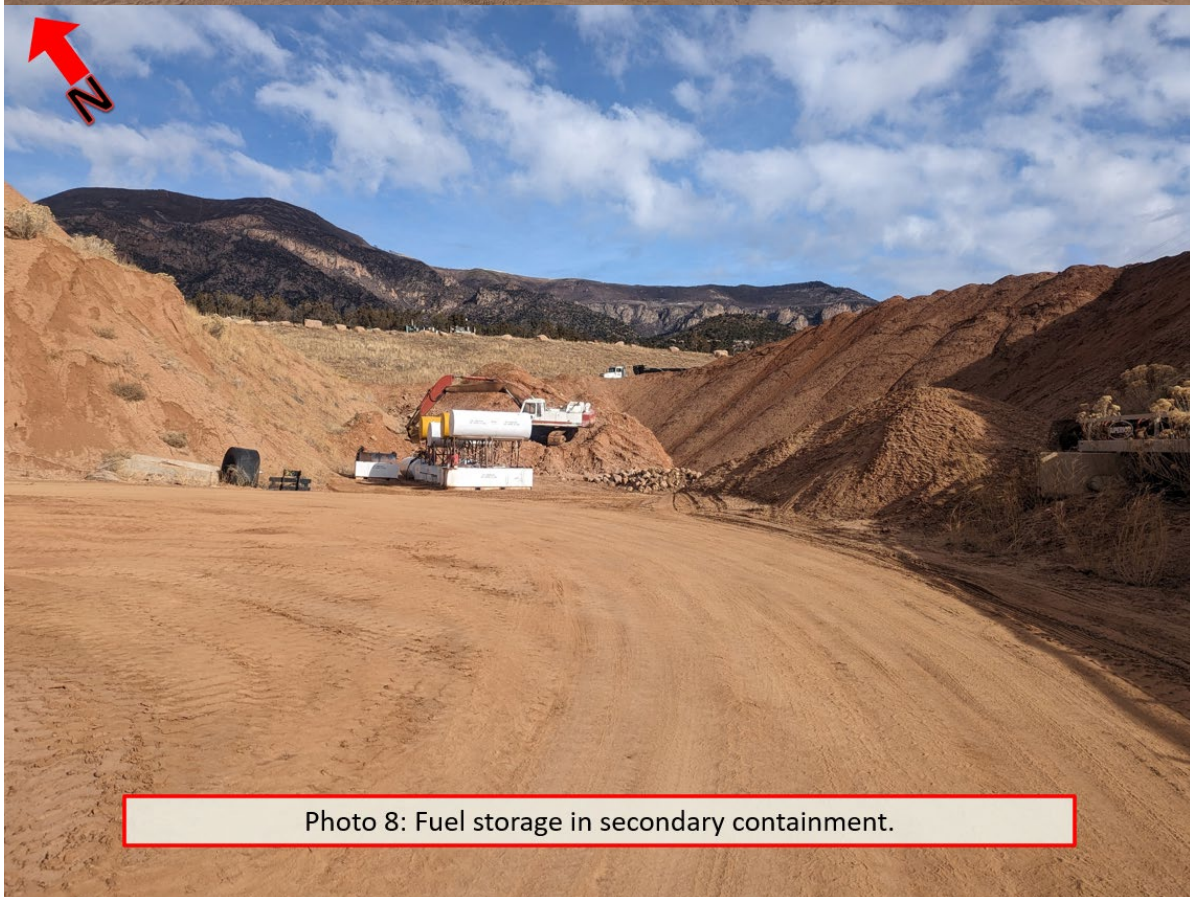
Photo 8: Fuel storage in secondary containment.

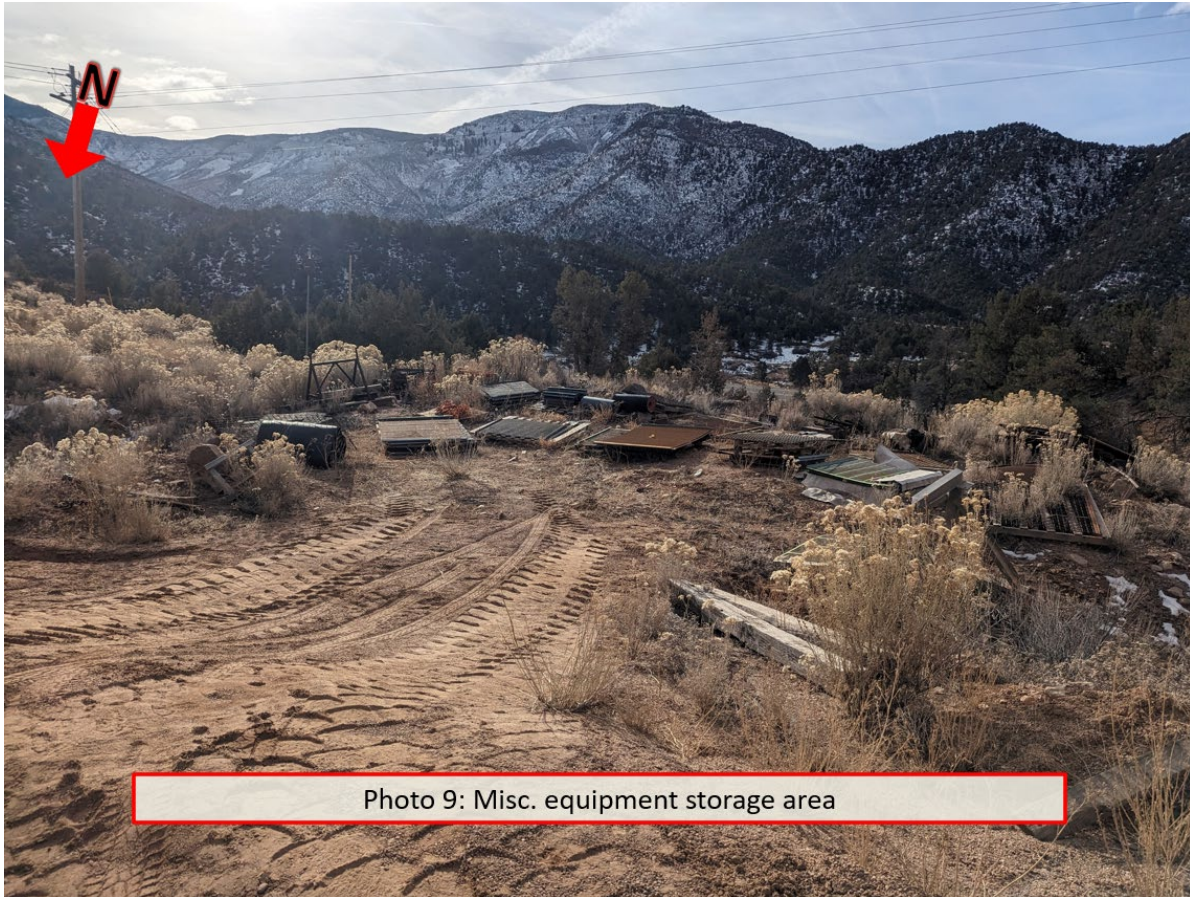
Along the southern edge of phase 2 adjacent to Highway 141 is a bone yard area. Miscellaneous excess equipment parts such as conveyors, screens and tires are stored neatly this area (Photo Nine). There is also a metal shop (portable), two conex sheds and a modular trailer building which remain on site (Photo Ten).

Photo 9: Misc. equipment storage area

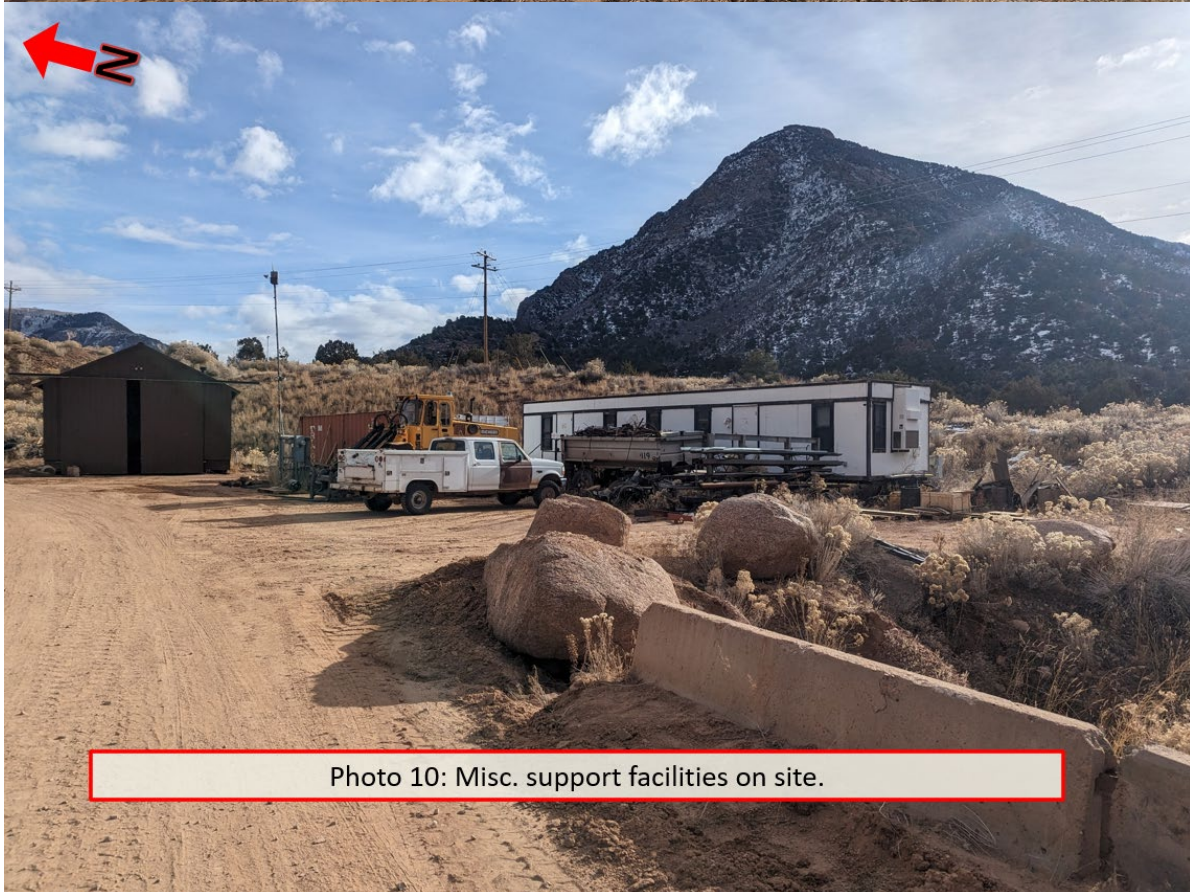
Photo 10: Misc. support facilities on site.

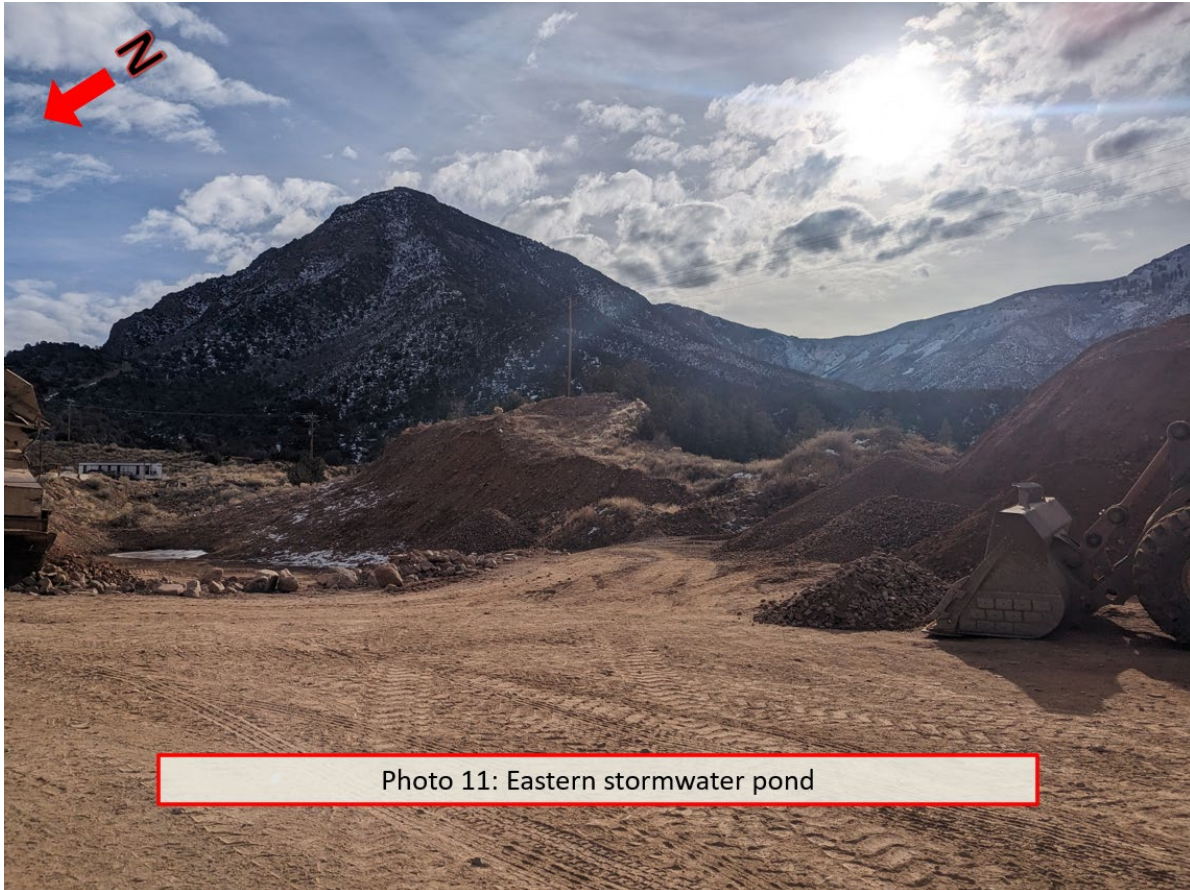
eastern pond has been created (Photo Eleven). A very small amount of spring run-off was observed (frozen) in the stormwater pond. Otherwise, the pit floor was dry (Photos 12 - 13).

Photo 11: Eastern stormwater pond

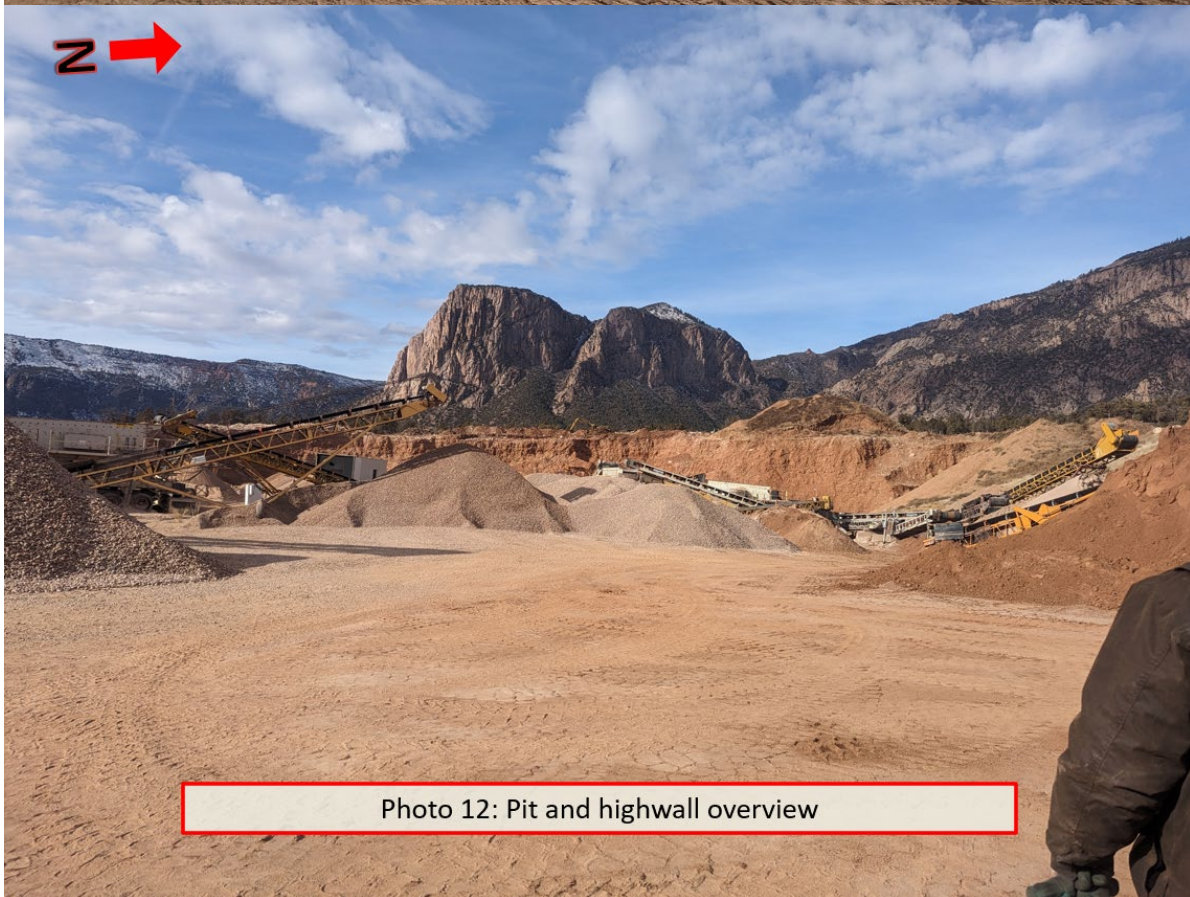
Photo 12: Pit and highwall overview
