MINERALS PROGRAM INSPECTION REPORT
PHONE: (303) 866-3567

MINE NAME: Morgan Pit	MINE/PROSPECTING ID#: M-2006-077	MINERAL: Sand and gravel	COUNTY: Huerfano
INSPECTION TYPE: Monitoring	WEATHER: Clear	INSP. DATE: December 12, 2023	INSP. TIME: 12:45
OPERATOR: Paul Morgan Excavating, Inc.	OPERATOR REPRESENTATIVE: Mike Morgan	TYPE OF OPERATION: 110c - Construction Limited Impact	
REASON FOR INSPECTION: Normal I&E Program	BOND CALCULATION TYPE: Complete Bond	BOND AMOUNT: \$8,844.00	
DATE OF COMPLAINT: NA	POST INSP. CONTACTS: None	JOINT INSP. AGENCY: None	
INSPECTOR(S): Amber Gibson	INSPECTOR'S SIGNATURE:

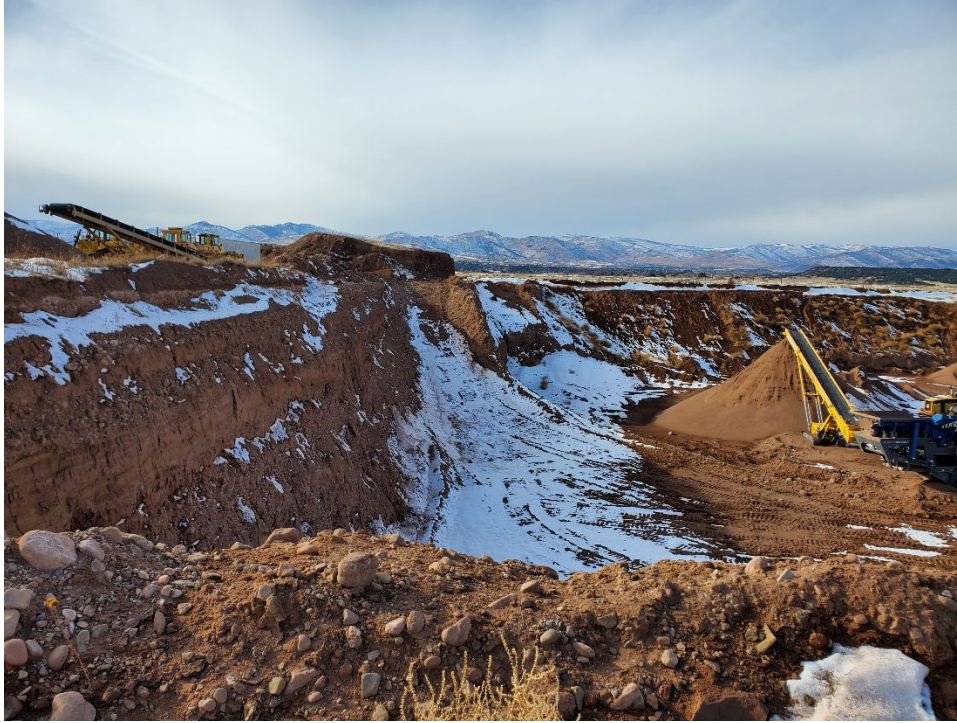
Active mining was not taking place at the time of the inspection but it was active relatively recently. Since the last inspection, mining has moved further south and further south-east. The Division logged a path along the southern highwall (Photo 1 & 2: Map 1) using Esri Field Maps. This path is represented as a yellow line on Map 1. The Operator stated during the inspection that they have likely mined as south as they will mine. The Division estimates that approximately 5.83 acres have been disturbed in the pit at this time. A few product stockpiles of various sizes were observed onsite (Photos 1-4: Map 1). Equipment on-site included a grizzly screener, portable screener, portable crusher, loader, and multiple conveyors (Photos 5: Map 1). The Operator stated that their operation is closed to public customers for the season, but product may be transported and used for the Operator's personal projects.

Photo 1: Looking west from the pit entrance road, across the south highwall.

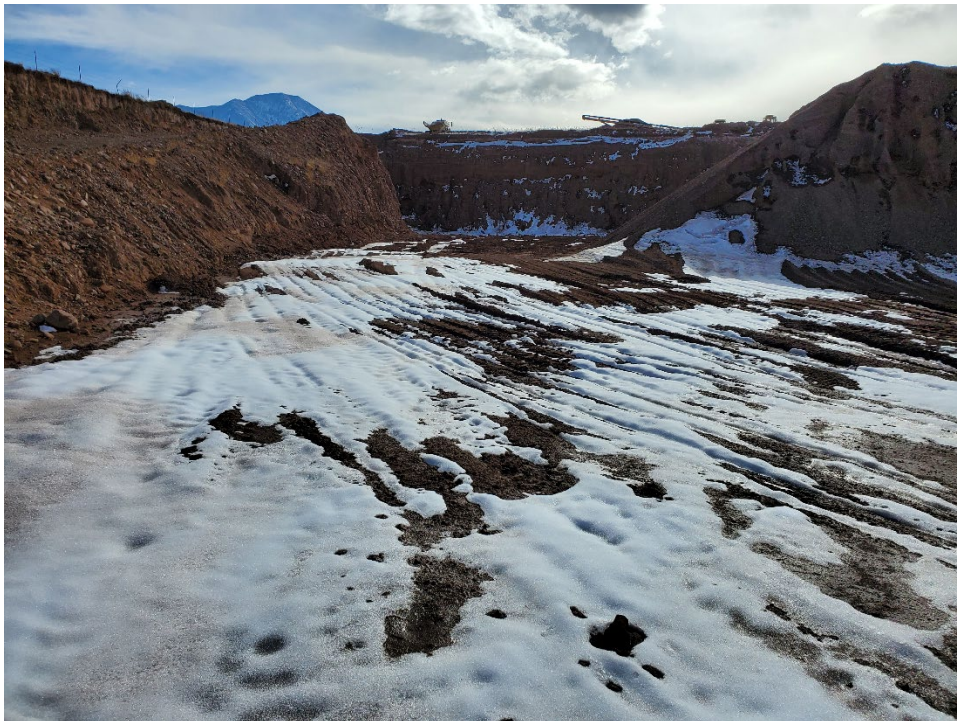
Photo 2: Looking south at the south highwall. The access road to the pit and east highwall are in the left portion of the photo.

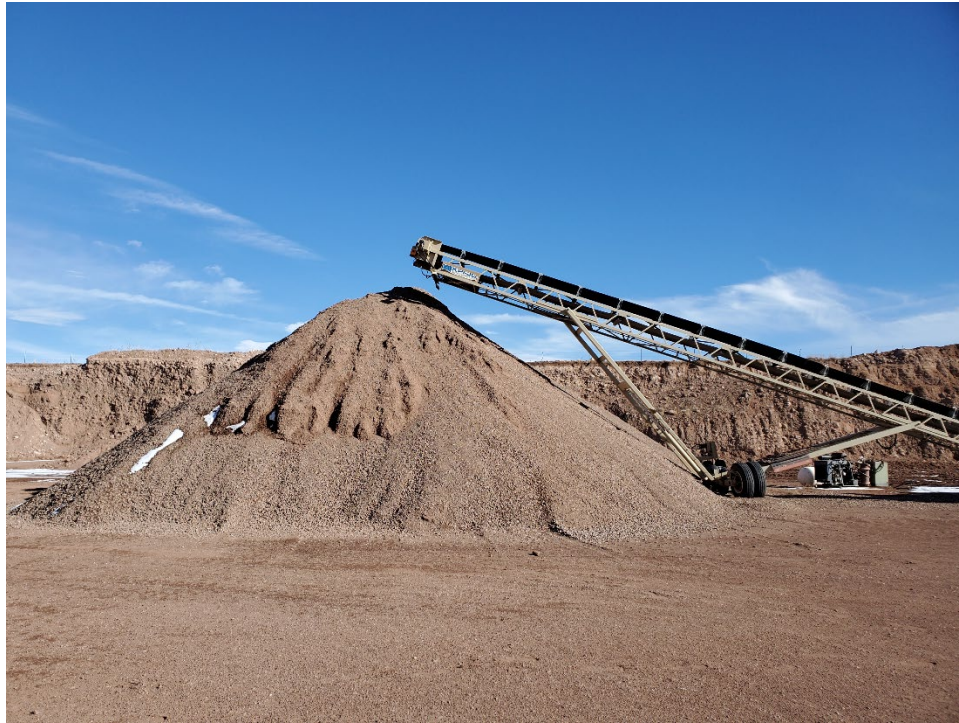
Contrary to the approved mining plan and mining plan map, mining at this site actually began at the north boundary, and has progressed southward (Photo 3: Map 1). This is not being cited as a problem, as the Operator does not plan to mine any further south. If the Operator decides to submit an amendment revision, mining plans will be updated through that process.

Photo 3: Looking east at a product stockpile.

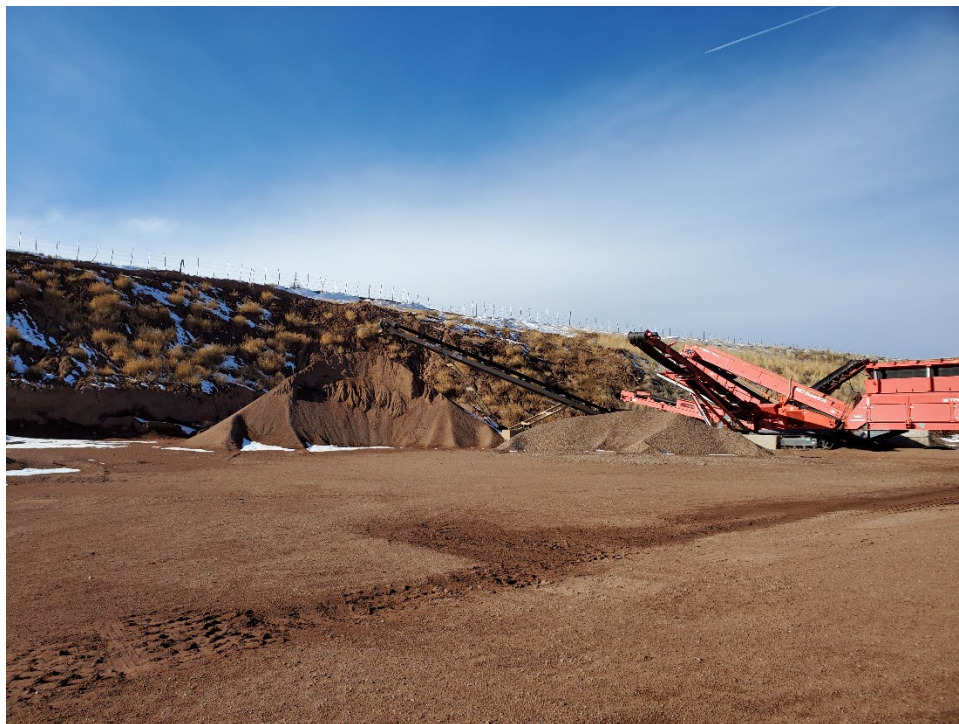
Photo 4: Looking west at stockpiled material.

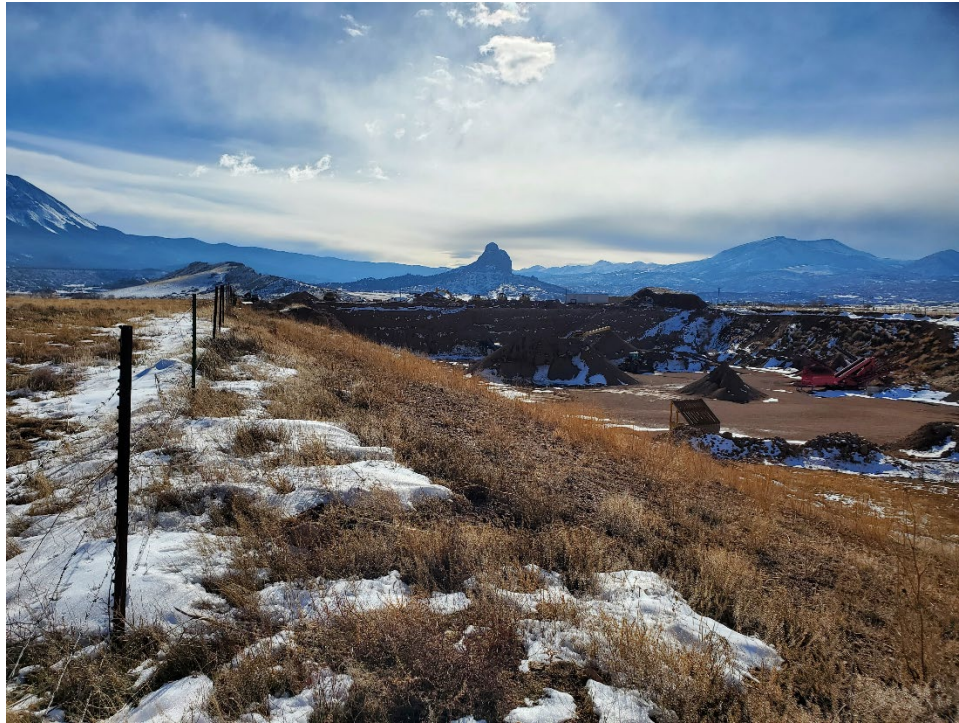
Photo 5: Standing at the northeast corner of the permit, looking southwest across the pit.

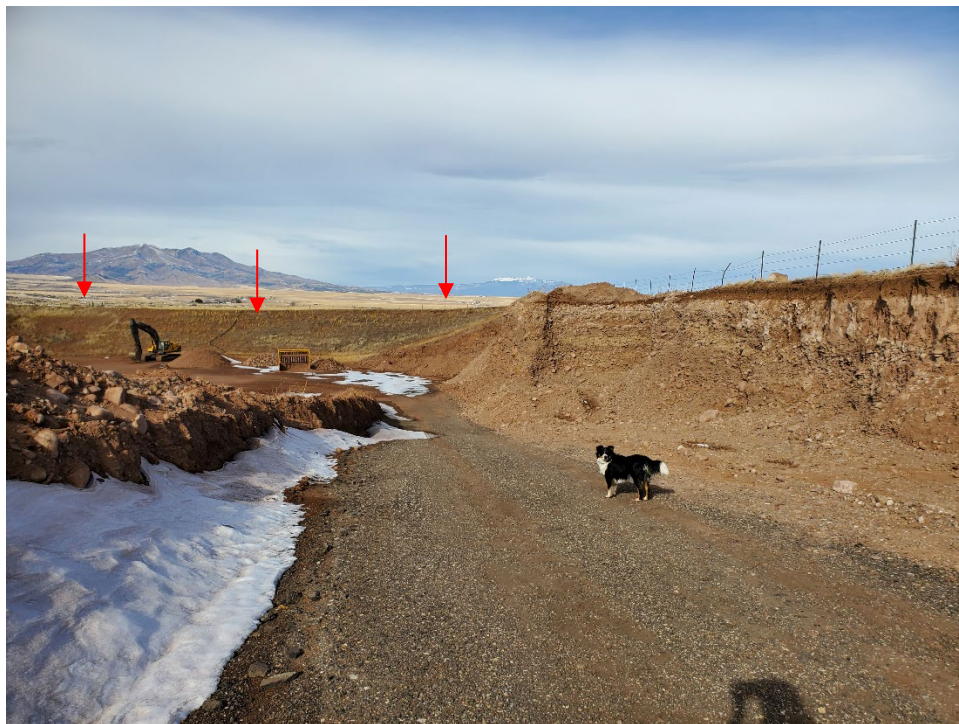
PROBLEM: The current mine plan needs to be updated and clarified pursuant to C.R.S. 34-32.5-112 (1)(c)(VI). The Operator must provide sufficient information to describe or identify how the Operator intends to conduct the operation.

The Operator stated during the inspection that an amendment is still likely planned to continue the operation to the East. Because the highwalls have remained (Photo 6: Map 1), and no revision has been submitted, the Division has cited this as a problem above. The Operator has three options. The Operator may choose to:

Photo 6: Looking north along the east highwall. The arrow points to the reclaimed northern slopes.

- Submit a Revision (Technical Revision or an Amendment), with the required revision fee, to update and clarify the current approved mine plan to reflect existing and proposed activities by the corrective action date.
- Backfill the eastern highwall to a 3H:1V slope and provide evidence to the Division that has been completed by the corrective action date.

1. Submit a Technical Revision that at minimum updates the mining and reclamation plans to account for and allow for the presence of highwalls throughout the site.
2. Submit an amendment or conversion to change the permit boundaries to allow for mining to continue to the east, and in doing so, update the plans to include highwalls.
3. Immediately backfill and grade the highwalls to a 3H:1V slope.

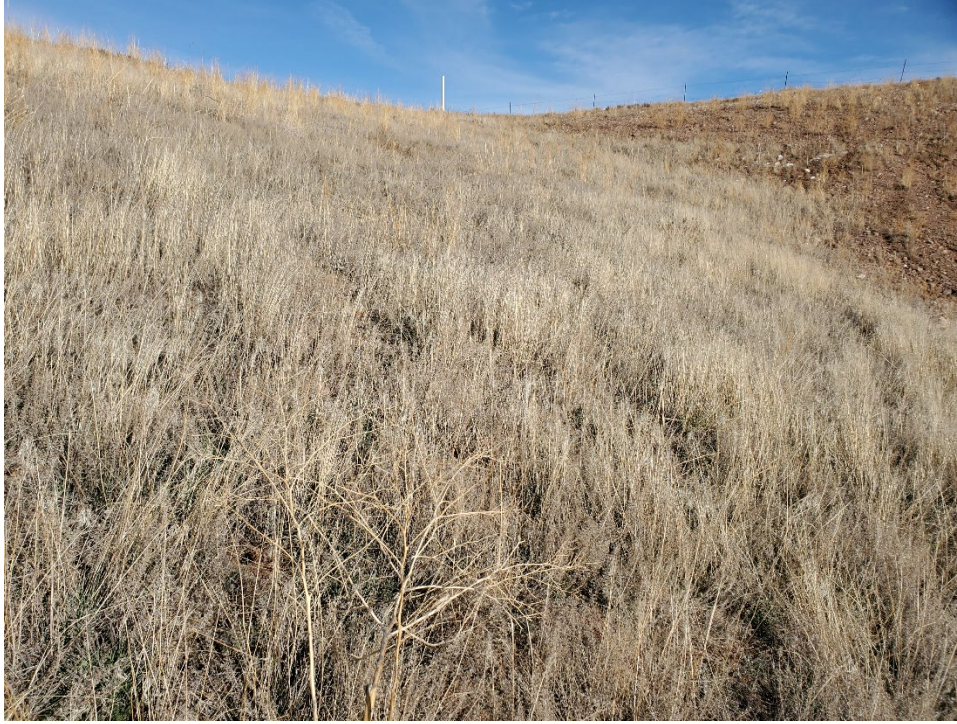
The north, northeast, and the majority of the western slopes have been backfilled and graded to a 3H:1V slope. The north, northeast, and northwest slopes have also been top soiled and seeded (Photos 6 & 7: Map 1). These slopes have vegetation established on them, with a variety of grasses and native plants (Figure 1). The Operator stated that they have had some erosion occur on various areas on these slopes, due to heavy rainfall, but have since repaired these areas. Overall, the revegetation on the reclaimed slopes is looking good and the slopes appear stable.

Photo 7: Looking east along a reclaimed northern slope. The white marker indicates the northeast corner of the permit boundary. The fence line in the photo lines the eastern perimeter.

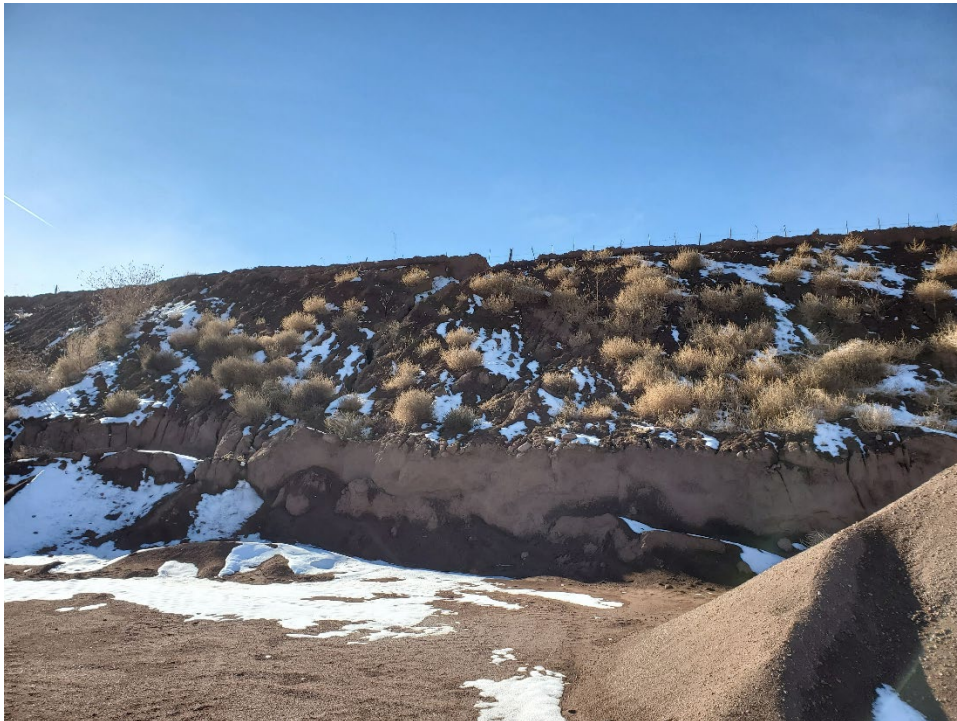
As stated in the Hydrologic Balance section, any surface water run-off is contained within the pit. Some erosion was noted on a portion of the western slope (see Photo 8: Map 1). However, the rilling is minor, and there is some vegetation that has volunteered in the area, stabilizing the slope at this time. The Division advises the Operator to monitor this area, and to grade this slope if the erosion worsens. The Operator stated during the inspection that they will likely grade, topsoil, and revegetate this area soon.

Photo 8: Looking west at some slight erosion on the western pit slopes. The fence lines the western permit perimeter.

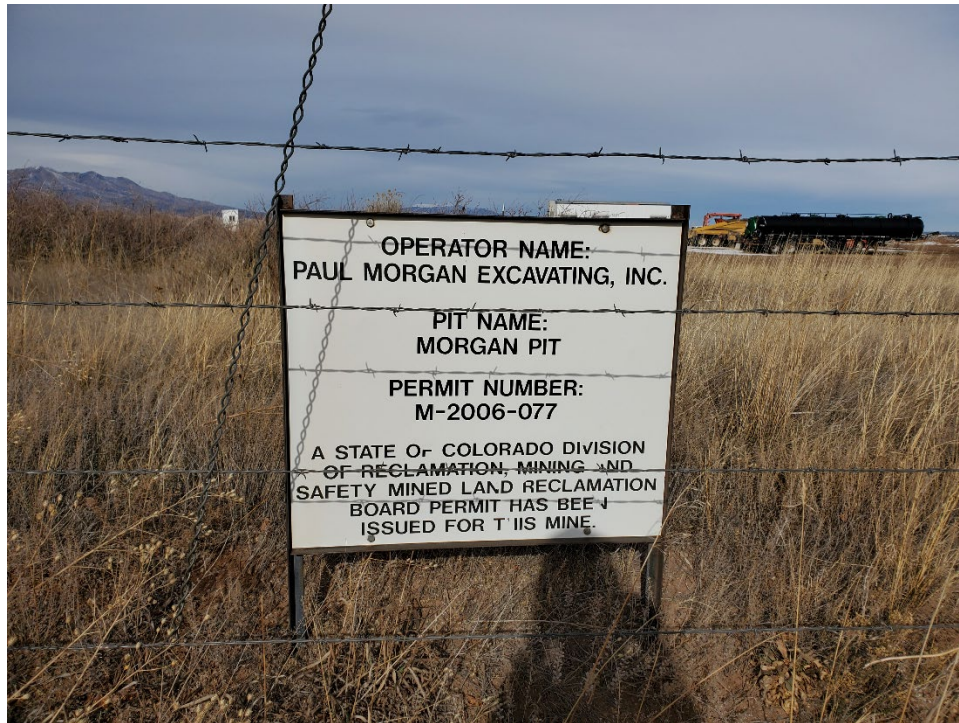
A permit sign was posted in compliance with Rule 3.1.12(1) (Photo 9: Map 1). Boundary markers were located during the 2019 inspection, and the north-west and entrance markers were re-verified during the 2023 inspection. The Division observed a fence surrounding the pit that serves as a boundary. The site is marked in compliance with 3.1.12(2).

Photo 9: Mine sign posted at the entrance to the permit boundary.

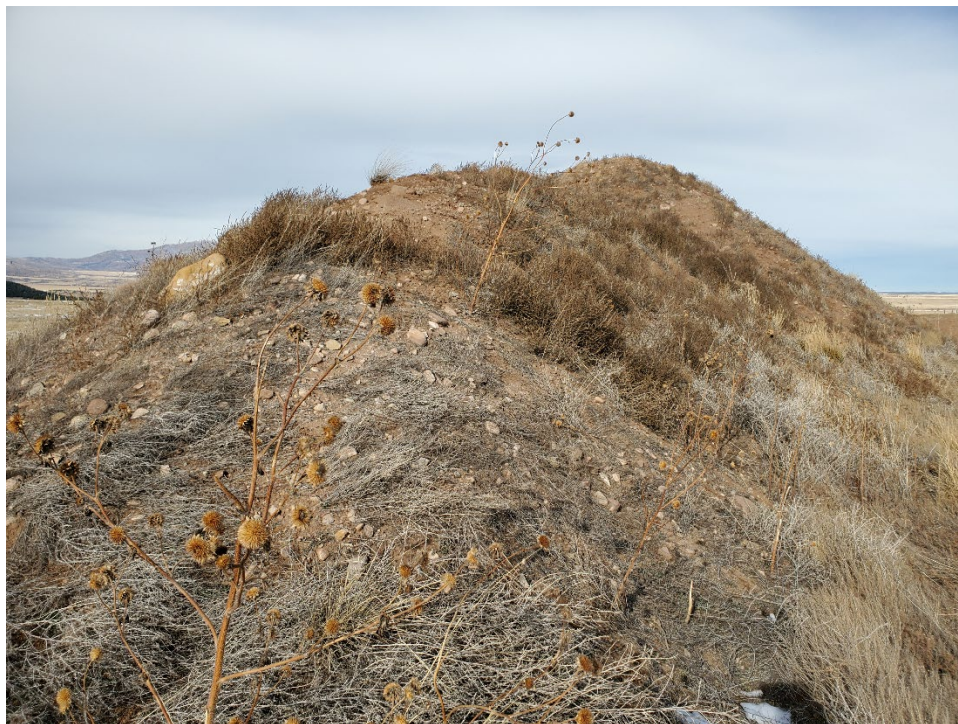
A large topsoil pile is located above the southwest corner of the pit (Photo 10: Map 1). This pile is vegetated with volunteer vegetation, and appears to be stable at this time. Additional smaller topsoil piles are located above the south portion of the west highwall as well, to help easily facilitate reclamation in this area. These piles also appear stable at this time.

Photo 10: Looking north along the vegetated topsoil pile located to the south of the southern pit boundary.

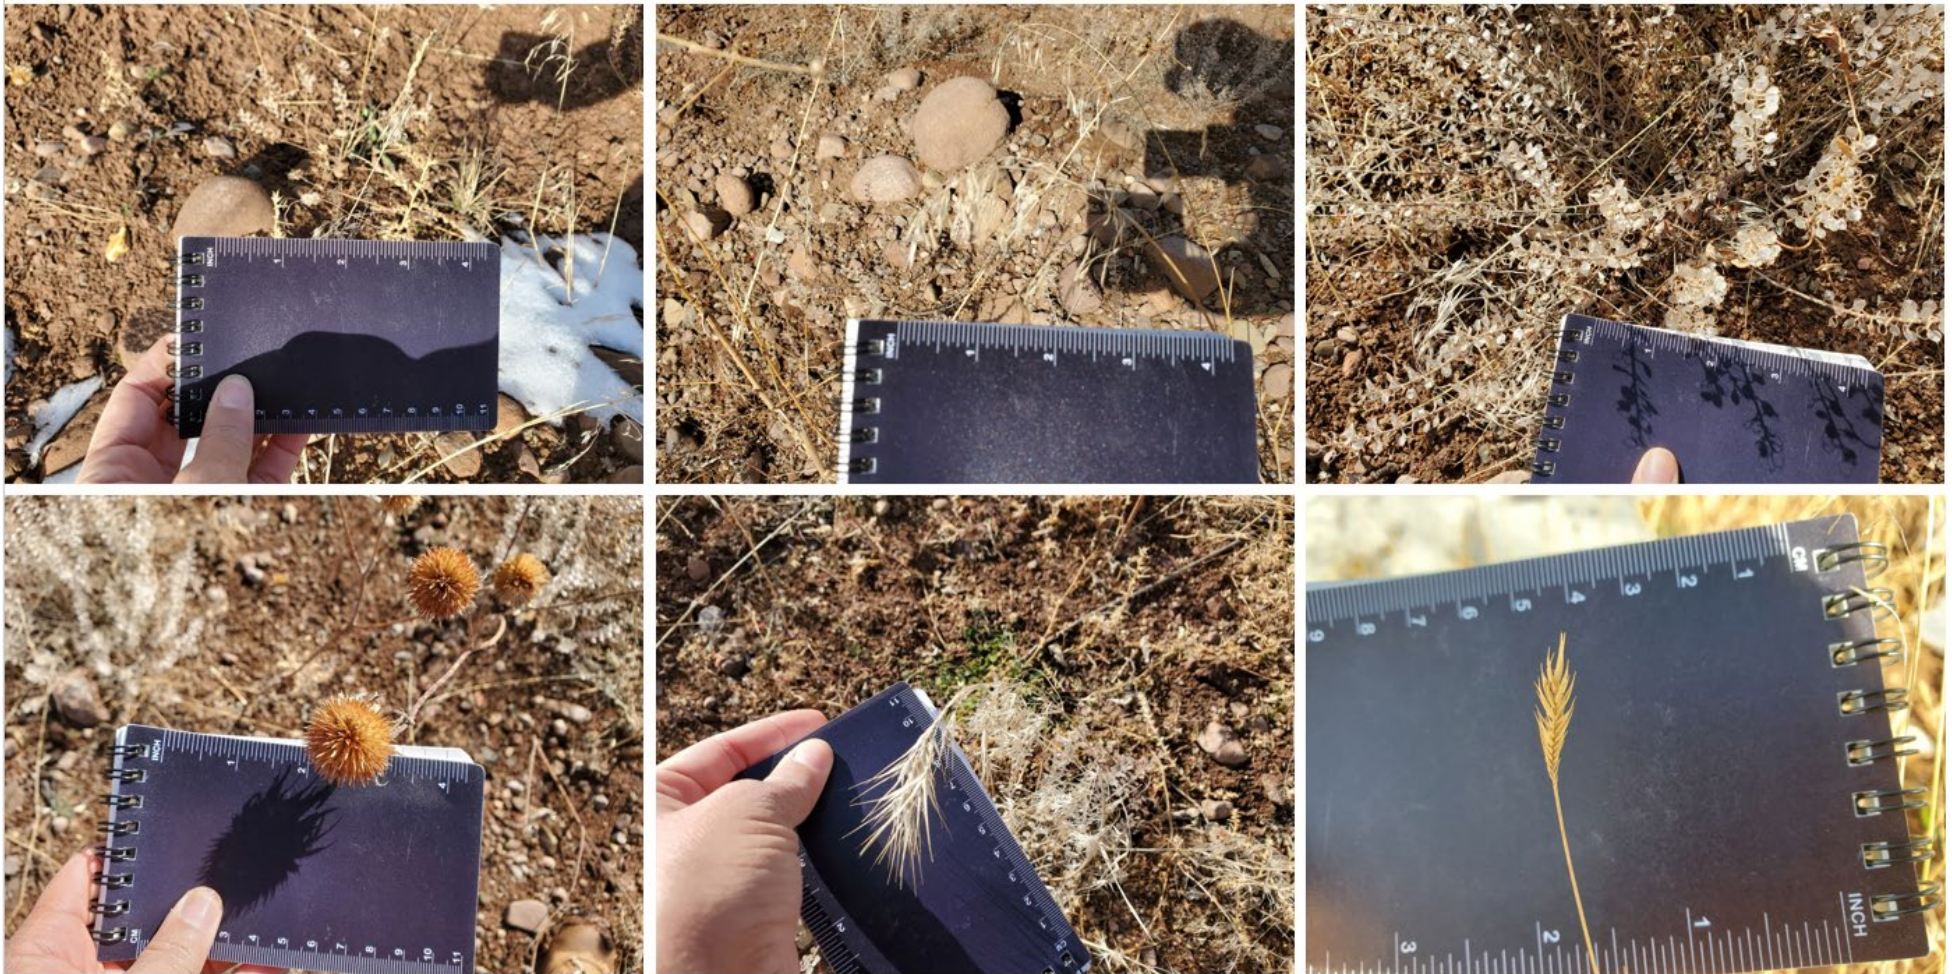
Figure 1: The six photos highlight some of the variety of grasses and native plants located on the reclaimed northern slopes.

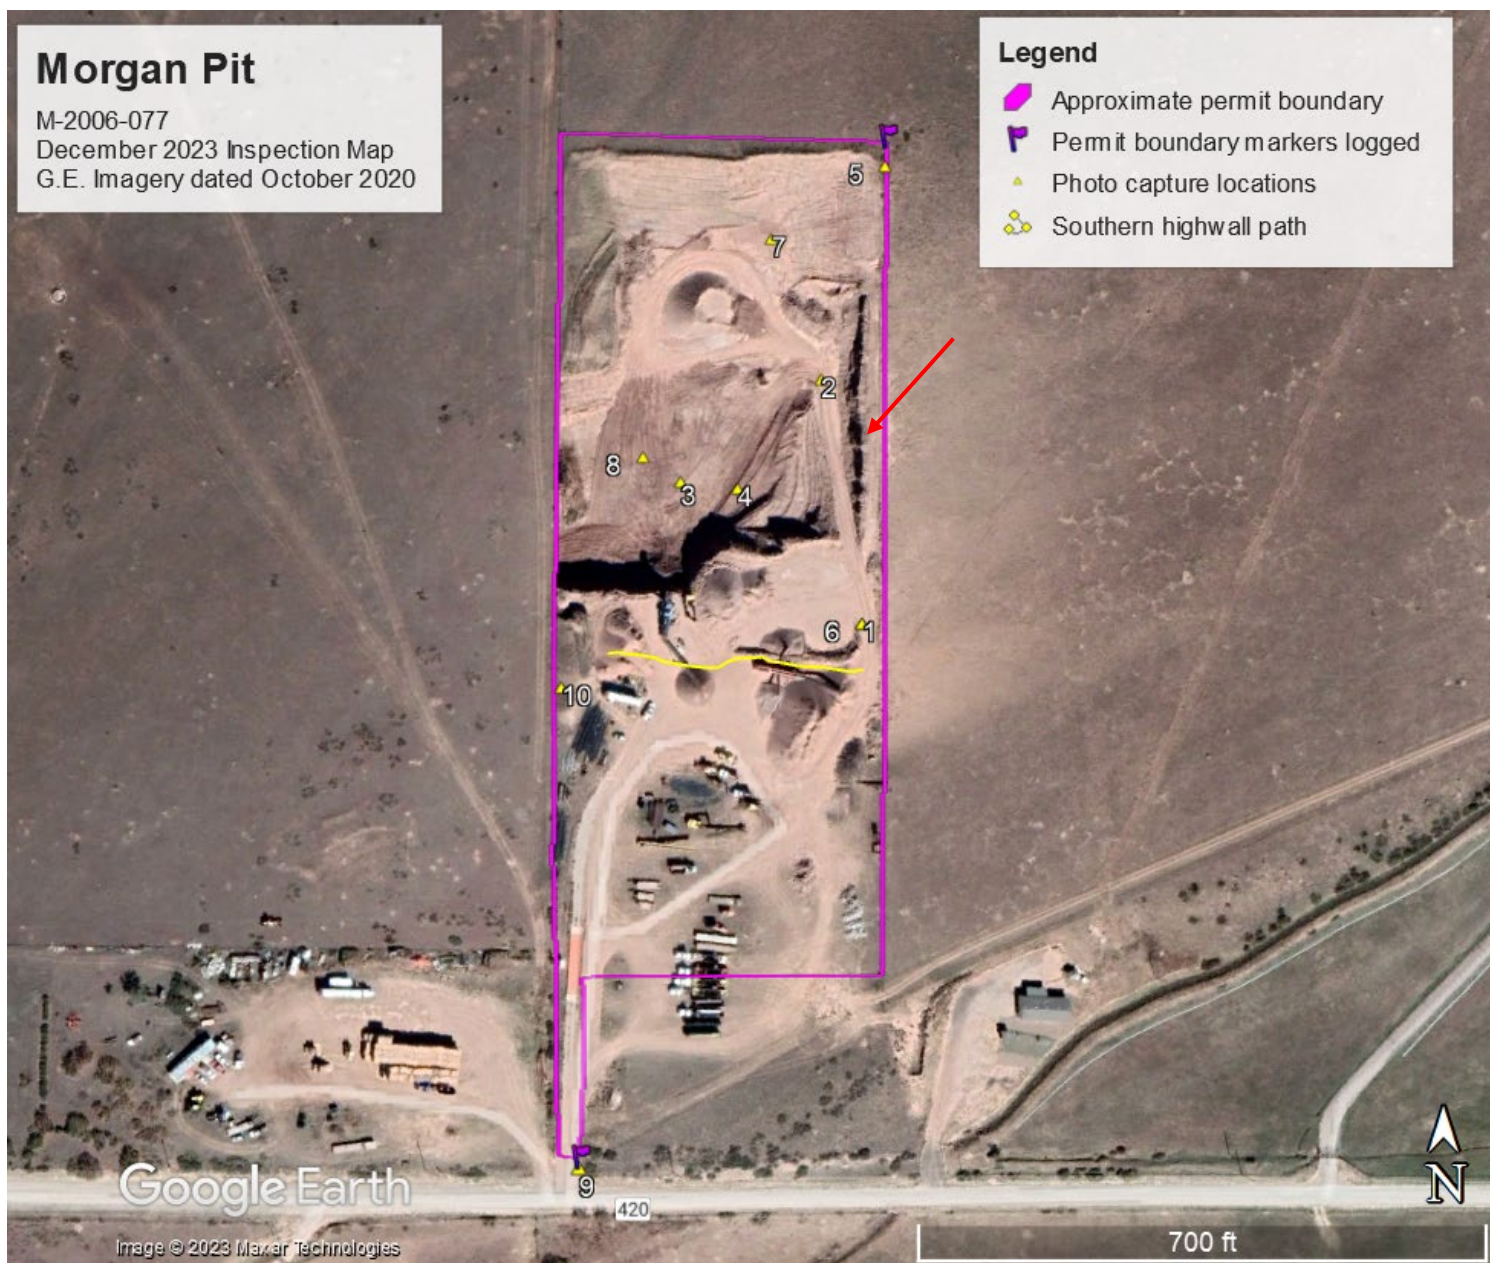
Map 1: Inspection map generated for the December 12, 2023 inspection. The most recent Google imagery is dated October 2020. Since the aerial image was taken, mining has progressed further south (yellow line) and south-east. The arrow points to the eastern highwall that needs to be addressed.
