MINERALS PROGRAM INSPECTION REPORT
PHONE: (303) 866-3567

MINE NAME: Rocky Flat Gravel	MINE/PROSPECTING ID#: M-1982-129	MINERAL: Sand and gravel	COUNTY: Huerfano
INSPECTION TYPE: Monitoring	WEATHER: Clear	INSP. DATE: December 12, 2023	INSP. TIME: 14:45
OPERATOR: L. Otto Goemmer	OPERATOR REPRESENTATIVE: Pete Goemmer and Lucas Dearmin	TYPE OF OPERATION: 110c - Construction Limited Impact

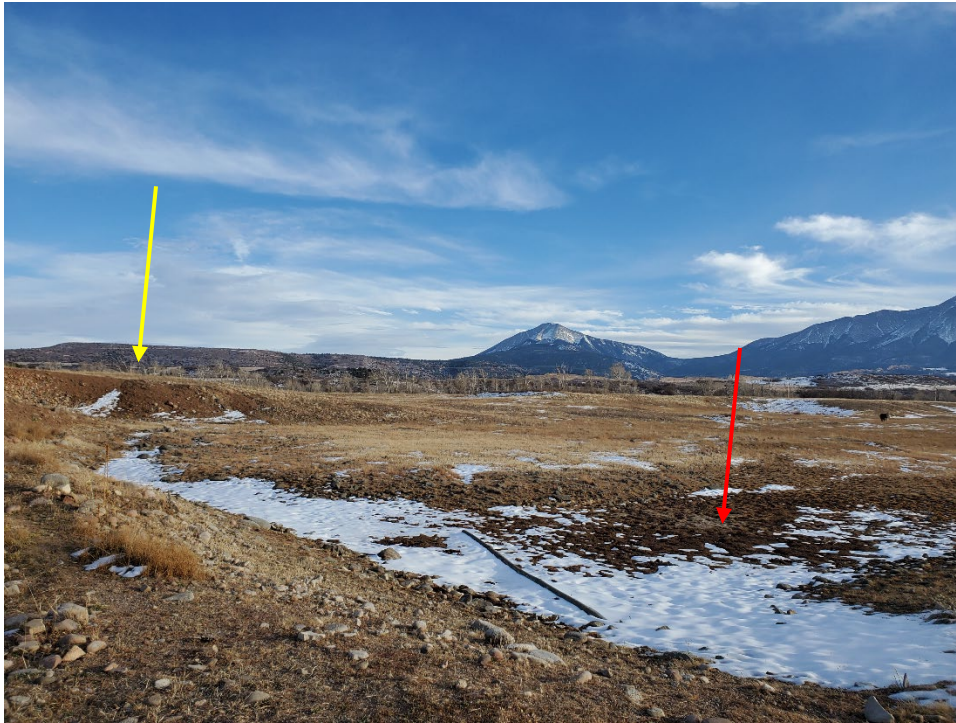
The northwest corner of the mined area had been cited for the presence of impounded water. The Operators were instructed to establish permanent positive drainage in the area and to backfill at least two feet above the water level. During the 2023 inspection, no standing water was observed onsite (Photo 1: Map 1). The Operators have installed a pipe to syphon standing water outside of the permit boundary, allowing it to infiltrate into the ground in an adjacent field. However, the Operators have not yet backfilled the corner. To help reduce the water retention in this area, and to aid in the growth of vegetation, the Division advises the Operator to still backfill at least two feet in this corner to bring the elevation up, and to increase the permeability. The Division reminds the Operator, that per DWR requirements, any stormwater runoff intercepted by this operation that is not diverted or captured in priority must be released to the stream system within 72 hours; otherwise the Operator will need to make replacements for evaporation.

As mentioned in the 'Gen. Compliance with Mine Plan' section above, the 2.28 acre area and the 0.22 acre area have been graded flat, and both contain established vegetation. The north, west, and eastern aspect slopes of the original 7.5 acre area have been graded to a 4:1 horizontal to vertical ratio or less (Photo 1: Map 1). The slopes appeared stable, and grass has established throughout the affected land, except for a small area in the northeast corner of the pit (see Photo 1: Map 1). The Operator stated that they will grade this area to a shallower slope, and re-seed it.

Photo 1: Looking east across the pit. The red arrow points to the low area that often collects water. The yellow arrow points to the portion of the eastern slope that may need to be regraded to a shallower slope, and vegetated.

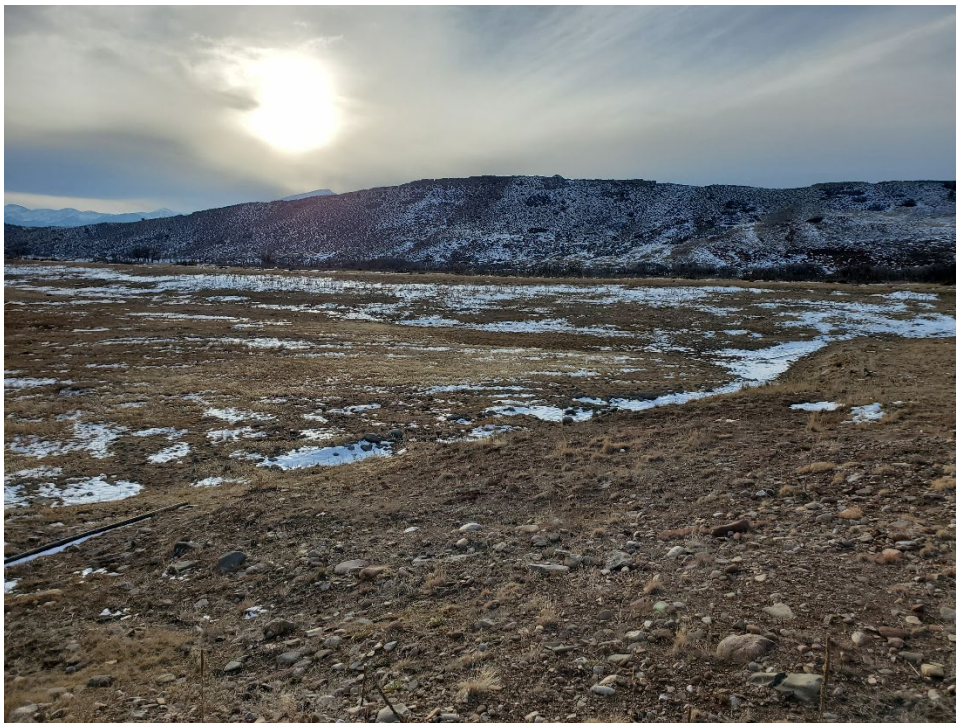
The original 7.5 acre permit area consists of a small basin where previous mining activity occurred. The basin daylighted to the south. The northern boundary of the Rocky Flat Gravel Pit is separated by a berm (Photo 2 & 3: Map 1) from a released Lafarge operation that was known as the La Veta Pit (M-2001 -086).

Photo 2: Looking west, from the northern boundary of the mined area.

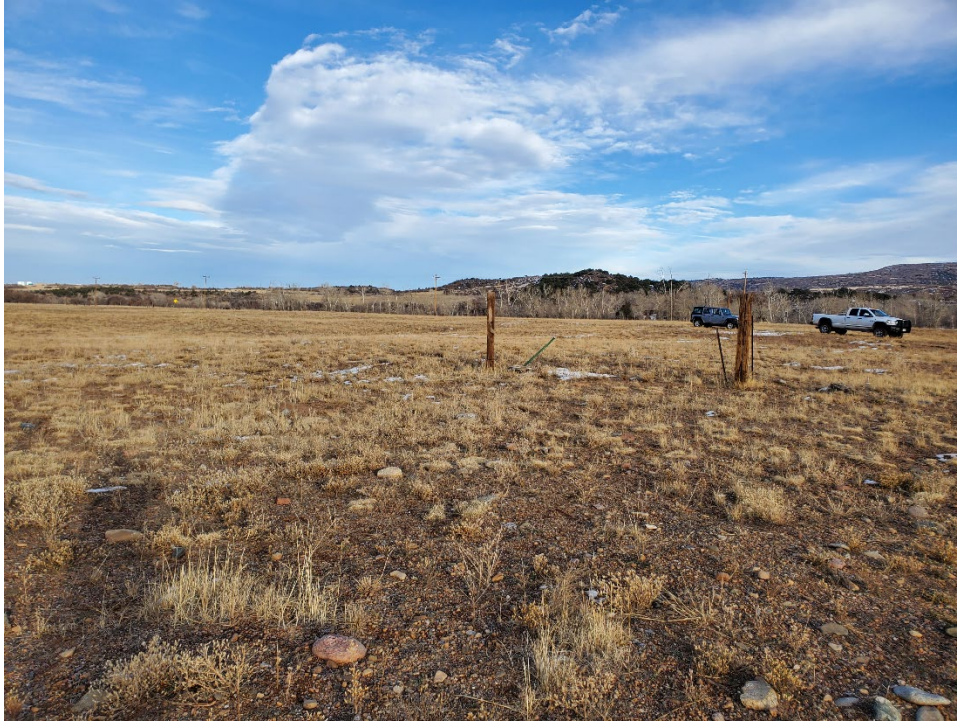
Photo 3: Looking east at a gate, marking the north-east boundary of the 7.5 acre area, leading to the 2.28 acre area.

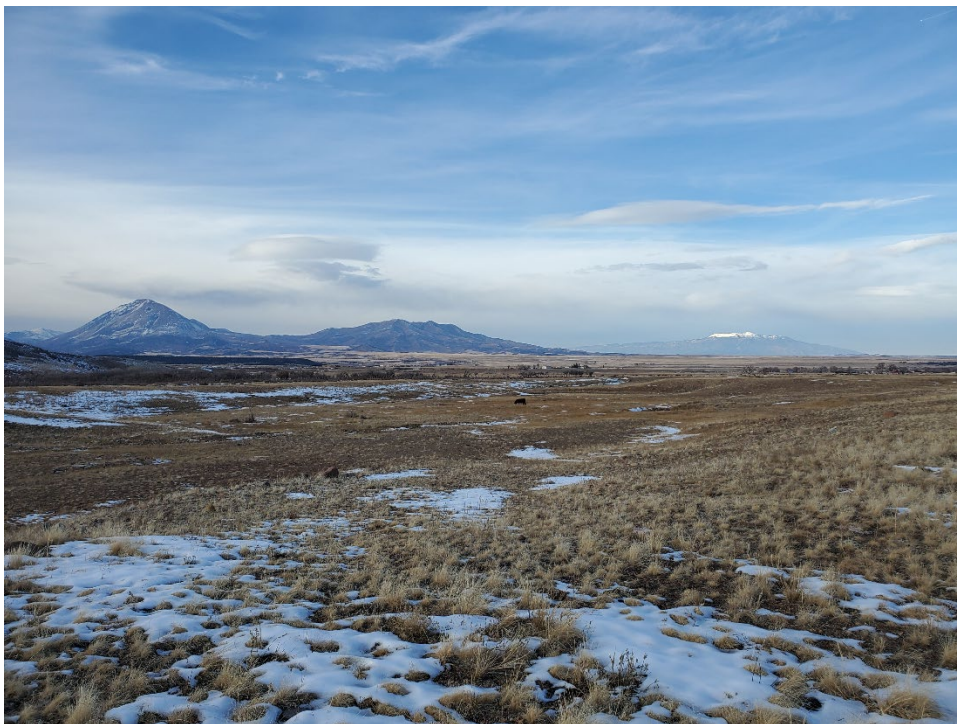
Photo 4: Looking northwest along the adjacent lands south of the main permit area.

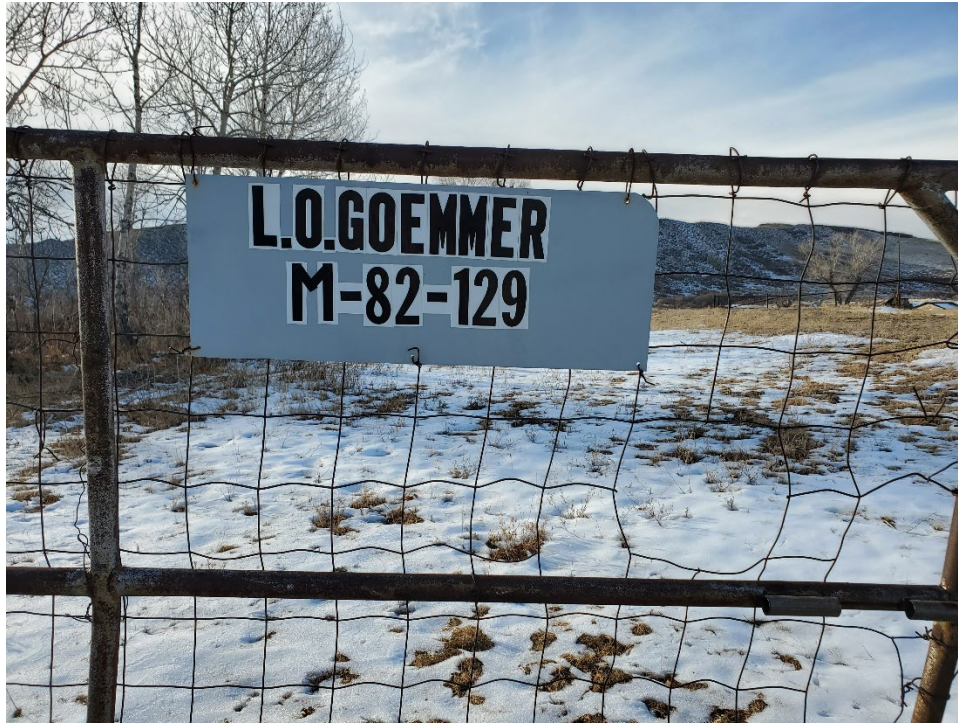
A sign was posted at the entrance to the site in compliance with Rule 3.1.12(1) (Photo 5: Map 1).

Photo 5: Mine sign posted at the entrance.

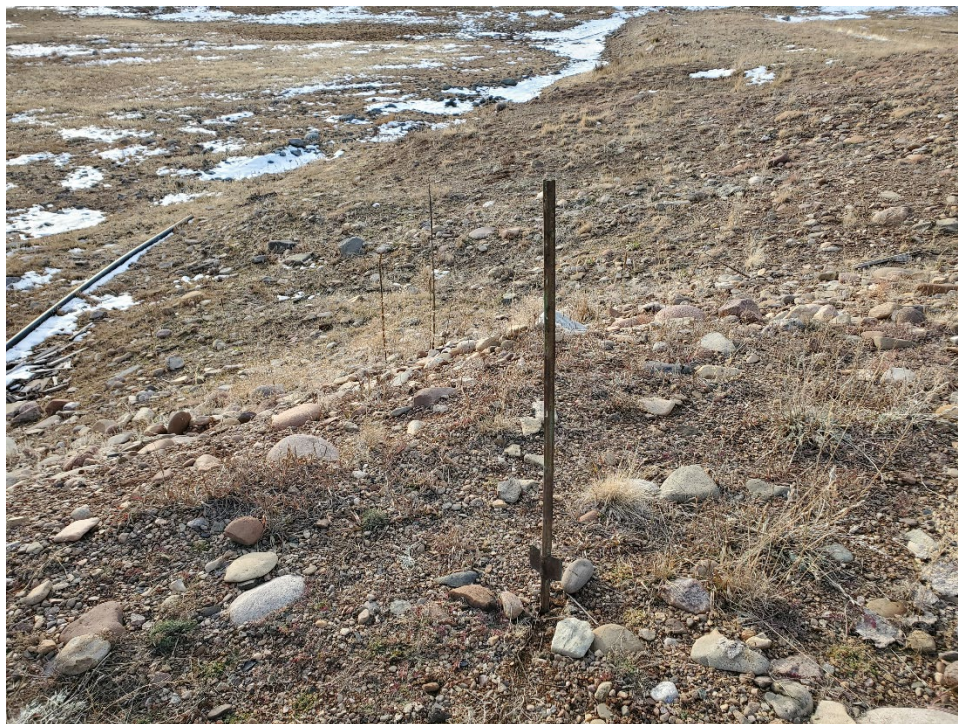
Two permit boundary markers were located during the inspection (Photos 6 & 7: Map 1), but the remainder were absent. **This has been cited above as a problem** for missing affected land boundary markers in compliance with Rule 3.1.12(2). **The Operator shall replace** permit boundary markers, using the survey map submitted during the amendment application (see Map 2), by the corrective action date.

Photo 6: Permit boundary marker on the northern berm along the 7.5 acre area.

CORRECTIVE ACTIONS: The Operator shall use the approved permit boundary map to replace the boundary markers in the correct location(s). The Operator shall provide proof to the Division that this has been done by the corrective action date.

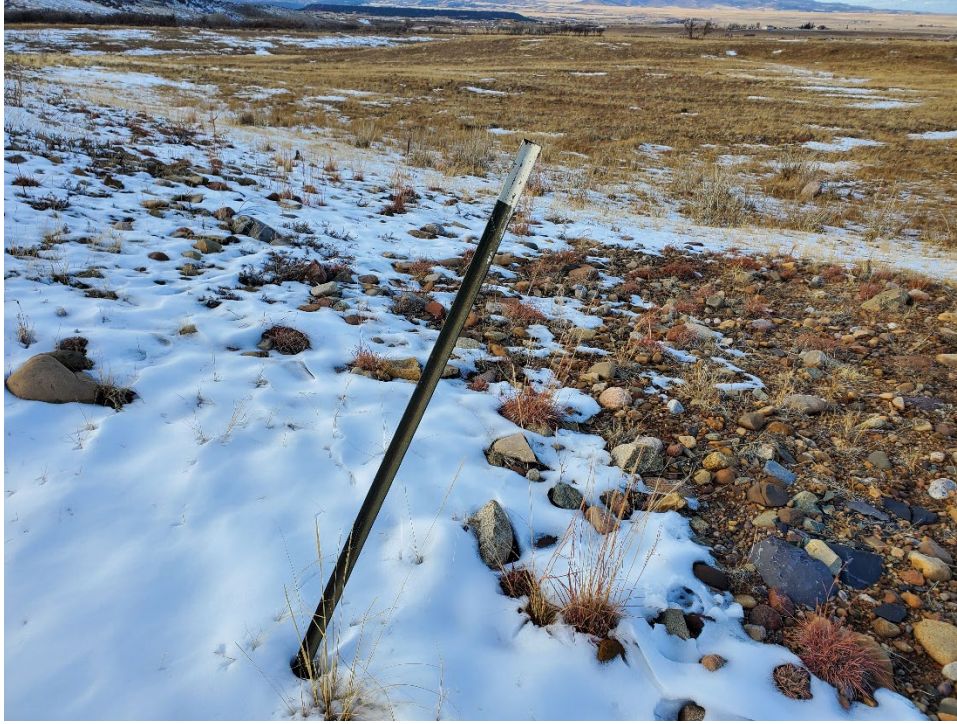
Photo 7: Permit boundary marker near the southeast corner of the amended 2.28 acre area.

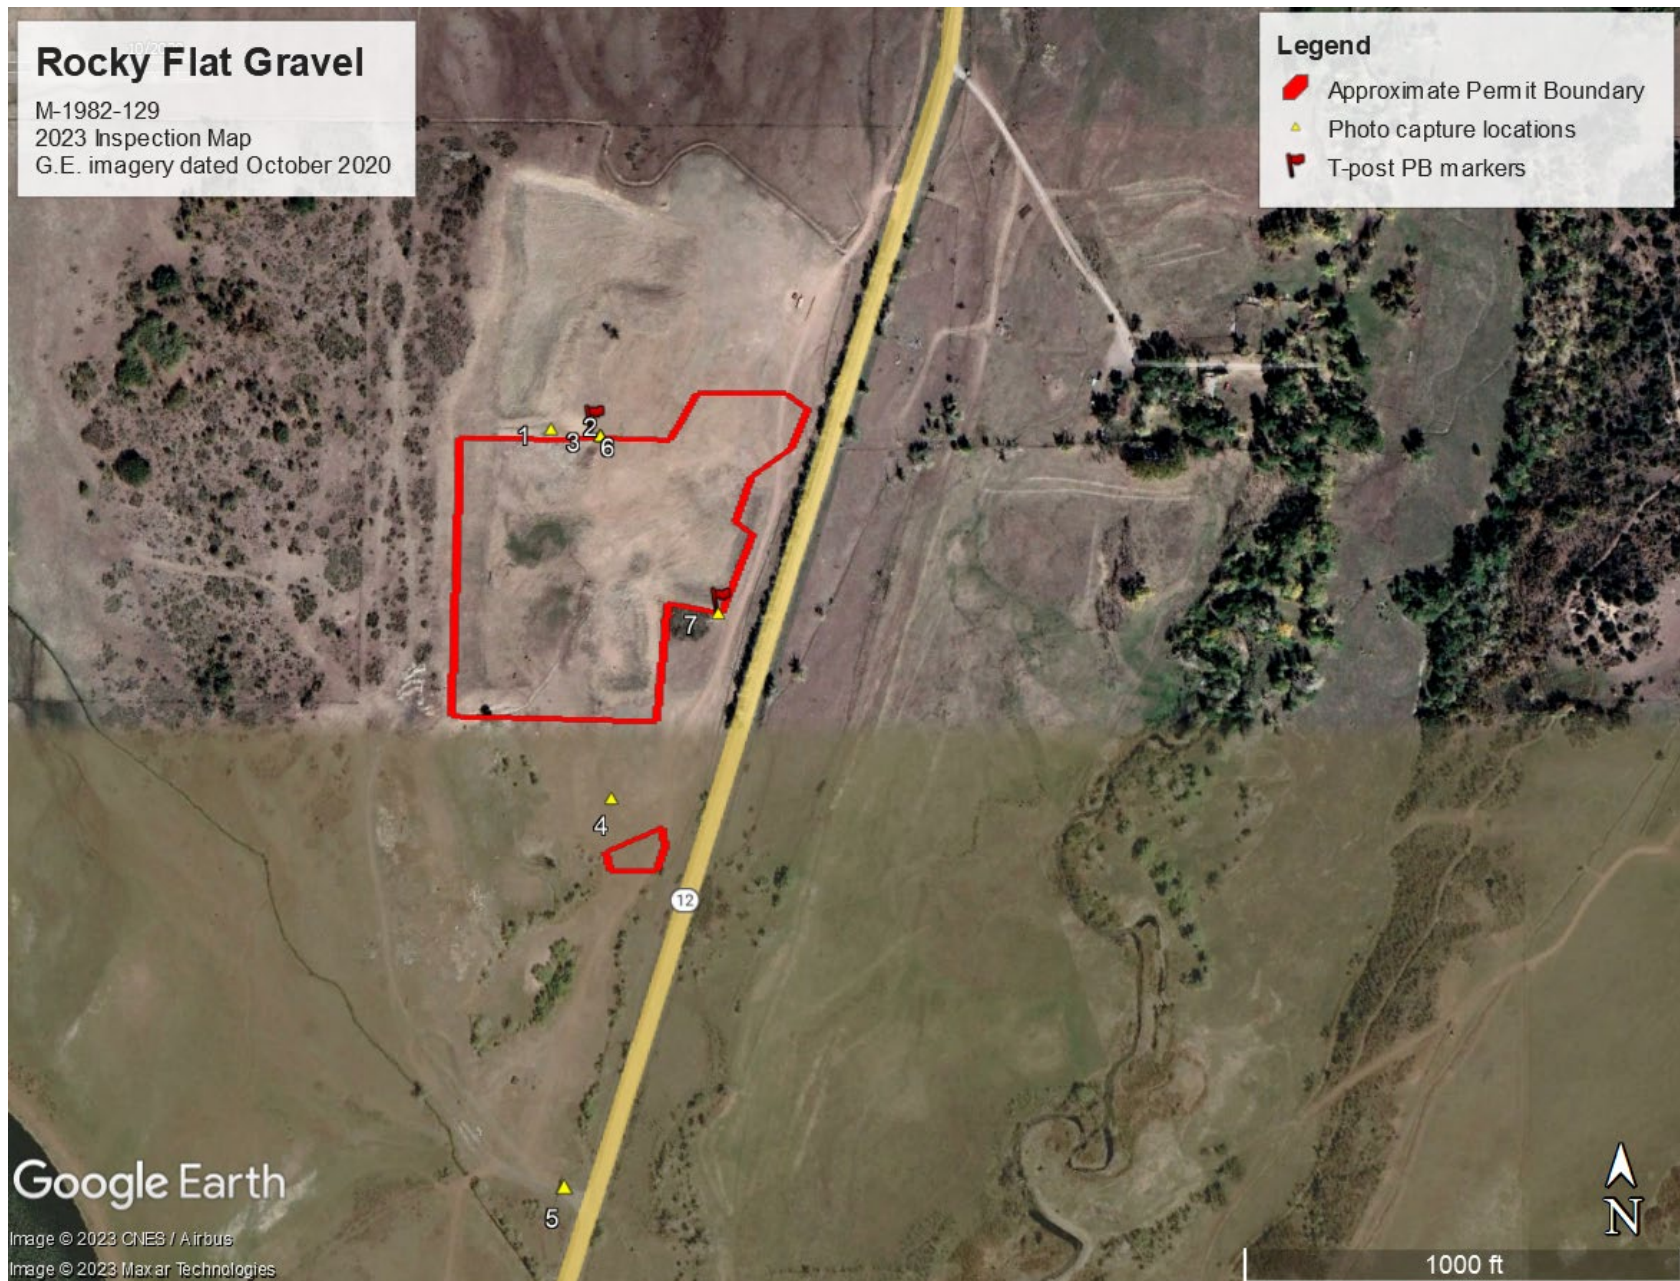
The original permit area was for approximately 7.5 acres; during an amendment (AM01) the Operator added 2.28 acres of land east of the original area and .22 acres to the south (total permit area is represented on Map 1 as the red polygons). The 2.28 acre area is east of where the primary pit basin is located, and has been graded to create a flat plain. Grass has established in this portion of the site, but cattle are allowed to graze the area surrounding and within the permit boundary. The 0.22 acre parcel is also a flat.

Map 1: Map generated using Google Earth pro to depict the approximate location of the permit boundary and the location where the inspection photos were taken.

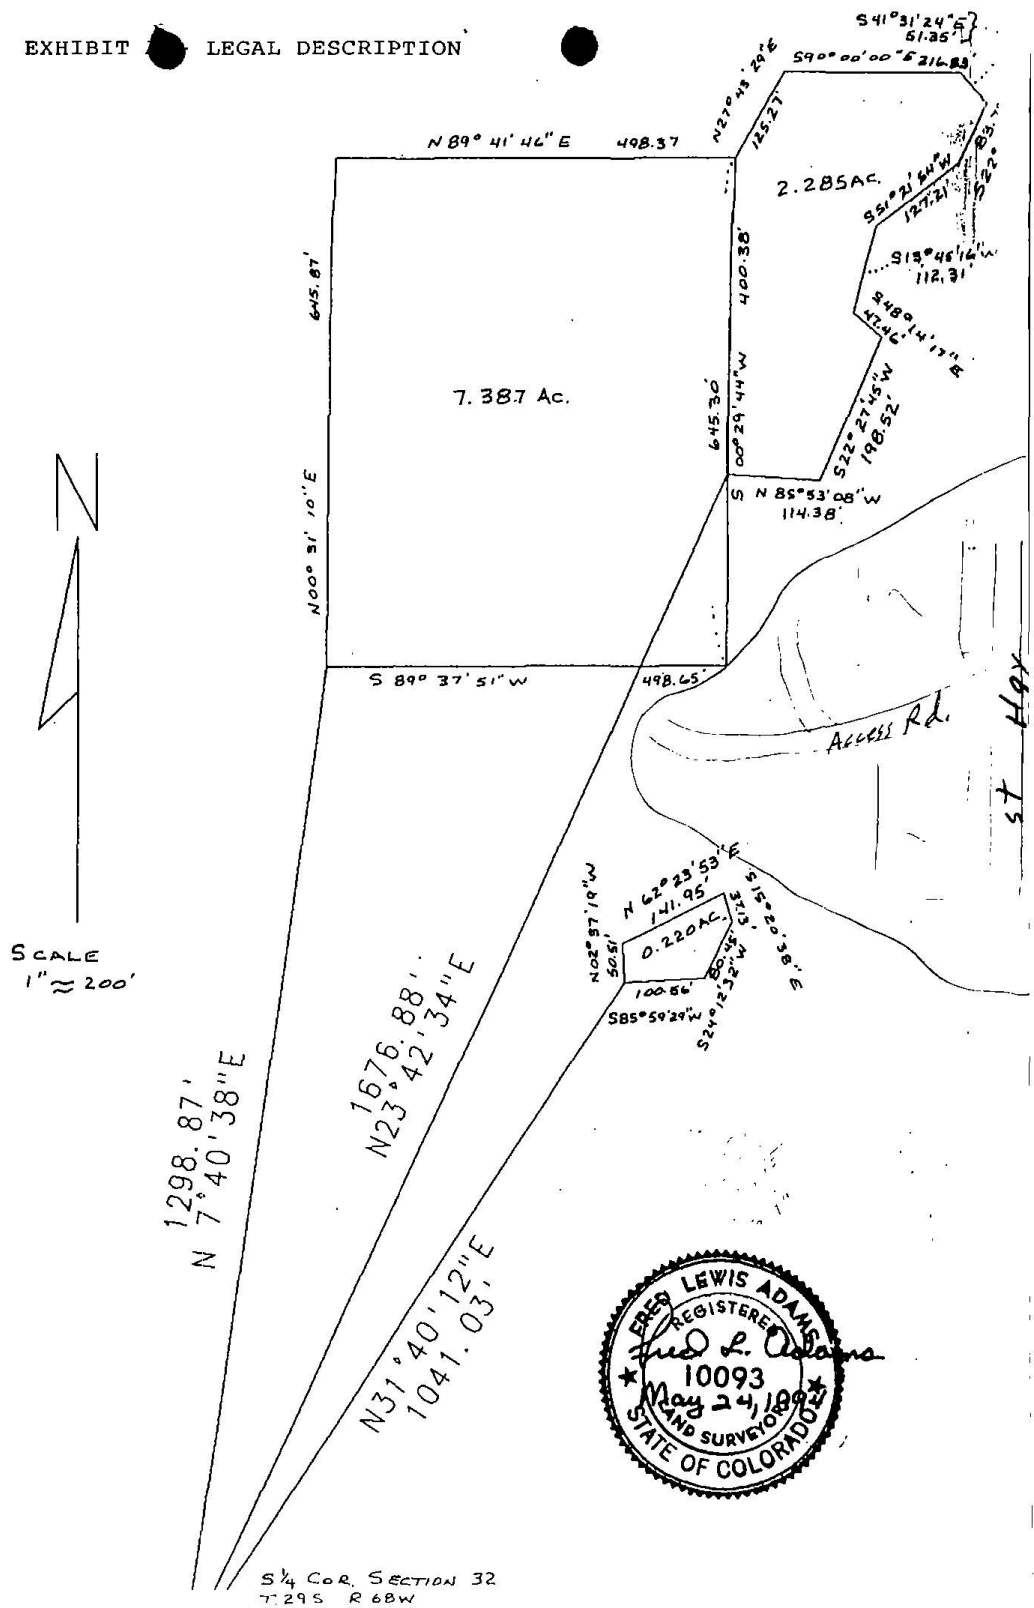
Map 2: Permit boundary map submitted as part of the amendment.
