Monadnock Mineral Services, L.L.C.

Re: Updated Reclamation Plans

The following provides Updated Reclamation Plans for the Burro (M-1977-297), Ellison (M-1978-342, and JD-5 (M-1977-248) as per your request. It is my understanding that Final Reclamation has been completed and approved for the Hawkeye Mine (M-1978-342).

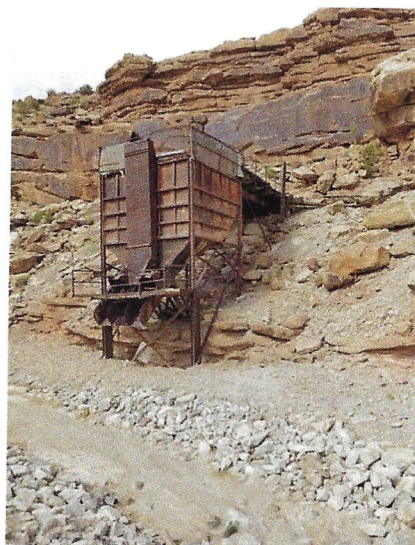
Quoted from Department of Reclamation Mining and Safety (DRMS) "Minerals Program Inspection Report" dated October 5, 2023, Page 2, 4th Paragraph: *"The only remaining task to have reclamation completed is securing the area surrounding the ore hopper to prevent trespassing. The reclamation of all other disturbed areas is considered complete, and agreed upon by all other agencies present during this inspection. Once the fencing surrounding the ore hopper is complete, a full and final release request can be pursued."* Stated in the first paragraph of the above report representatives of DOE and BLM were present during the inspection.

The Updated Reclamation Plan for the Burro Mine only includes constructing an Eight-foot high Chain-Link Fence across the ramp leading to the ore-hopper in order to prevent trespass by others.

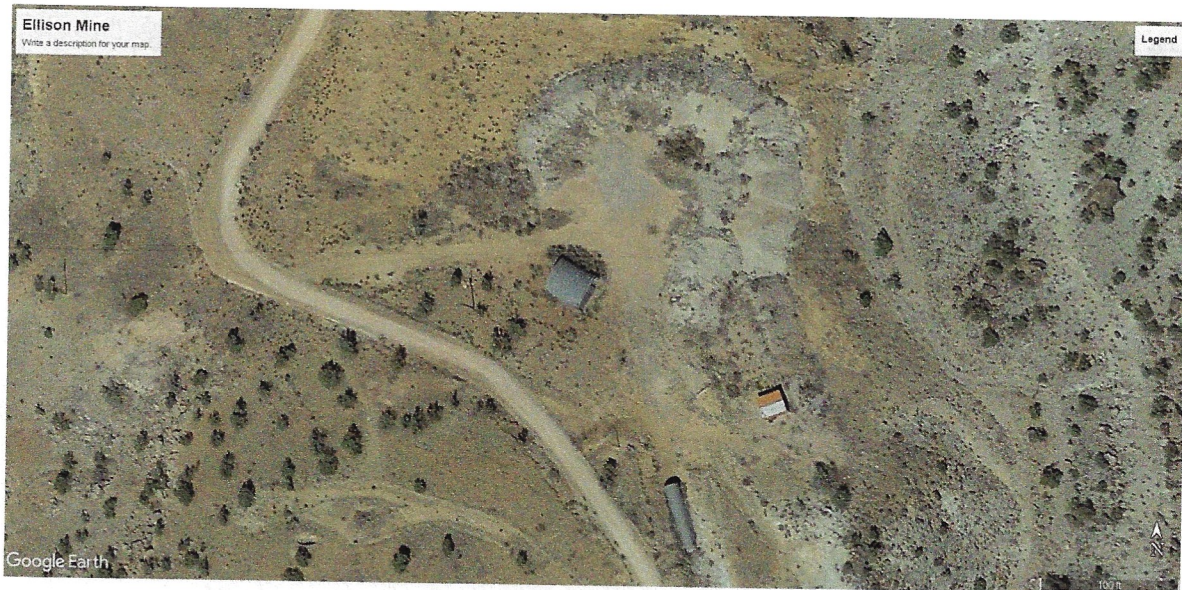
The following provides information on the work to be completed at the Ellison Mine Site to achieve Final Reclamation Approval. The following Google-Earth image of the Ellison Mine area shows the road access, limit of existing disturbed area, shop building, storage container, and Ellison Portal.

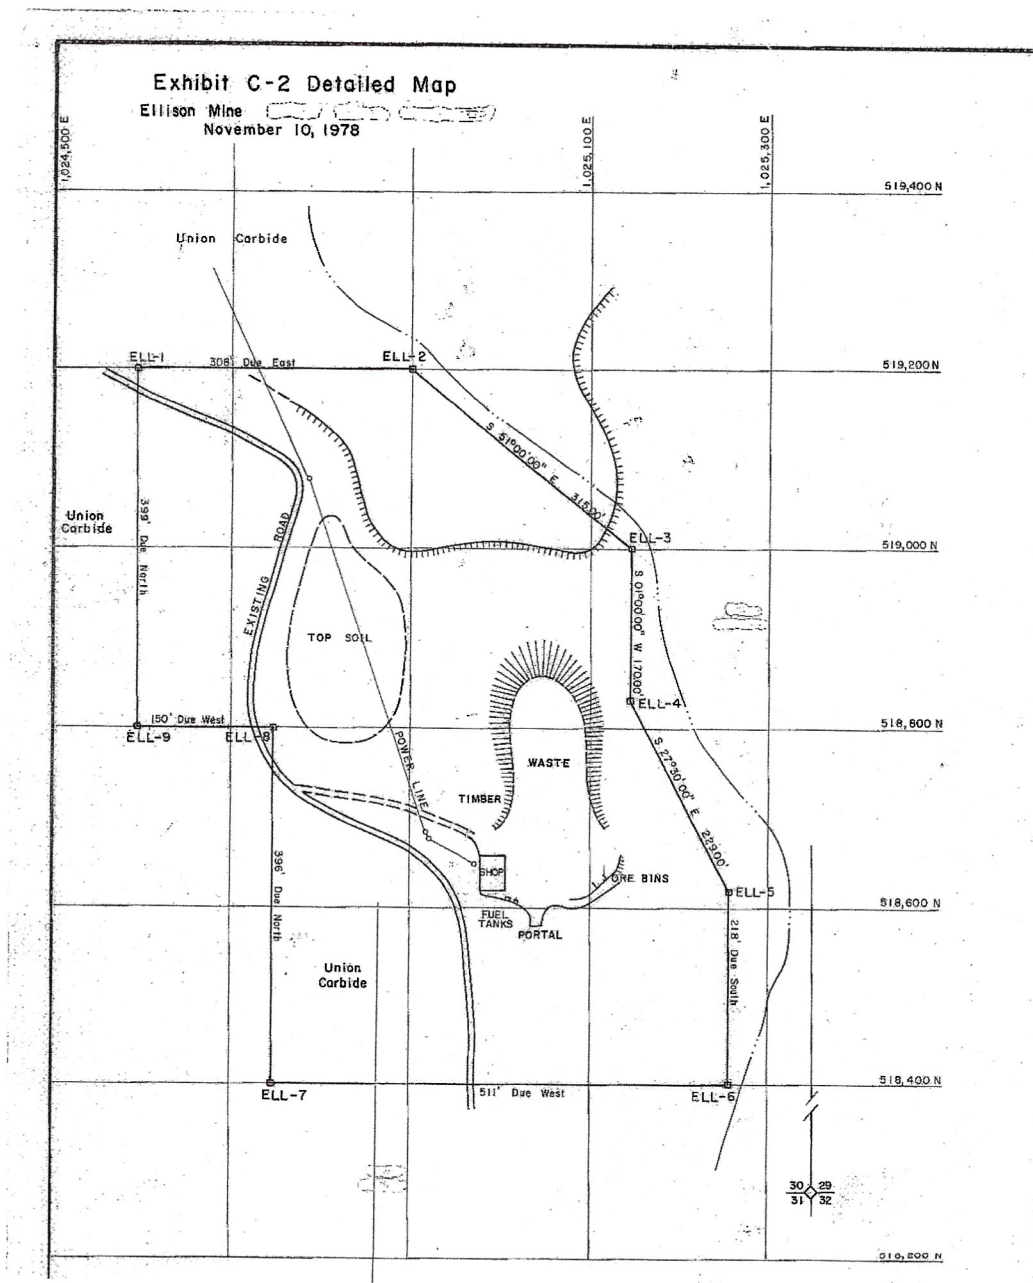
As shown on DRMS M-1978-342 Reclamation Plan Map and defined in 3.0 Proposed Reclamation Plan and Activities of Technical Revision TR-04, "Site Grading and Contouring" will be conducted in a manner to bring materials uphill, where necessary, to reduce all existing slopes to no greater than 3H:1V.

- **Confirm that existing slopes of waste rock comply with 3H:1V definition**
- **Provide minimum site-grading and contouring, if necessary, to achieve 3H:1V slopes**
- **Mechanically rip any areas that need "effective growth media" preparation**
- **Add topsoil from existing stored topsoil pile to any areas needing additional vegetation**
- **Re-vegetate with approved seed mixtures as weather conditions permit**

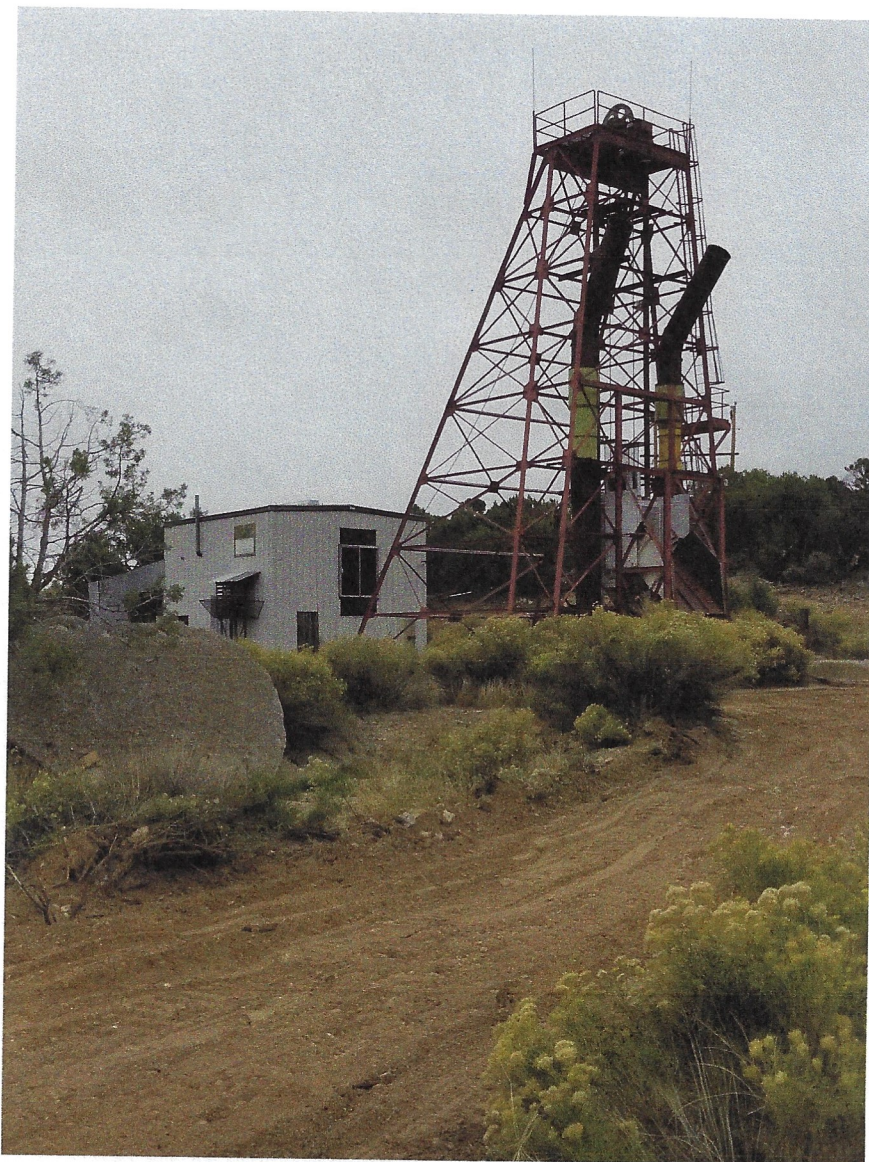
Previous Inspection Reports have indicated that the Steel Headframe and associated structures are “**Culturally Significant – Historical Structures**”. These are to remain intact for both the historical relevance and the possible future mining of the defined resources that have been reported on DOE Lease Tract JD-5.
