Inspection Report 2023 Dec WF

COLORADO
Division of Reclamation,
Mining and Safety
Department of Natural Resources

Permit Number: C-1981-044 Mine Name: Williams Fork Mines Operator: Moffat County Mining, LLC Operator Address: Ms. Miranda Kawcak 29515 Routt County Road #27 Oak Creek, CO 80467	County: Moffat Operation Type: Underground Permit Status: Active Ownership: Private Operator Representative Present: None as this was an aerial inspection.
Operator Representative Signature: (Field Issuance Only) This report was issued electronically from the Divisions' Denver Office.

Inspection Start Date: 3 January 2024 Inspection Start Time: 8:00 a.m. Inspection End Date: 3 January 2024 Inspection End Time: 8:05 a.m.		Inspection Type: Aerial Inspection Inspection Reason: Normal I & E Weather: Cloudy	
Joint Inspection Agency: None		Joint Inspection Contacts:	
Post Inspection Agency: None		Post Inspection Contacts:	
Inspector(s): Robin Reilley, M.S. GISP Brock Bowles	Inspector's Signature:

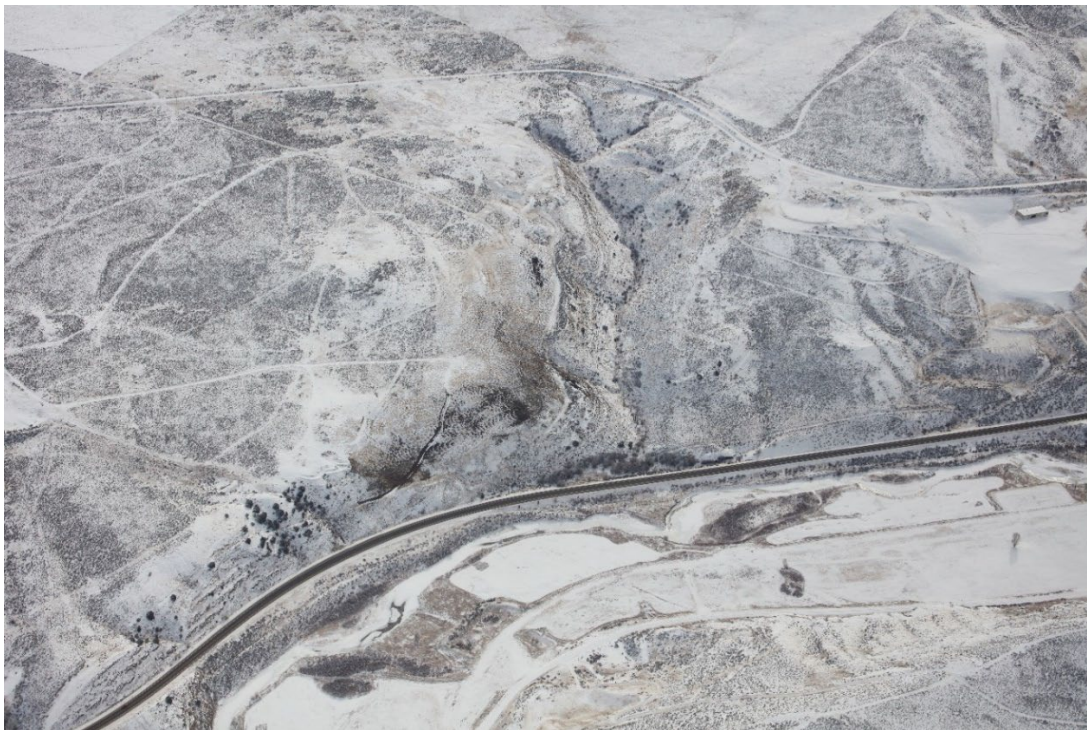
Photo 1: Site overview.

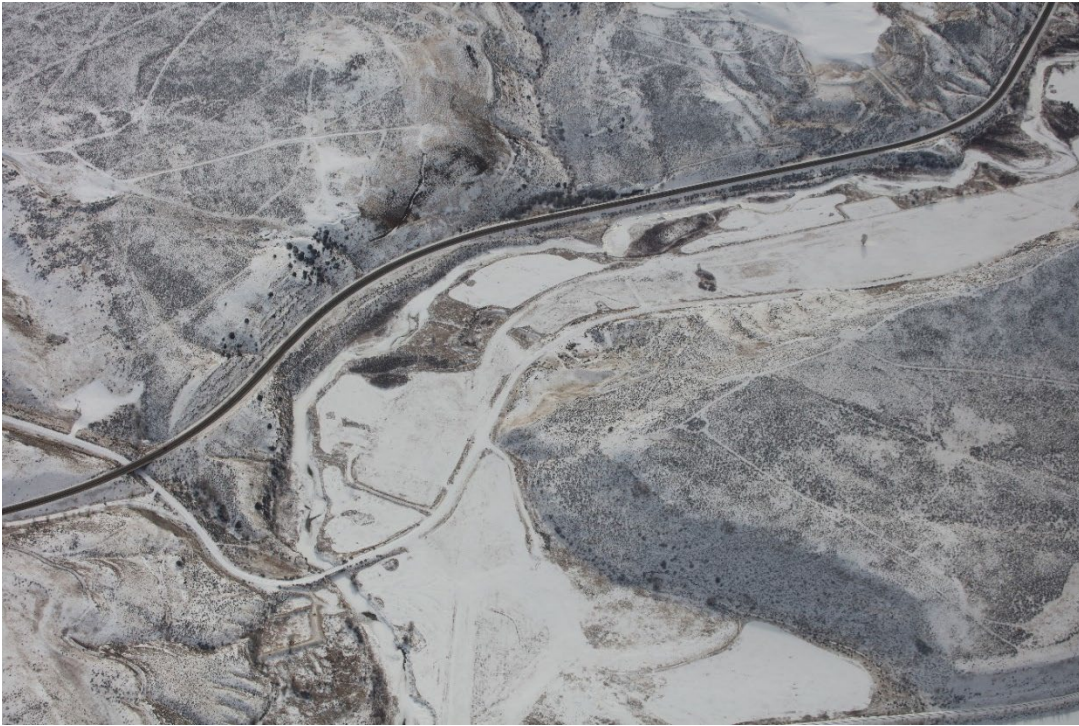
Photo 2: Bottom lands at north end of site looking south.

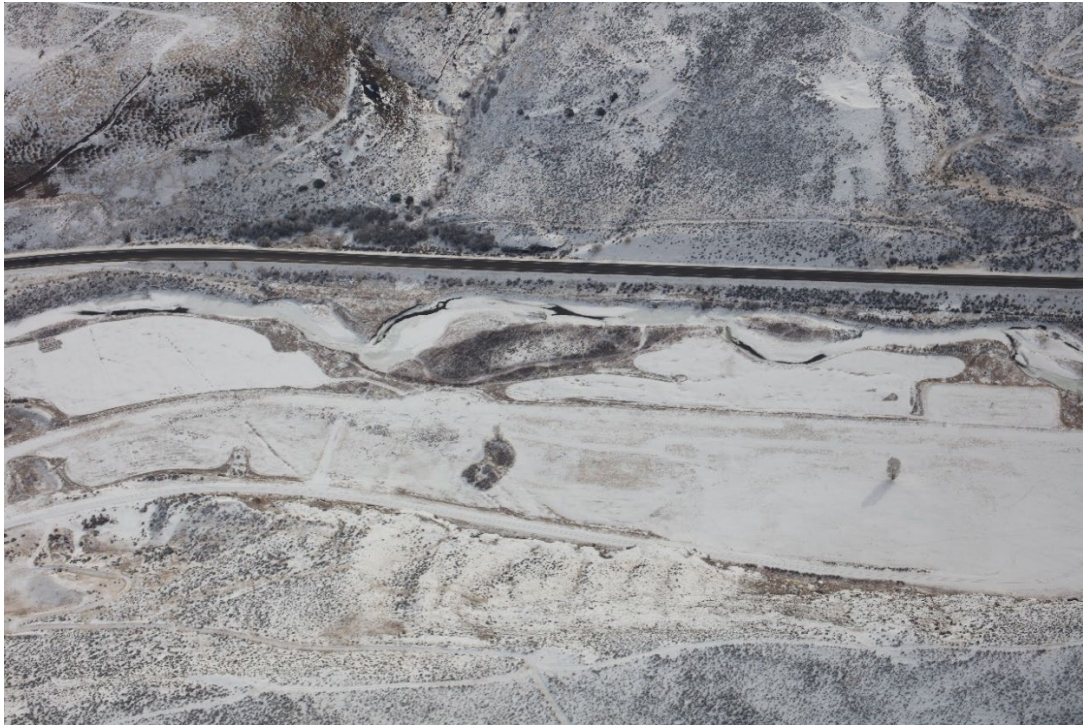
Photo 3: Bottom lands at looking south.

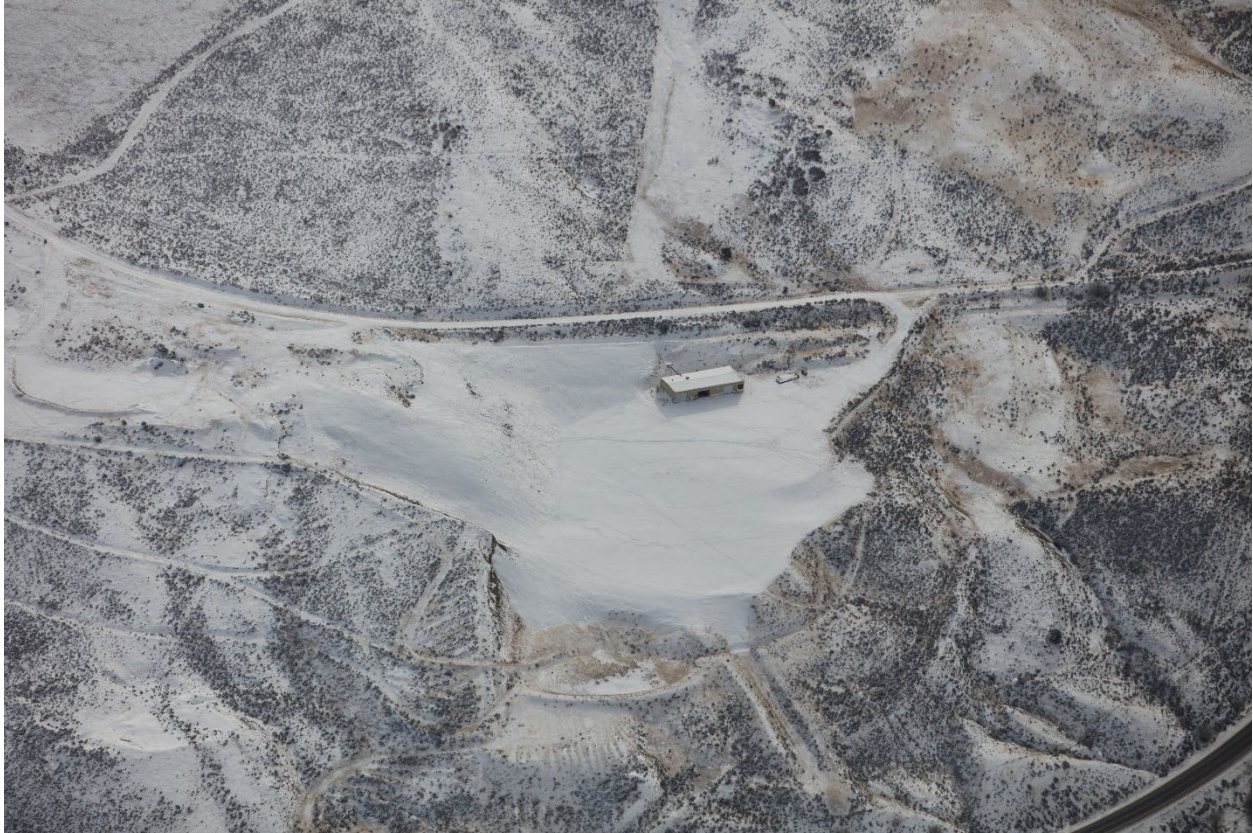
Photo 4: 5APortal looking east.
