MINERALS PROGRAM INSPECTION REPORT
PHONE: (303) 866-3567

MINE NAME: Costilla Cnty Pit 1	MINE/PROSPECTING ID#: M-1977-044	MINERAL: Sand and gravel	COUNTY: Costilla
INSPECTION TYPE: Monitoring	WEATHER: Clear	INSP. DATE: November 28, 2023	INSP. TIME: 13:30
OPERATOR: Costilla County	OPERATOR REPRESENTATIVE: Leroy Medina	TYPE OF OPERATION: 110c - Construction Limited Impact	
REASON FOR INSPECTION: Normal I&E Program	BOND CALCULATION TYPE: None	BOND AMOUNT: \$0.00	
DATE OF COMPLAINT: NA	POST INSP. CONTACTS: None	JOINT INSP. AGENCY: None	
INSPECTOR(S): Lucas West	INSPECTOR'S SIGNATURE:

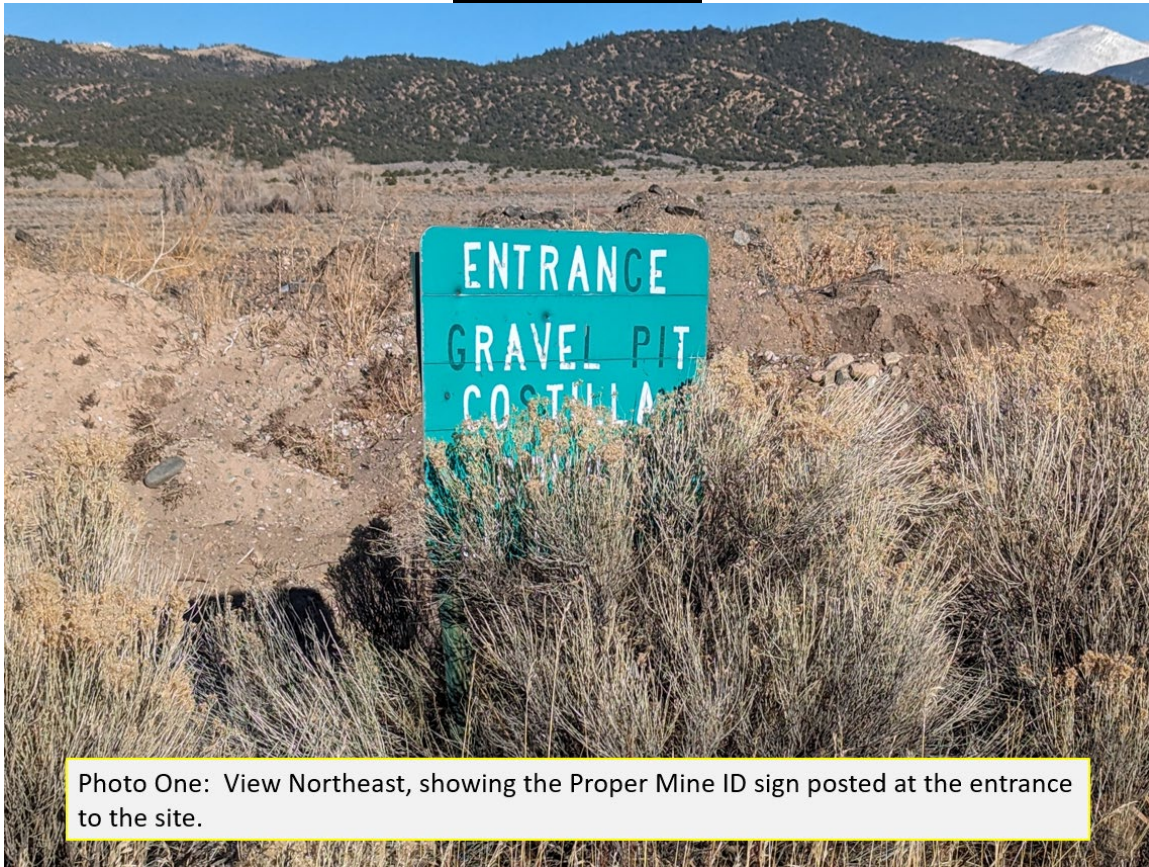
Proper mine identification signage was posted at the entrance to the site and can be seen in Photo One. The permit boundaries were properly outlined with fence lines and earthen berms. The site was not actively being mined during the inspection; however slash material was being backhauled into the pit for burning as a result of ditch and canal maintenance. No mining related equipment was observed on site during the inspection. The side slopes of the pit appear to have been mined and relaxed to approximately a 3H:1V slope and appear to be stable. The slopes are well vegetated with volunteer species, appear to be in good condition and an example of the slopes can be seen in Photo Two. The pit floor was observed to be in good condition, shown in Photo Three. Several stockpiles of various sized materials were noted on the pit floor, all of which appear to be stable and in good condition. No impounded storm water was noted in the pit during the inspection. A small stockpile of recycled concrete and other building materials was located near the access road to the pit floor. Discussions with the operator indicated that the materials are temporarily being stored on site, the presence of these stockpiles are not considered a problem at this time.

Photo One: View Northeast, showing the Proper Mine ID sign posted at the entrance to the site.

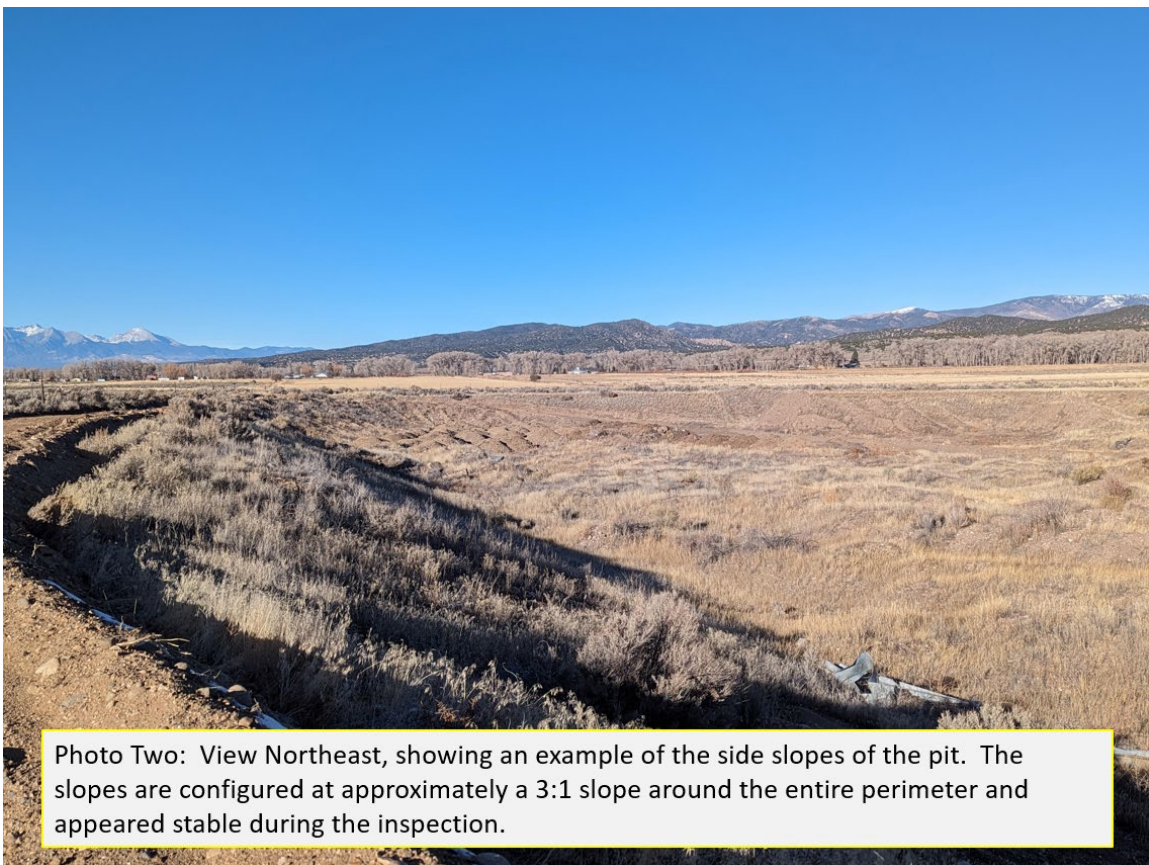
Photo Two: View Northeast, showing an example of the side slopes of the pit. The slopes are configured at approximately a 3:1 slope around the entire perimeter and appeared stable during the inspection.
