MINERALS PROGRAM INSPECTION REPORT
PHONE: (303) 866-3567

MINE NAME: San Acacio Gravel Pit	MINE/PROSPECTING ID#: M-1999-024	MINERAL: Gravel	COUNTY: Costilla
INSPECTION TYPE: Monitoring	WEATHER: Clear	INSP. DATE: November 28, 2023	INSP. TIME: 14:15
OPERATOR: Costilla County	OPERATOR REPRESENTATIVE: Leroy Medina	TYPE OF OPERATION: 112c - Construction Regular Operation	
REASON FOR INSPECTION: Normal I&E Program	BOND CALCULATION TYPE:	BOND AMOUNT: \$0.00	
DATE OF COMPLAINT: NA	POST INSP. CONTACTS: None	JOINT INSP. AGENCY: None	
INSPECTOR(S): Lucas West	INSPECTOR'S SIGNATURE:

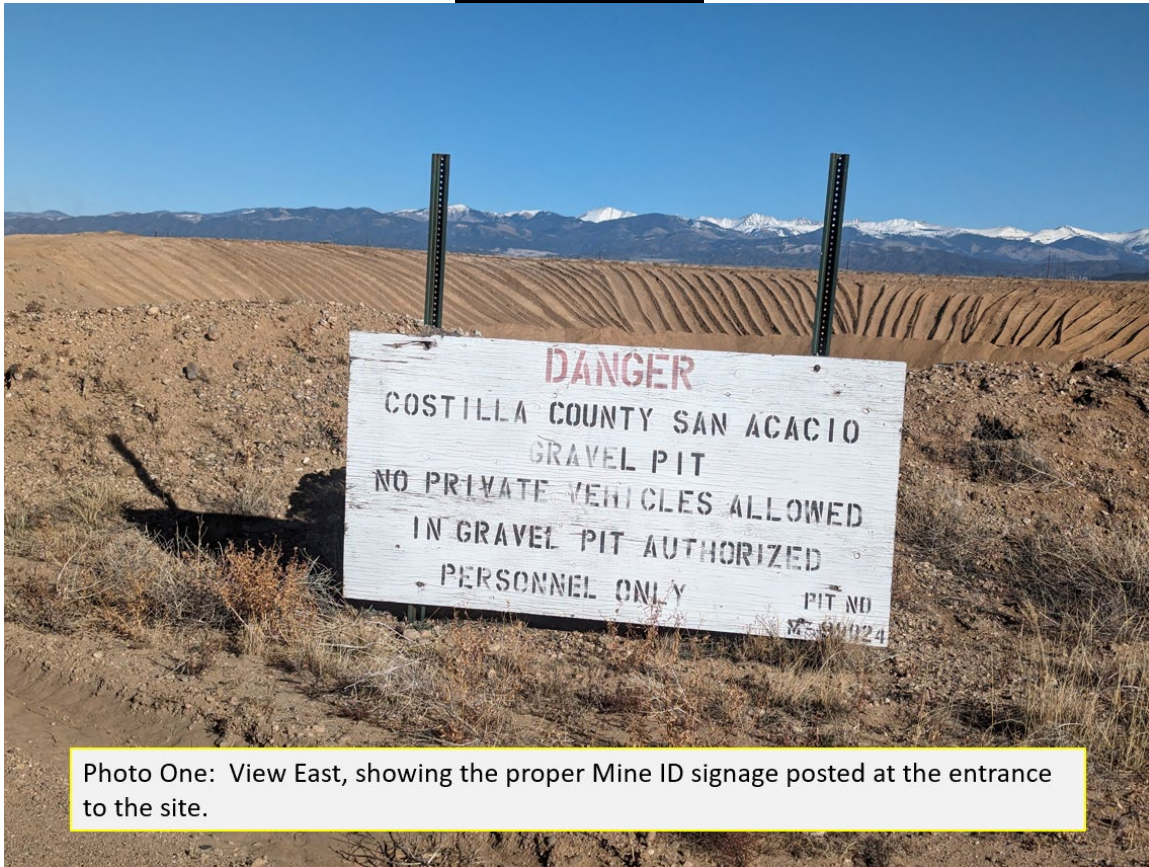
Proper mine identification signage was posted at the entrance to the site, shown in Photo One. The site was not active during the inspection but mining equipment was staged on the pit floor. There are currently approximately 15 Acres of the 76 Acre permitted area disturbed by mining activities. The inactive side slopes have been relaxed to approximately a 3H: 1V slope, appear to be stable and are in good condition. Photos Two and Three show examples of the side slopes that show no evidence of slumping, settling or erosion. Several stockpiles of material were located on the pit floor. All stockpiles observed appeared to be stable and in good condition. The pit floor is exhibiting positive drainage and shows no signs of significant erosion, settling or slumping. The pit floor and stockpiles can be seen in Photo Four.

Photo One: View East, showing the proper Mine ID signage posted at the entrance to the site.

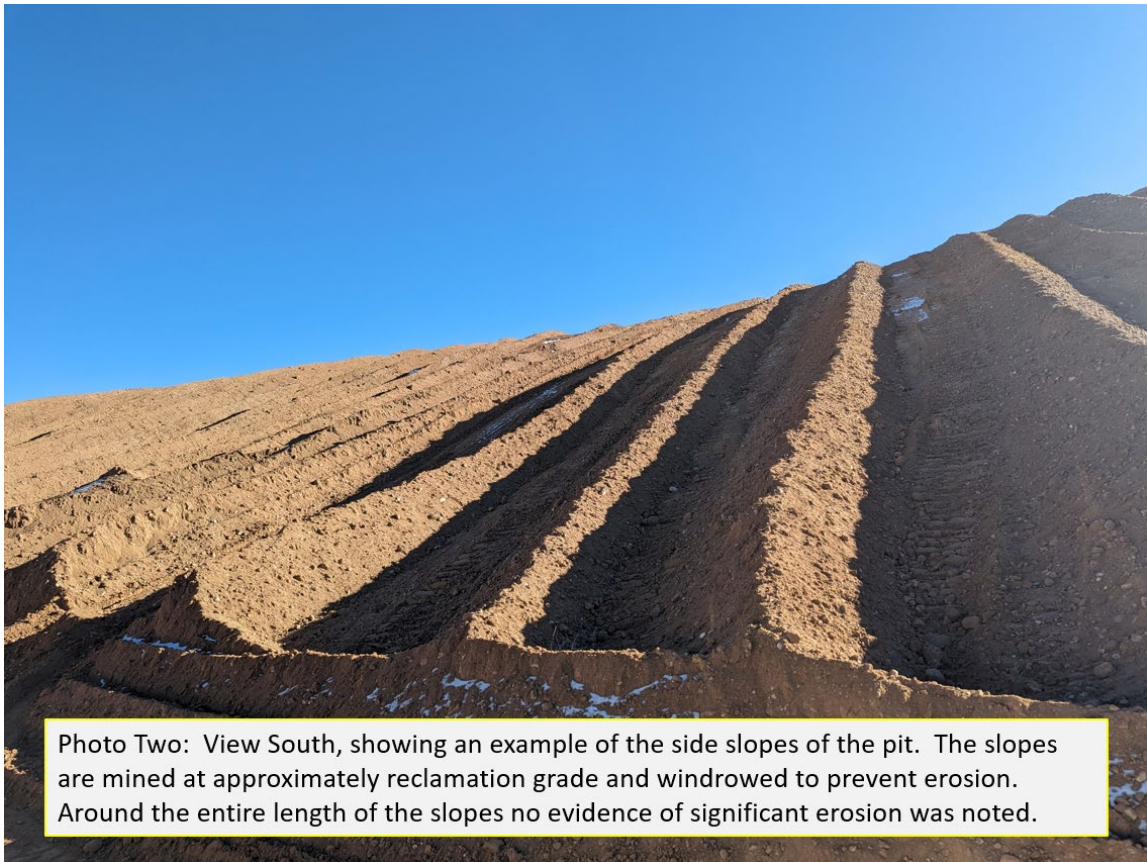
Photo Two: View South, showing an example of the side slopes of the pit. The slopes are mined at approximately reclamation grade and windrowed to prevent erosion. Around the entire length of the slopes no evidence of significant erosion was noted.
