Inspection Report, Hayden Gulch Loadout, C-1992-081

PERMIT INFORMATION

Permit Number: C-1992-081 Mine Name: Hayden Gulch Loadout Operator: Hayden Gulch Terminal, LLC Operator Address: Ms Miranda Kawcak 29515 Routt County Road 27 Oak Creek, CO 80467	County: Routt Operation Type: Loadout Permit Status: Active Ownership: Private
	Operator Representative Present: None, as this was an aerial inspection.
Operator Representative Signature: (Field Issuance Only)

INSPECTION INFORMATION

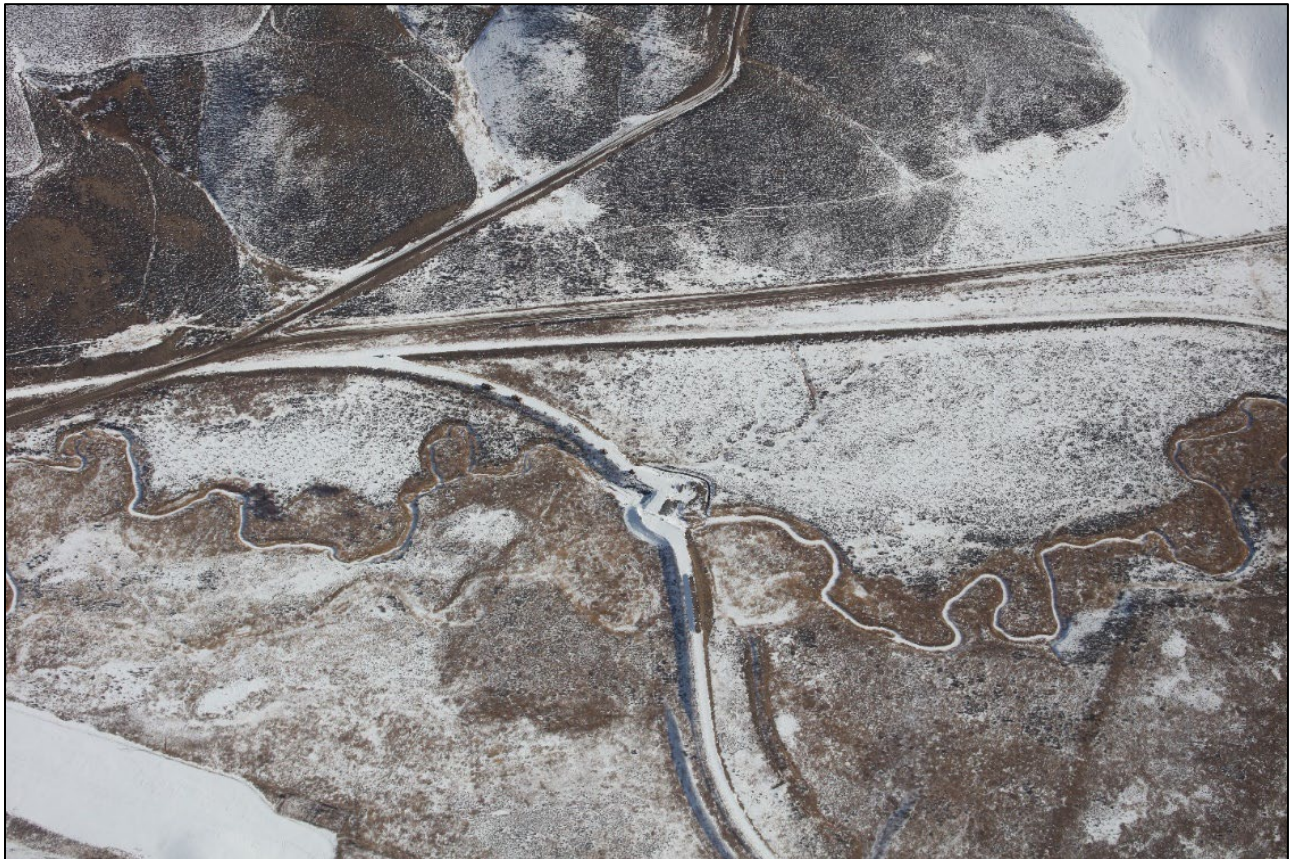
Culverts within the previously released Tracks to Trails area are still under construction by the City of Hayden. Construction looks to be halted for the winter. However, equipment was still being stored along the trail path (Photo 1). The Tracks to Trails area was turned over to the City of Hayden for recreational use with the approval of SL-2 in 2022.

Photo 1: View of the Tracks-to-Trails entry to the east, equipment used in culvert repair in the area is visible along the path.

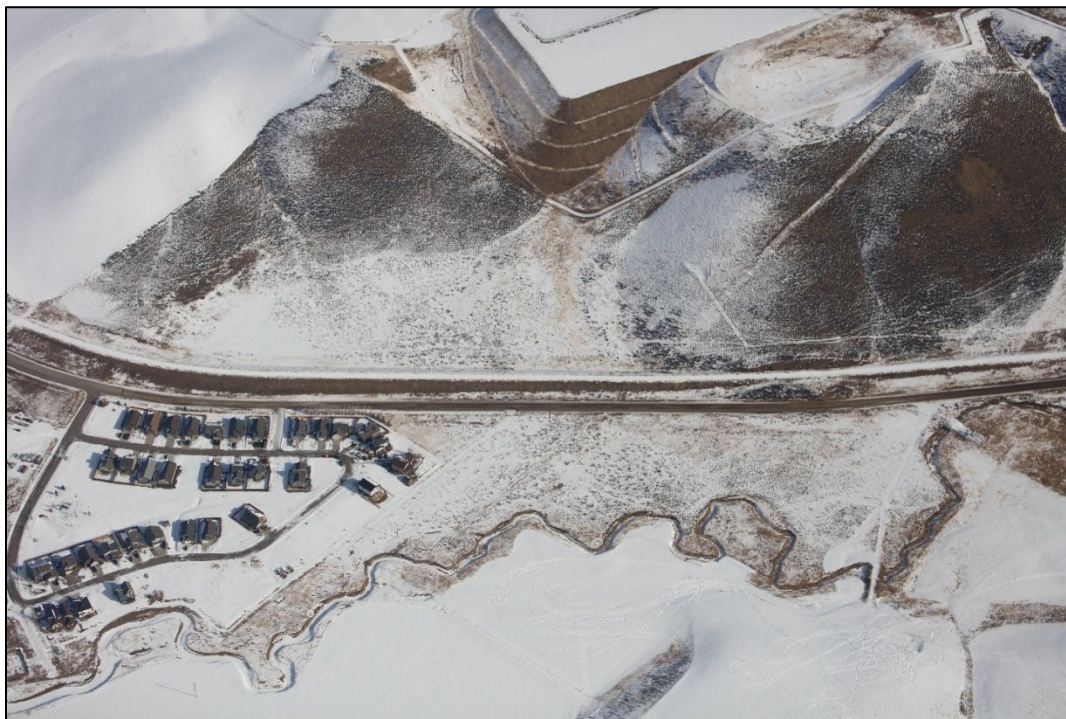
The Sage Creek Trail path was snowed over (Photo 2), but CR37 looked to be plowed and accessible. The parking lot for the Sage Creek Trail was also snowed over (Photo 3). The TAHR was not visible in aerial imagery.

Photo 2: View of the Tracks-to-Trails recreational loop along CR 37.

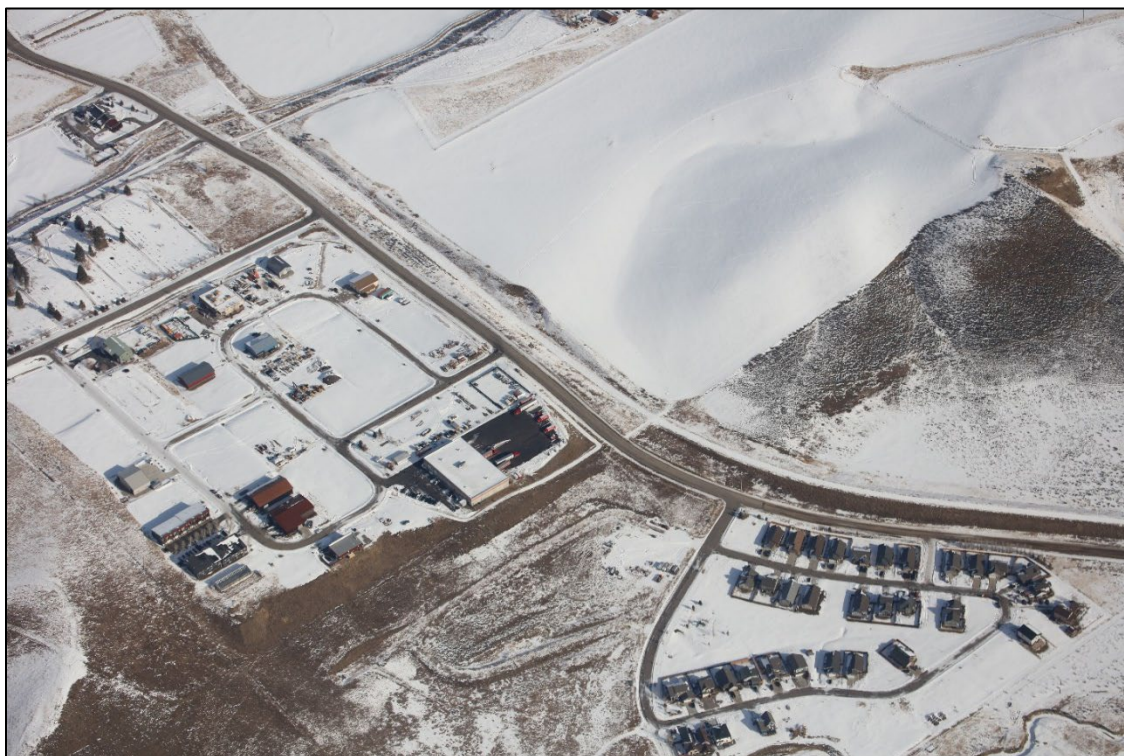
Photo 3: The trail continues along CR 37; a small dirt parking lot is located at the beginning of the trail.

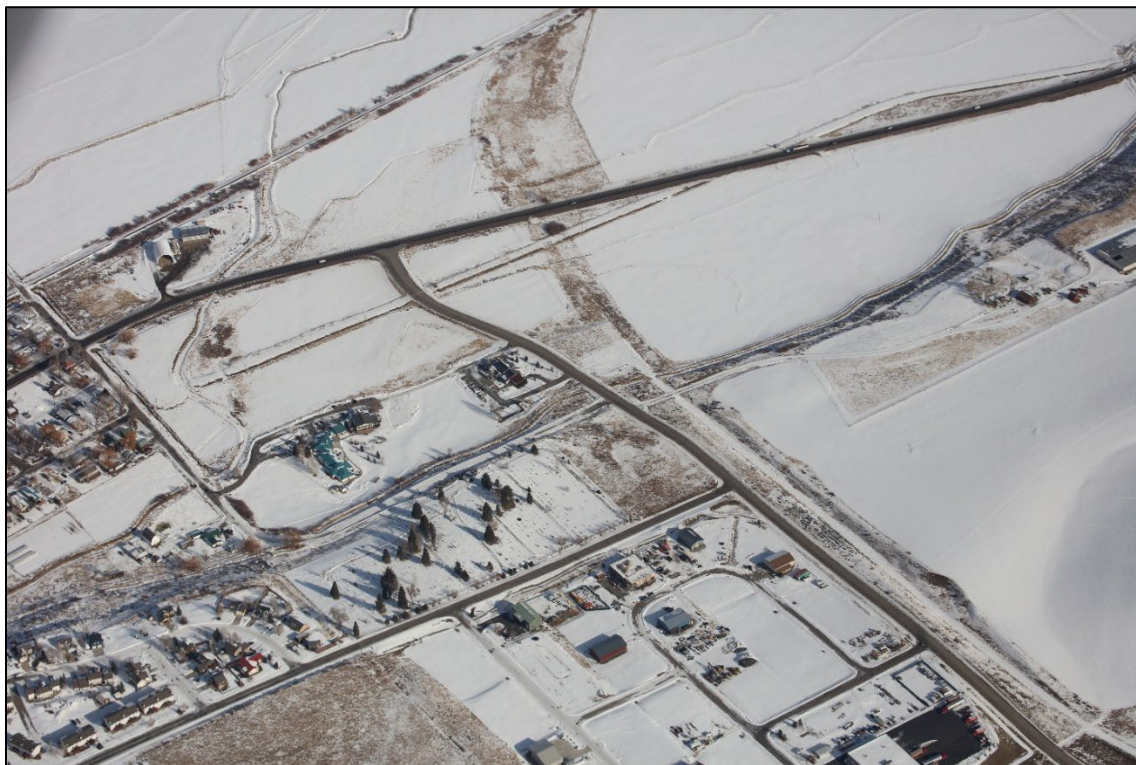
Areas not Phase III bond released and not included in the current SL-3 release area include the fields directly north and south of Hwy 40, to be reclaimed to agricultural use as hay fields. This area includes 6.8 acres of which 2.3 are disturbed (Photos 4 - 7).

Photo 4: View of the unreleased agricultural area in the northern most permit boundary.

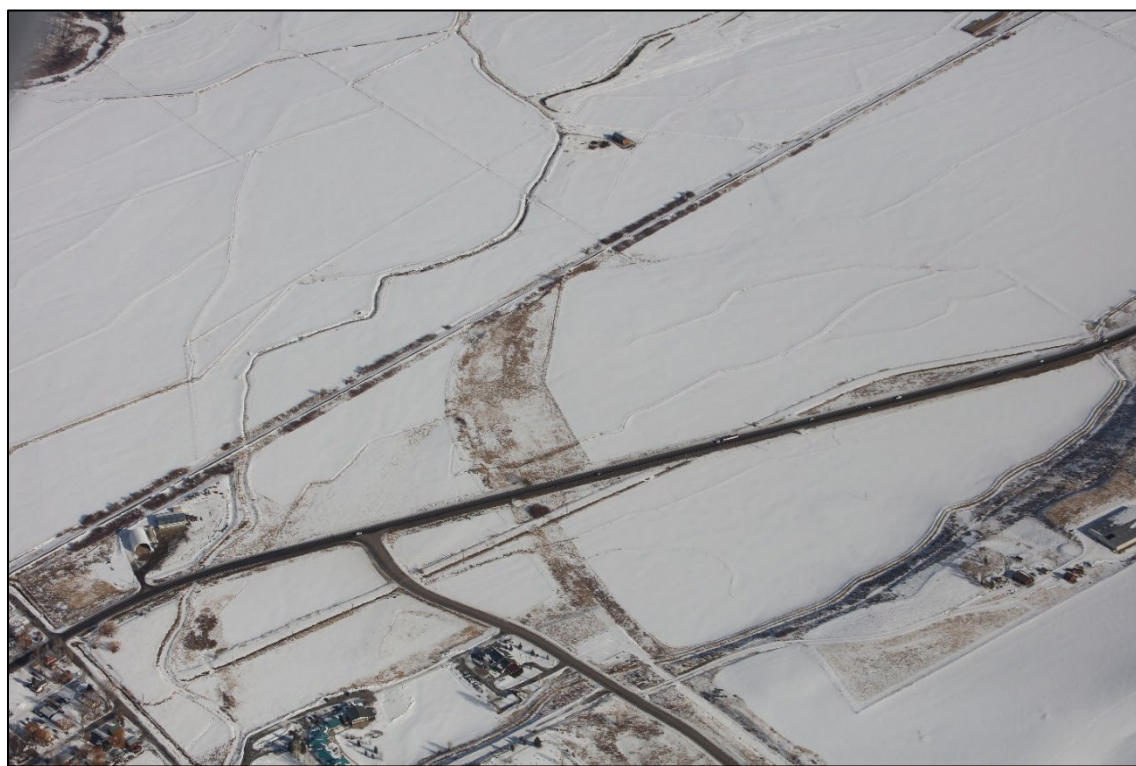
Photo 5: Another view of the 6.8 acres of unreleased agricultural fields located at the intersection of Hawthorne St / CR 37 and Hwy 40.

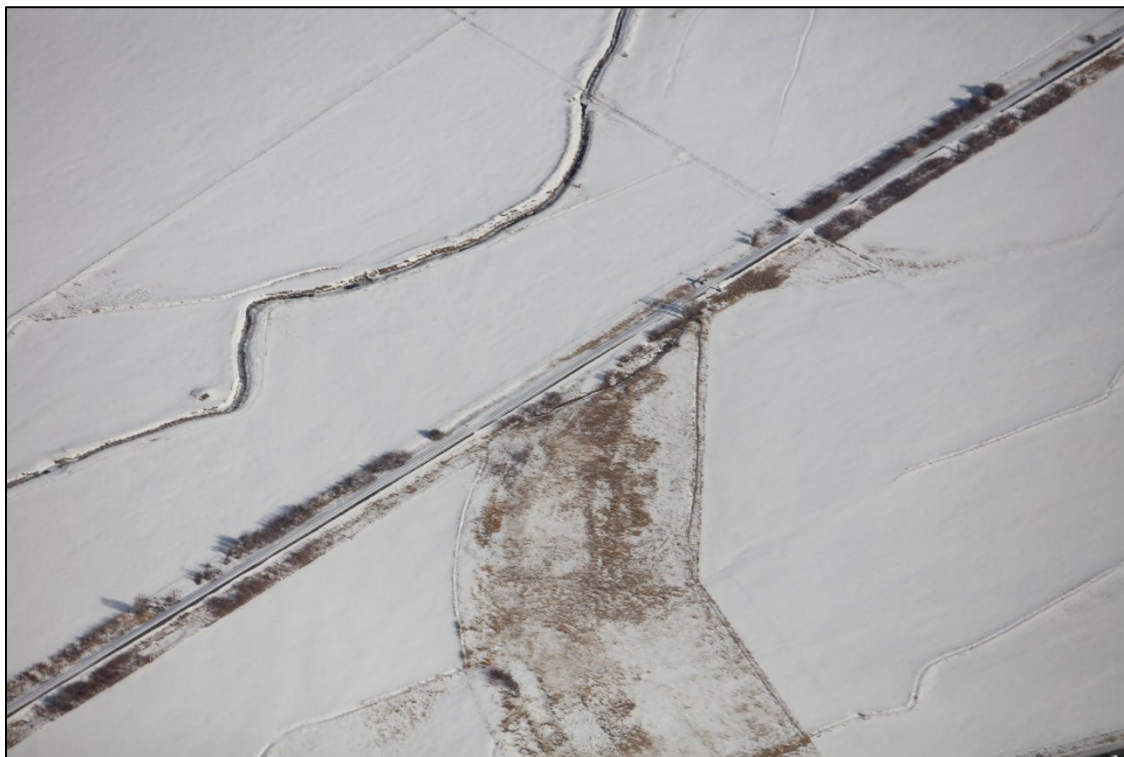
Photo 6: While snow covered, the existing vegetation in the 2.3 acres of disturbance looks to be well established.

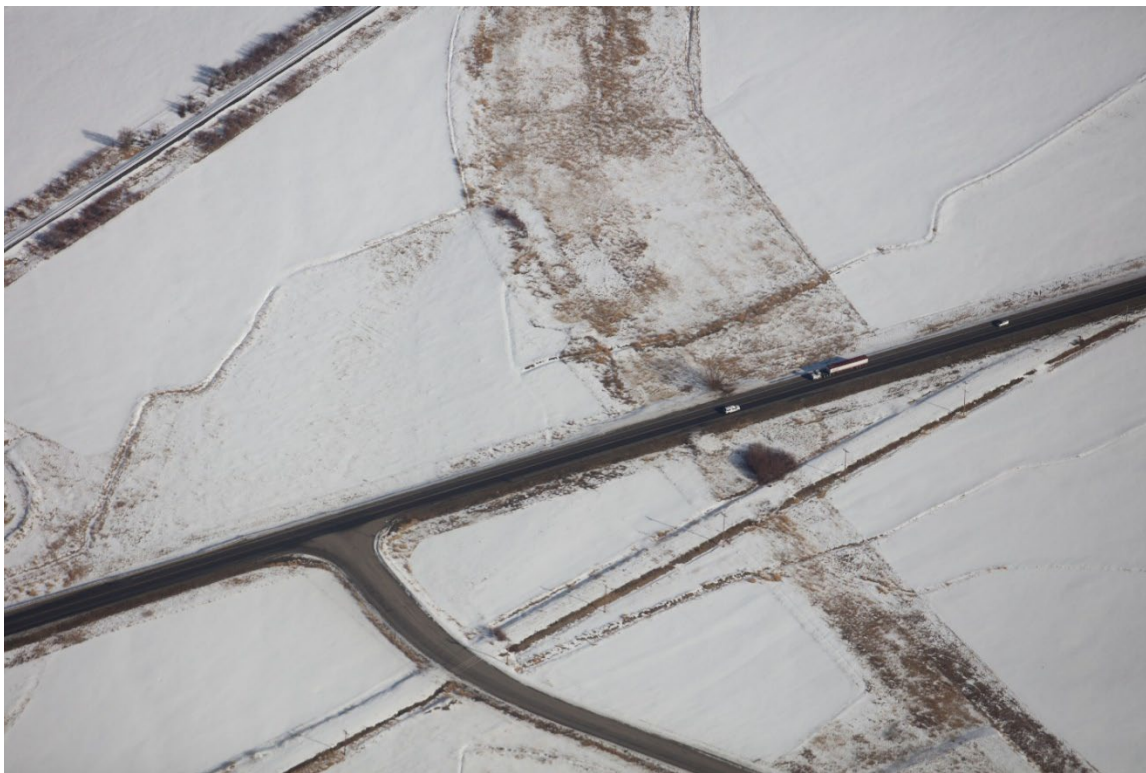
Photo 7: While snow covered, the existing vegetation in the 2.3 acres of disturbance looks to be well established.
