Inspection Report, Foidel Creek Mine, C-1982-056

PERMIT INFORMATION

Permit Number: C-1982-056 Mine Name: Foidel Creek Mine Operator: Twentymile Coal, LLC Operator Address: Ms Miranda Kawcak 29515 Routt County Road No. 27 Oak Creek, CO 80467	County: Routt Operation Type: Underground Permit Status: Active Ownership: Private
	Operator Representative Present: None, as this was an aerial inspection.
Operator Representative Signature: (Field Issuance Only)

Inspection Start Date: January 3, 2024 Inspection Start Time: 11:15 Inspection End Date: January 3, 2024 Inspection End Time: 11:25	Inspection Type: Aerial Inspection Inspection Reason: Normal I&E Program Weather: Clear	
Joint Inspection Agency: None	Joint Inspection Contacts: 	
Post Inspection Agency: None	Post Inspection Contacts: 	
Inspector(s): Hunter Ridley Brock Bowles	Inspector's Signature:

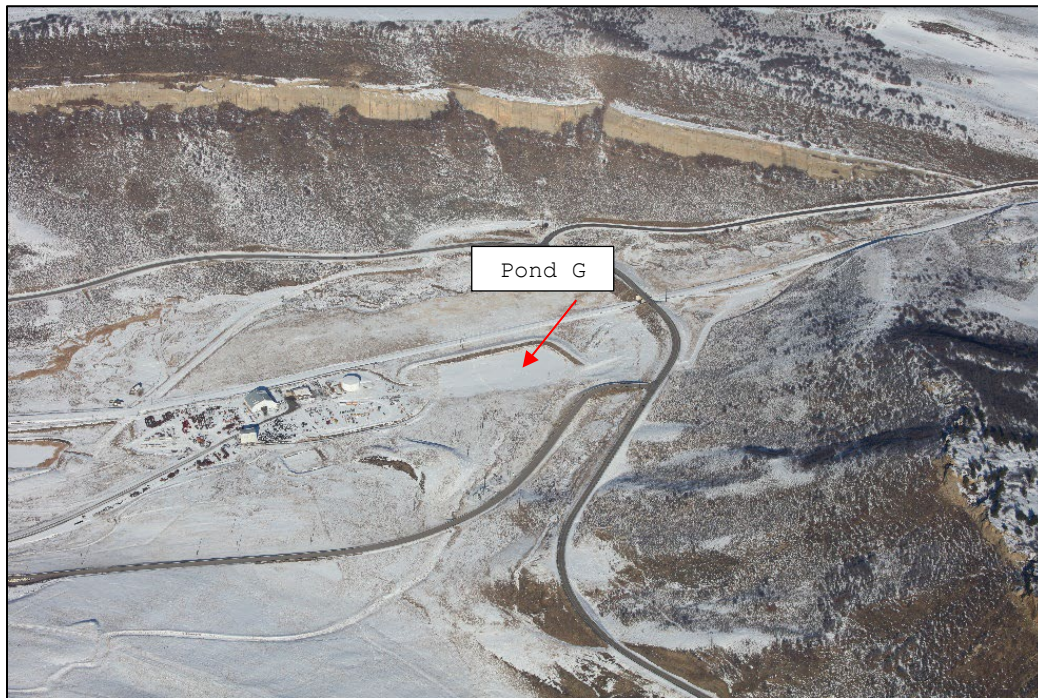
From above, all ponds looked to be stable and free of major issues. Many ponds are either frozen over for the season or not currently discharging (Photos 1, 3-5, 7, 10, and 12). Several ditches were visible under the snowy conditions and looked to be free of major erosional issues or blockages (Photos 2, 3, 5, and 9).

Photo 1: View of the mine entrance road off CR 37, Pond G, and storage area.

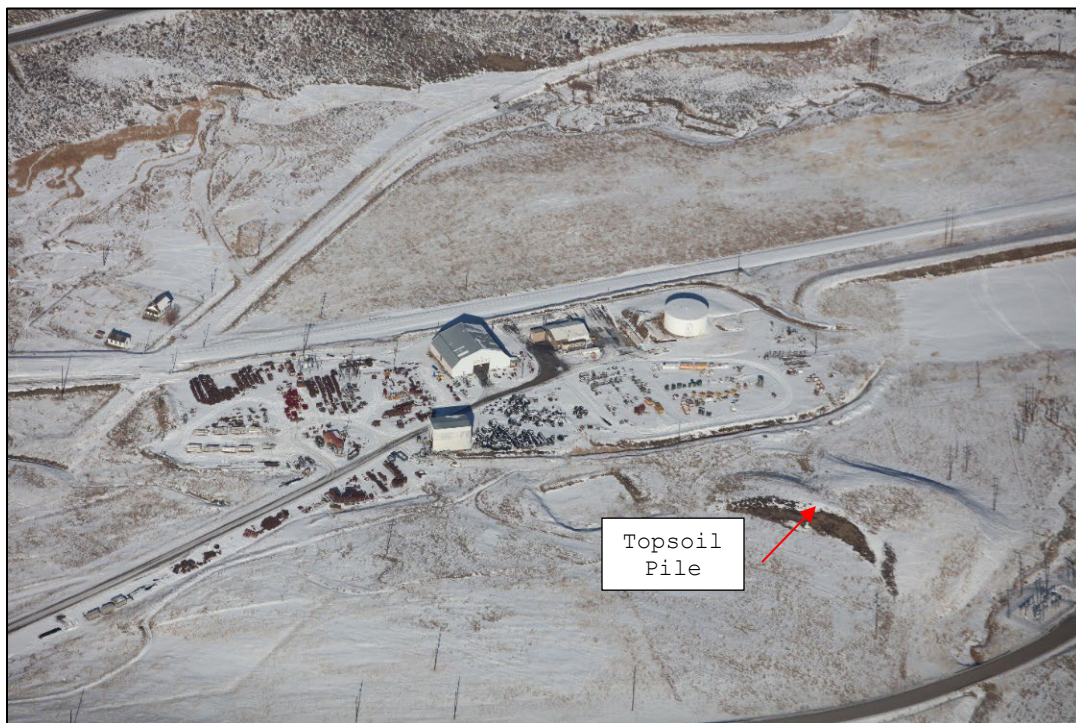
Several topsoil piles not easily inspected during usual on the ground visits were seen from above during this inspection (Photos 2, 3, 5, 7, 9, and 15). All piles looked to be stable and free of erosional issues. Special care should be taken in the winter months to ensure that topsoil piles are protected from snow plowing activities. This continues to be a maintenance item.

Photo 2: Closer view of the million-gallon tank, electrical shop, and storage area to the south of Pond G.

- Protect topsoil piles along all roads during maintenance and snow plowing activities throughout the winter months.

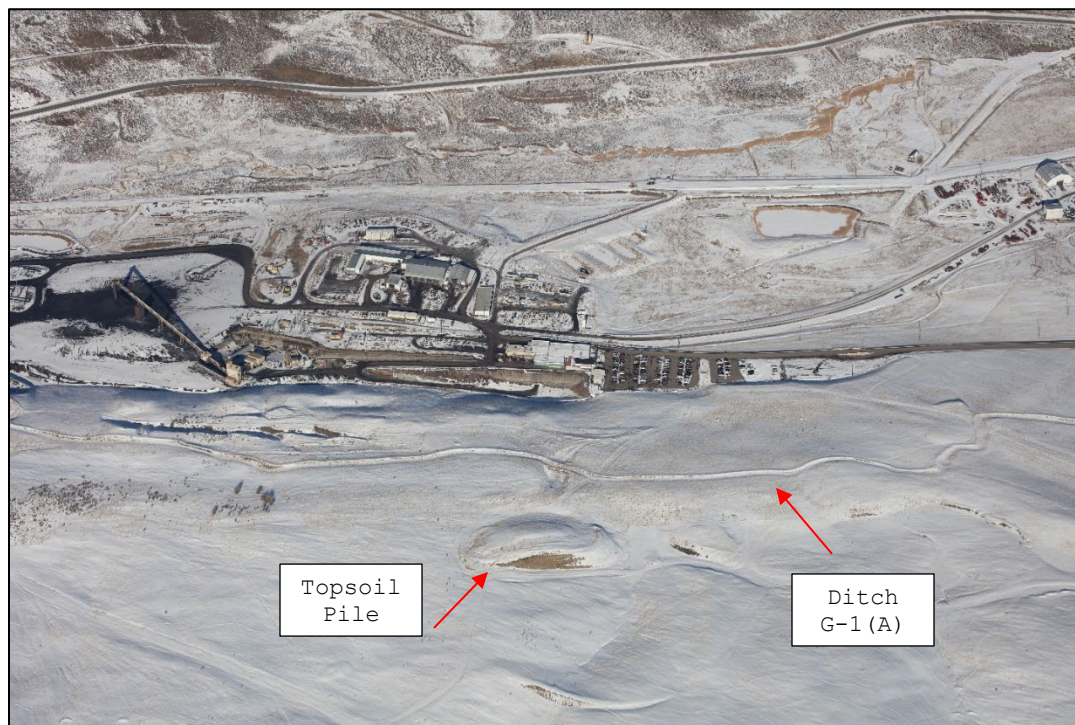
Photo 3: View of the main facilities area which includes a view of a topsoil stockpile to the south and Ditch G-1(A).

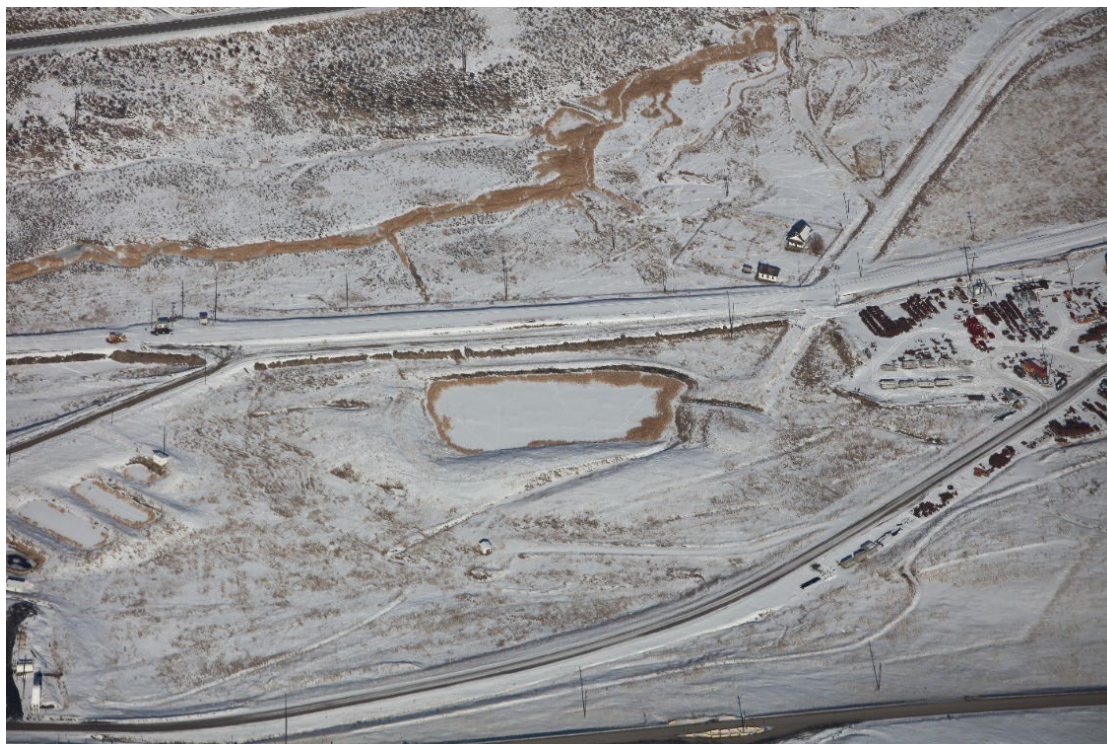
Photo 4: View of Pond F and the wastewater treatment ponds.

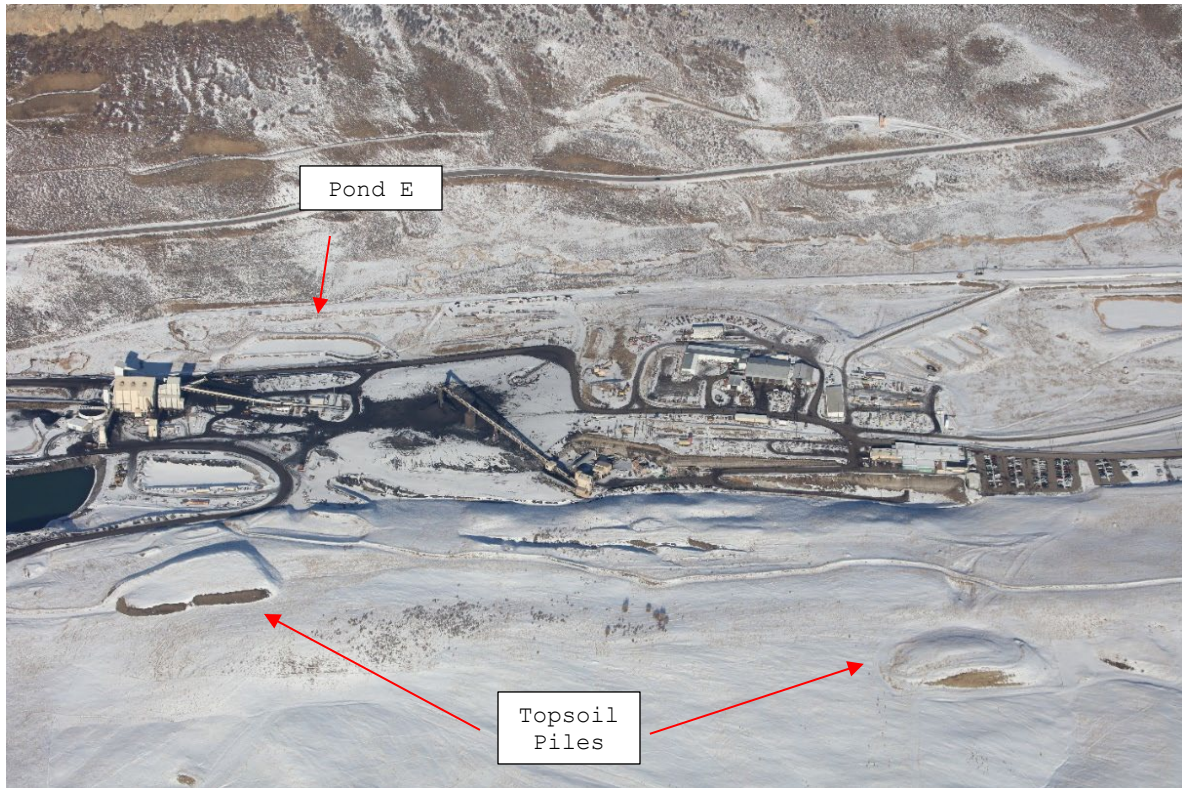
Photo 5: Overview of the main facilities area including the main ROM stockpile area and stoker coal loadout building, 2 topsoil stockpiles and Pond E are also visible.

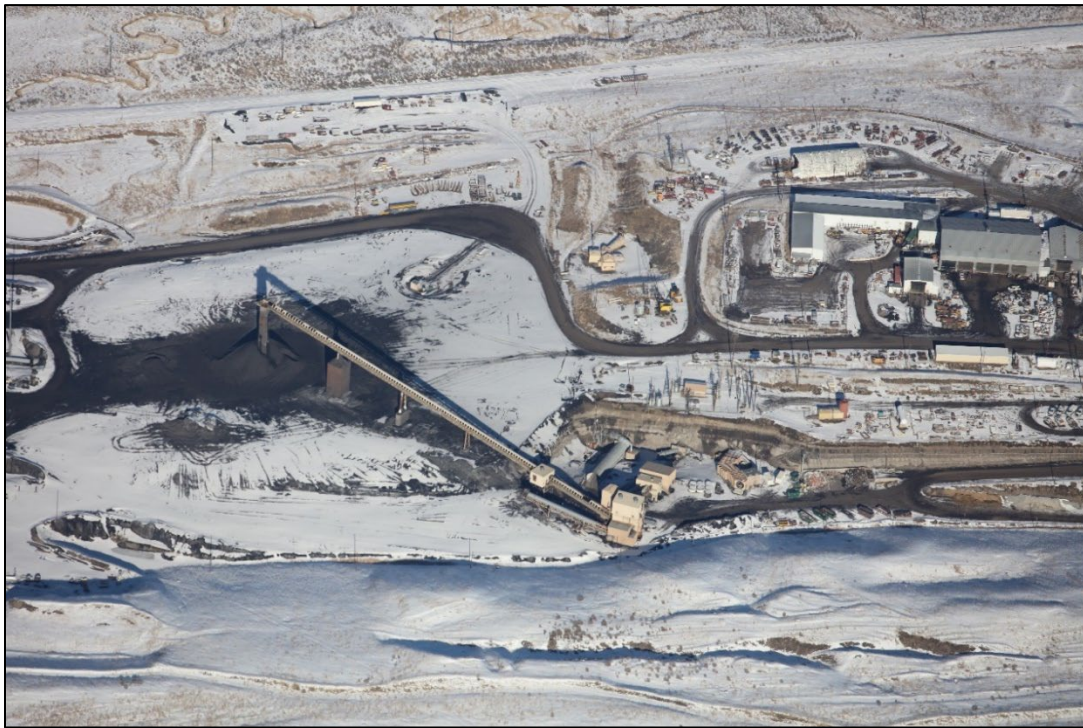
Photo 6: Main ROM conveyor, stockpile, and transfer building. The mine entrance portal is also visible.

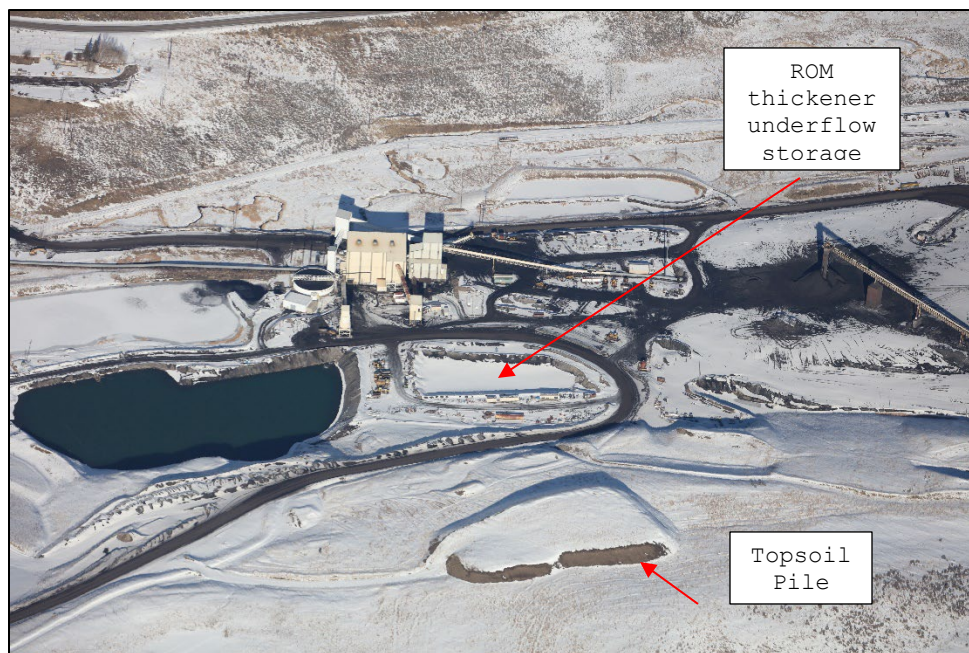
Photo 7: View of Pond D, the Pit Pond, Pond E, the ROM thickener underflow storage basin, ash plant, and stoker loadout facility. One topsoil pile is also visible.

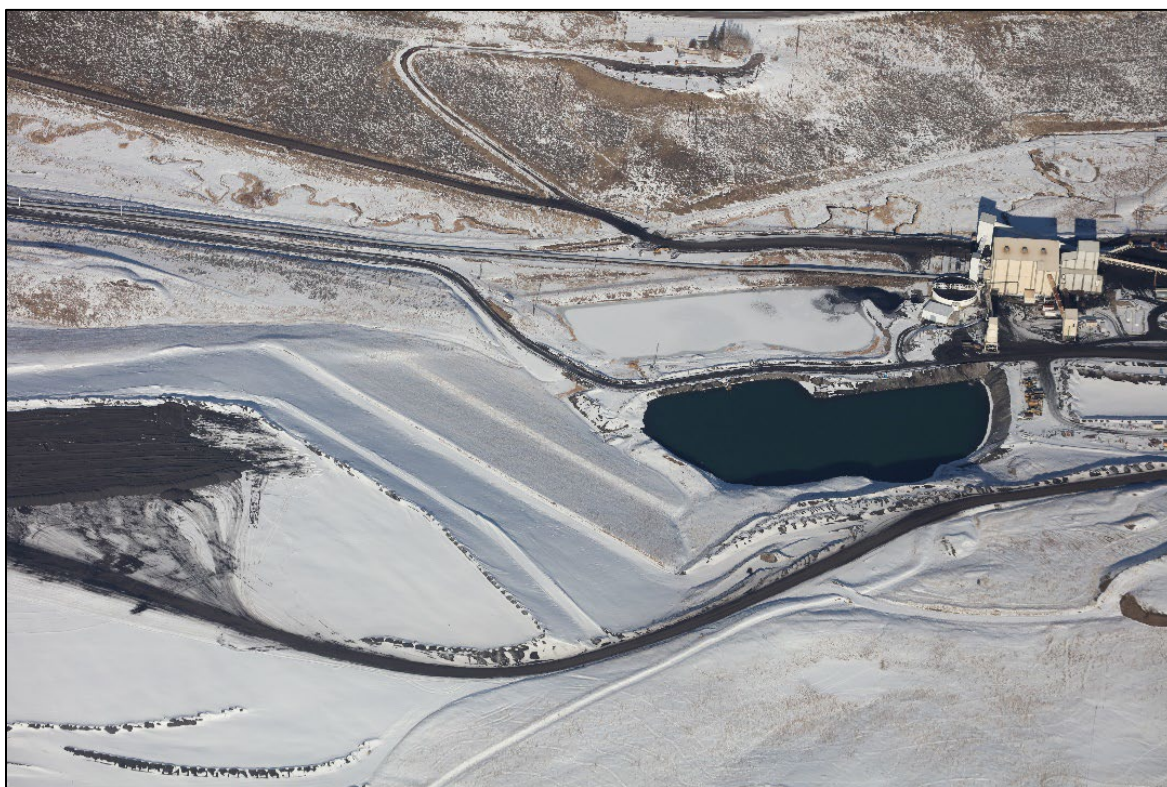
The refuse pile was inspected from above and no standing water was observed in the photographs. One truck was seen to be actively hauling material at the time of inspection (Photo 8). The pile appeared to be stable on all sides which have been most recently active (Photos 8-11, 13). Construction of lift three is currently underway and will continue throughout the winter season as weather allows.

Photo 8: View of the first three lifts of the refuse pile.

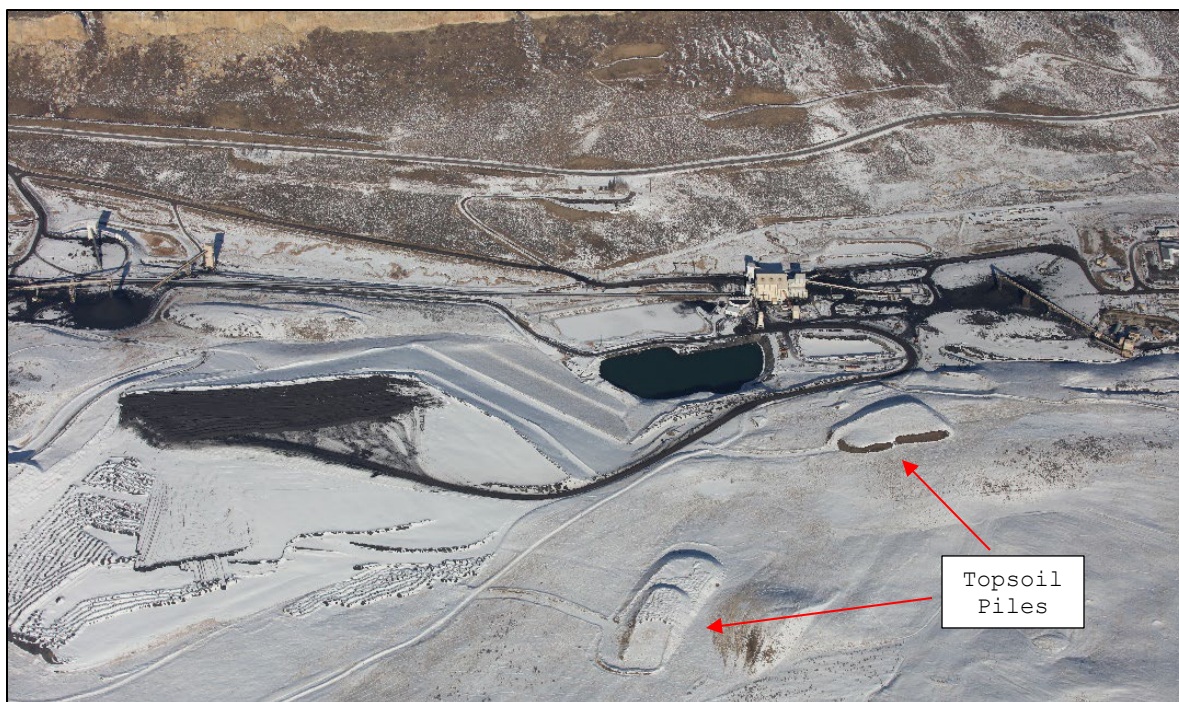
Photo 9: Overview of the refuse pile area including two topsoil stockpiles.

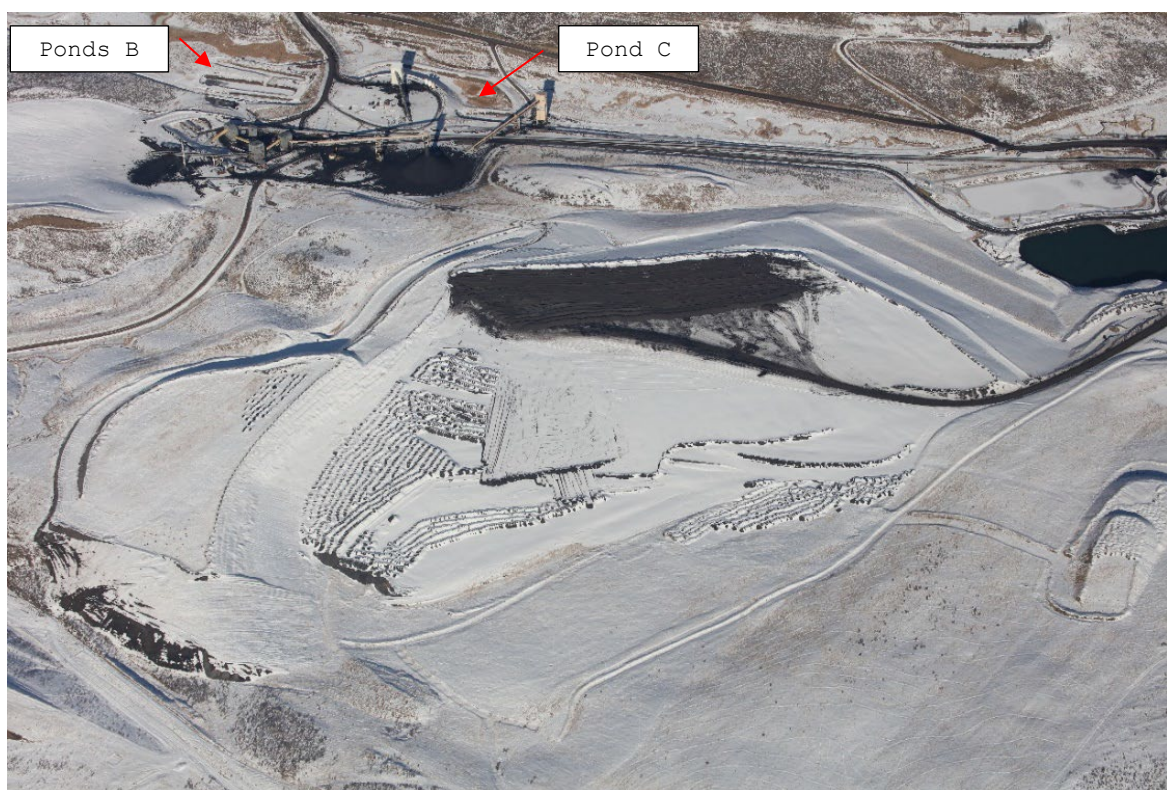
Photo 10: Coal refuse pile area and the ROM stockpile area. Pond C and Ponds B are visible.

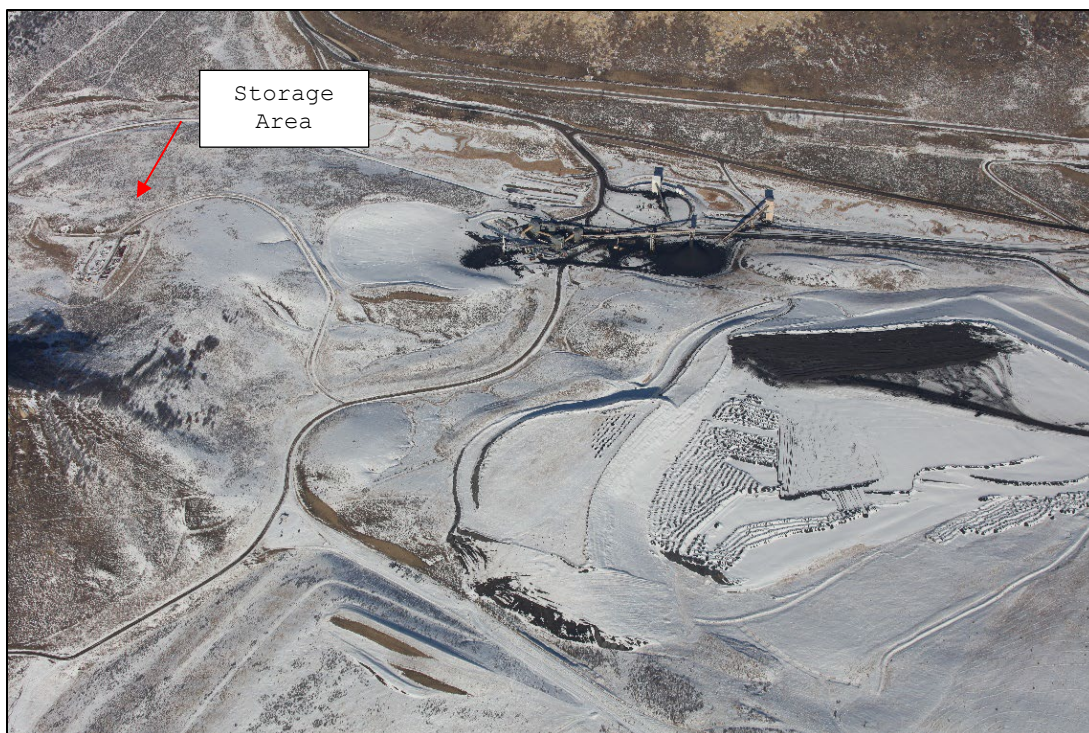
Three explosives storage bunkers are located on the far southwestern side of the main facilities area (Photo 11). Explosives are kept on site for general blasting and the storage bunkers are inventoried monthly. A storage lot for excess equipment and vehicles is also located in this same area. This area was noted to be free of any issues and roads to this area appear to be effectively plowed.

Photo 11: Western most extent of the main facilities area which shows the explosives storage area.

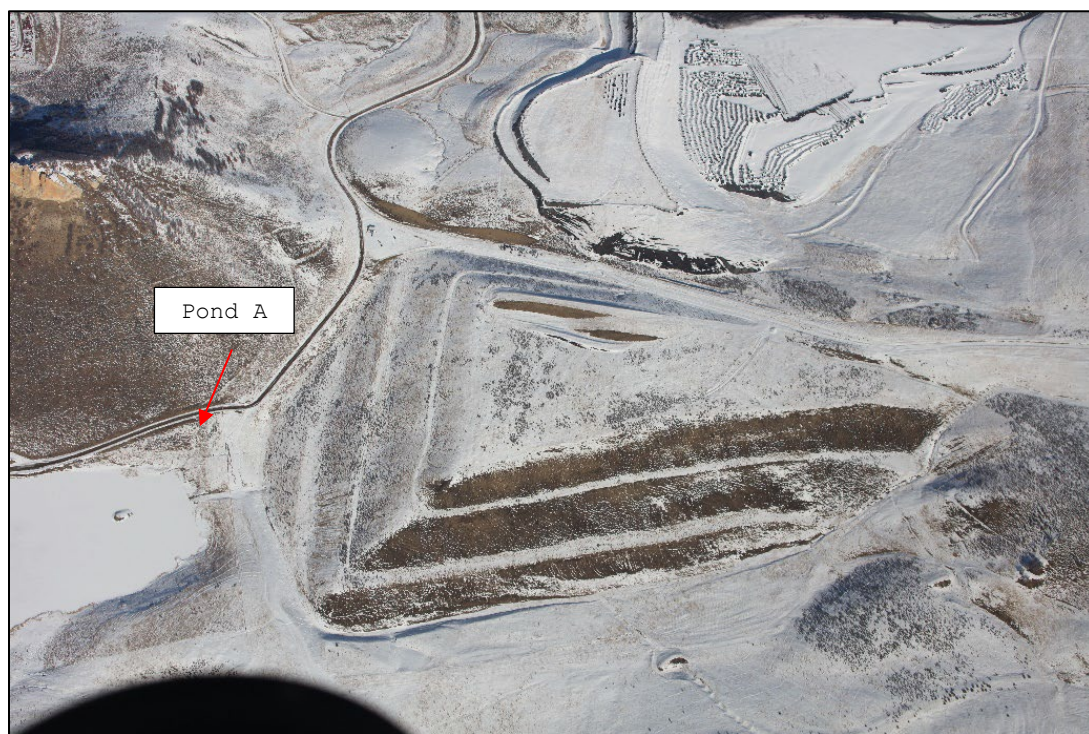
Photo 12: A topsoil and overburden stockpile site located south of the refuse pile and MSHA Pond A.

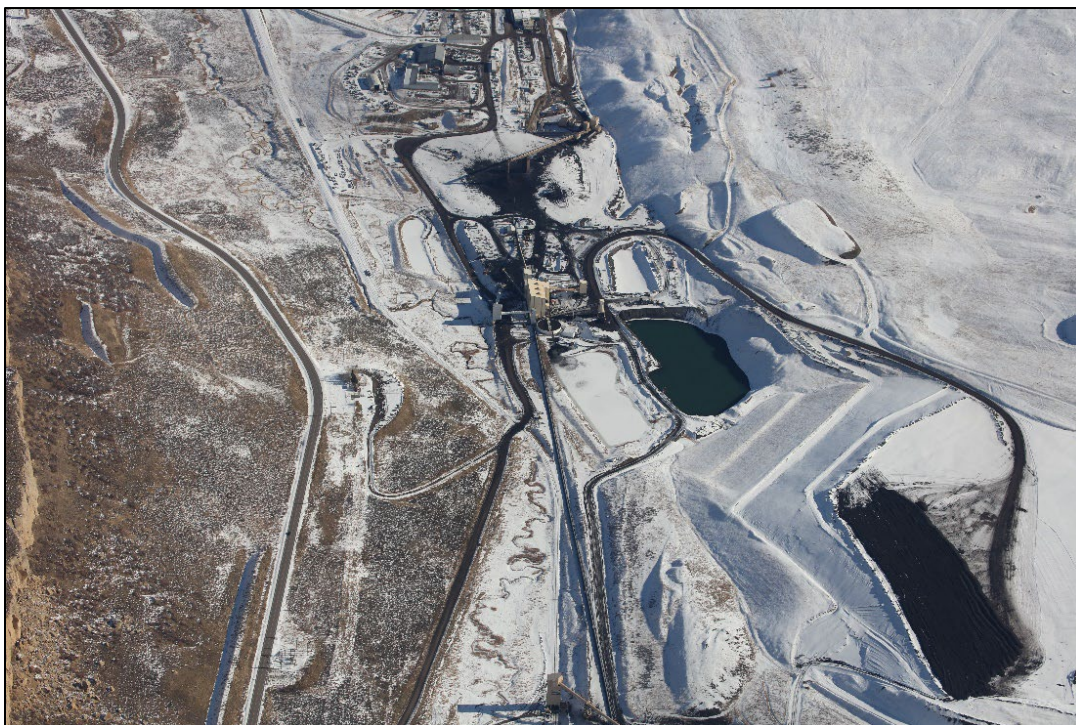
Photo 13: View of the western side of the refuse pile.

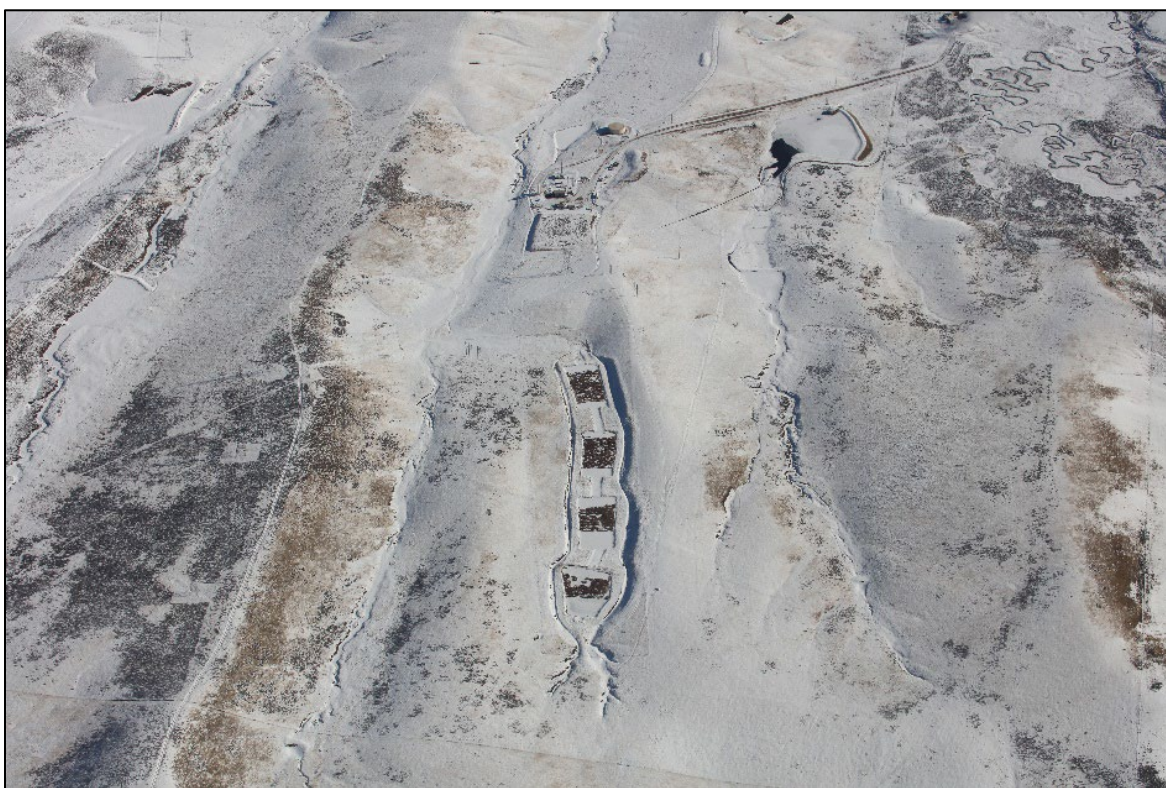
The 6MN Facilities are mostly unused in the winter. The heat fan used for the underground mine workings has been turned on for the winter and is accessed via the 6MN area. Roads were plowed to this area and ponds looked to be functioning properly (Photos 14 and 15). The Passive Water Treatment Plant has been turned off for the winter months (Photo 14). No major erosional and structural issues have been identified in the aerial images.

Photo 14: Overview of the 6MN area and the Passive Water Treatment System.

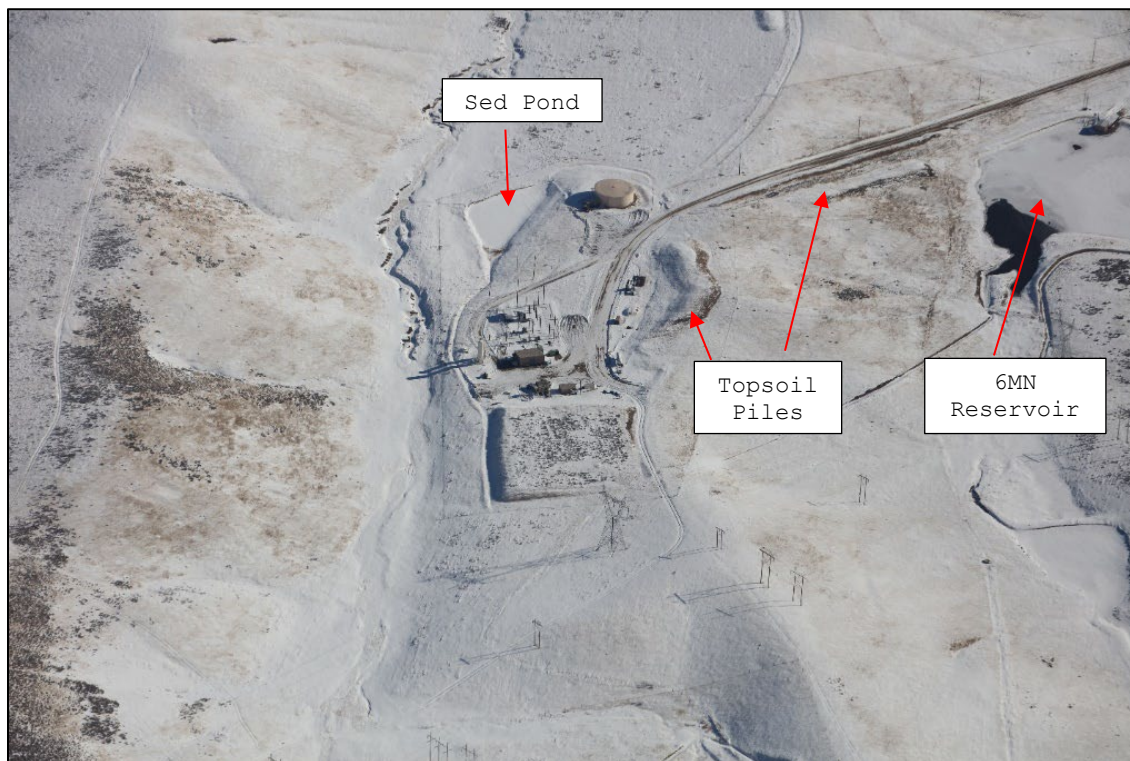
Photo 15: Closer view of the 6MN area, the 6MN reservoir, sediment pond, and several topsoil stockpiles are visible.
