## Colowyo Inspection Report

### PERMIT INFORMATION

<b>Permit Number:</b> C-1981-019 <b>Mine Name:</b> Colowyo Coal Mine <b>Operator:</b> Colowyo Coal Company L.P. <b>Operator Address:</b> Mr Tony Tennyson 5731 State Highway 13 Meeker, CO 81641	<b>County:</b> Moffat, Rio Blanco <b>Operation Type:</b> Surface <b>Permit Status:</b> Active <b>Ownership:</b> Private
	<b>Operator Representative Present:</b>  Tom Fry
<b>Operator Representative Signature: (Field Issuance Only)</b>

<b>Inspection Start Date:</b> January 3, 2024 <b>Inspection Start Time:</b> 07:30 <b>Inspection End Date:</b> January 3, 2024 <b>Inspection End Time:</b> 11:30		<b>Inspection Type:</b> Coal Partial inspection (ground visit) with Aerial <b>Inspection Reason:</b> Normal I&E Program <b>Weather:</b> Cloudy	
<b>Joint Inspection Agency:</b>  None		<b>Joint Inspection Contacts:</b>  None	
<b>Post Inspection Agency:</b>  None		<b>Post Inspection Contacts:</b>  None	
<b>Inspector(s):</b>  Zach Trujillo	<b>Inspector's Signature:</b>

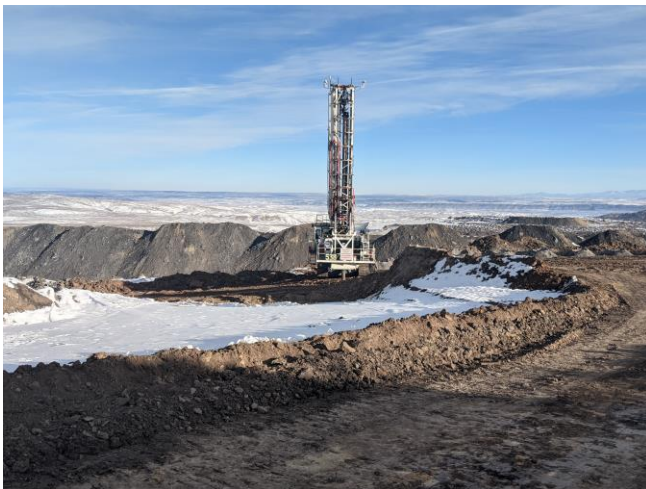
Active drilling for a future blast was occurring at the time of the inspection. The area of the blast was along the overburden along the Collom Pit highwall to the south. The blast was not observed during the inspection.

Drilling for future blast at Collom Pit.

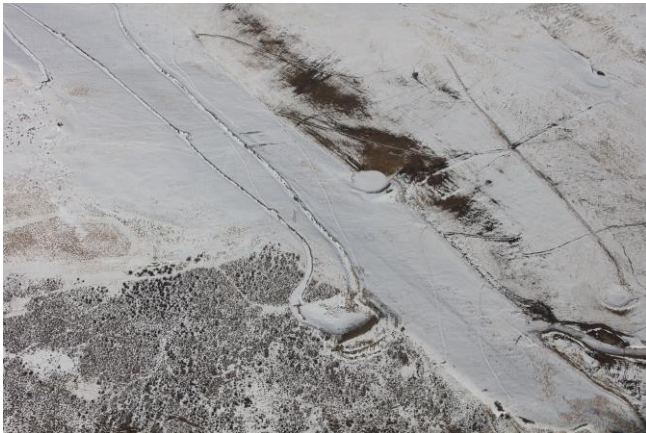
The Final East Pit Ditch and North Trib., East Pit Ditch were inspected from the aerial inspection. The ditches are stable and no issues were observed.

Final East Pit Ditch and Section 15 Pond.

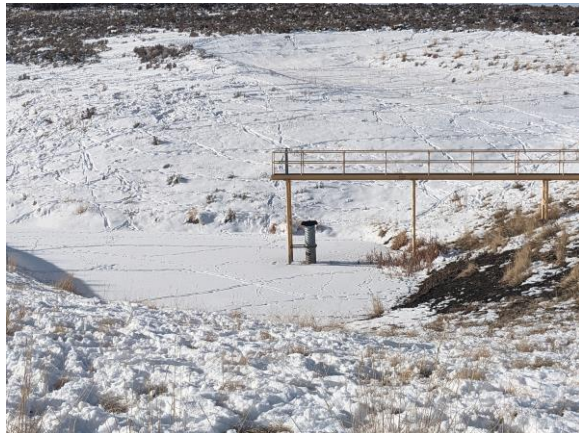
The Collom ponds Coal Stockpile, Section 36, Middle and Sidehill were inspected. Section 25 and Section 26 pond were inaccessible at the time of the inspection however were observed during the aerial inspection as stable. All ponds except the Sidehill Pond inspected during the on-the-ground site visit held water with no discharge. All Collom Ponds were stable and no issues were observed.

Middle Pond.

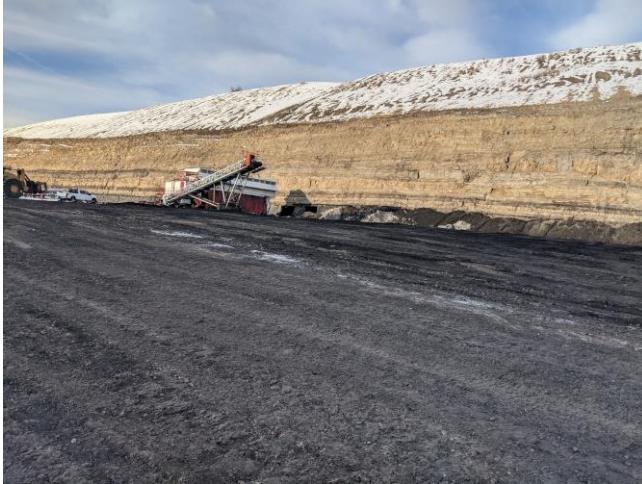
Highwall mining was occurring within the Little Collom Gulch area. All previously mined entries from the highwall miner were completely backfilled.

Highwall miner.
