## MINERALS PROGRAM INSPECTION REPORT

<b>MINE NAME:</b> Menzer Quarry	<b>MINE/PROSPECTING ID#:</b> M-1976-009-HR	<b>MINERAL:</b> Granite, granite gneiss	<b>COUNTY:</b> El Paso
<b>INSPECTION TYPE:</b> Monitoring	<b>WEATHER:</b> Cloudy	<b>INSP. DATE:</b> August 29, 2023	<b>INSP. TIME:</b> 11:05
<b>OPERATOR:</b> Schmidt Construction Company	<b>OPERATOR REPRESENTATIVE:</b> Dan Chavez	<b>TYPE OF OPERATION:</b> 112c - Construction Regular Operation	
<b>REASON FOR INSPECTION:</b> Normal I&E Program	<b>BOND CALCULATION TYPE:</b> Complete Bond	<b>BOND AMOUNT:</b> \$667,738.00	
<b>DATE OF COMPLAINT:</b> NA	<b>POST INSP. CONTACTS:</b> None	<b>JOINT INSP. AGENCY:</b> None	
<b>INSPECTOR(S):</b> Timothy Cazier, P.E.	<b>INSPECTOR'S SIGNATURE:</b>

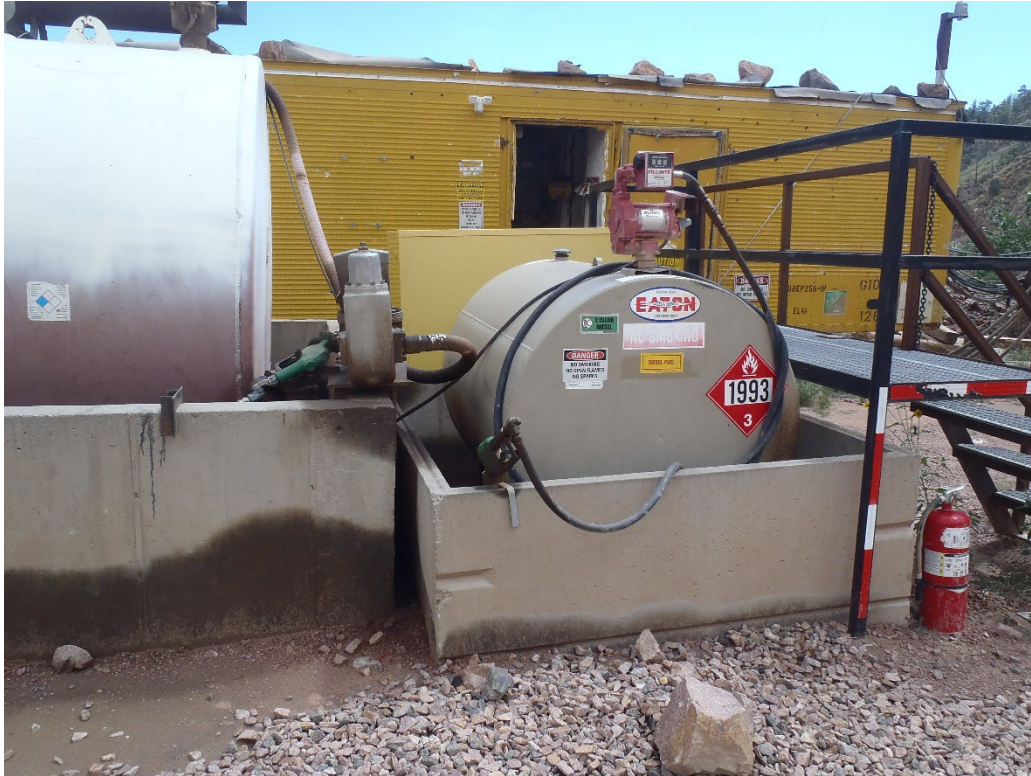
**Acid And Toxic Materials:** Above ground fuel/oil storage tanks were observed (see **Photos 1 and 2**) and had adequate secondary containment.

Photo 1. Diesel fuel tanks with secondary containment (processing area).

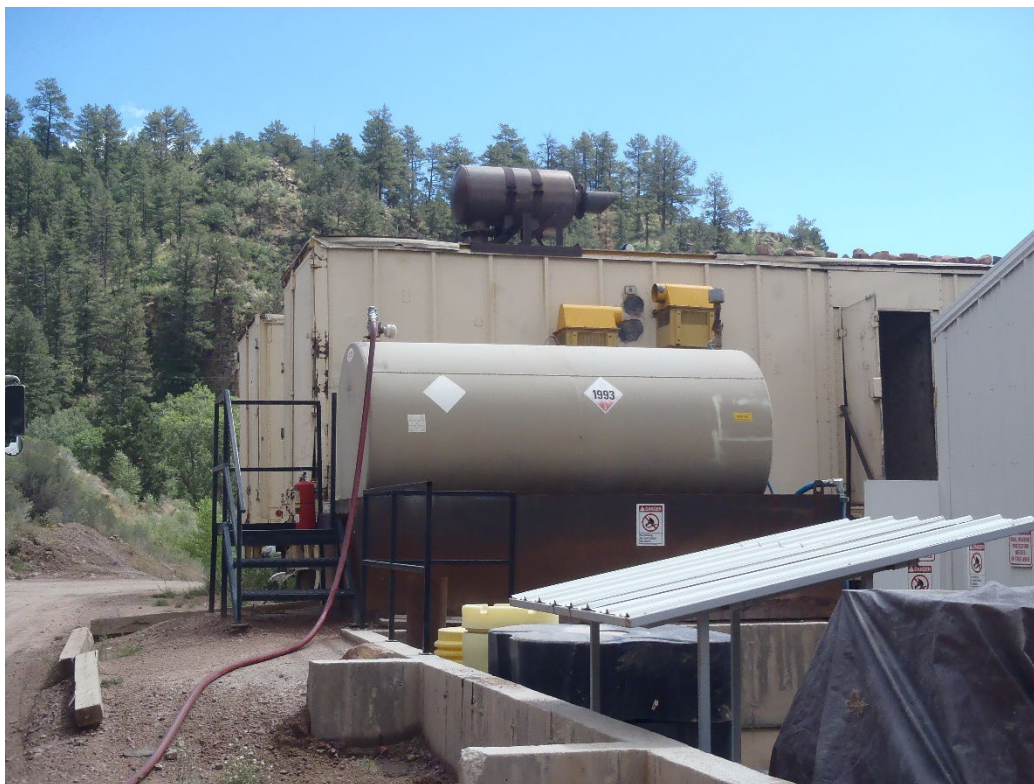
Photo 2. More petroleum tanks with secondary containment (processing area, note drums and spill kits in the foreground).

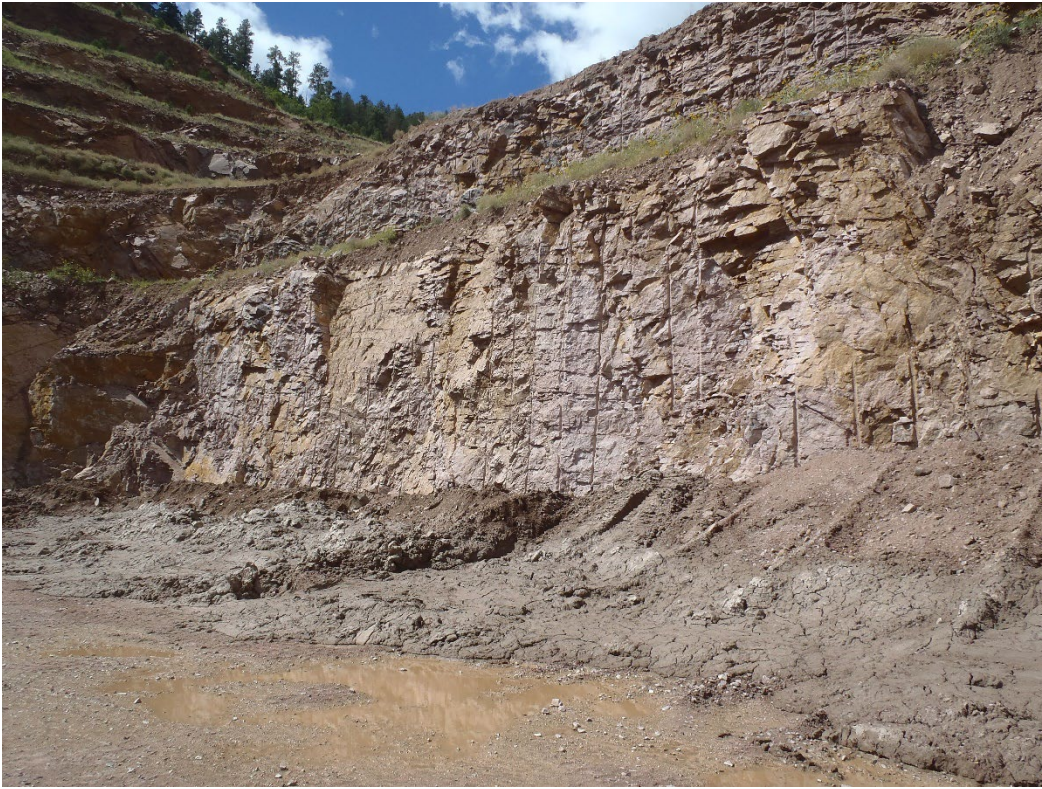
**Backfilling and Grading:** Fines are intended for bench backfilling. Material from the sediment pond had been placed against a recent highwall (see **Photo 3**) to dry out and supplement backfill.

**Explosives:** The mine has not filed a blasting plan with DRMS. Their contractor, Southwest Energy generates blast plans for each shot, which is typically about every three weeks. Site representatives stated they have begun pre-splitting their shots (see **Photo 3**) which can decrease blasting-induced disturbance and damage, protect the integrity of the rock mass, and form a smooth excavation face. The DRMS and Schmidt Construction are aware of residences near the top of the ridge on the south side of the quarry. These residences appear to be within a half mile of the areas being blasted for production. No complaints have been received by the DRMS.

Photo 3. Presplit highwall face with sediment placed at toe (toe of west highwall).

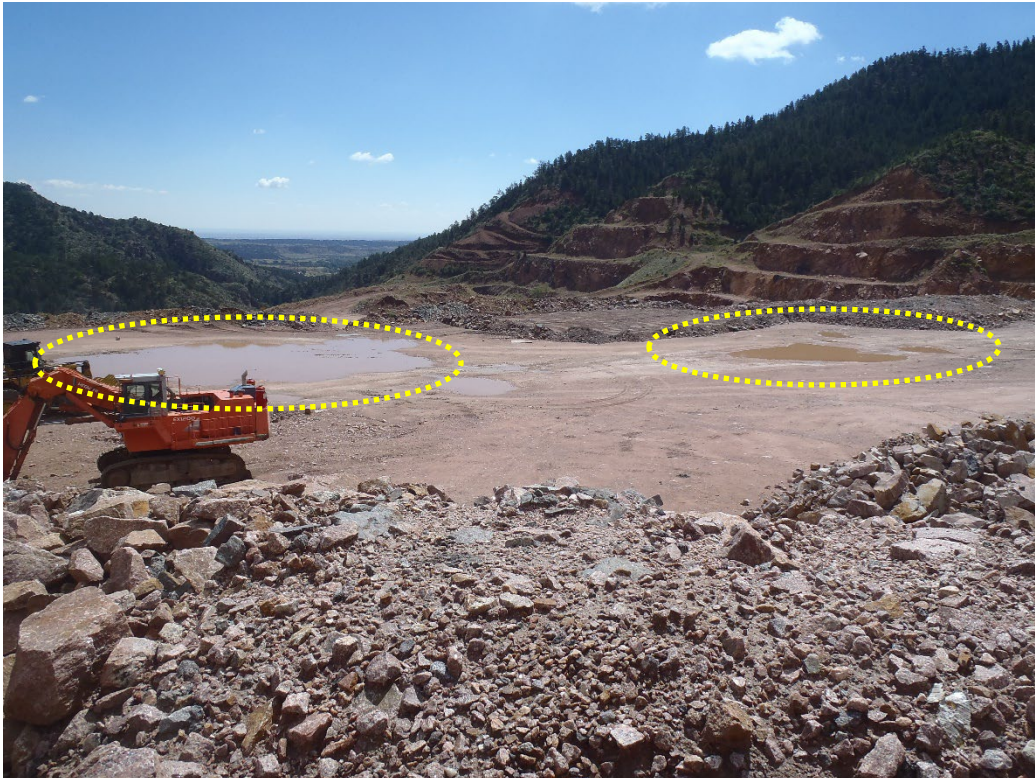
**Hydrologic Balance:** Due to recent rain, there were several puddles and areas of shallow ponding (see **Photo 4**). No exposed groundwater was observed.

Photo 4. Stormwater ponded on active bench (looking east – highwalls undergoing reclamation beyond).

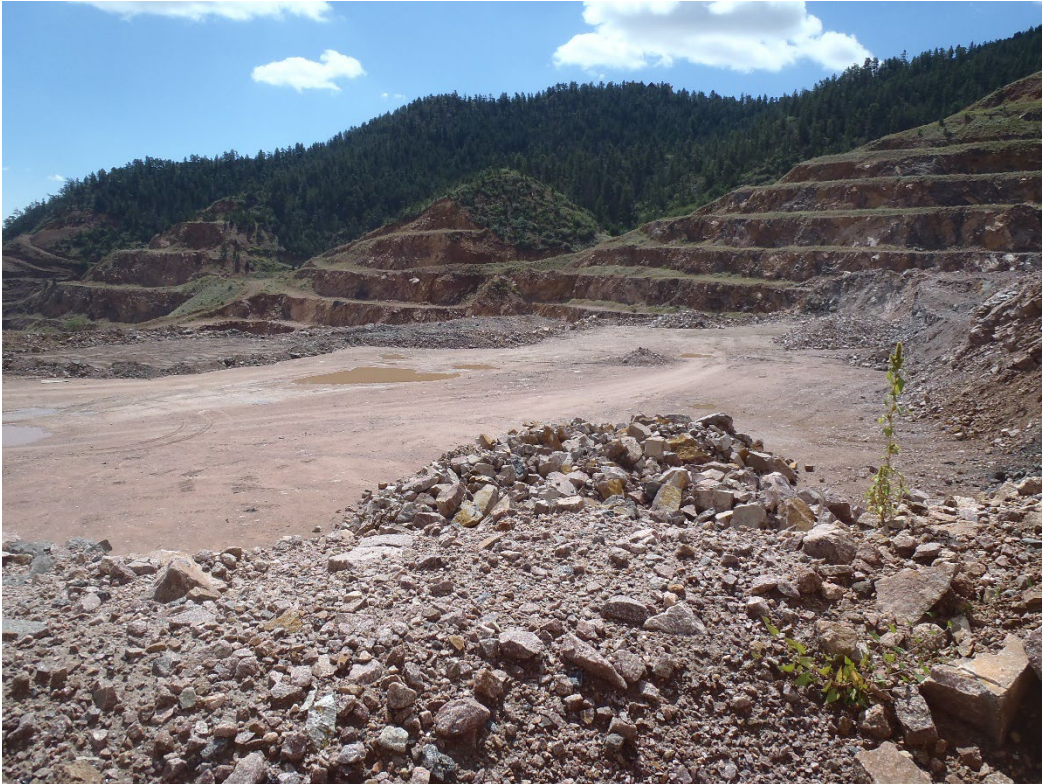
**Gen. Compliance with Mine Plan:** The operation appeared to be in compliance with the approved mine plan. The maximum allowed disturbed area is 141.4 acres. Google Earth was used to measure the disturbed area, which was approximately 92 acres, based on older 2020 imagery. Highwalls were estimated to be 40 feet in height and appeared stable (see **Photos 5 and 6**). Water storage tanks were observed on the west side of the pit floor (see **Photo 7**).

Photo 5. Typical site highwalls before presplitting practice initiated (SW corner).

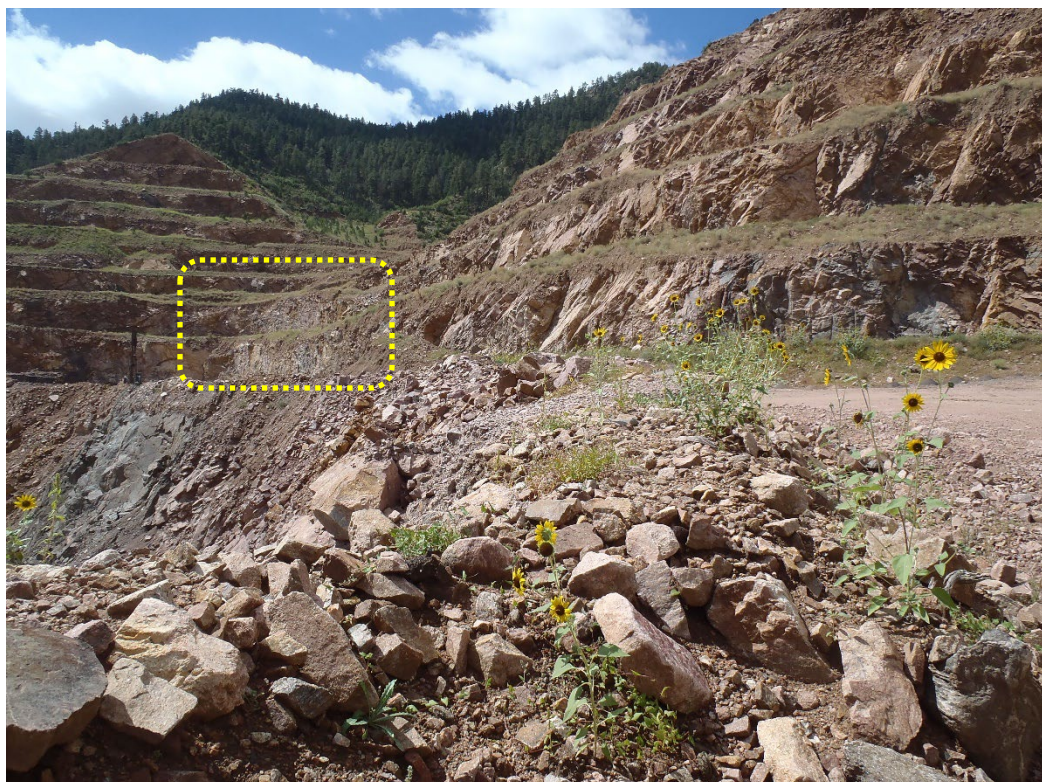
Photo 6. West highwall – presplit segment in the corner.

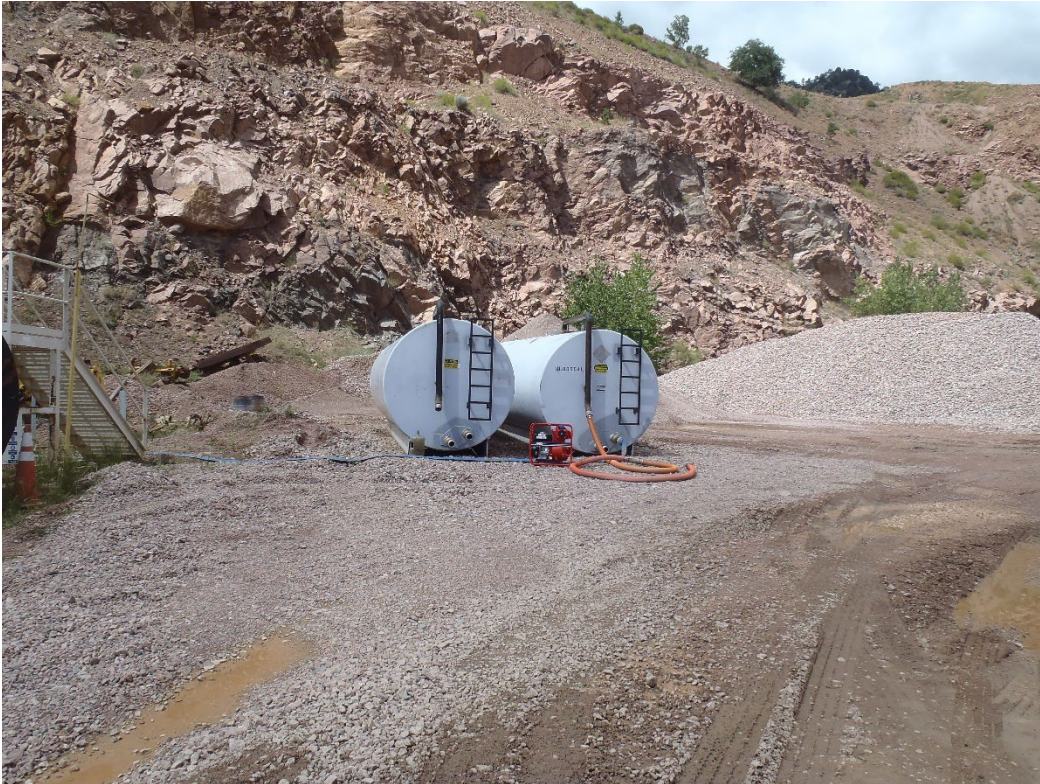
Photo 7. Water storage tanks (west side of processing area).

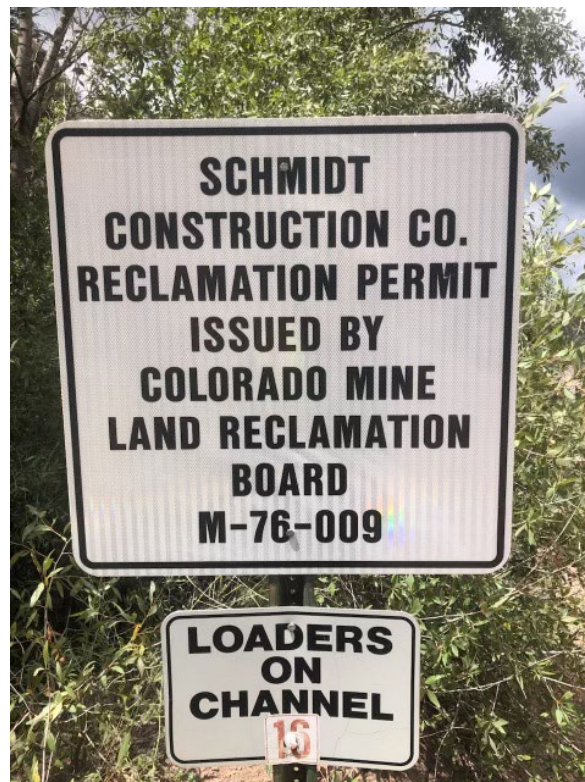
Signs and Markers: The permit sign was properly posted (see **Photo 8**) and boundary markers were observed to delineate the permit boundary.

Photo 8. Permit sign at canyon entrance.
