Geotechnical Addendum

2023 Annual Report

Holcim – US Deer Creek Quarry

Permit M1977-014
Jefferson County, Colorado

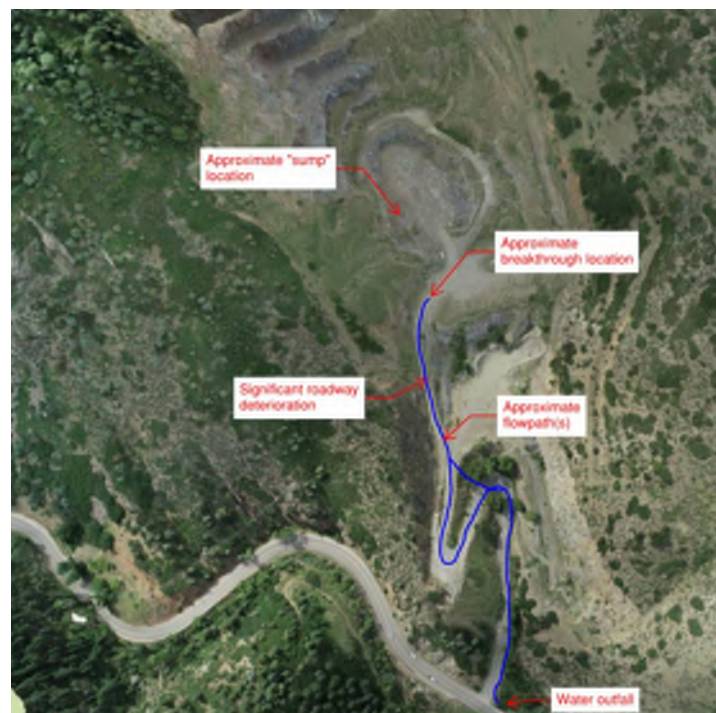
Figure 1 – Aerial view of noted site conditions

Based on HDR's observations, it appears a significant rain event occurred and impacted the existing flowpaths throughout the site. Existing overland flow does not appear to be controlled by the existing BMP's on site, and the current discharge location is not consistent with the approved discharge point. The following photos document the observed conditions.

Regarding the evidence of recent surface water runoff and access road degradation observed during our June 2023 site visit, HDR recommends a drainage survey be performed to identify positive drainage channels and methods to channelize future surface water runoff away from sensitive features such as access roads, highwalls slopes, and benches.

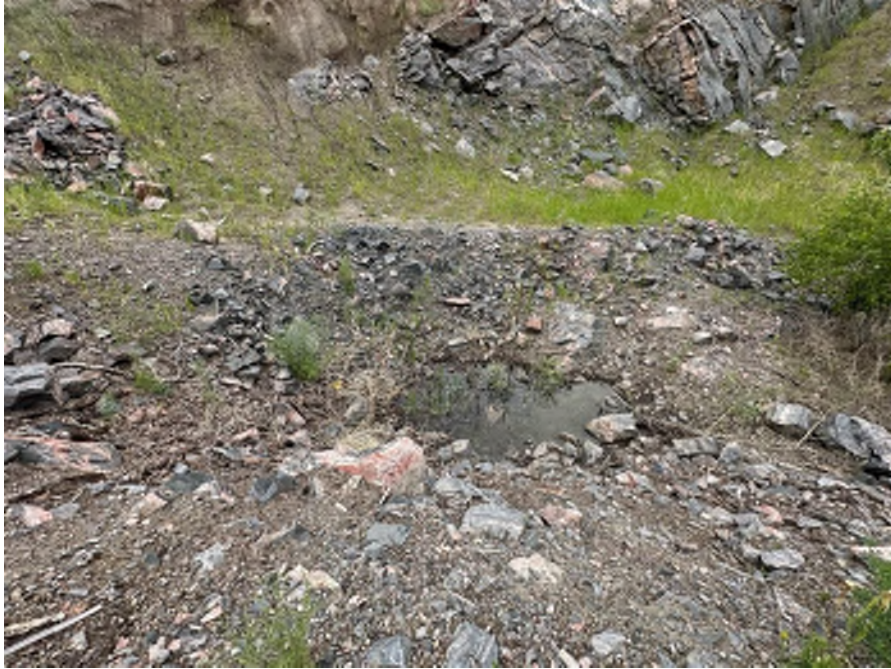
Photo 1 – View of existing “sump” area and standing water

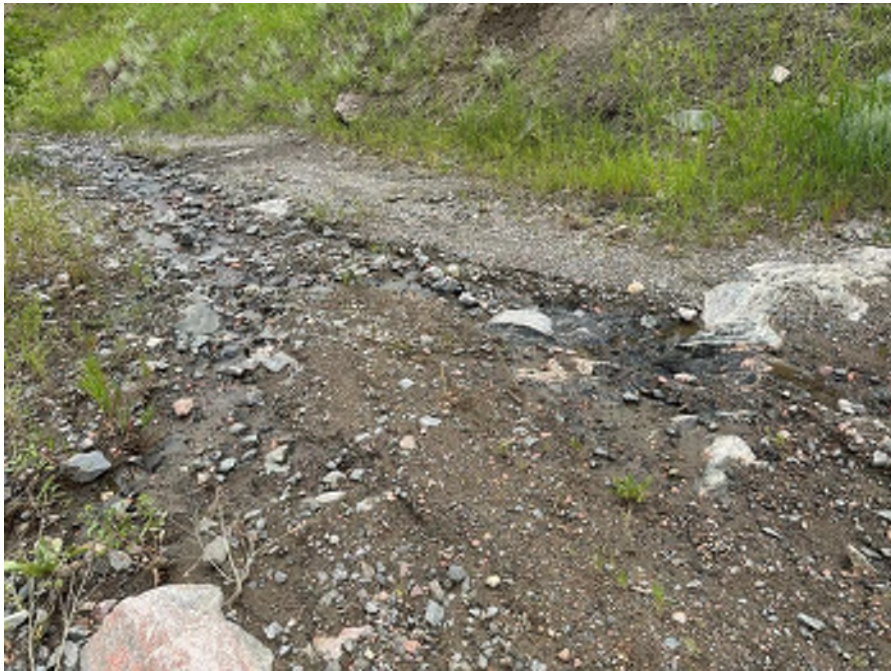
Photo 2 – View of damaged access road

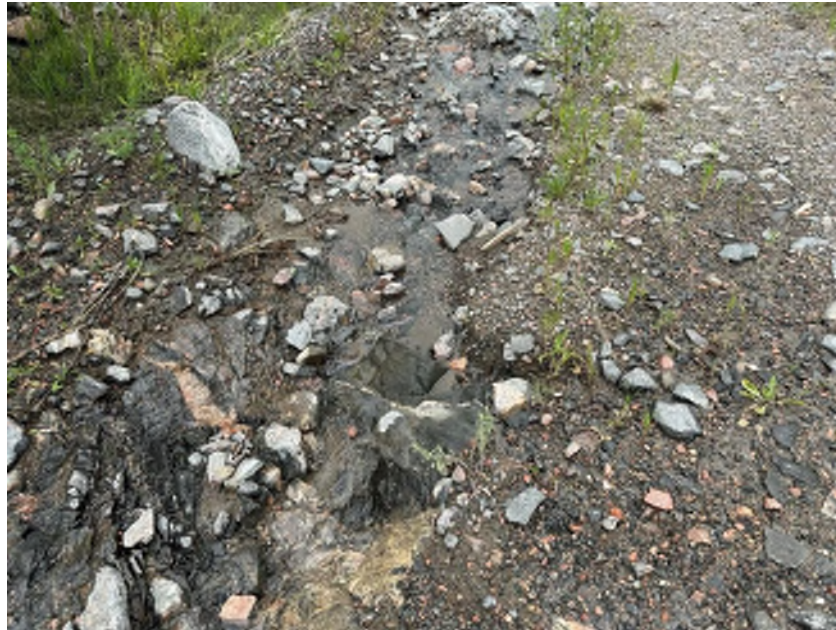
Photo 3 – View of exposed bedrock and flowing water

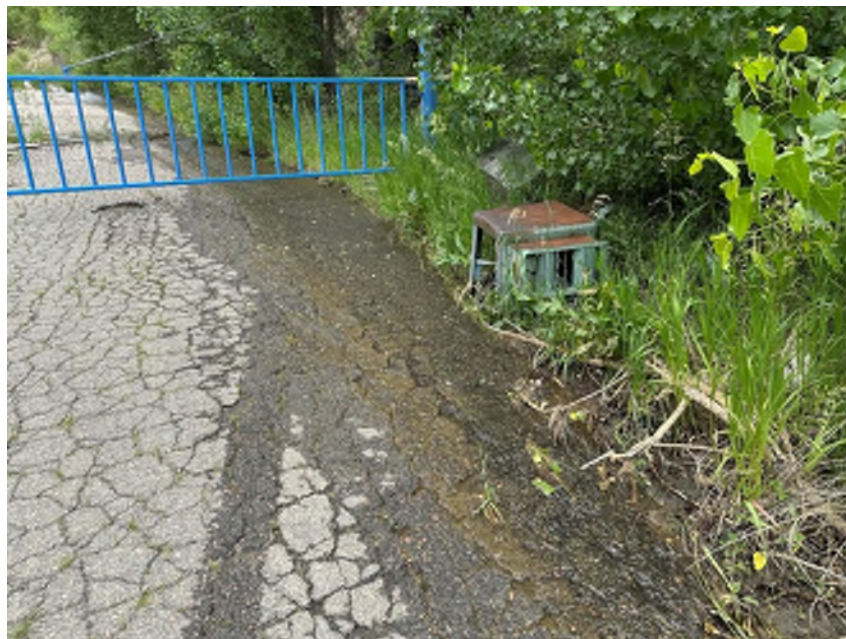
Photo 4 – View of flowing water by guard gate and unmaintained drainage ditch

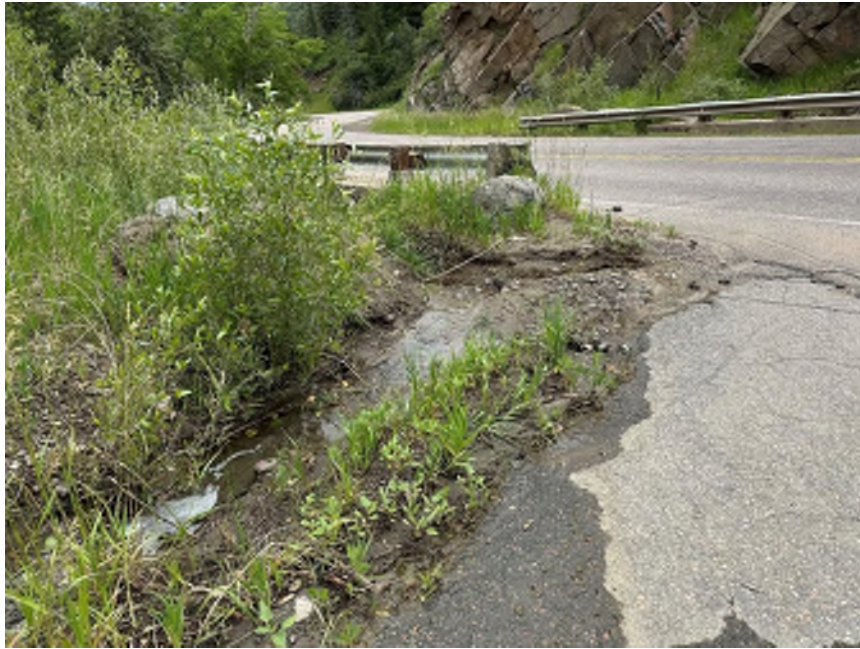
Photo 5 – View of flowing water and unmanaged drainage behind existing wingwall

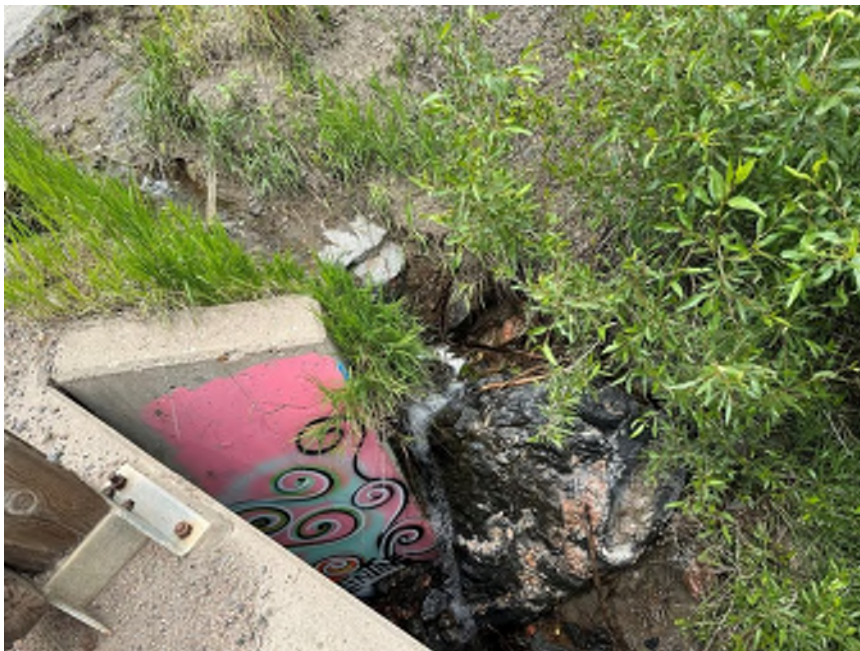
Photo 6 – View of scoured out wingwall

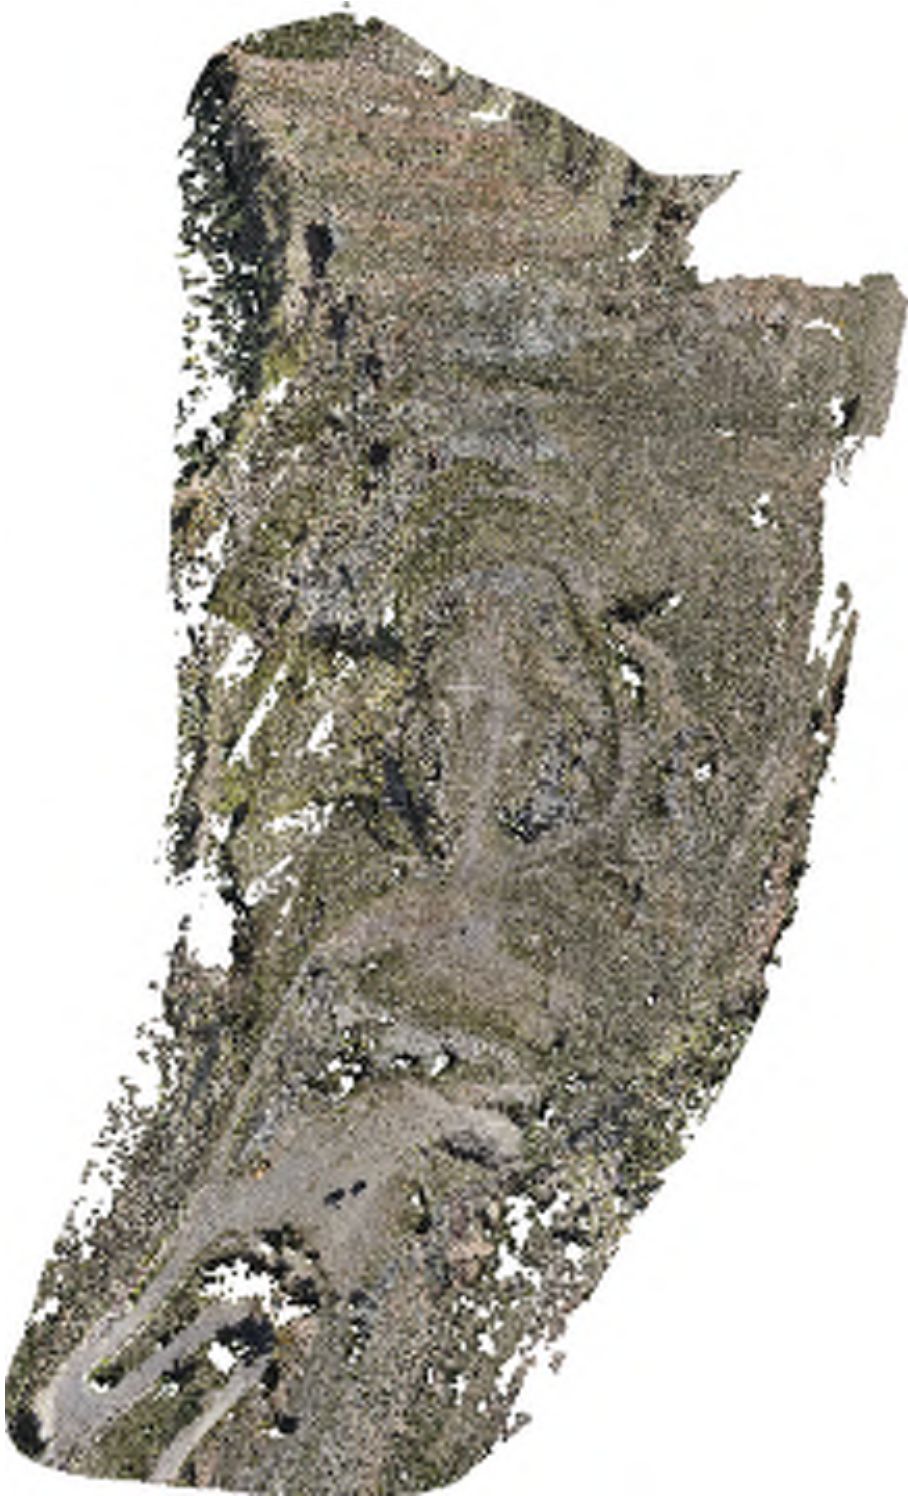
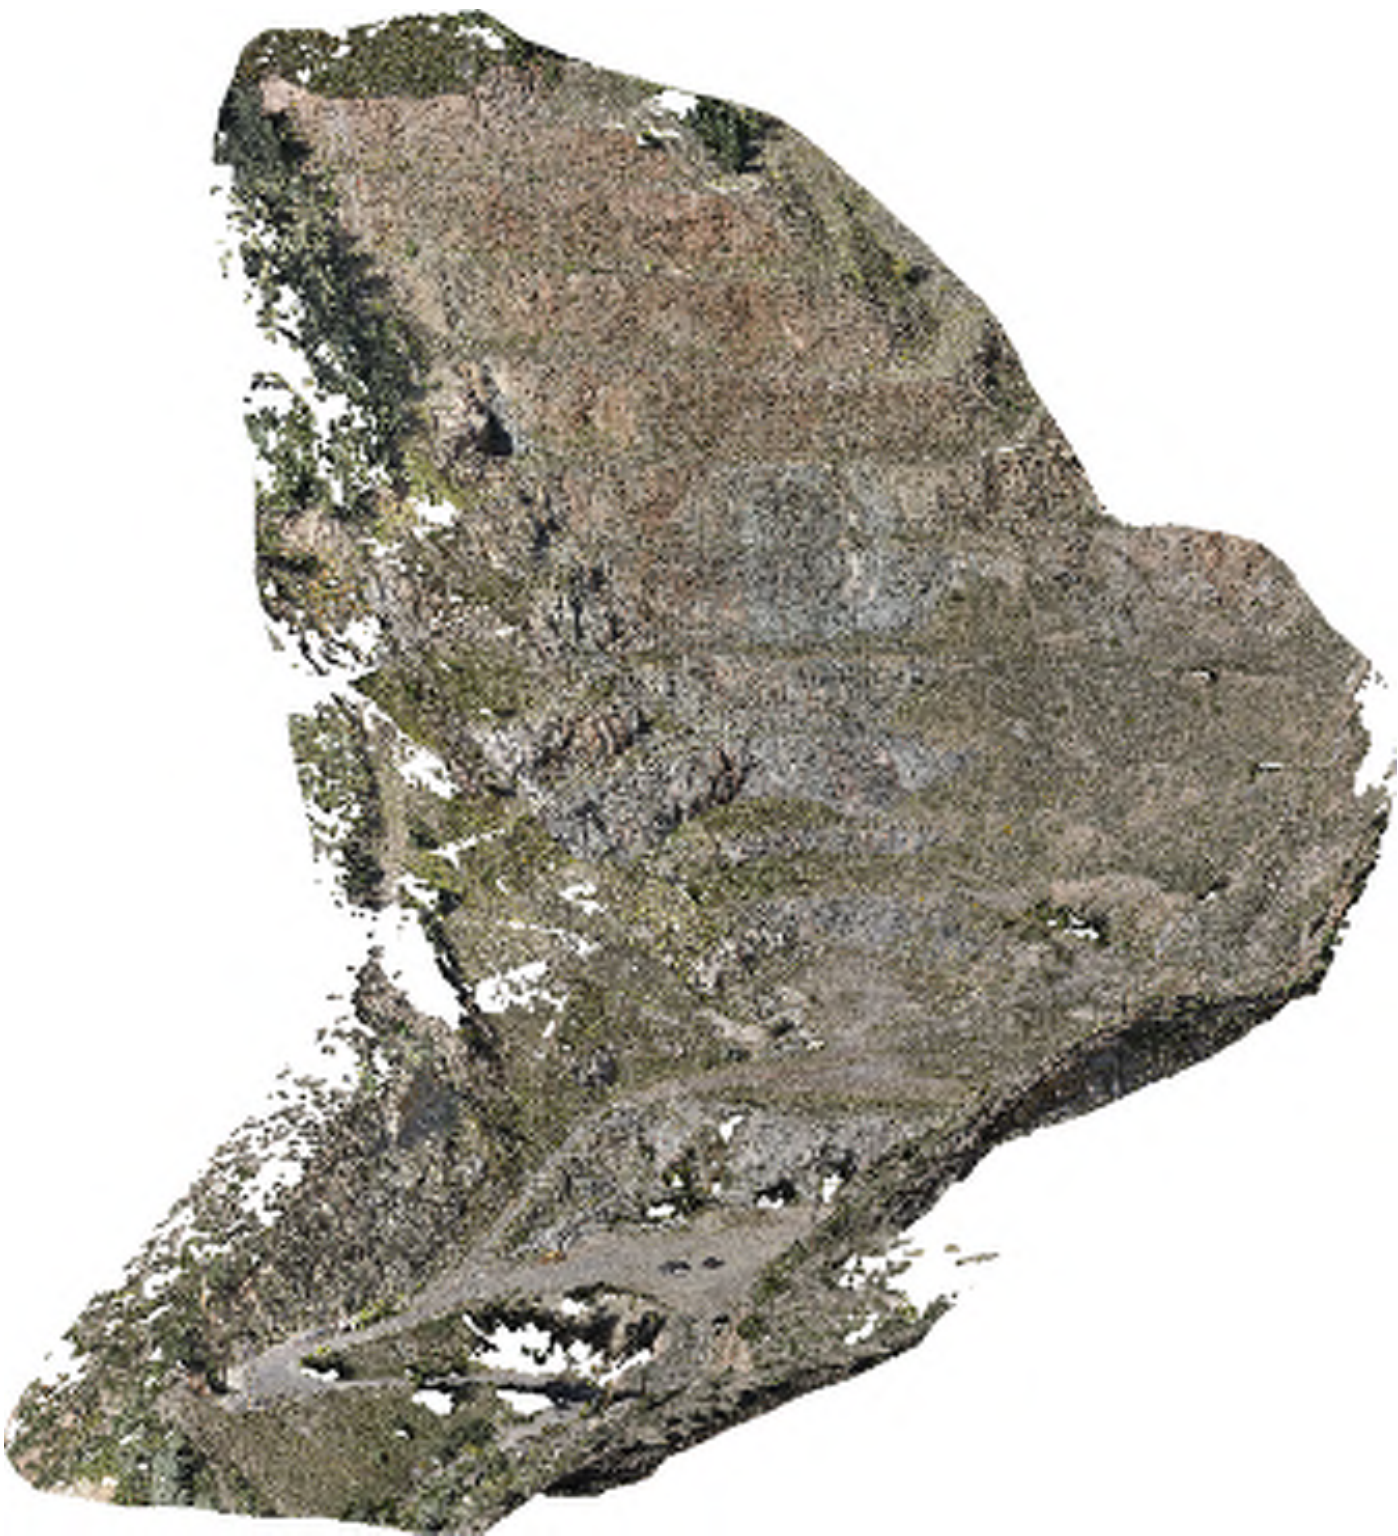
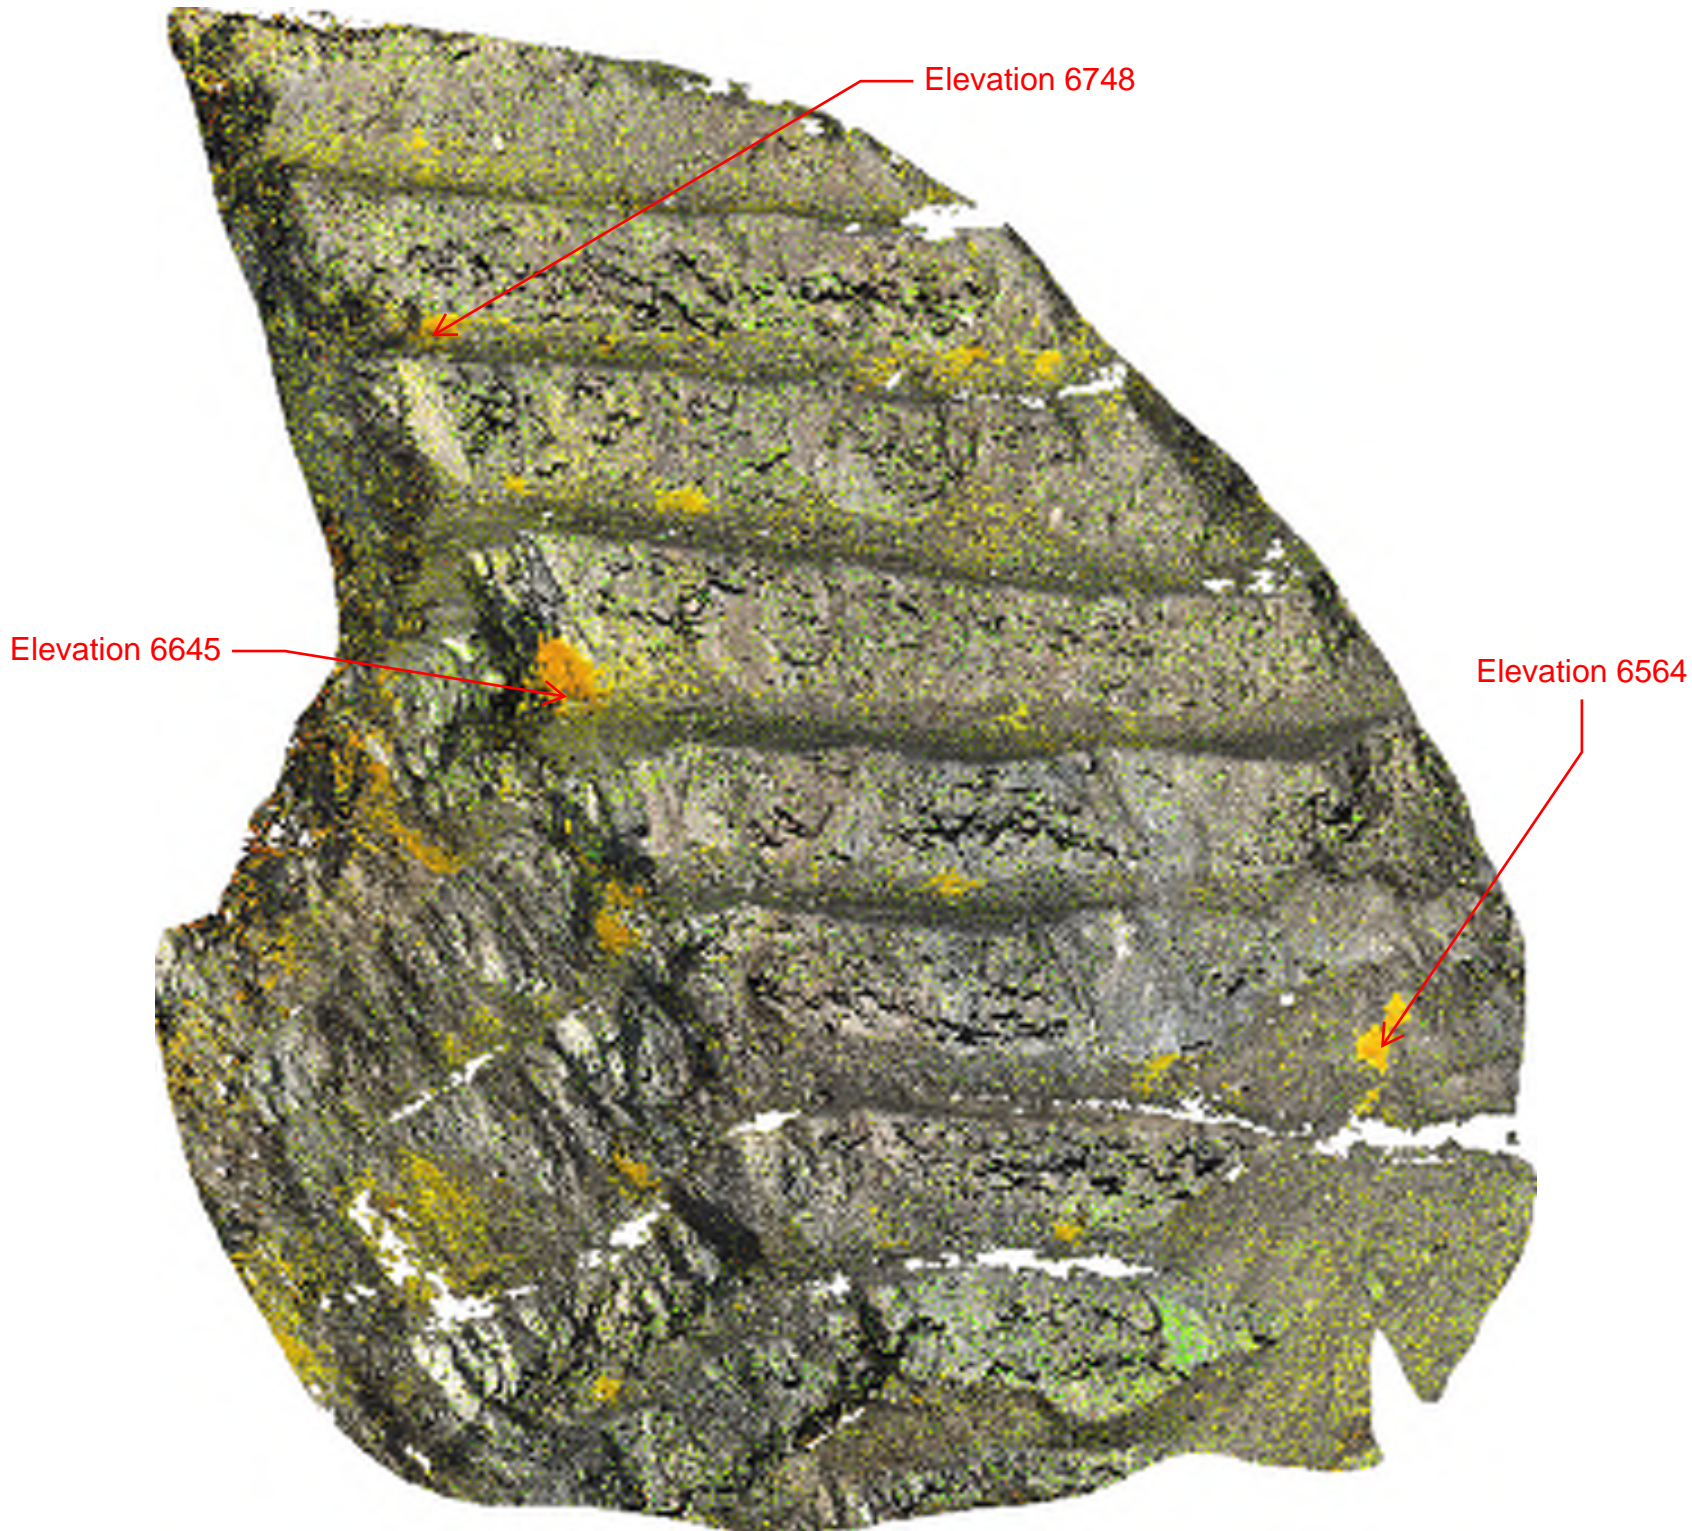
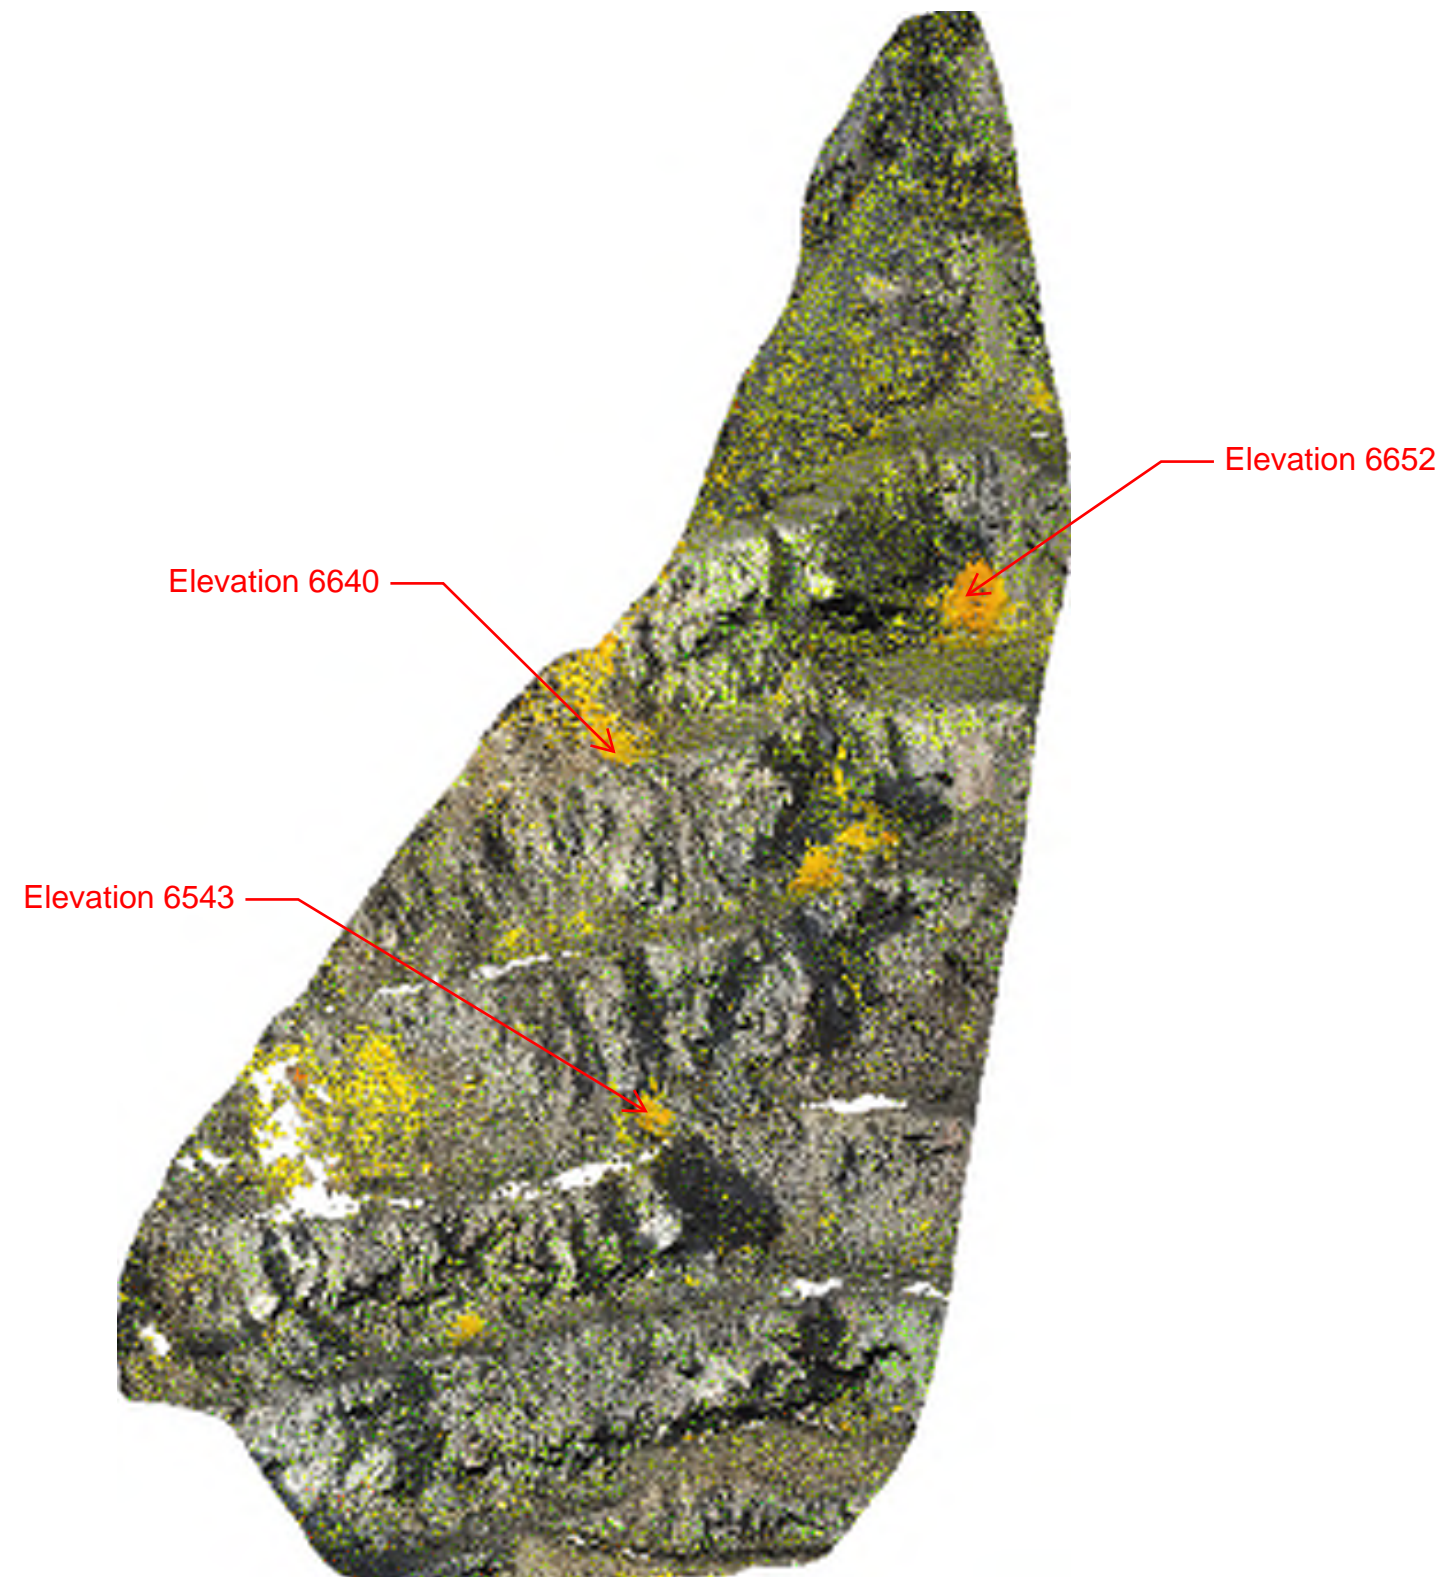
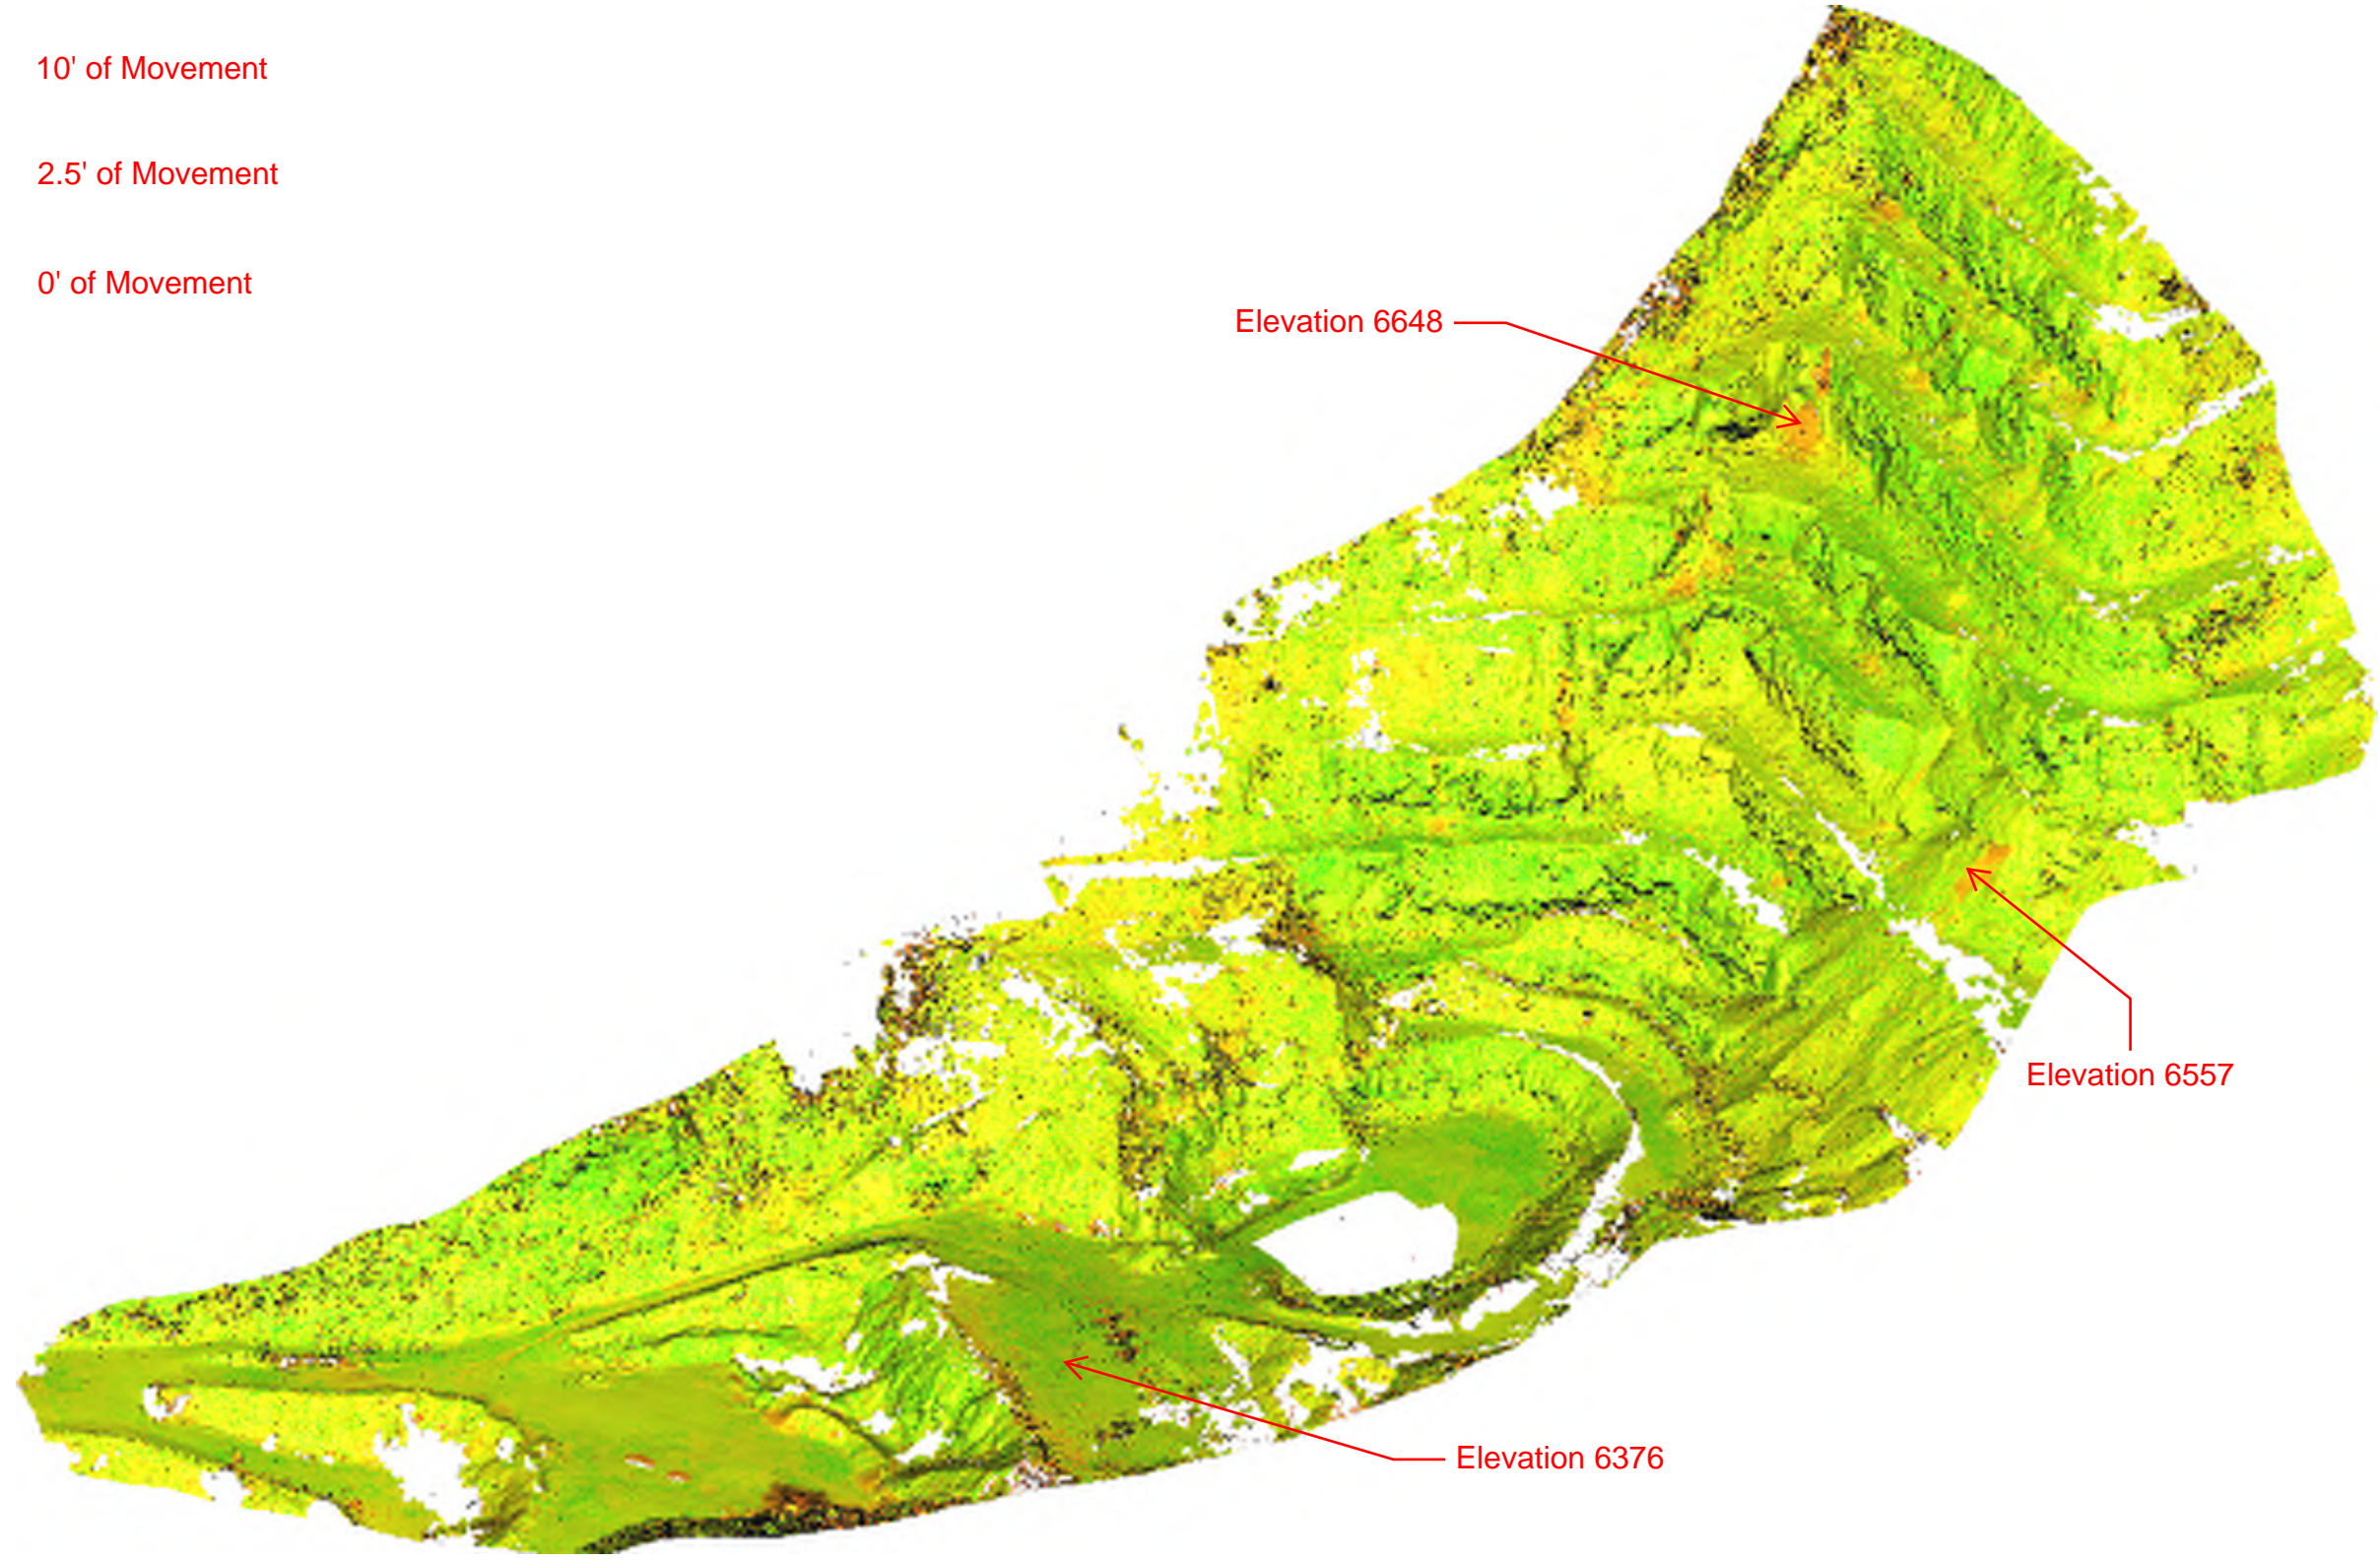
Change Detection Results

In general, HDR noted that at the corner of the existing north and east facing highwalls, the most amount of rockfall or movement was identified. Specifically between Elevation 6470 and 6650, a significant amount of rockfall from the bench above was noted in the analysis. On the east facing highwall specifically, a rockfall event occurred near Elevation 6564. Then, on the north facing highwall, a noted rockfall event occurred at Elevations 6640 and 6540. Minor raveling / talus accumulation was aboserved, primarily retained on the bench below.

Due to the presence of recent rockfall conditions, and the potential larger scale failure risk identified through the kinematic analyses, HDR recommends that ongoing monitoring as part of the annual inspections continue moving forward. Additionally, as noted during the change detection analysis, any work along the existing benches should be limited, as it is noted that the benches are continuing to weather and ravel in numerous areas. If rockfall persists beyond an adjacent lower bench, as noted during our research, benches should be cleaned and/or stabilized to mitigate excessive rockfall energies.

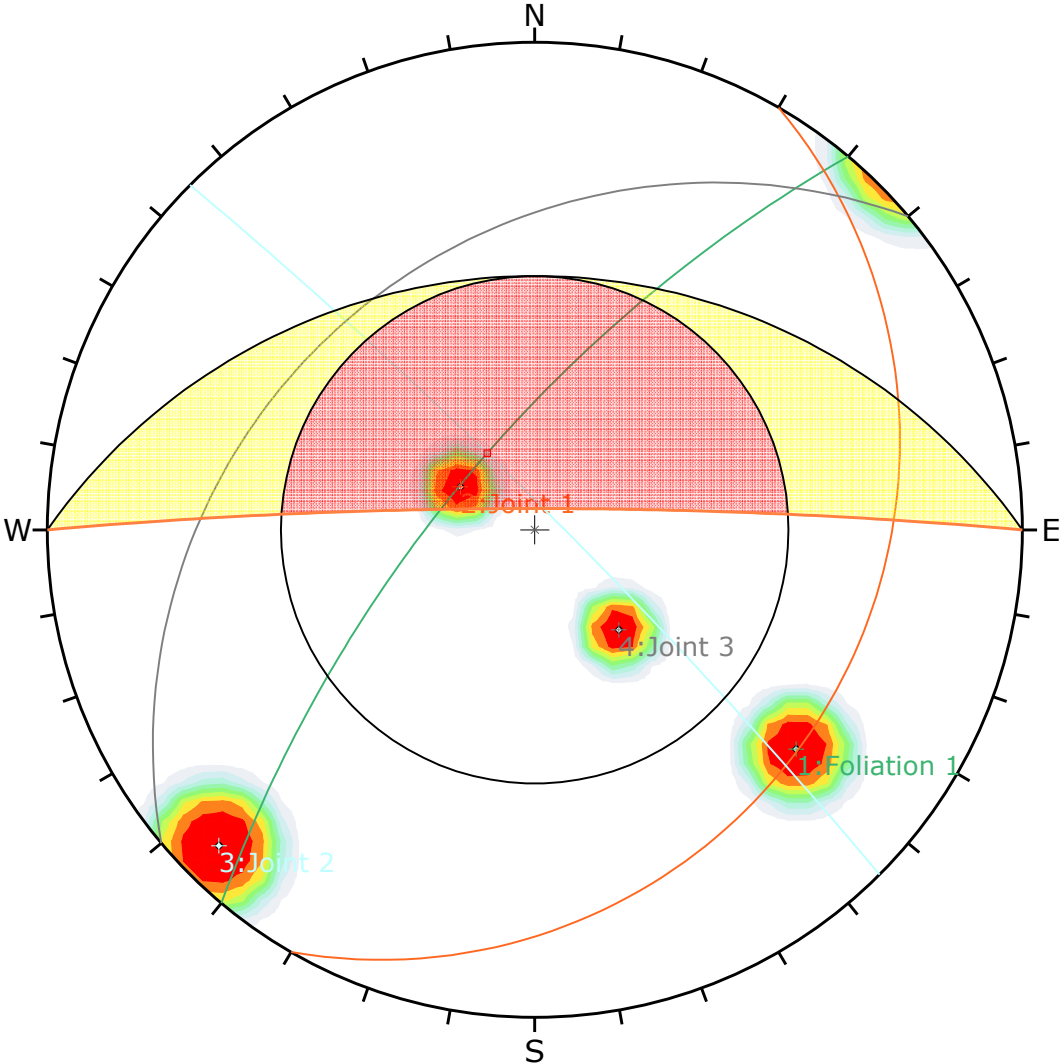
Kinematic Analysis	Wedge Sliding		
Slope Dip	85		
Slope Dip Direction	0		
Friction Angle	35°		
	Critical	Total	%
Wedge Sliding	1	6	16.67%

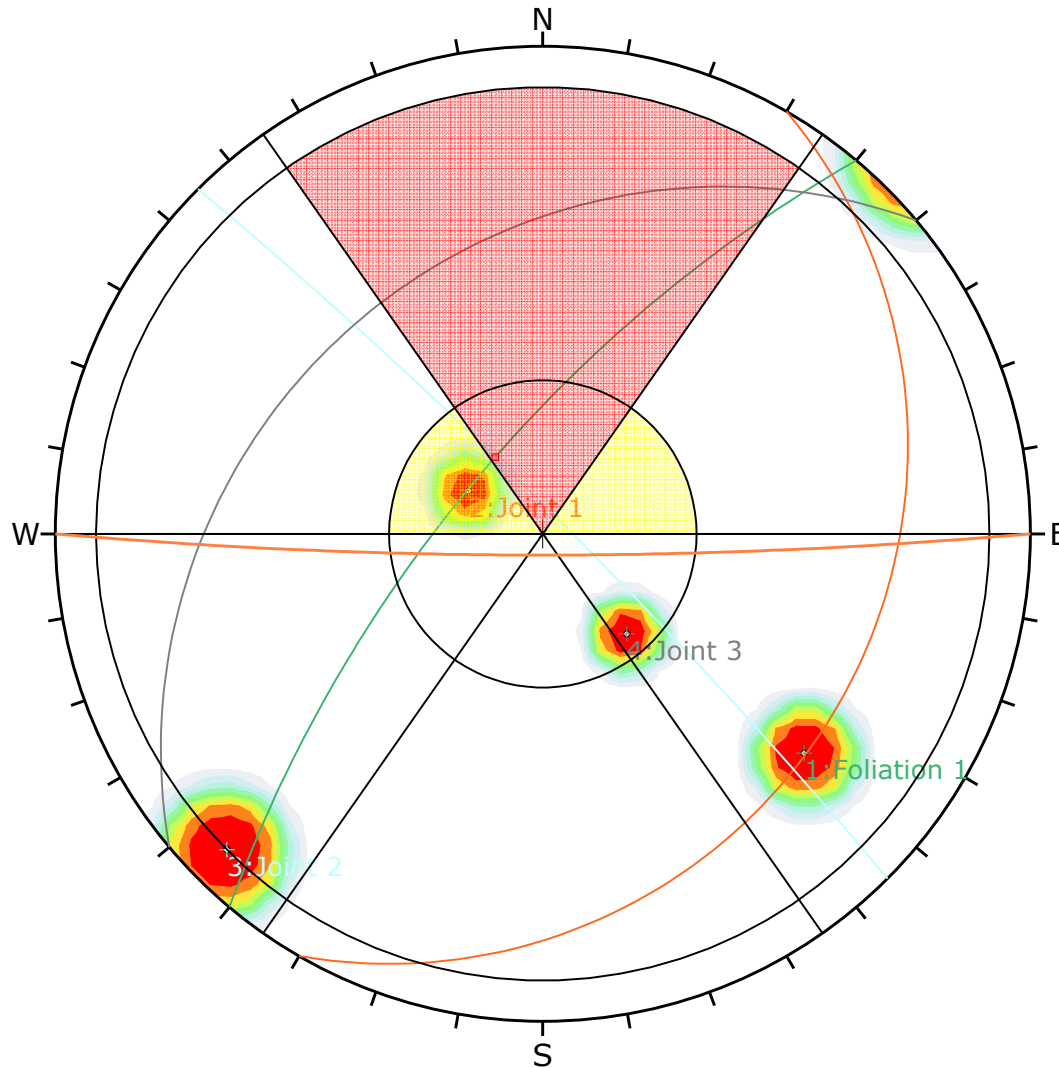
Critical	Total	%
Direct Toppling (Intersection)	1	6	16.67%
Oblique Toppling (Intersection)	0	6	0.00%
Base Plane (All)	1	4	25.00%

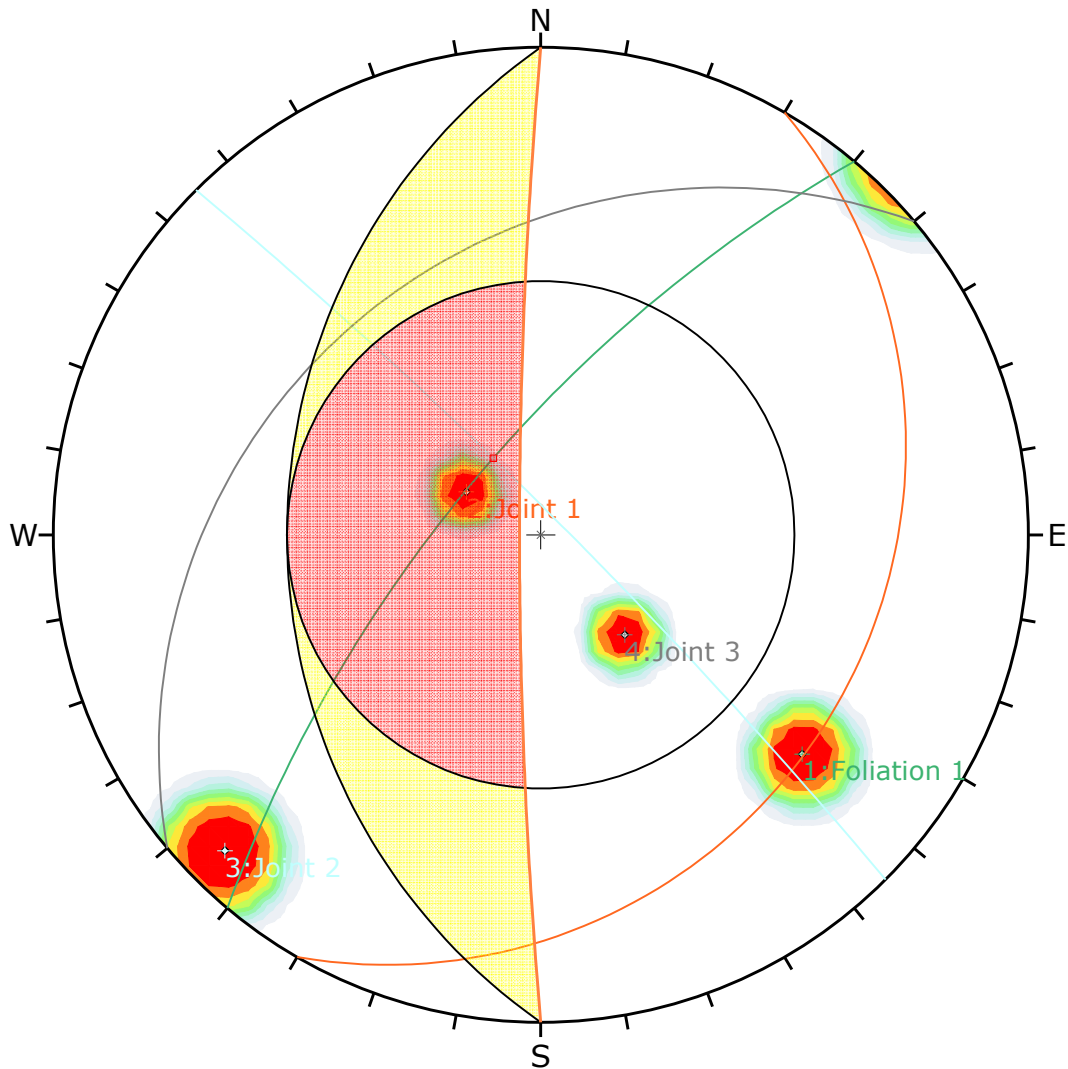
Kinematic Analysis	Wedge Sliding			
Slope Dip	85			
Slope Dip Direction	270			
Friction Angle	35°			
		Critical	Total	%
Wedge Sliding	1	6	16.67%
