## January Inspection

Division of Reclamation,  
Mining and Safety

<b>Permit Number:</b> C-1981-018 <b>Mine Name:</b> Deserado Mine <b>Operator:</b> Blue Mountain Energy, Inc <b>Operator Address:</b> Mr Kurtis Blunt 3607 County Road 65 Rangely, CO, 81648	<b>County:</b> Moffat, Rio Blanco <b>Operation Type:</b> Underground <b>Permit Status:</b> Active <b>Ownership:</b> Private
	<b>Operator Representative Present:</b>  NA
<b>Operator Representative Signature: (Field Issuance Only)</b>

<b>Inspection Start Date:</b> January 3, 2024 <b>Inspection Start Time:</b> 13:20 <b>Inspection End Date:</b> January 3, 2024 <b>Inspection End Time:</b> 13:30		<b>Inspection Type:</b> Aerial Inspection <b>Inspection Reason:</b> Normal I&E Program <b>Weather:</b> Clear	
<b>Joint Inspection Agency:</b>  None		<b>Joint Inspection Contacts:</b>  NA	
<b>Post Inspection Agency:</b>  None		<b>Post Inspection Contacts:</b>  NA	
<b>Inspector(s):</b>  Todd Jesse  Brock Bowles	<b>Inspector's Signature:</b>

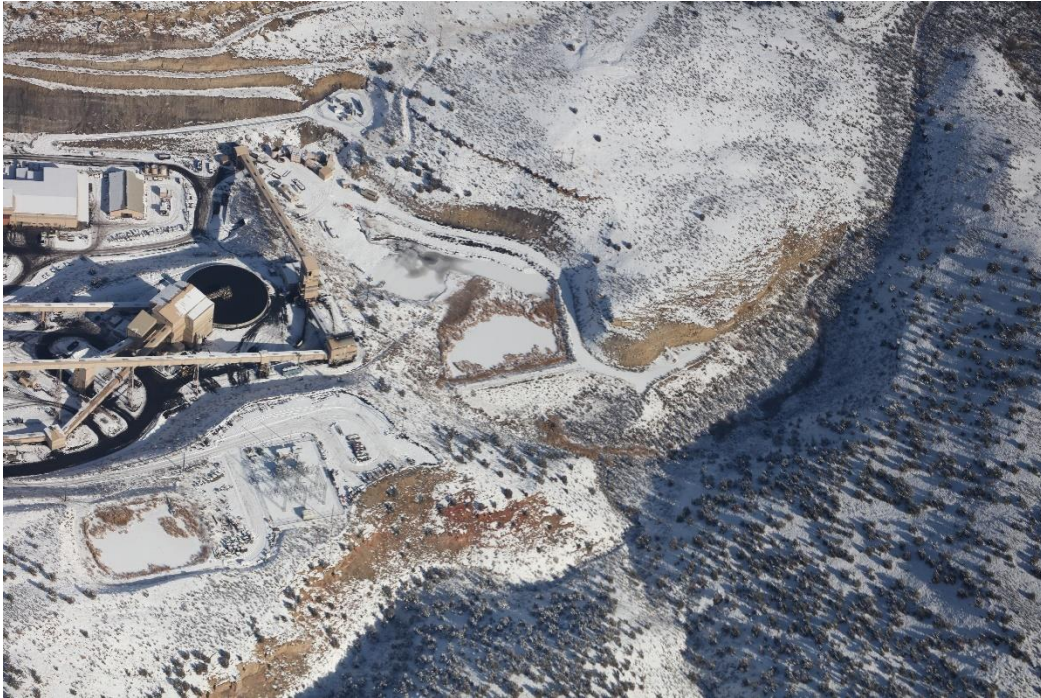
There are three ponds located in the main facilities area: the DP-1 Pond, the PP-1 Pond and the PP-2 Pond. The DP-1 pond was frozen at the time of inspection. The embankments appear stable with vegetative cover showing through the snow. There were no erosional concerns identified. The PP-2 Pond was also frozen. The embankment was stable with no erosional features identified. The outlet structure was in good condition with no vegetation obscuring the outlet. The PP-1 Pond is located on the middle bench of the facilities area. The pond was covered by processing plant structures during the areal inspection. (Photo 1)

Photo 1: Facilities area showing the DP-1 and PP-2 Ponds.

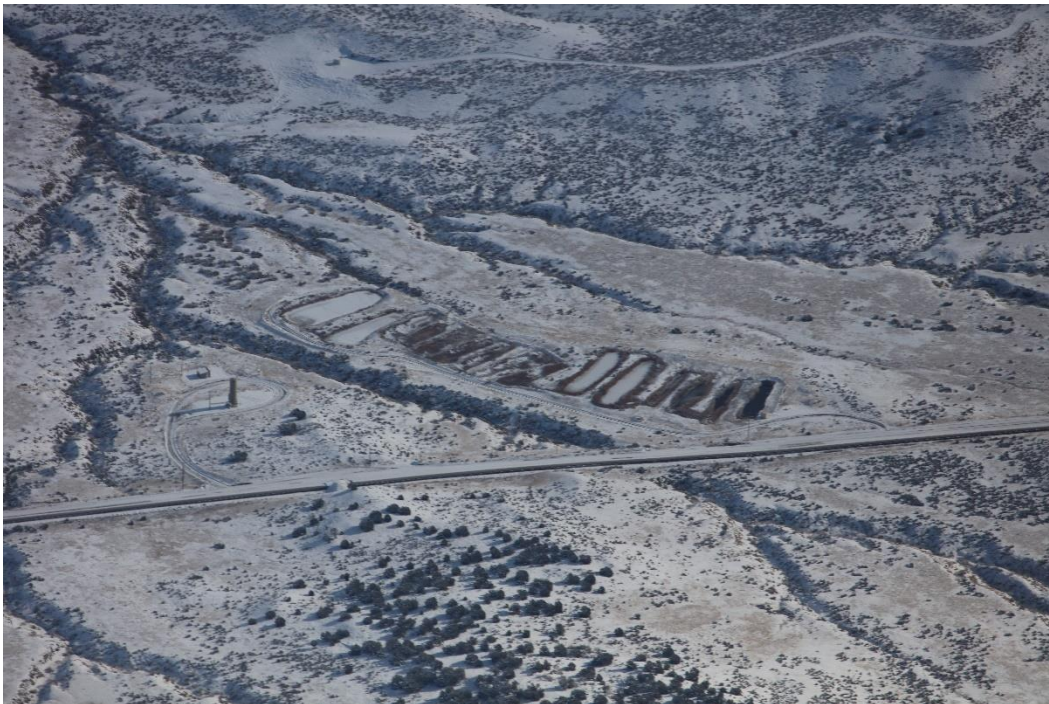
The B Seam Dewatering System No. 1 was active during the inspection. Cells were impounding water and the lower cells were frozen and snow covered. Embankments of the cells were stable with no erosional features noted. The Last Chance Pond appears to be at the approximate level of the discharge. (Photo 2)

Photo 2: B Seam Dewatering System No 1. With RDH-4 in the foreground.

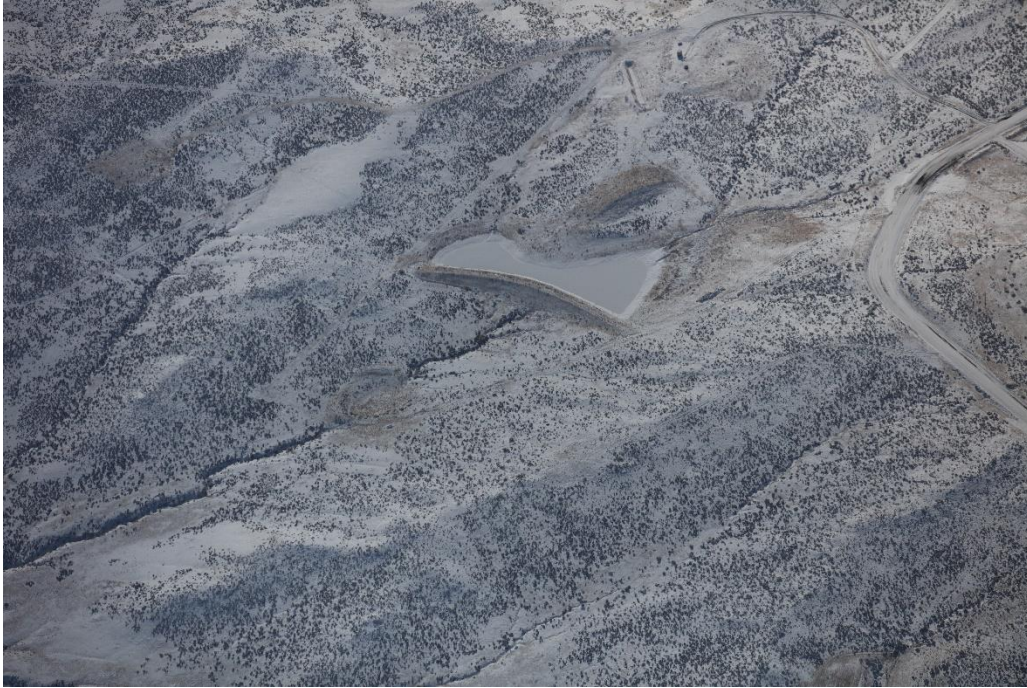
The B Seam Dewatering System No. 2 is located to the east of the Slot Storage. The system was inactive during the inspection. The first cell was snow covered with no indications of water being present. The main cell was holding a small amount of water below the level of discharge. The water was frozen and snow covered. The embankments of the pond were stable with no indications of erosion. (Photo 3)

Photo 3: B Seam Dewatering System No. 2

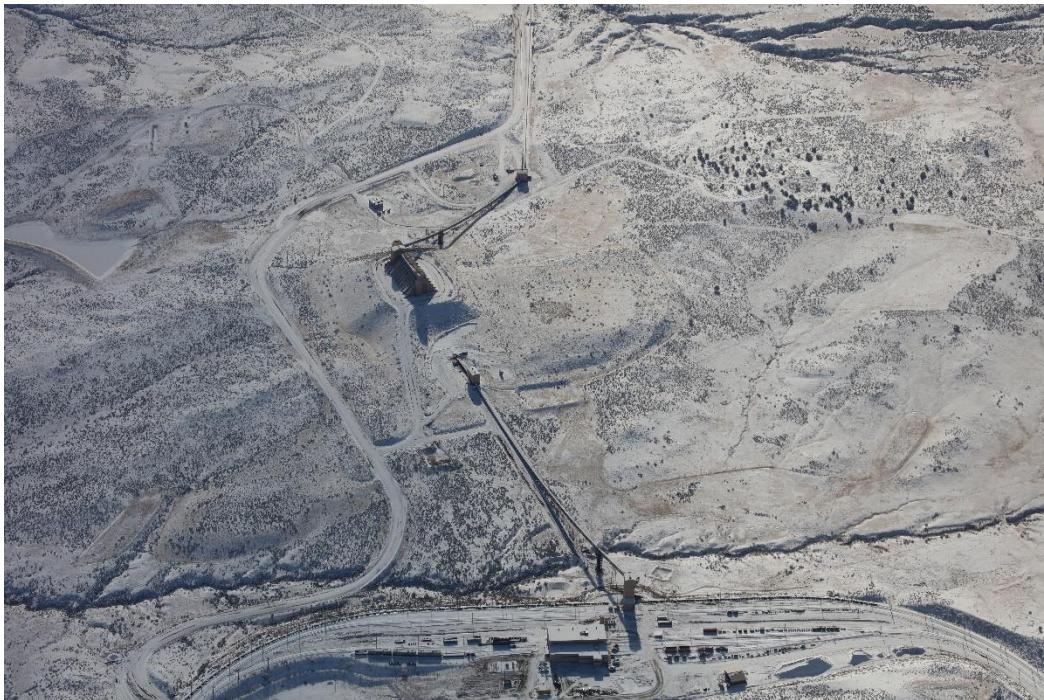
Two ponds, SS-1 and SS-2, are located to the north of the Slot Storage facility. Both ponds were snow covered at the time of inspection. The embankments were also snow covered, but appeared stable. There were no erosional features identified. The outlets of the ponds were clear of debris. (Photo 4)

The RS-1 Sump and the RR-1 Pond are located at the south side of the Rail Loadout. The RS-1 Sump was snow covered at the time of the inspection. There were no indications of erosion. The RR-1 Pond was also snow covered during the inspection. The embankments of the pond seem stable with no erosional features noted. (Photo 4)

Photo 4: Slot Storage Facility and Rail Load Out. Nitrogen Plan No. 2 is to the south of the Slot Storage Facility. Ponds SS-1 and SS-2 are just to the north of the Slot Storage. Sump RS-1 and the RR-1 Pond are just to the south of the Rail Load Out

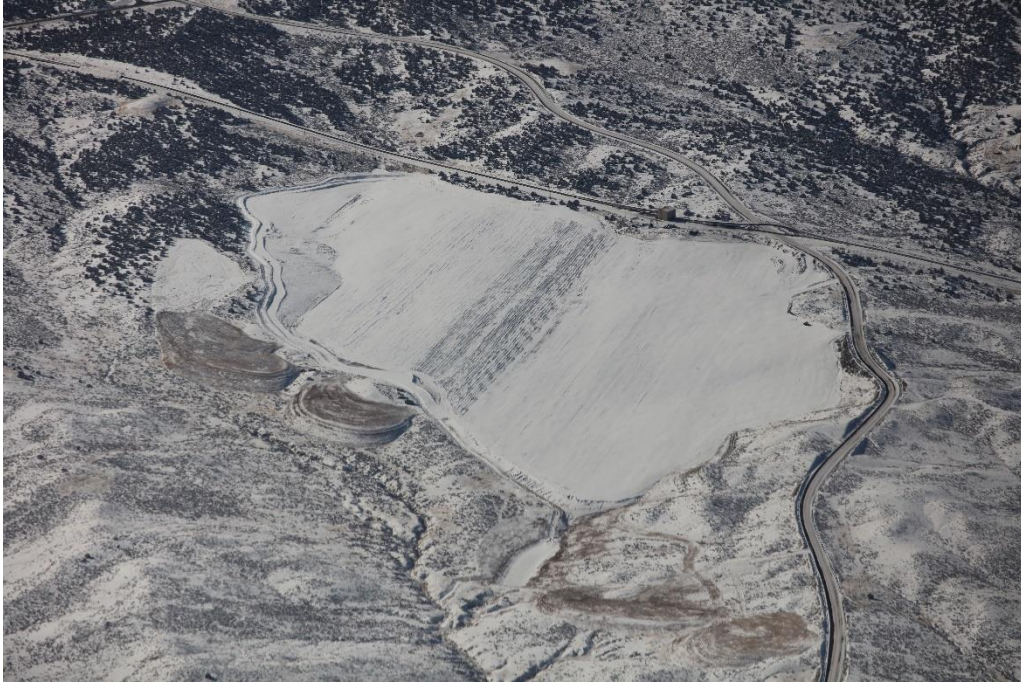
Refuse Disposal Area RP-A has one sediment pond located at its eastern end. The RP-A Pond was snow covered during the inspection. The embankment was stable and no erosional features were noted. (Photo 5)

The RP-A Refuse Pile was snow covered during the inspection. Refuse on the top of the RP-A Refuse Pile appears to have been spread and compacted. The pile was mostly snow covered during the inspection. The pile is stable and no erosional features were noted. (Photo 5)

Photo 5: RP-A Refuse Pile with the RP-A Pond in the foreground.

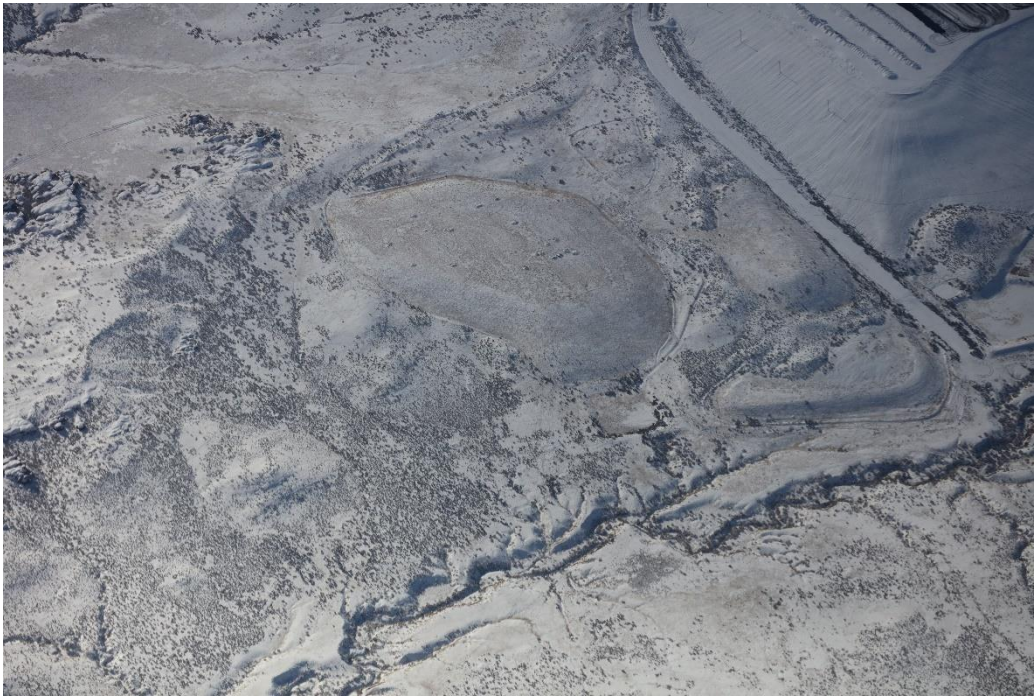
Pond RP-1 is located at the base of the reclaimed RP-1 Refuse Pile. The pond was snow covered during the inspection. The embankments of the pond were stable with no indications of erosion observed. There was no debris on the trash rack over the pond's outlet. (Photo 6)

Photo 6: Reclaimed RP-1 Refuse Pile with RP-1 Pond to the north.

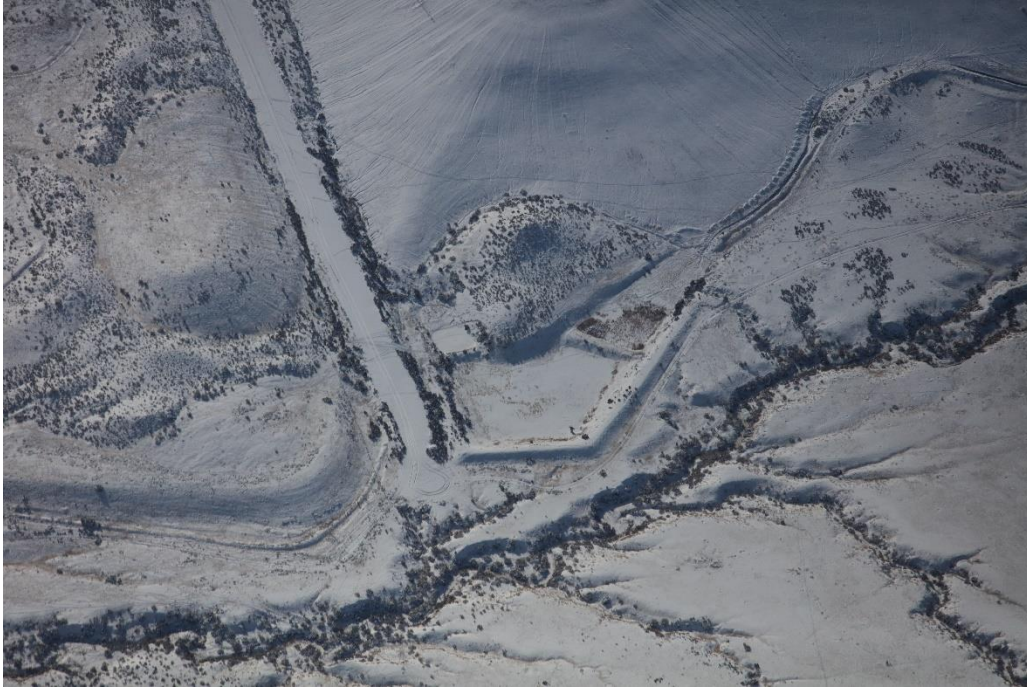
Ungulate tracks can be seen in Pond RP-2/3 and the adjacent road. A number of tracks from either small mammals or waterfowl can also be seen on the ice in the ponds that make up the B Seam Dewatering System No. 1.

Two ponds are located at the northern base of Refuse Pile RP-2/3/4. The RP -2/3 Pond (Photo 7) is located on the pile's northeast corner. The Pond consists of three cells. All three cells were snow covered. There were no erosional features identified. The channels above the ponds were snow covered, but clear of debris. No erosional features were noted on the embankments of the conveyance ditches. The trash rack was clear of debris. The RP-4 Pond is located at the northwest base of the pile. The pond was snow covered during the inspection. The embankments were stable and no erosional concerns were identified. The outlet for the RP-4 Pond is capped with a trash rack. The outlet was clear of debris.

Photo 7: RP-2/3 Pond on the northeast corner of RP-2/3/4 Refuse Pile. Animal tracks can be seen in the pond and adjacent road.

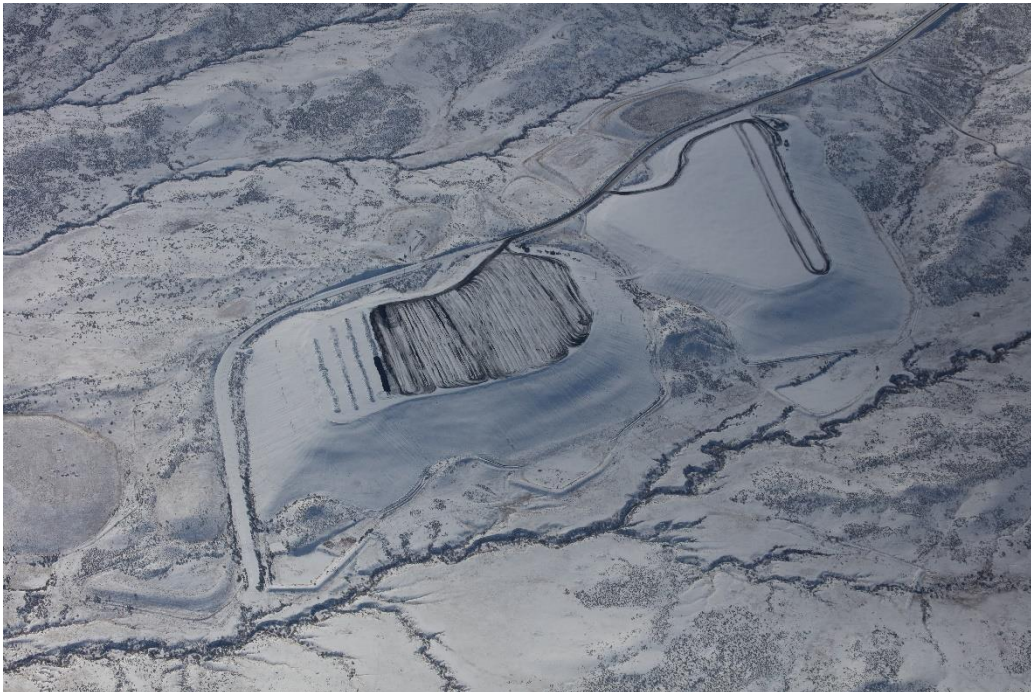
Pond RP-5 is located at the northern base of the RP-5a Refuse Pile. The pond was snow covered at the time of the inspection. The embankments of the pond appear stable, and no indications of erosion were observed. The outlet was clear of obstructions. (Photo 8)

During the inspection refuse material was being placed on the RP-2/3/4 Refuse Pile in windrows. The pile was stable. Erosion on the slopes of the pile has been noted in previous Division inspection reports. The rills have not significantly enlarged since the last inspection. (Photo 8)

Refuse on the top of the RP-5a Pile has been spread and compacted. The pile was snow covered and stable during the inspection. Erosion on the slopes of the pile has been noted in previous Division reports. Similar to the RP-2/3/4 Refuse Pile, these rills have not significantly enlarged since the last inspection. There were no signs of displacement or slumping on the refuse pile. (Photo 8)

Photo 8: RP-2/3/4 and RP-5 Refuse Piles. The RP-2/3, RP-4, and RP-5a Ponds can also be seen in the photo.

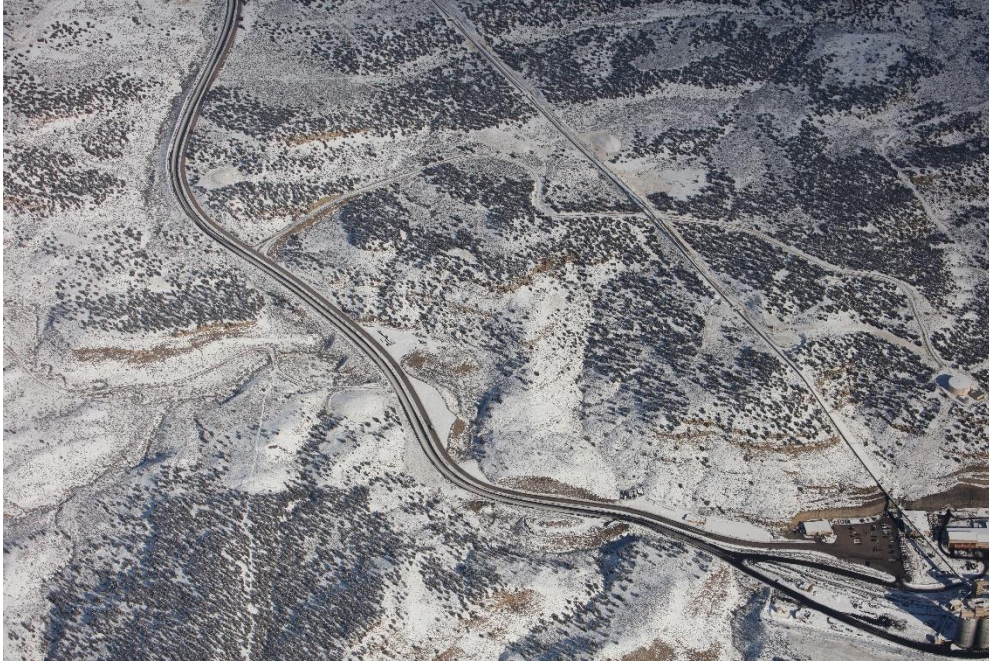
The haul road was plowed and in good condition during the inspection. The road was stable and there were no erosional features identified. Access roads throughout the rest of the mine are mostly snow covered. There were no erosional concerns identified. (Photo 9)

Photo 9: Haul road and conveyor corridor. Water tanks and radio tower can also be seen.

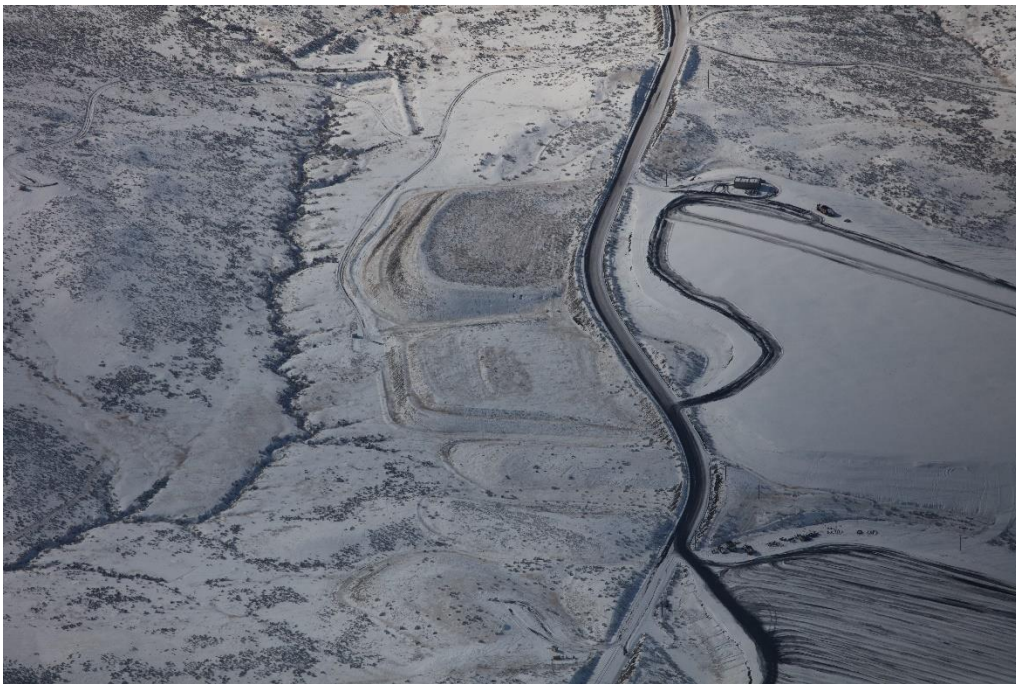
Topsoil stockpiles RA-4 through RA-8 are located next to the RP-2/3/4 and RP-5a Refuse Piles. These topsoil stockpiles were covered with snow during the inspection. There were no indications of erosion or instability observed on any of these stockpiles. (Photo 10)

Photo 10: Topsoil Stockpiles RA-4 through RA-8.
