MINERALS PROGRAM INSPECTION REPORT
PHONE: (303) 866-3567

MINE NAME: Pueblo Cement Plant and Limestone Quarry	MINE/PROSPECTING ID#: M-2002-004	MINERAL: Limestone (general)	COUNTY: Pueblo
INSPECTION TYPE: Monitoring	WEATHER: Clear	INSP. DATE: November 17, 2023	INSP. TIME: 10:30
OPERATOR: GCC Rio Grande, Inc.	OPERATOR REPRESENTATIVE: Amy Rodriguez	TYPE OF OPERATION: 112c - Construction Regular Operation	
REASON FOR INSPECTION: Normal I&E Program	BOND CALCULATION TYPE: Complete Bond	BOND AMOUNT: \$2,539,432.00	
DATE OF COMPLAINT: NA	POST INSP. CONTACTS: None	JOINT INSP. AGENCY: None	
INSPECTOR(S): Brock Bowles	INSPECTOR'S SIGNATURE:

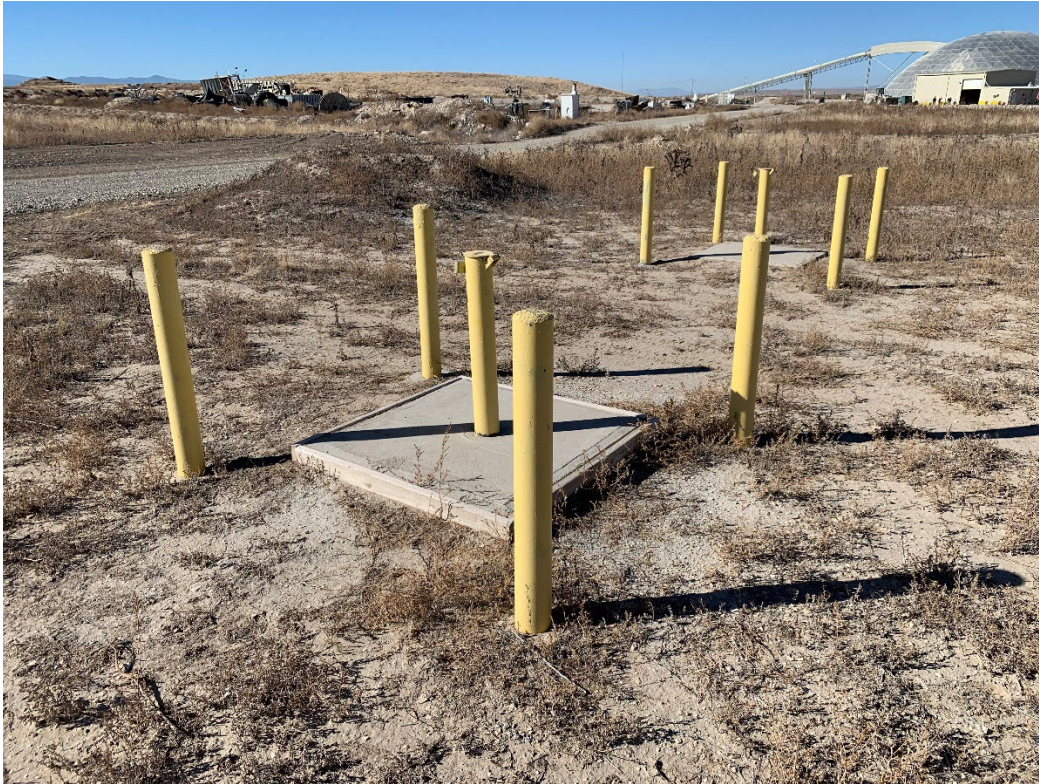
Wells MW-6, MW-7 and MW-8 were inspected. Each well pipe was set in a concrete pad and the well cap was locked. 4 cement filled pipes were set at each corner of the concrete pads to protect the well pipe from being damaged by vehicles. This is the configuration the new wells approved in TR12 will be installed (photo 1).

Photo 1 – Monitoring wells -6, and -7

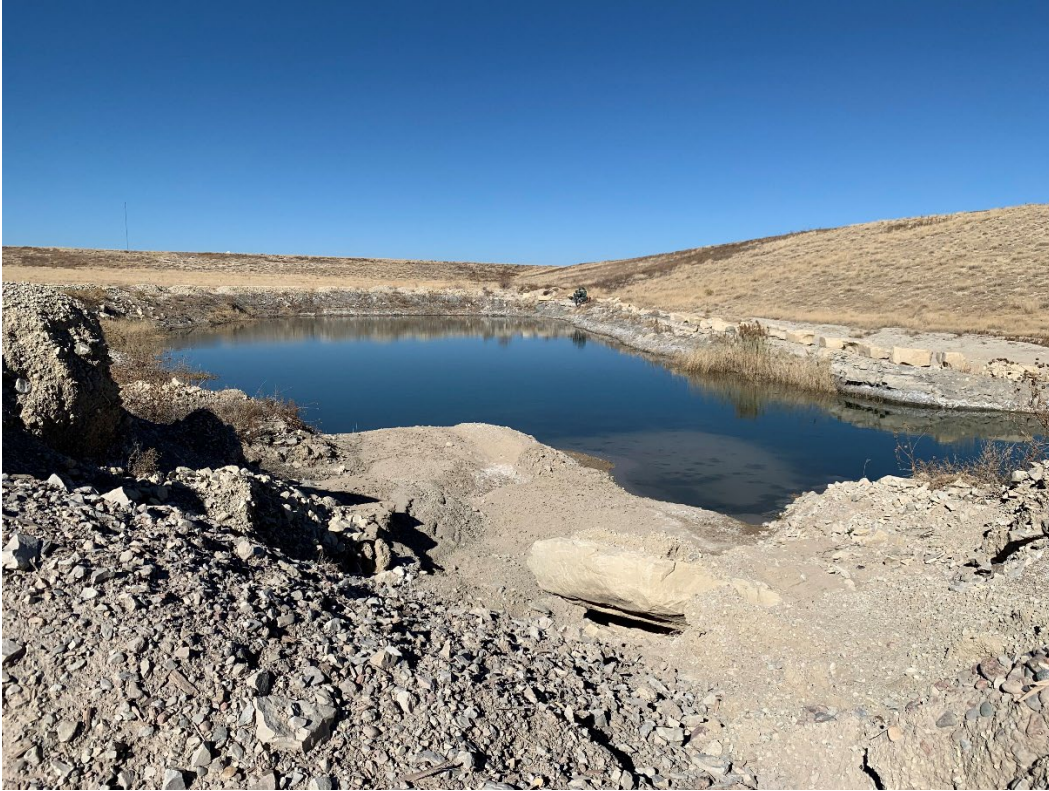
The sediment pond in the northeast corner of Block-1 contained water (photo 2). A pump was located on the west side of the pond and is used to manage the water level by discharging to an unnamed arroyo to the St. Charles River according to Discharge Permit #COG501540.

Photo 2 – Sediment Pond

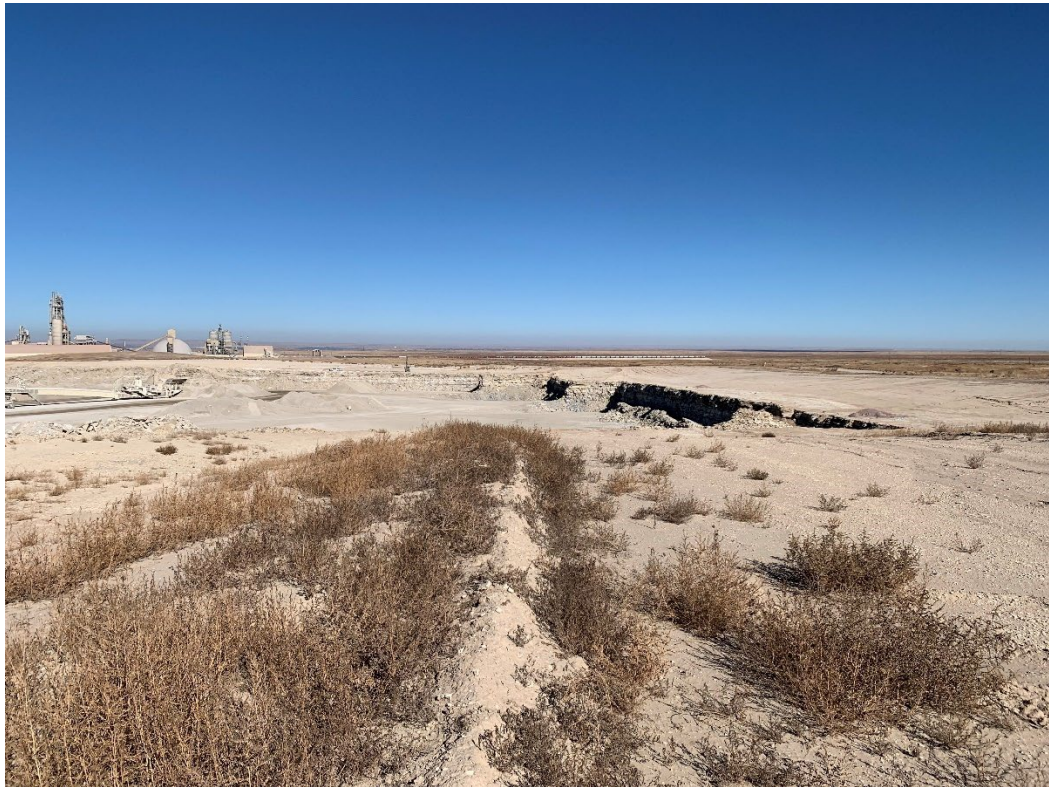
Mining is currently taking place in the northeast section of Block-3 (photo 3). The working highwall is following the northern boundary of Block-3 to the southeast and eventually into Block-4 (see map). A drill rig was drilling holes preparing for the next blast. The conveyor system has been set up to move material from the northeast sections of Blocks-3 and -4.

Photo 3 – Active mining highwall in Block-3

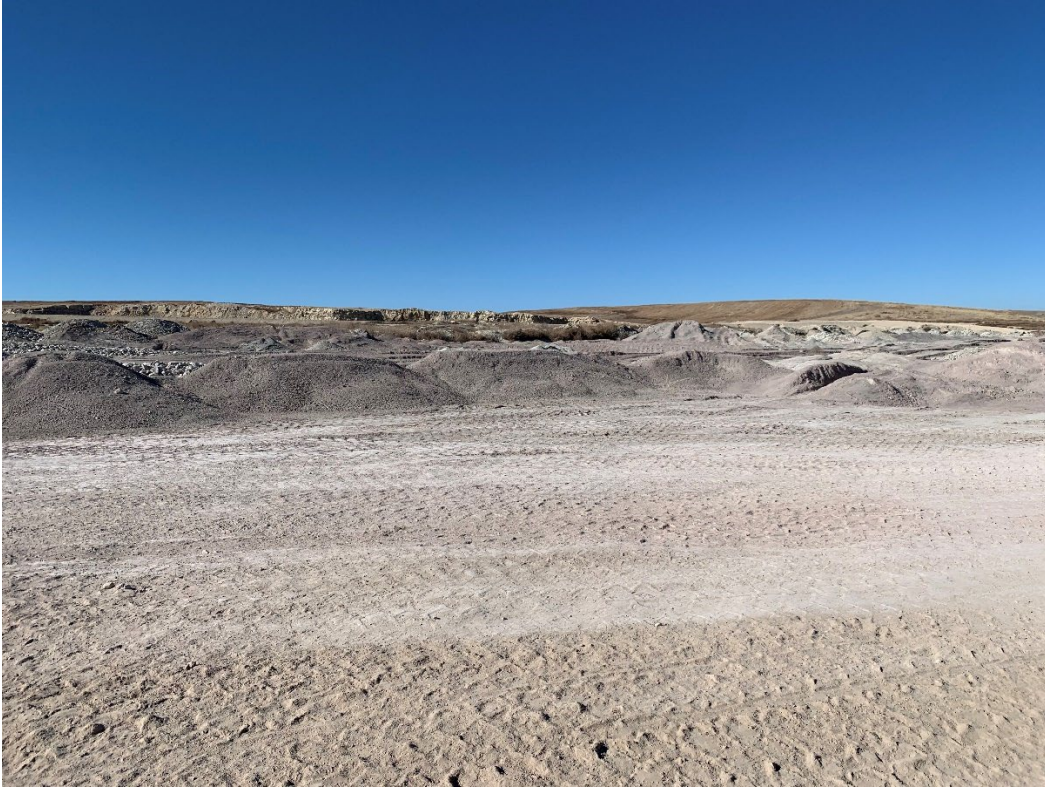
Mining was not taking place in the southwest section of Block-3 (photo 4). This area was being utilized for material and overburden storage. No backfill or grading has been completed in this area.

Photo 4 – Southwest area of Block-3

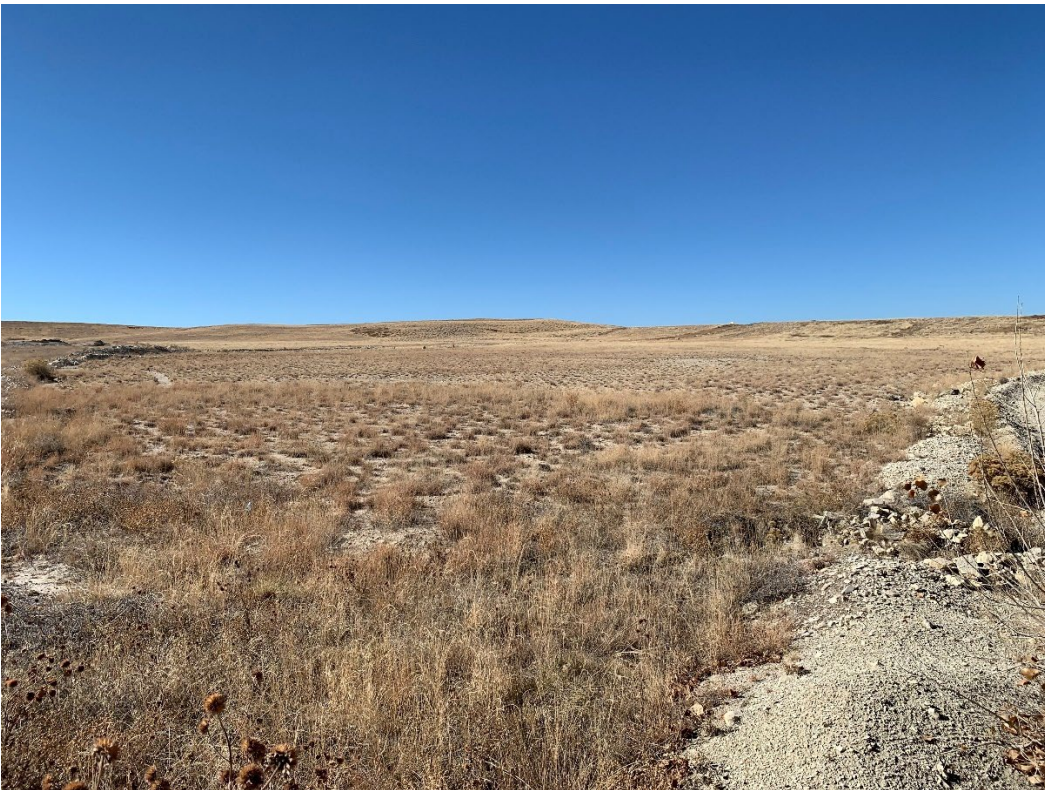
The northern part of the mining area is known as Block-1 (photo 5). This area is mostly reclaimed with the slopes graded, the pit floor was graded, and vegetation is growing. Only the main haul road, conveyor corridor and the sediment pond need to be reclaimed in Block-1.

Photo 5 – Mining area Block-1
